# **LIDAR Inspection Report of VUP ch.915 + 100**

**Bridge Chainage:** 915 + 100 (CKRP)

## **CH: 915+100 – VUP**

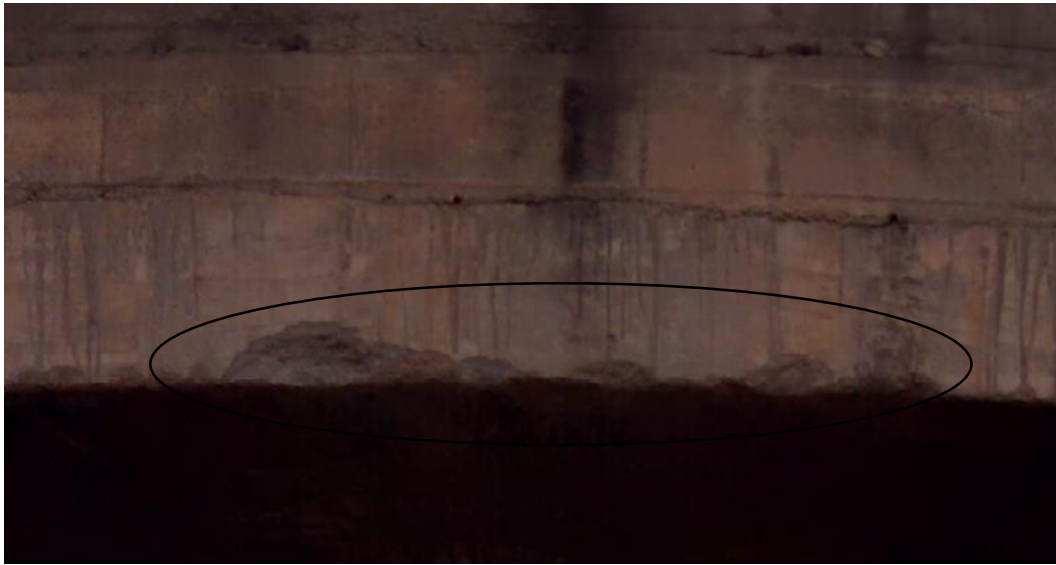
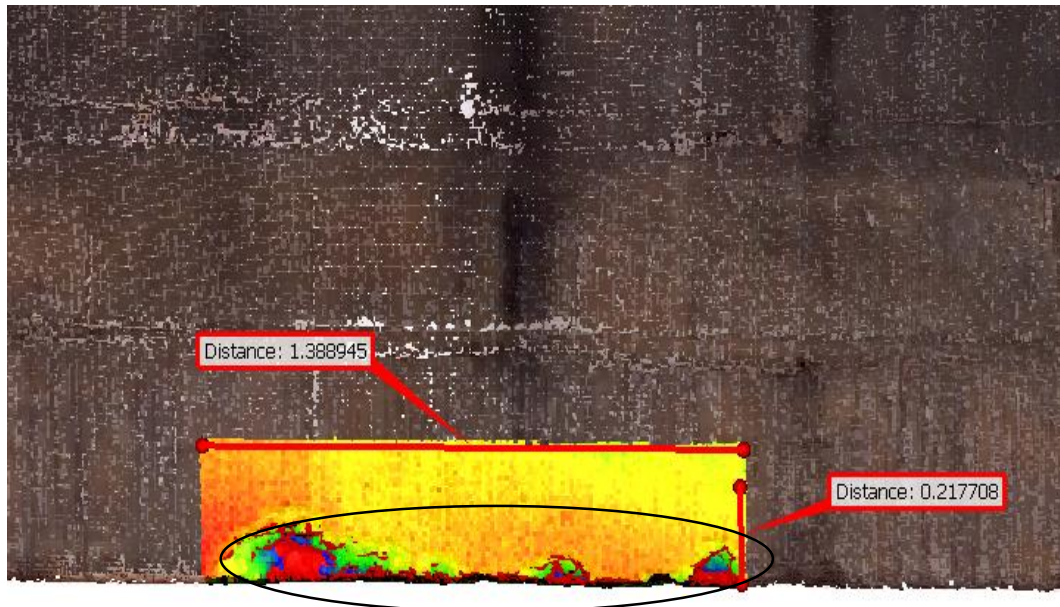
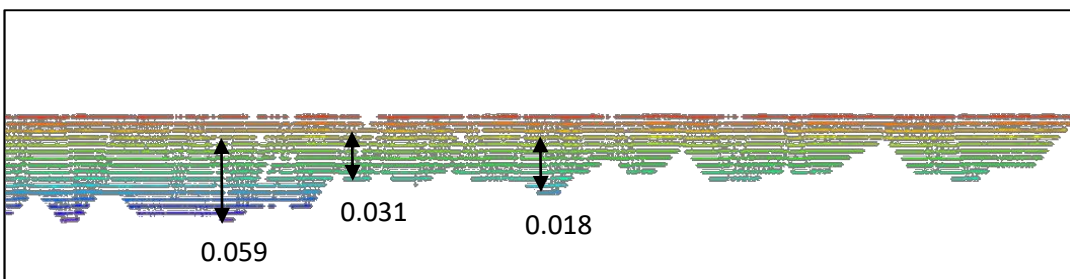
| Element Name | Observation | Location of Distress | Photo No. | Units | Distress Details | | | Area of Repair (Sq.m/ RMT/ m3) |
|---|---|---|---|---|---|---|---|---|
| Parapet Wall | Damage | | 1 | M | 1.38 | 0.21 | 0.031 | 0.0089 |

**1. Damage observed on RHS Parapet Wall 1, measuring 1.38 m in length and 0.21 m in width, Depth ranges from 0.018 m (min) to 0.059 m (max), with an average depth of 0.031 m. The calculated volume of the distress is 0.0089 m<sup>3</sup>.**

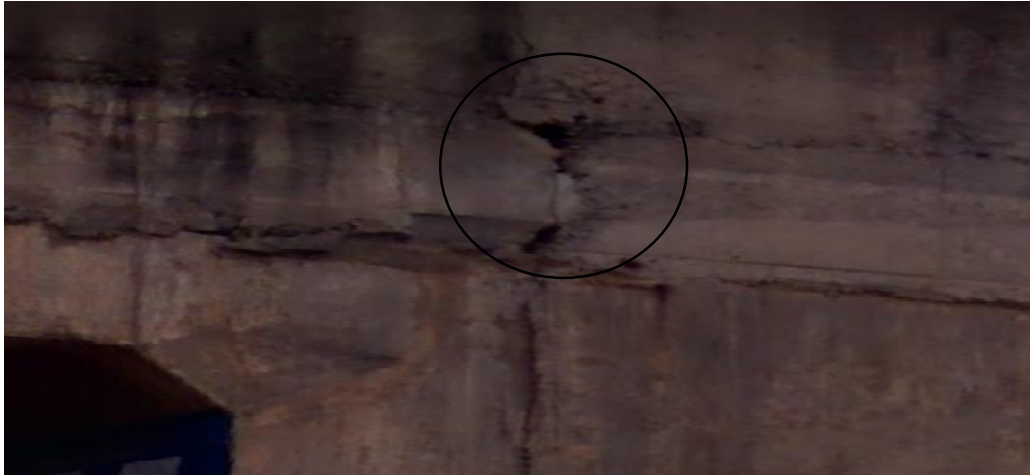
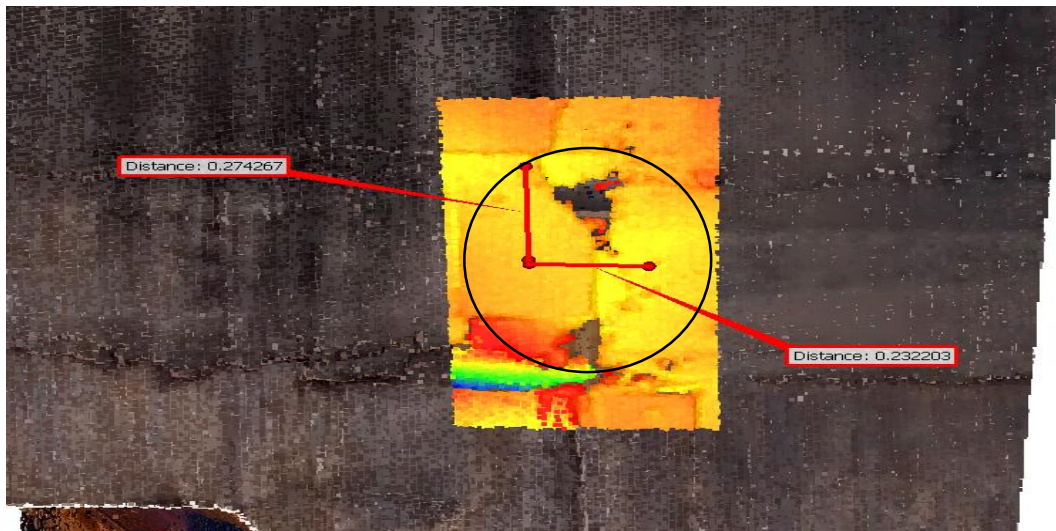
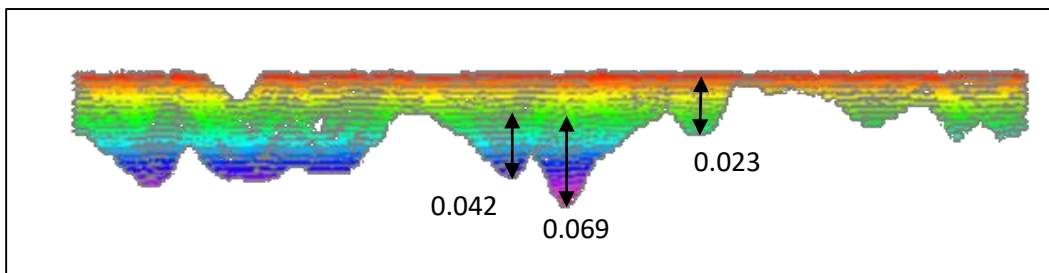
| Element Name | Observation | Location of Distress | Photo No. | Units | Distress Details | | | Area of Repair (Sq.m/ RMT/ m3) |
|---|---|---|---|---|---|---|---|---|
| Parapet Wall | Damage | | 2 | M | 0.27 | 0.23 | 0.042 | 0.0026 |

**2. Damage observed on RHS Parapet Wall 2, measuring 0.27 m in length and 0.23 m in width, Depth ranges from 0.023 m (min) to 0.069 m (max), with an average depth of 0.042 m. The calculated volume of the distress is 0.0026 m<sup>3</sup>.**

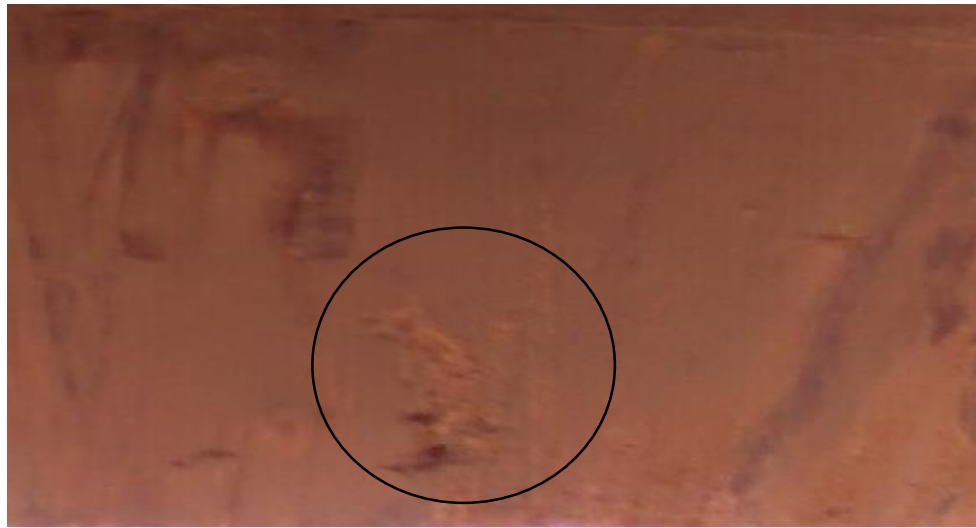
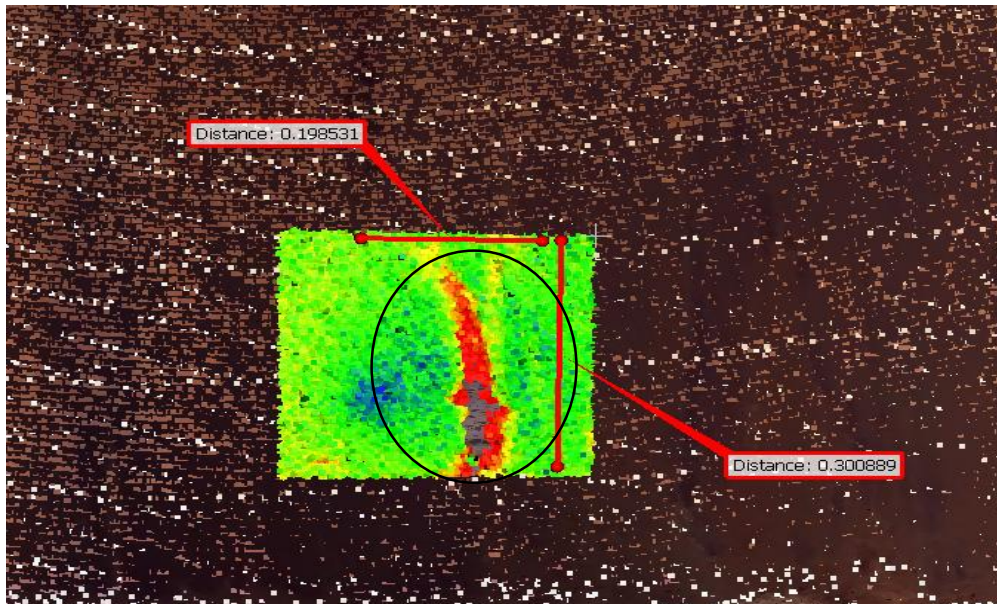
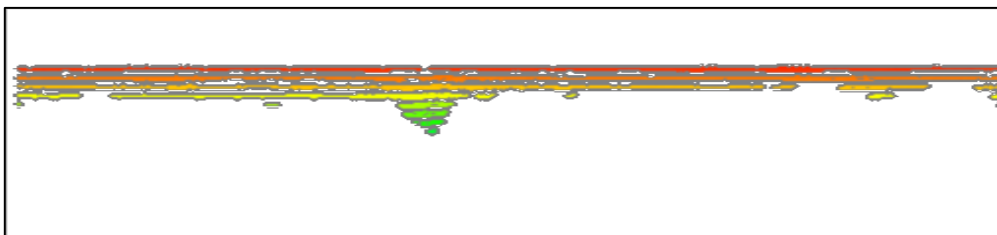
| Element Name | Observation | Location of Distress | Photo No. | Units | Distress Details | | | Area of Repair (Sq.m/ RMT/ m3) |
|---|---|---|---|---|---|---|---|---|
| Slab Bottom | Scaling | | 3 | M | 0.30 | 0.19 | | 0.057 |

**3. Scaling observed on RHS Slab Bottom , measuring 0.30 m in length and 0.19 m in width, covering an area of 0.0570 m<sup>2</sup>.**
