# **LIDAR Inspection Report of Box Culvert ch.915+853**

**Bridge Chainage:** 915+853

- **Bridge No:** -
- **Chainage:** 915+853
- **Structure type:** Box Culvert

# **CH: 915+853 BOX CULVERT**

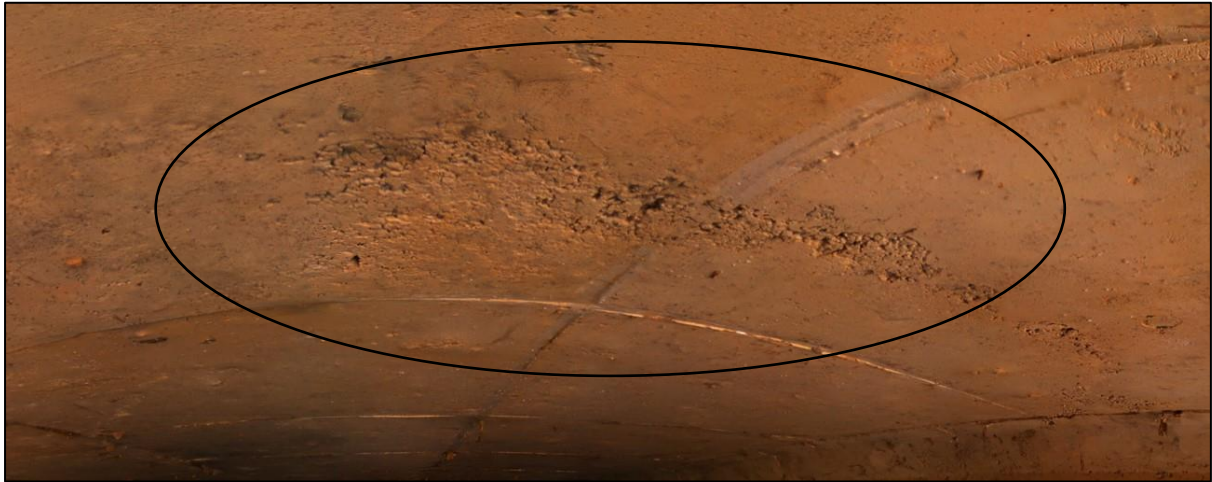
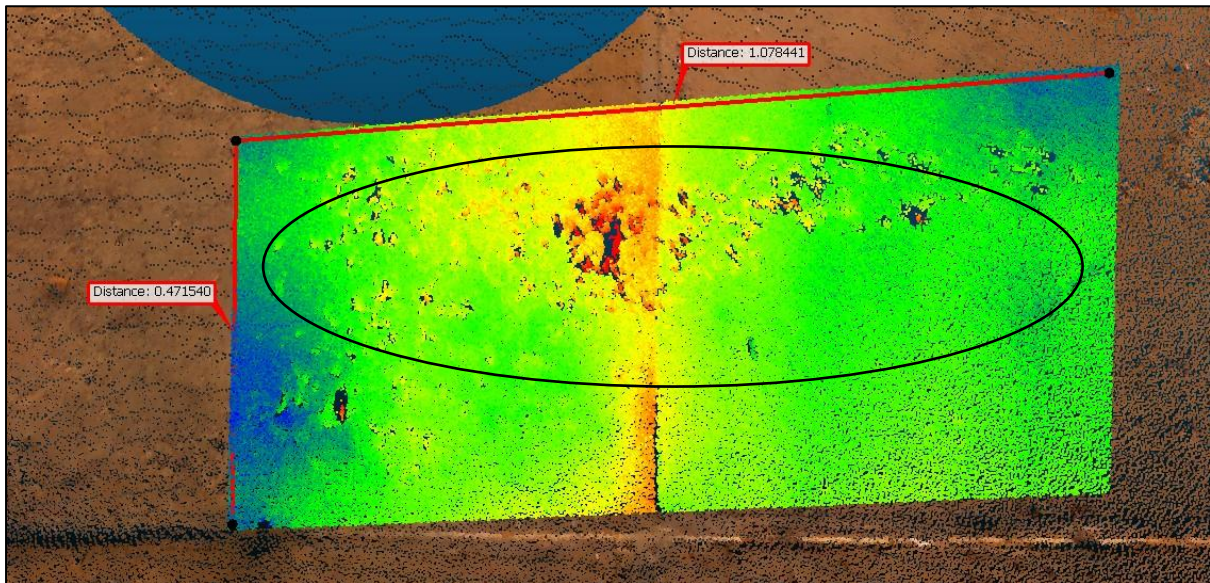
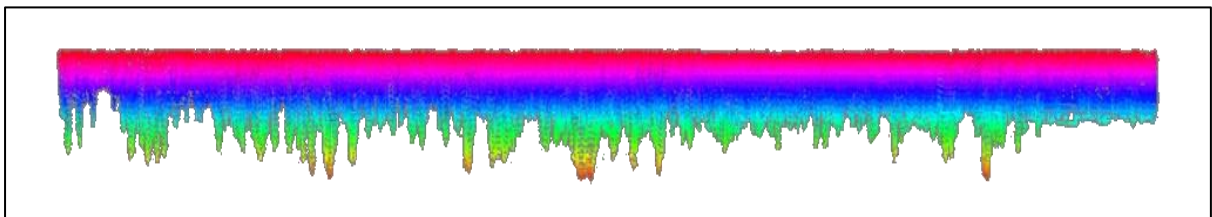
| Element Name | Observation | Location of Distress | Photo No. | Units | Distress Details | | | Area of Repair (Sq.m/R MT/m3) |
|---|---|---|---|---|---|---|---|---|
| Deck Slab | Scalling | - | 1 | Sq m | 1.07 | 0.47 | - | 0.50 |

**1. Scaling observed on deck slab LHS side, measuring 1.07 m in length and 0.47 m in width, covering an area of 0.50 m<sup>2</sup>.**

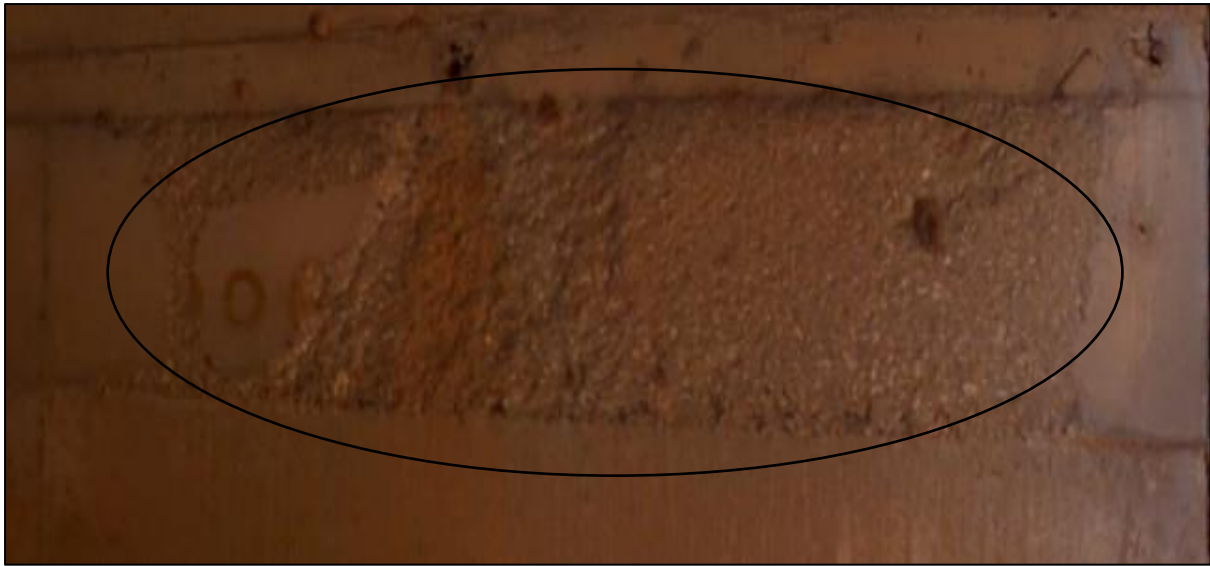
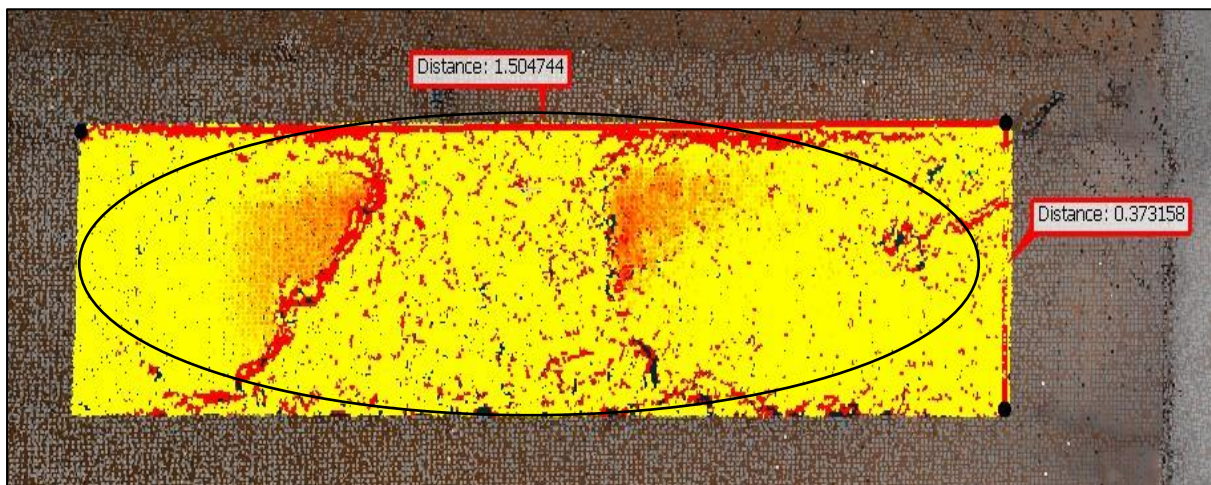
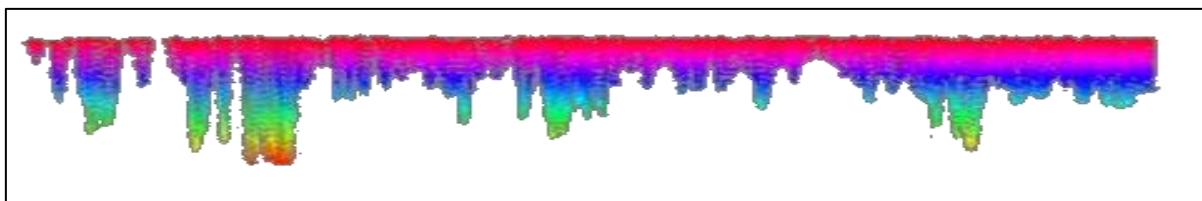
| Element Name | Observation | Location of Distress | Photo No. | Units | Distress Details | | | Area of Repair (Sq.m/R MT/m3) |
|---|---|---|---|---|---|---|---|---|
| Abutment 2 | Scalling | - | 2 | Sq m | 1.50 | 0.37 | - | 0.55 |

**2. Scaling observed on Abutment 2 RHS side, measuring 1.50 m in length and 0.37 m in width, covering an area of 0.55 m<sup>2</sup>.**
