# **LIDAR Inspection Report of MNB ch.916+750**

**Bridge No:** 917/2

**Bridge Chainage:** 916+750

- **CKRP:** Chittorgarh to kota
- **State:** Rajasthan NH 27
- **Zone:** RJ-20

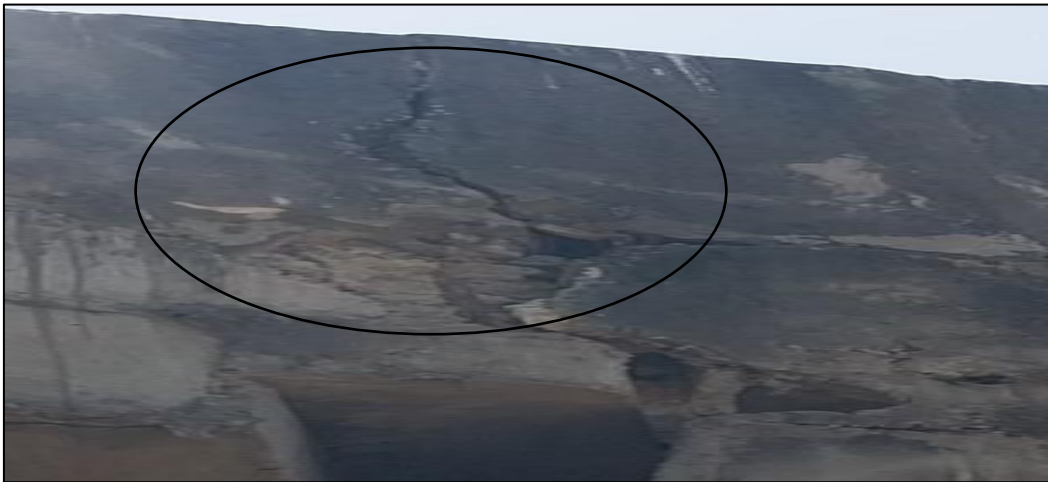
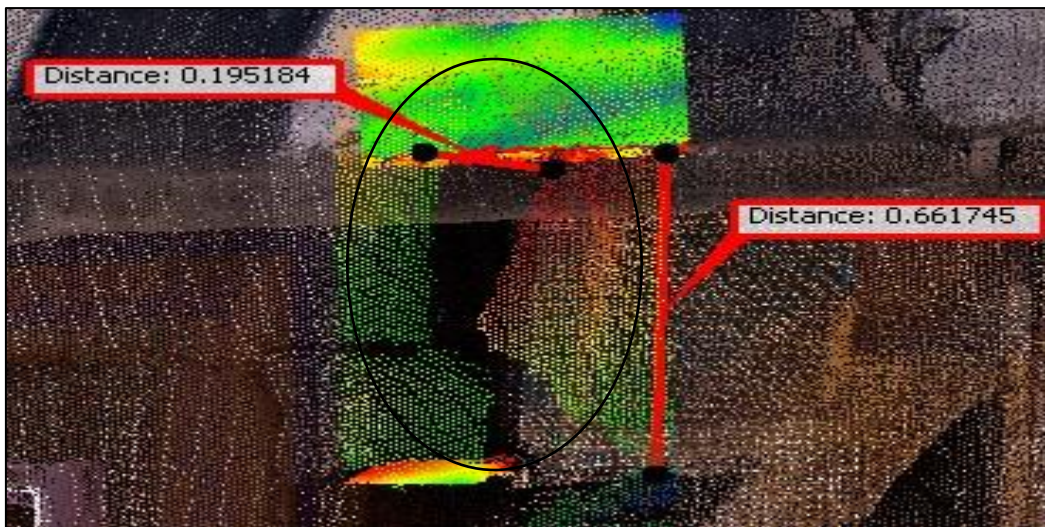
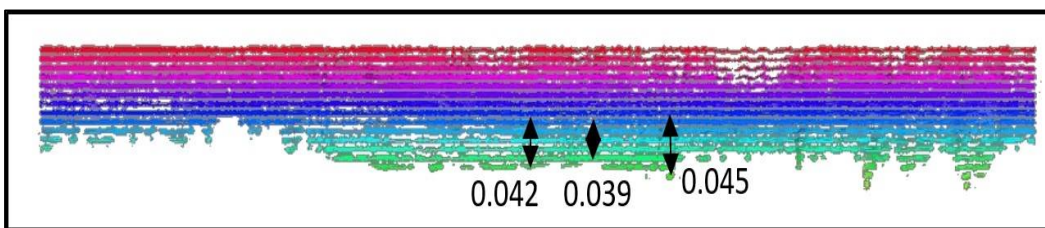
| Element Name | Observation | Location of Distress | Photo No. | Units | Distress Details | | | Area of Repair (Sq./RM T/m3) |
|---|---|---|---|---|---|---|---|---|
| Abutment 1 | Damage & Scaling | | 1 | Cu m | 0.661 | 0.195 | 0.042 | 0.00541 |

**1.Damage & SE (Steel Exposed) observed on A1 (LHS), measuring 0.661 m in length and 0.195 m in width, covering an area of 0.00541 m<sup>2</sup>, with an average depth of 0.042 m.**

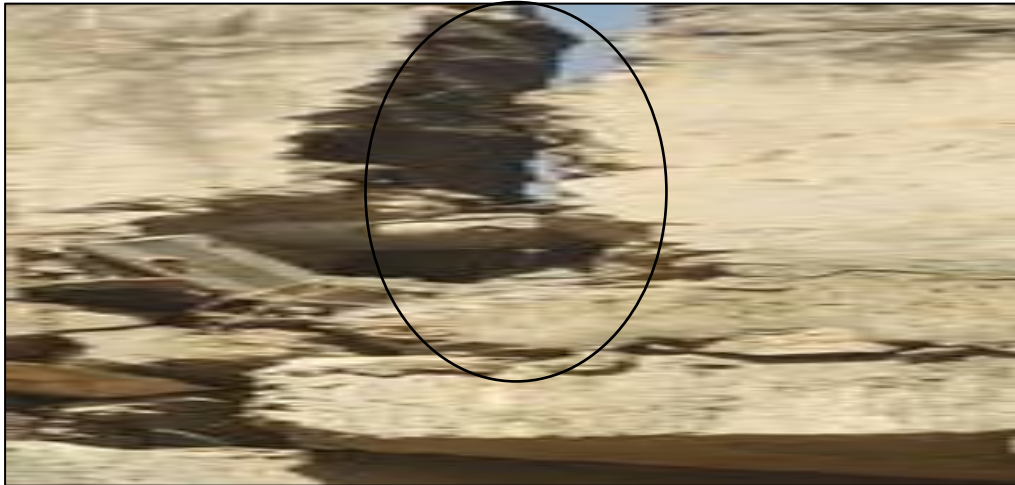
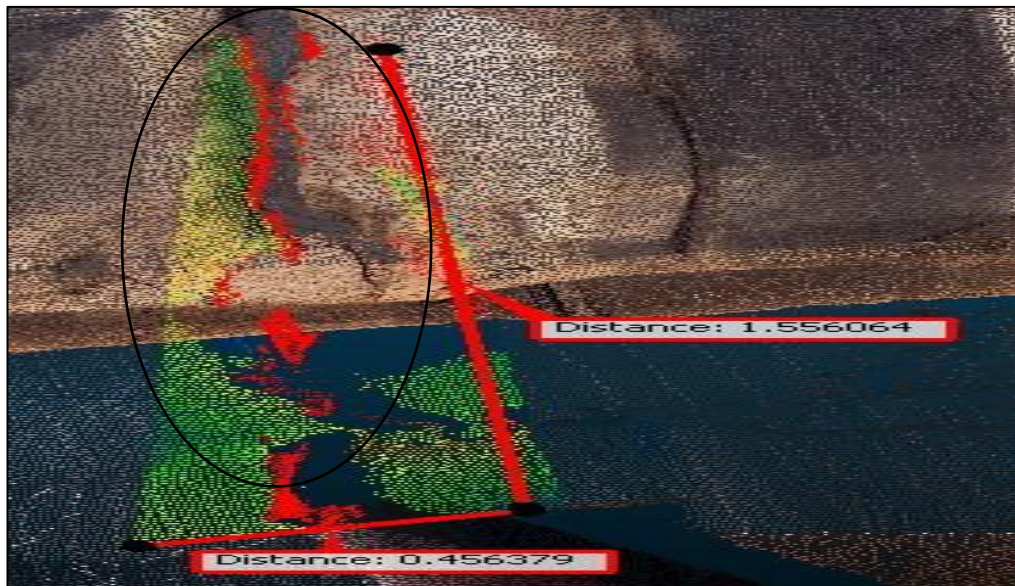
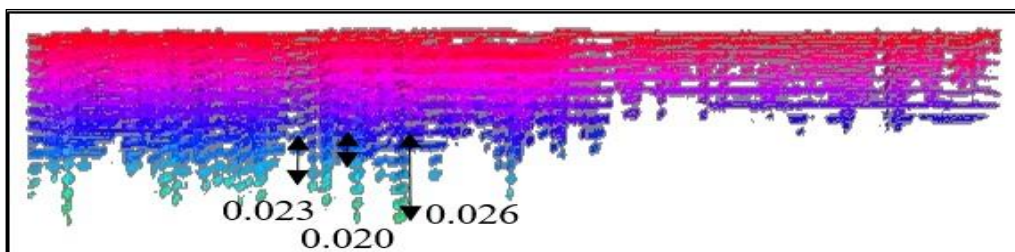
| Element Name | Observation | Location of Distress | Photo No. | Units | Distress Details | | | Area of Repair (Sq./RM T) |
|---|---|---|---|---|---|---|---|---|
| Expansion Joint | Damage | | 2 | Cu m | 1.556 | 0.456 | 0.023 | 0.01631 |

**2. Expansion Joint Damaged** observed on A1 (RHS), measuring 1.556 m in length and 0.456 m in width, covering an area of 0.01631 m<sup>2</sup>, with an average depth of 0.023 m

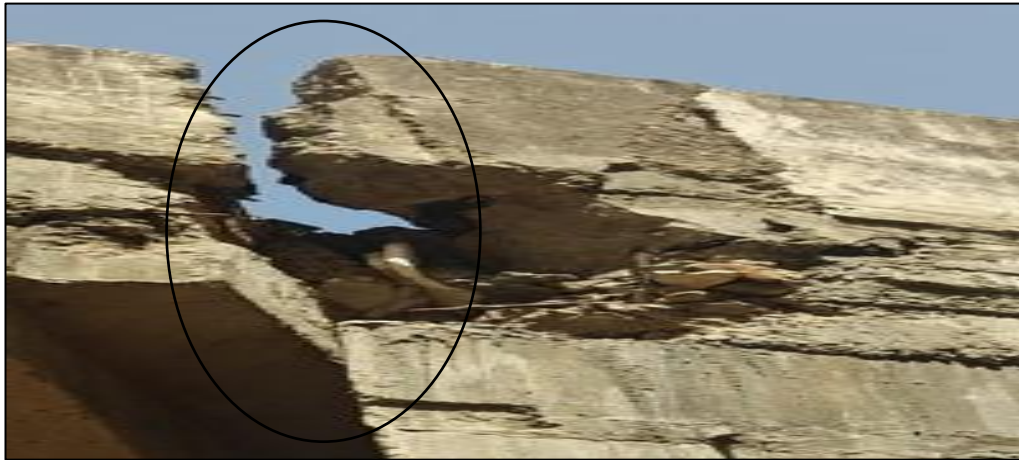
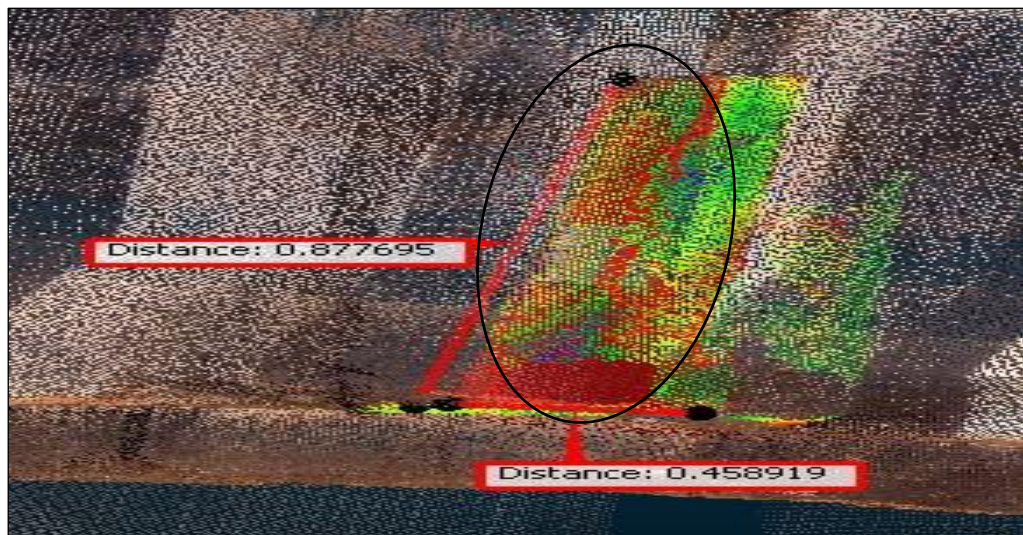
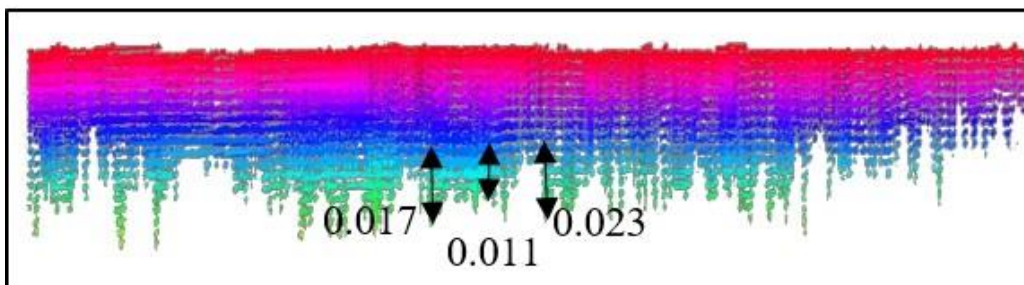
| Element Name | Observation | Location of Distress | Photo No. | Units | Distress Details | | | Area of Repair (Sq./RM T) |
|---|---|---|---|---|---|---|---|---|
| Expansion Joint | Damage | | 3 | Cu m | 0.877 | 0.458 | 0.017 | 0.00682 |

**3. Expansion Joint Damaged observed on A2 (RHS), measuring 0.877 m in length and 0.458 m in width, covering an area of 0.00682 m<sup>2</sup>, with an average depth of 0.017 m.**
