# **LIDAR Inspection Report of MNB ch.917+700**

**Bridge No:** MNB – 918/5

**Bridge Chainage:** 917 + 700 (CKRP)

- CKRP: Chittorgarh to kota
- State: Rajasthan NH 27
- Zone: RJ-06

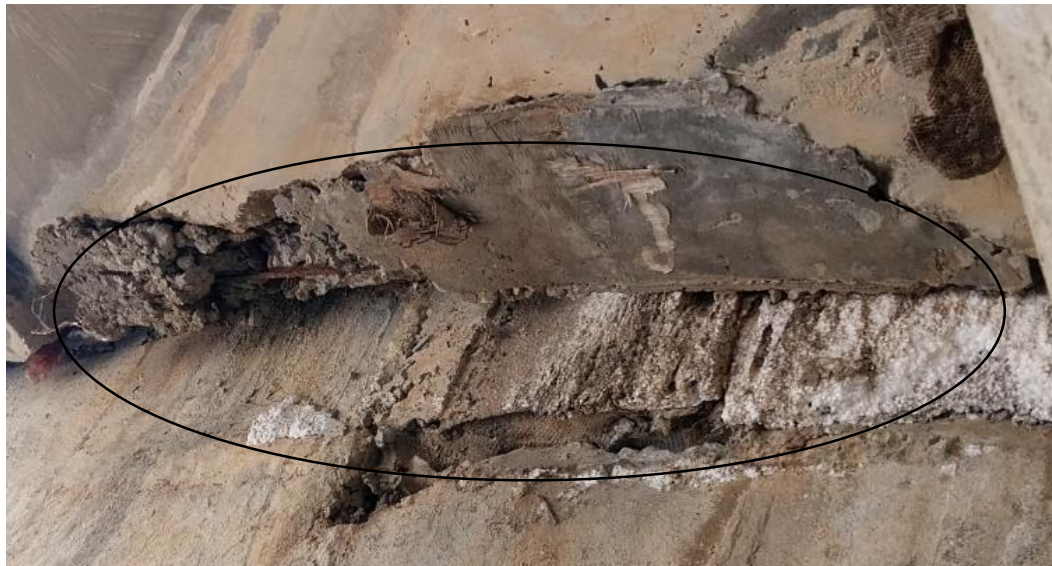
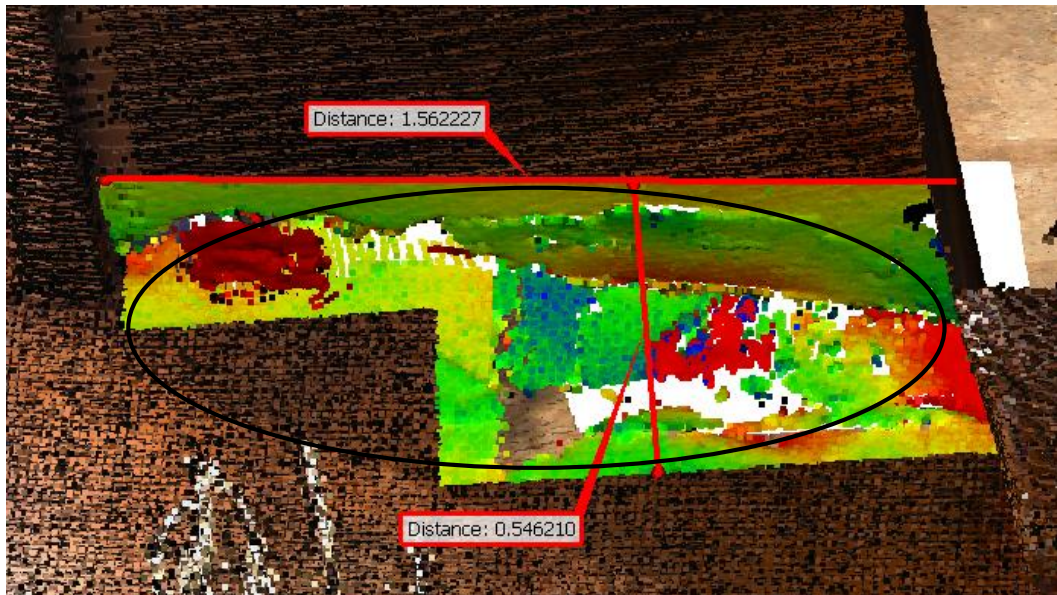
| Element Name | Observation | Location of Distress | Photo No. | Units | Distress Details | | | Area of Repair (Sq./RM T/m3) |
|---|---|---|---|---|---|---|---|---|
| Dirt Wall | Spalling and Steel Expose | | 1 | M | 1.56 | 0.54 | 0.054 | 0.0454 |

1. Spalling and Steel Exposure distress observed on the LHS at Abutment 1 along the dirt wall ,measuring 1.56 m in length and 0.54 m in width. Depth ranges from 0.037 m (min) to 0.066 m (max), with an average depth of 0.054 m. The calculated volume of the distress is 0.0454 m<sup>3</sup>.

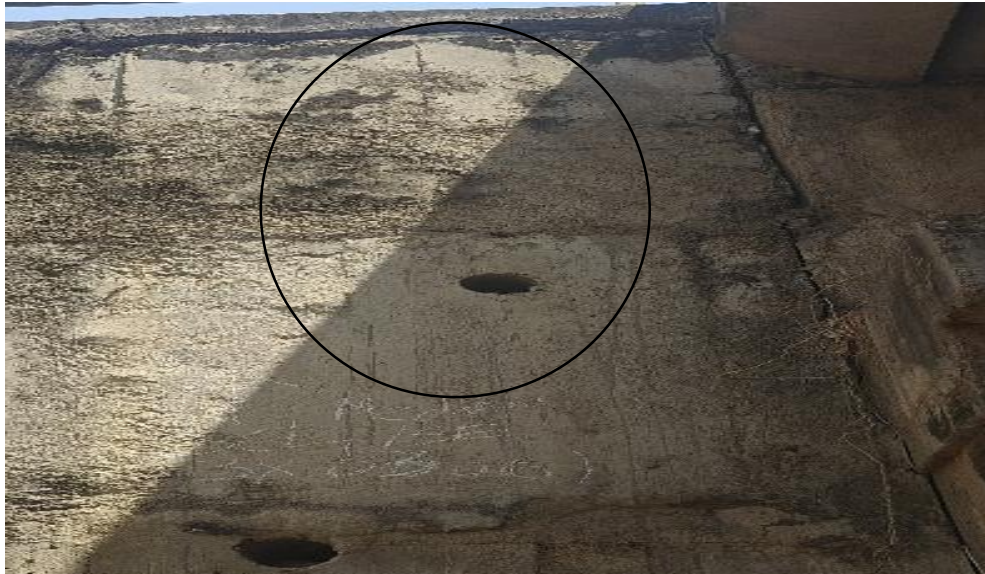
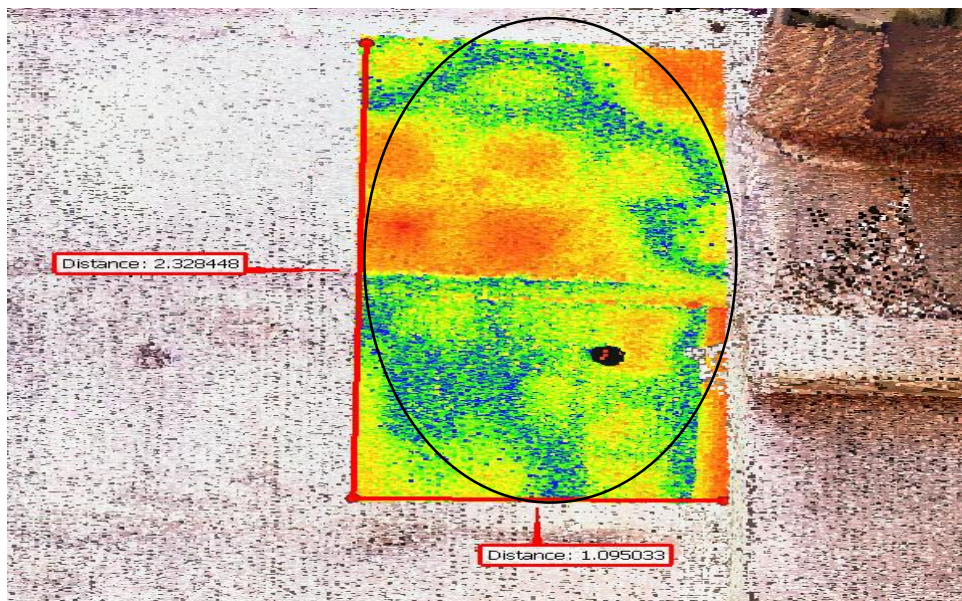
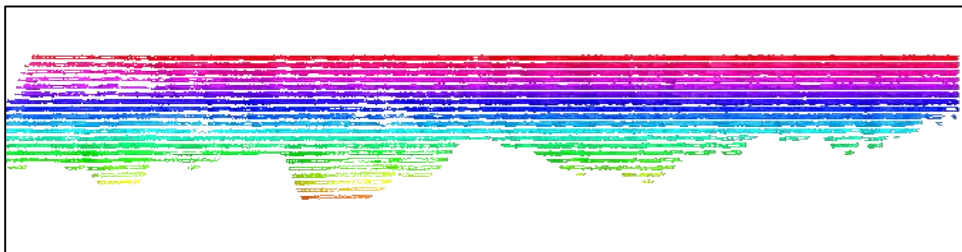
| Element Name | Observation | Location of Distress | Photo No. | Units | Distress Details | | | Area of Repair (Sq.m/R MT) |
|---|---|---|---|---|---|---|---|---|
| Median | Spalling and Steel Expose | | 2 | M | 2.32 | 1.09 | | 2.52 |

2. Spalling observed at Abutment 2 on the median side , measuring 2.32 m in length and 1.09 m in width, covering an area of 2.52 m<sup>2</sup>.

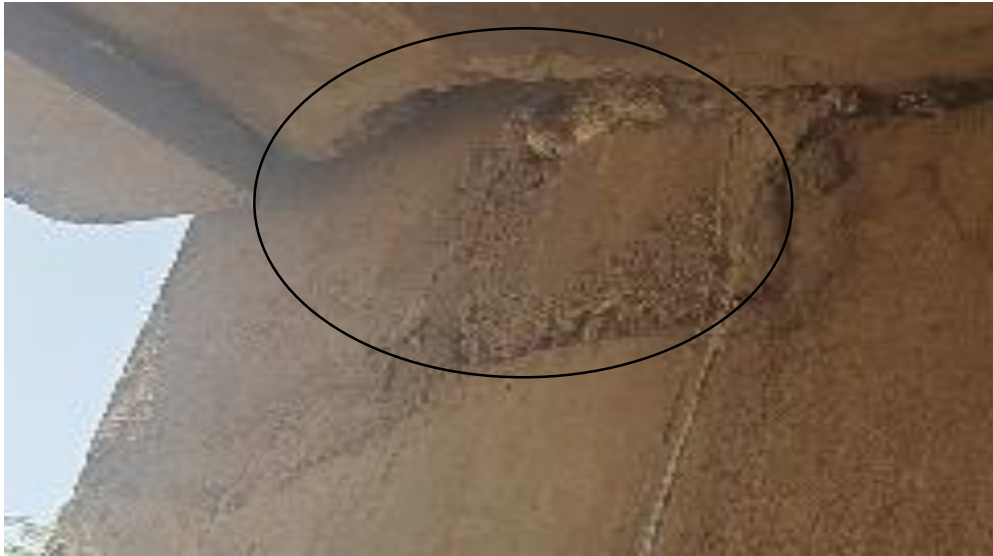
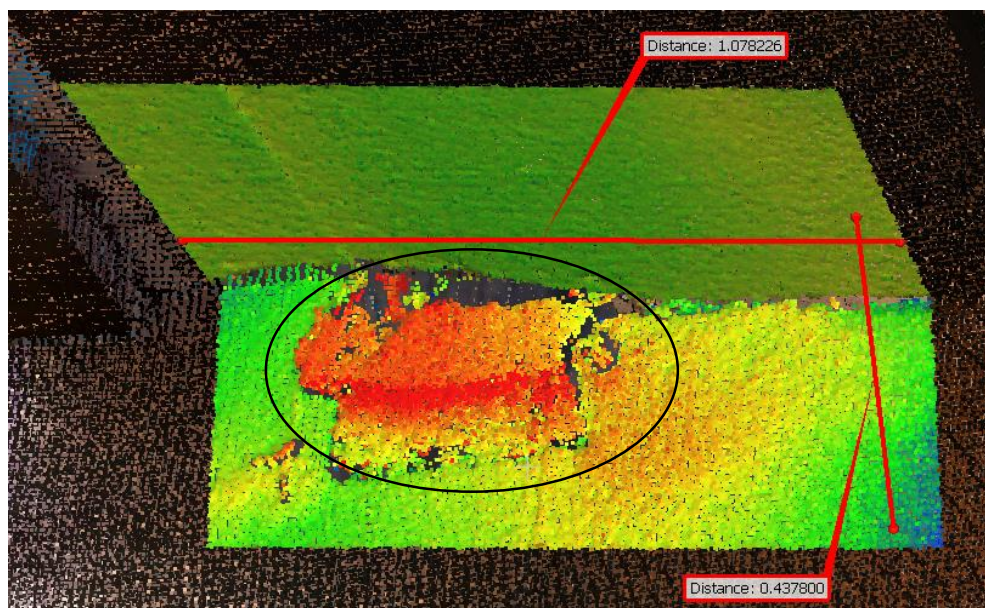
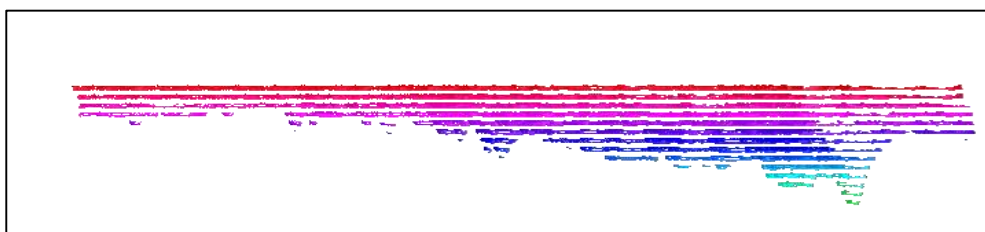
| Element Name | Observation | Location of Distress | Photo No. | Units | Distress Details | | | Area of Repair (Sq.m/R MT) |
|---|---|---|---|---|---|---|---|---|
| Dirt Wall | Honeycombing | | 3 | M | 1.07 | 0.43 | | 0.4601 |

3. Honey Combing Distress observed at Abutment 1 RHS along the dirt wall, measuring 1.07 m in length and 0.43 m in width, covering an area of 0.4601 m<sup>2</sup>.

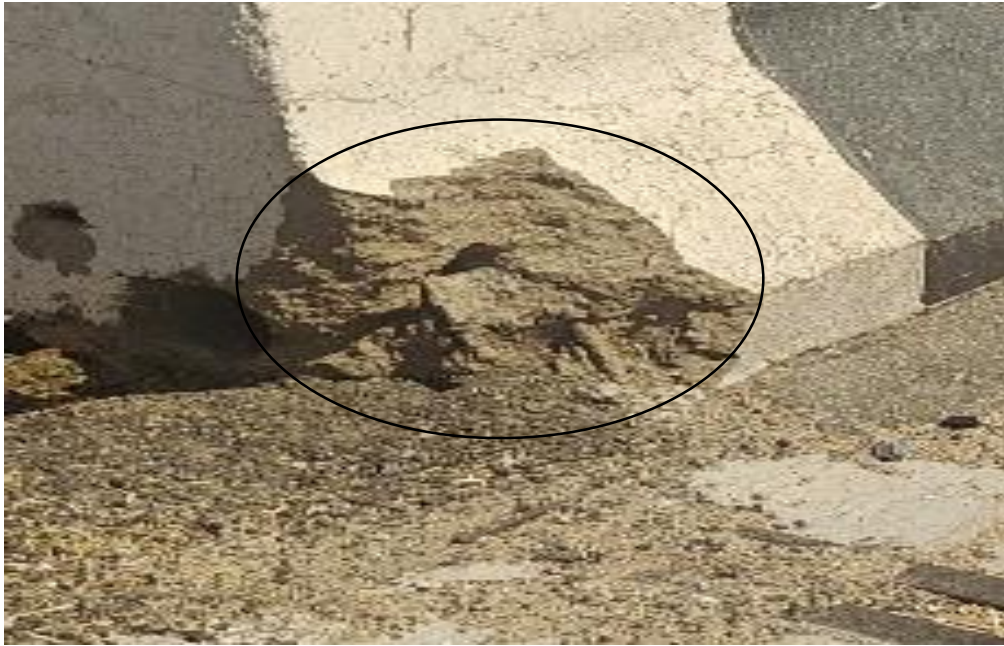
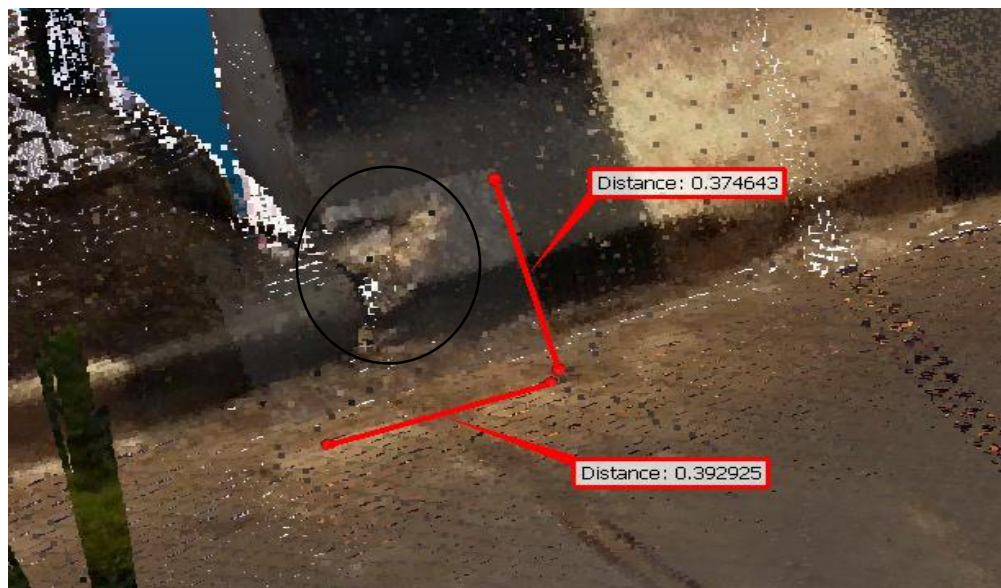
| Element Name | Observation | Location of Distress | Photo No. | Units | Distress Details | | | Area of Repair (Sq.m/R MT) |
|---|---|---|---|---|---|---|---|---|
| Crash barrier | Damage | | 4 | M | 0.39 | 0.37 | | 0.1443 |

- 4. Crash barrier damage observed on RHS at Abutment 1, measuring 0.39 m in length and 0.37 m in width, covering an area of 0.1443 m<sup>2</sup>.**
