# LIDAR Inspection Report of **Box Culvert** ch.917+005

**Bridge Chainage:** 917+005 (CKRP)

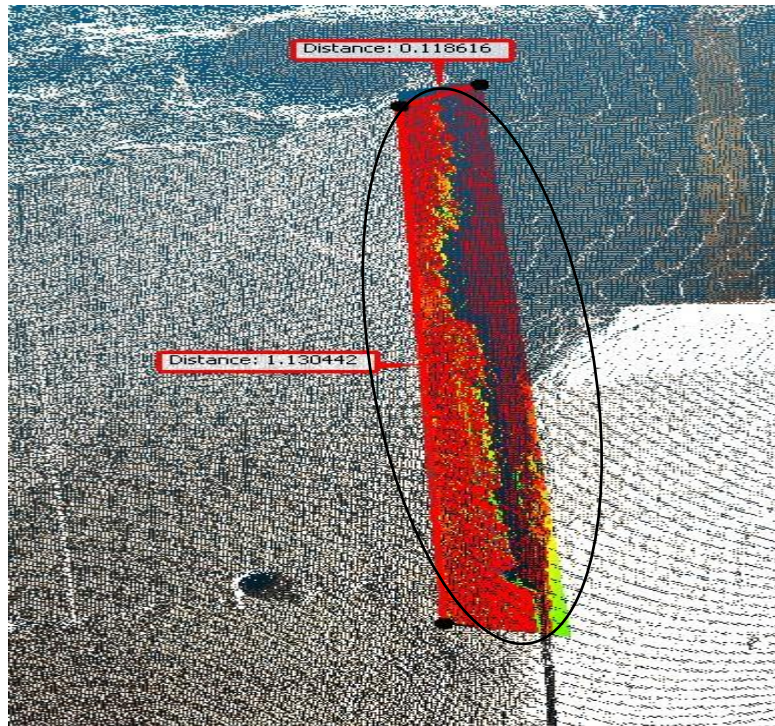
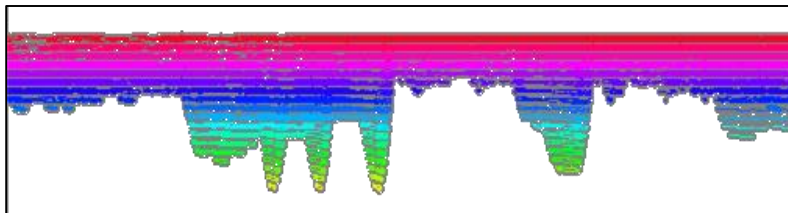
| Element Name | Observation | Location of Distress | Photo No. | Units | Distress Details | | | Area of Repair (Sq.m/ RMT/ m3) |
|---|---|---|---|---|---|---|---|---|
| Wing Wall | Damage | - | 1 | M | 0.11 | 1.13 | | 0.1243 |

**1. Wing wall damage observed, measuring 0.11 m in length and 1.13 m in width, covering an area of 0.1243 m<sup>2</sup>.**

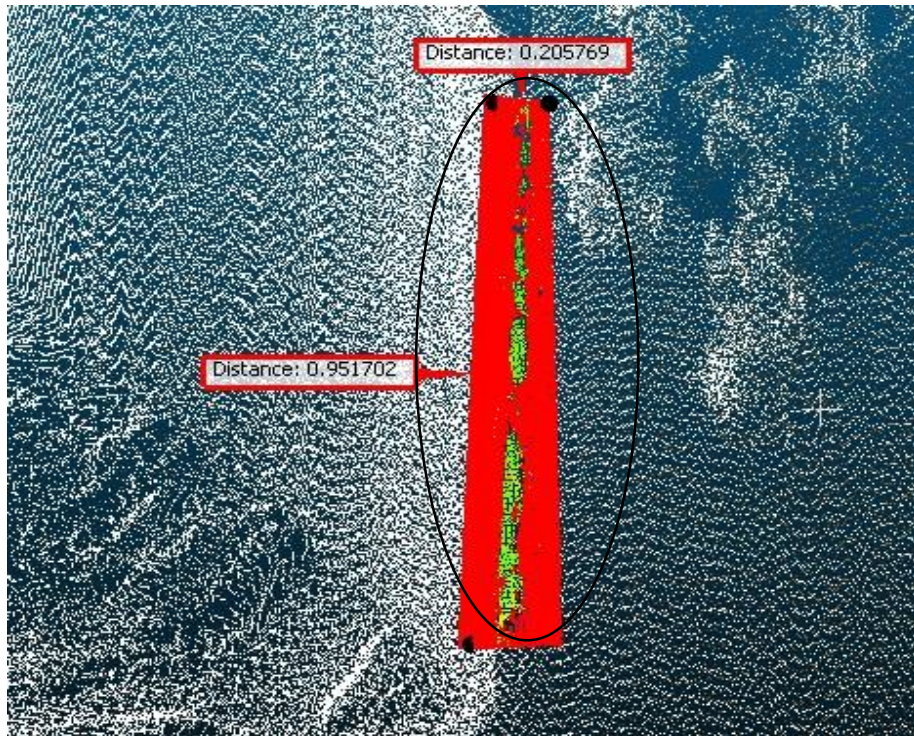
| Element Name | Observation | Location of Distress | Photo No. | Units | Distress Details | | | Area of Repair (Sq.m/ RMT/ m3) |
|---|---|---|---|---|---|---|---|---|
| Wing Wall | Damage | - | 2 | M | 0.20 | 0.95 | | 0.19 |

**2. Wing wall damage observed, measuring 0.20 m in length and 0.95 m in width, covering an area of 0.19 m<sup>2</sup>.**

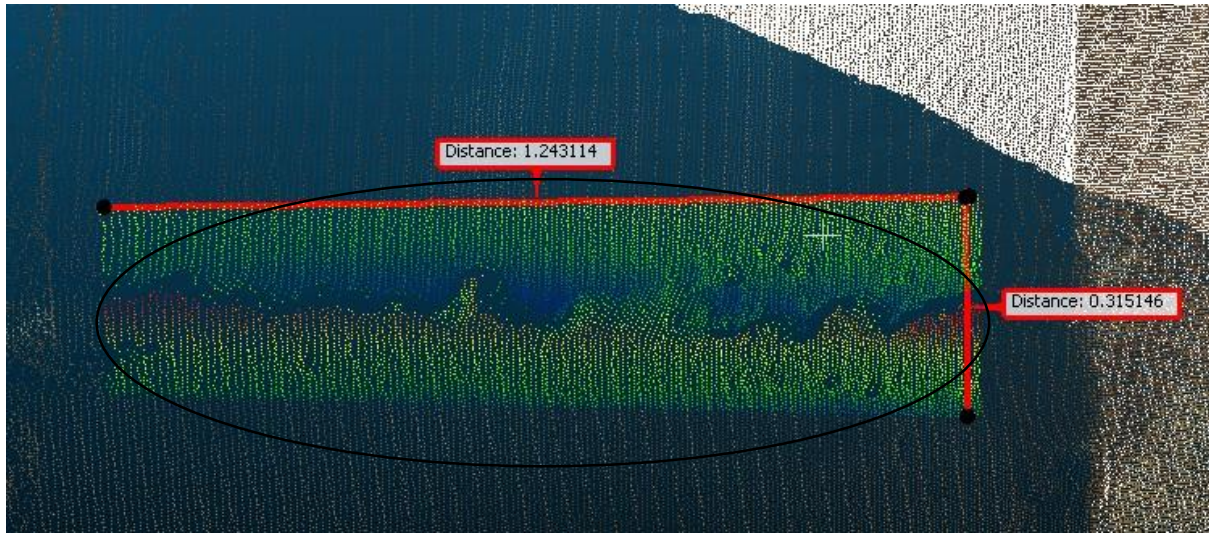
| Element Name | Observation | Location of Distress | Photo No. | Units | Distress Details | | | Area of Repair (Sq.m/ RMT/ m3) |
|---|---|---|---|---|---|---|---|---|
| Return Wall | Scaling | - | 3 | M | 1.24 | 0.31 | | 0.3844 |

**3. Return wall scaling observed, measuring 1.24 m in length and 0.31 m in width, covering an area of 0.3844 m<sup>2</sup>.**

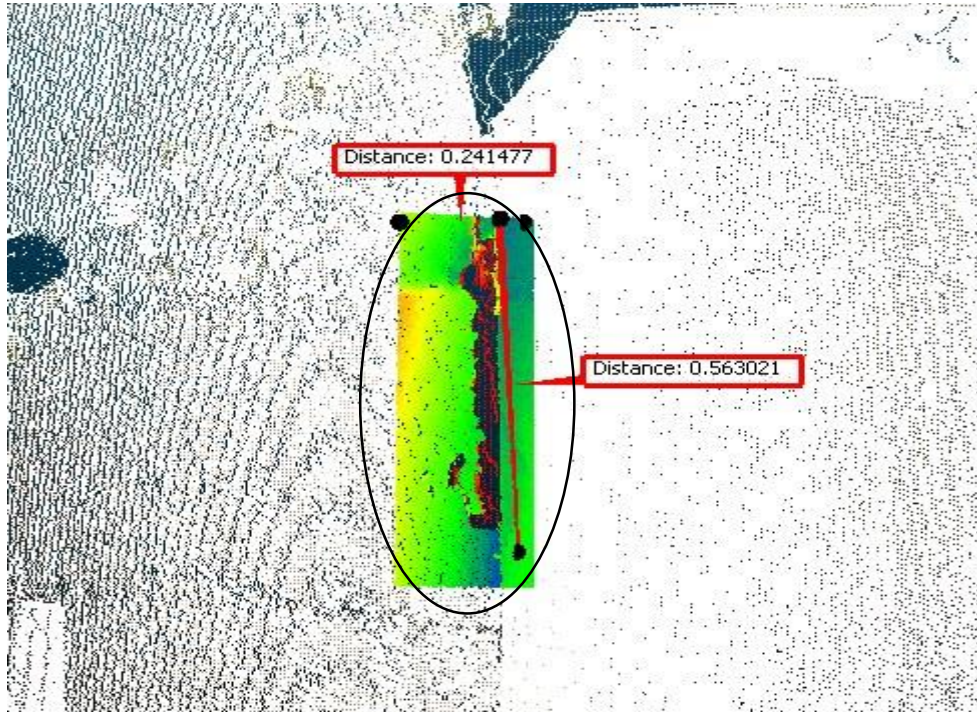
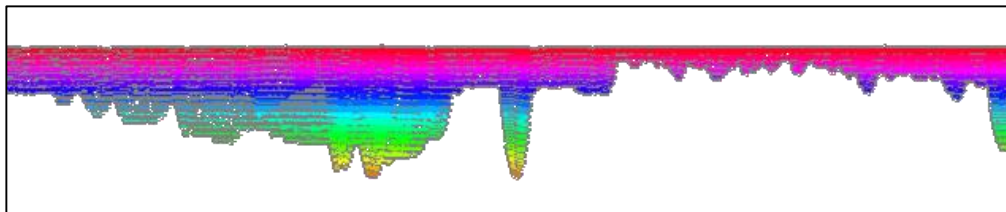
| Element Name | Observation | Location of Distress | Photo No. | Units | Distress Details | | | Area of Repair (Sq.m/ RMT/ m3) |
|---|---|---|---|---|---|---|---|---|
| Wing Wall | Damage | - | 4 | M | 0.24 | 0.56 | | 0.1344 |

**4. Wing wall damage observed, measuring 0.24 m in length and 0.56 m in width, covering an area of 0.1344 m<sup>2</sup>.**

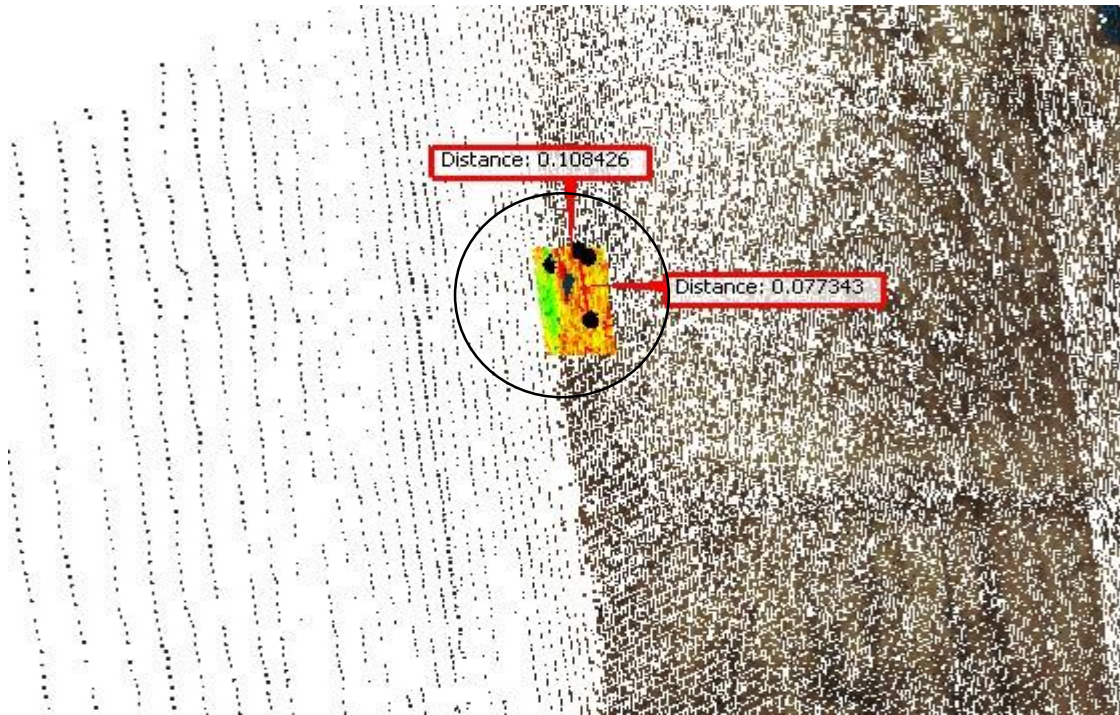
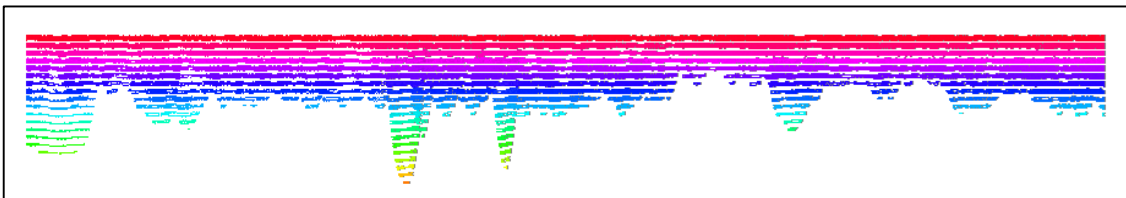
| Element Name | Observation | Location of Distress | Photo No. | Units | Distress Details | | | Area of Repair (Sq.m/ RMT/ m3) |
|---|---|---|---|---|---|---|---|---|
| Wing Wall | Damage | - | 5 | M | 0.10 | 0.07 | | 0.007 |

**5. Wing wall damage observed, measuring 0.10 m in length and 0.07 m in width, covering an area of 0.007 m<sup>2</sup>.**

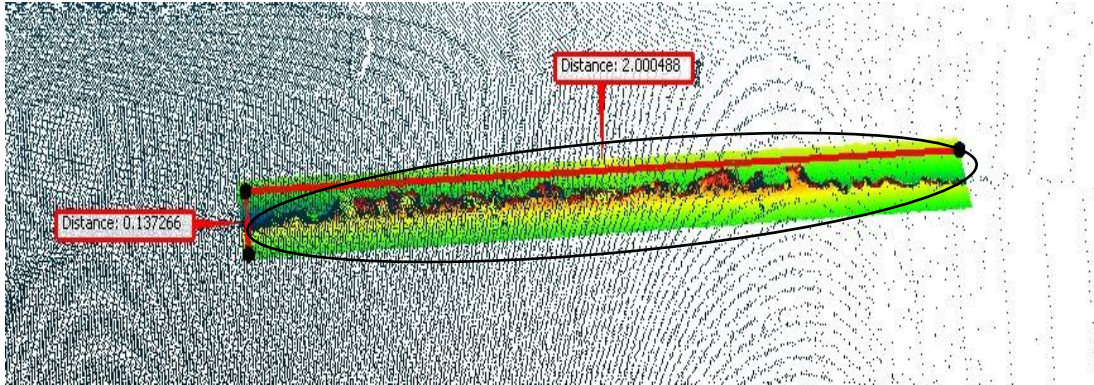
| Element Name | Observation | Location of Distress | Photo No. | Units | Distress Details | | | Area of Repair (Sq.m/ RMT/ m3) |
|---|---|---|---|---|---|---|---|---|
| Abutment Wall | Scaling | - | 6 | M | 2.00 | 0.13 | | 0.26 |

**6. Abutment wall scaling observed, measuring 2.00 m in length and 0.13 m in width, covering an area of 0.026 m<sup>2</sup>.**
