# **LIDAR Inspection Report of MNB ch.917+650**

**Bridge No:** MNB - 918/4

**Bridge Chainage:** 917+650 (CKRP)

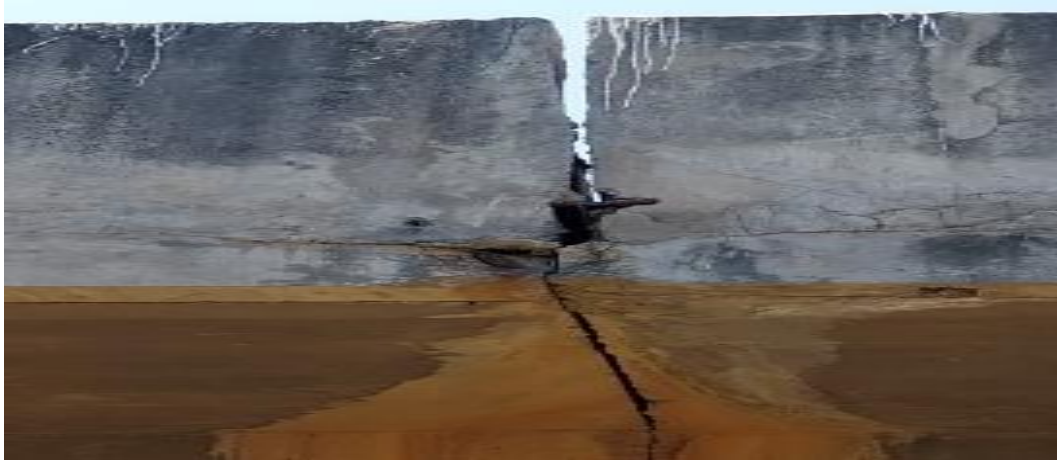
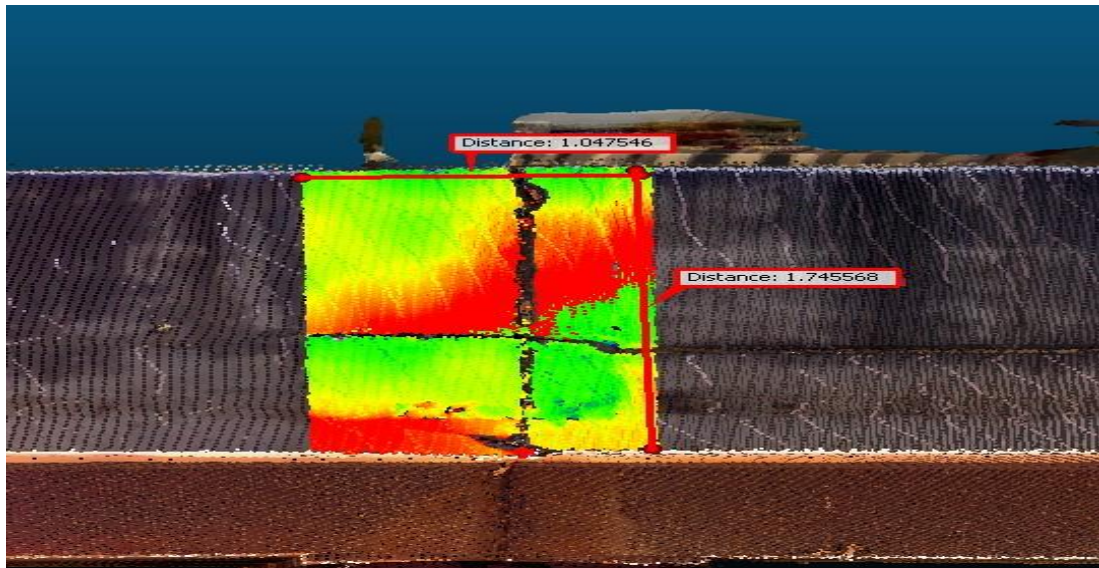
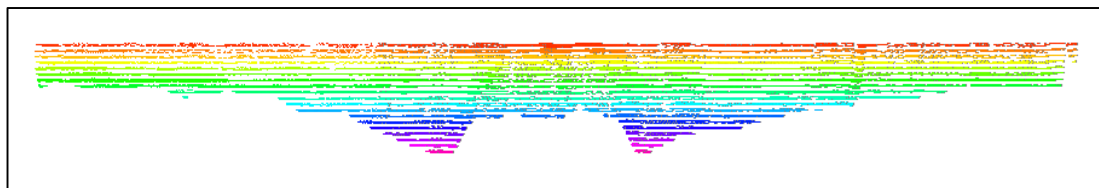
| Element Name | Observation | Location of Distress | Photo No. | Units | Distress Details | | | Area of Repair (Sq./RM T/m3) |
|---|---|---|---|---|---|---|---|---|
| Abutment 1 | Damage | | 1 | | 1.04 | 1.74 | | 1.809 |

**1. Steel exposed observed at Abutment 1 to Pear 1 span near expansion joint, measuring 1.04 m in length and 1.74 m in width, covering an area of 1.809 m<sup>2</sup>.**

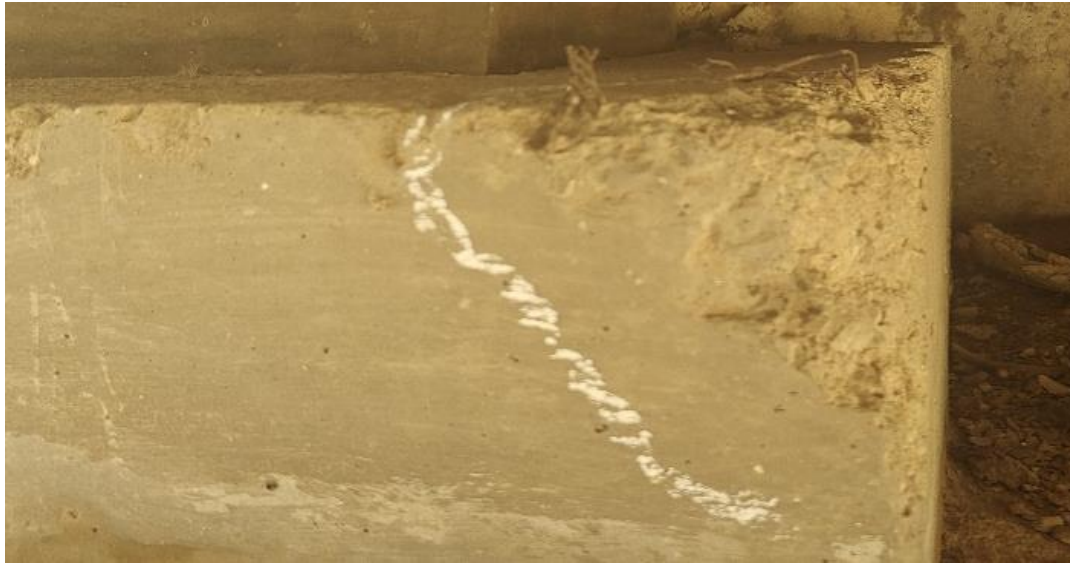
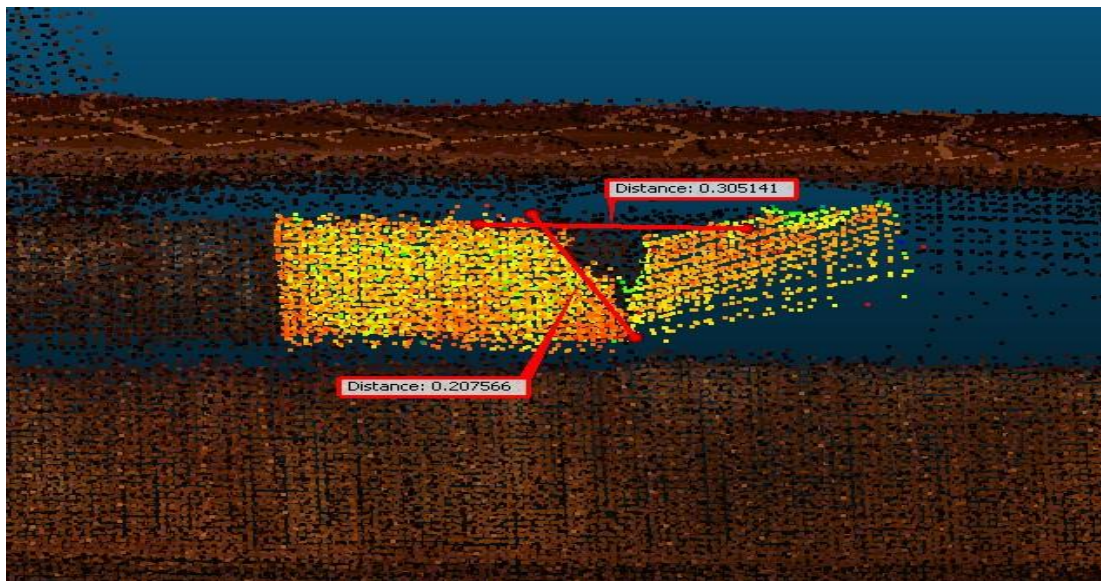
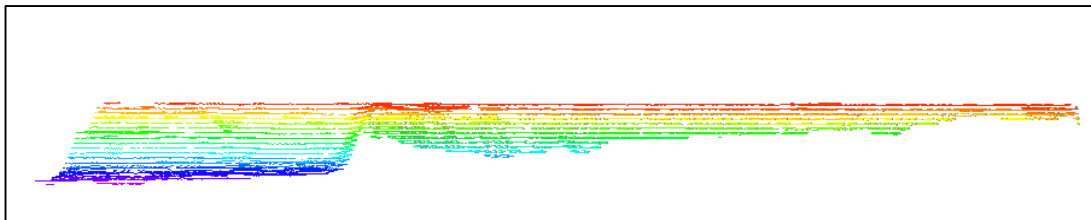
| Element Name | Observation | Location of Distress | Photo No. | Units | Distress Details | | | Area of Repair (Sq./RM T/m3) |
|---|---|---|---|---|---|---|---|---|
| Abutment 2 | Damage | | 2 | | 0.30 | 0.20 | | 0.06 |

2. Damage is observed at A2 RHS Bearing 1 , measuring 0.30 m in length and 0.20 m in width, covering an area of 0.06 m<sup>2</sup>.

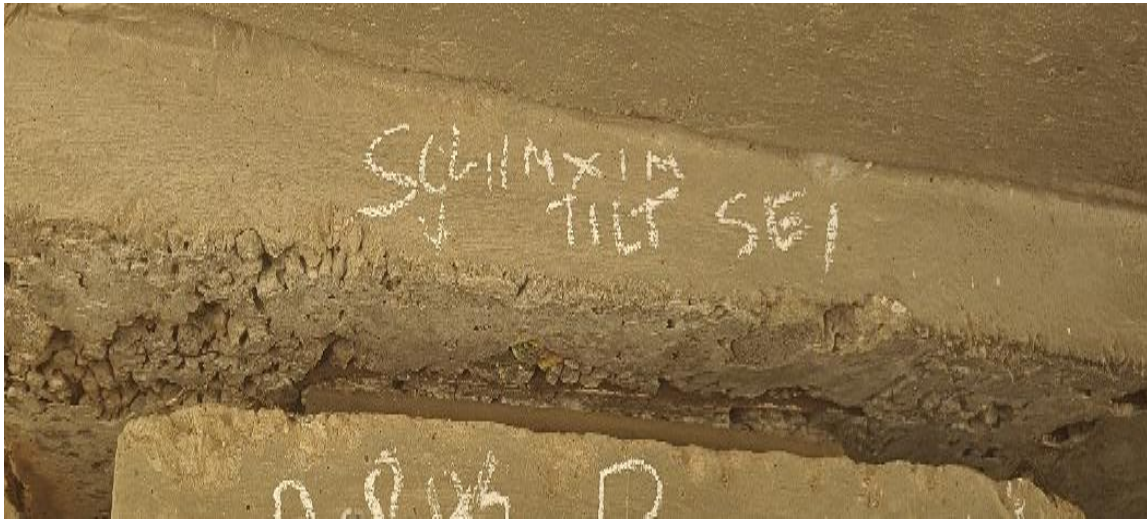
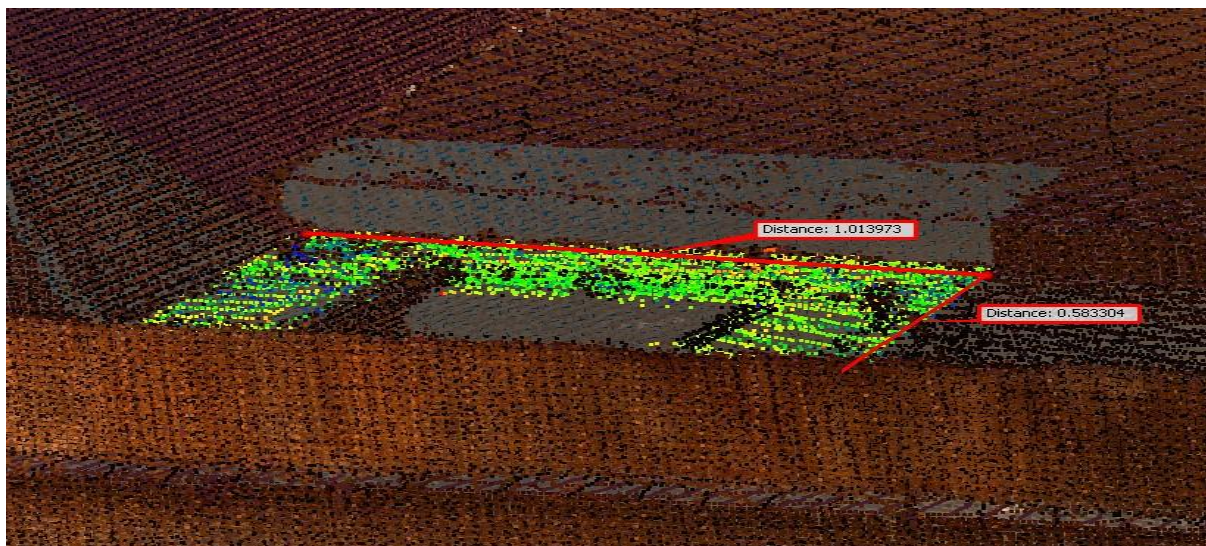
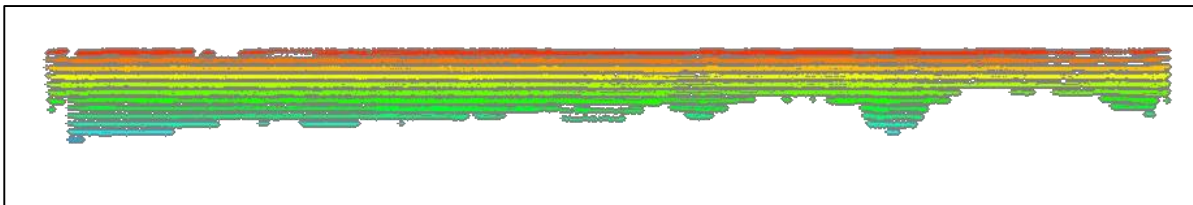
| Element Name | Observation | Location of Distress | Photo No. | Units | Distress Details | | | Area of Repair (Sq./RM T/m3) |
|---|---|---|---|---|---|---|---|---|
| Abutment 2 | Scaling | | 3 | | 1.01 | 0.58 | | 0.585 |

- 3. Scaling is observed at Abutment 2 RHS Bearing 1 , measuring 1.01 m in length and 0.58 m in width, covering an area of 0.585 m<sup>2</sup>.**

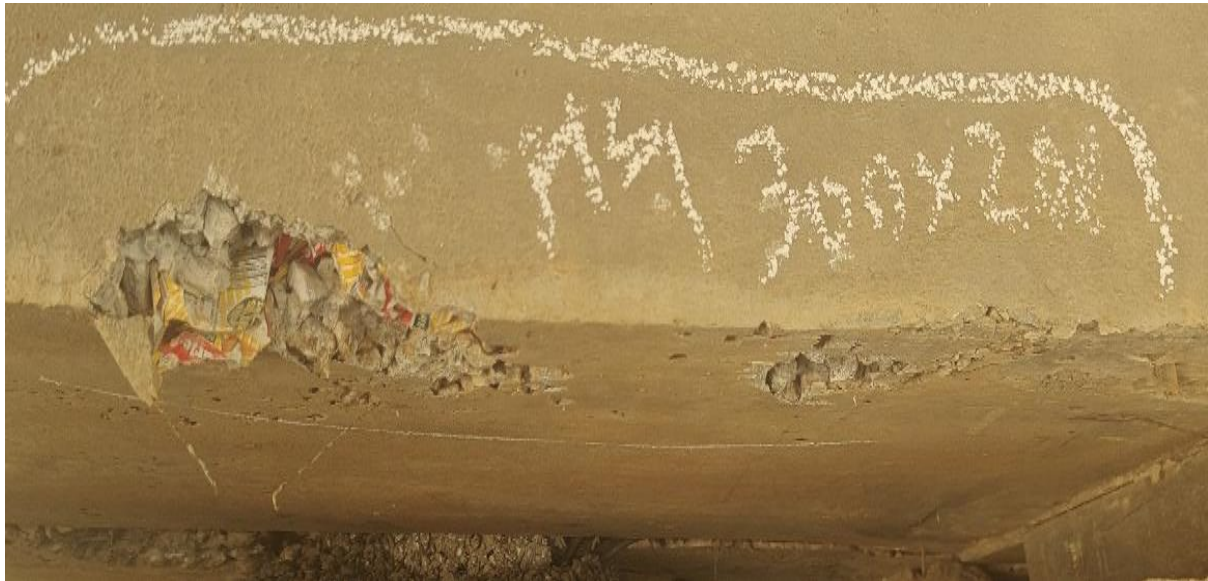
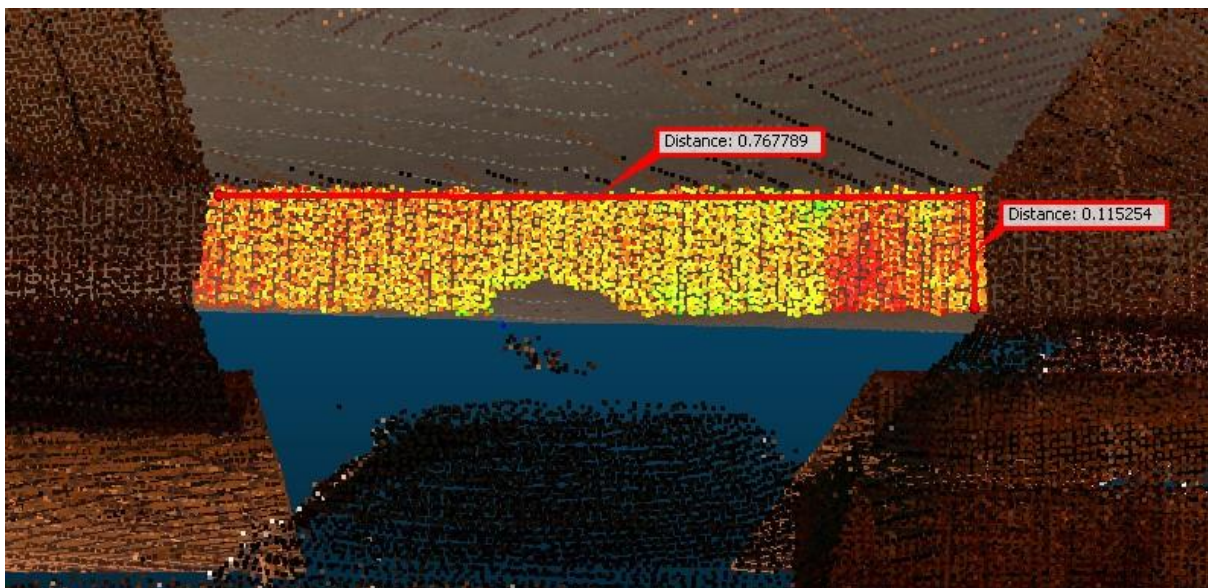
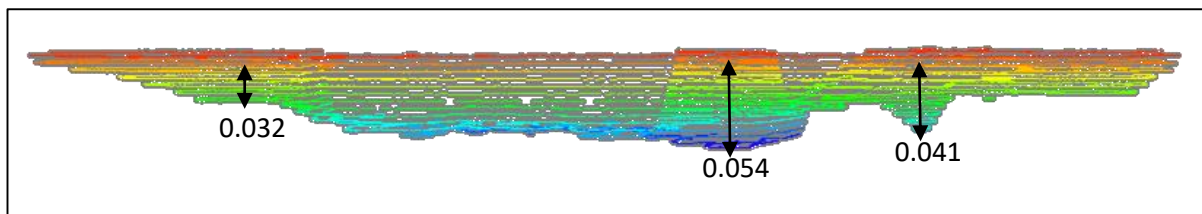
| Element Name | Observation | Location of Distress | Photo No. | Units | Distress Details | | | Area of Repair (Sq./RM T/m3) |
|---|---|---|---|---|---|---|---|---|
| Pier 1 | Hollow section | | 4 | | 0.66 | 0.05 | 0.041 | 0.0013 |

**4. Hollow section observed on A2 (LHS), measuring 0.76 m in length and 0.11 m in width. Depth ranges from 0.032 m (min) to 0.054 m (max), with an average depth of 0.08 m. The calculated volume of the distress is 0.0013 m<sup>3</sup>.**

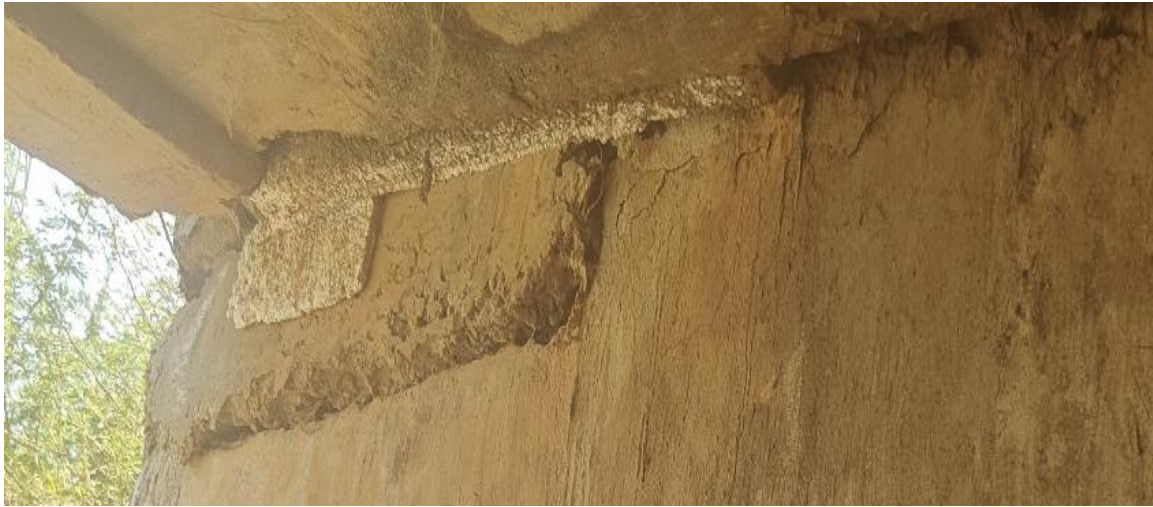
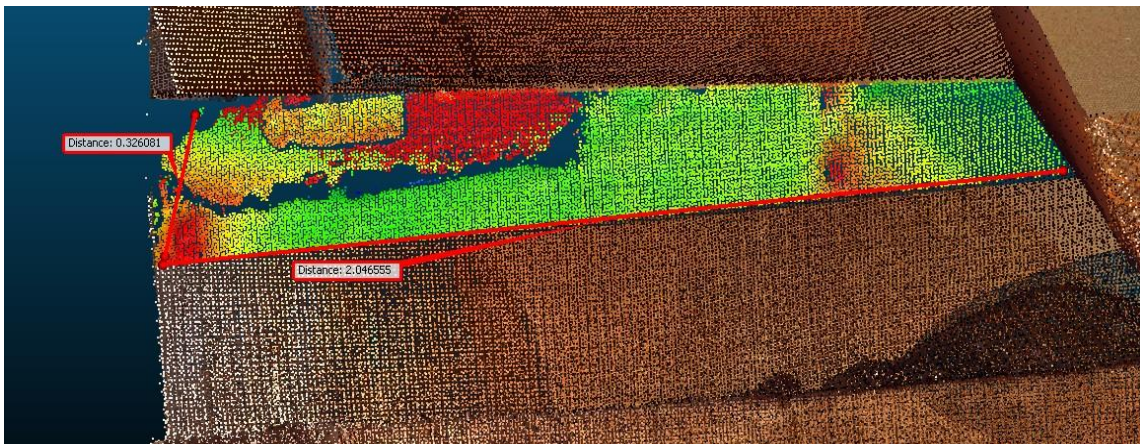
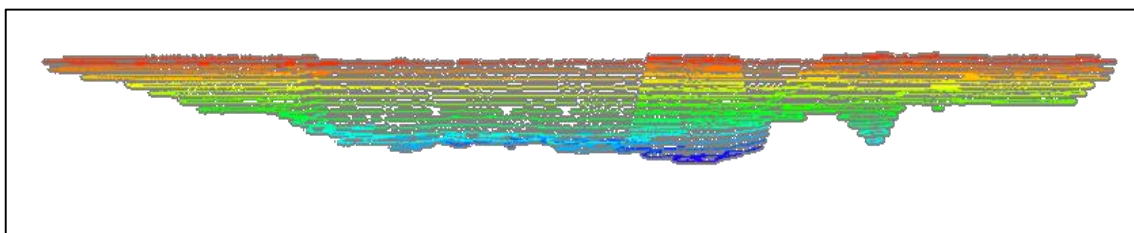
| Element Name | Observation | Location of Distress | Photo No. | Units | Distress Details | | | Area of Repair (Sq./RM T/m3) |
|---|---|---|---|---|---|---|---|---|
| Abutment 1 | Damage | | 5 | | 2.04 | 0.32 | | 0.652 |

- 5. Damage is observed at Abutment 1 RHS dirt wall, measuring 2.04 m in length and 0.32 m in width, covering an area of 0.652 m<sup>2</sup>.**
