# **LIDAR Inspection Report of MNB ch.917+980**

**Bridge No:** MNB - 919/1

**Bridge Chainage:** 917+980 (CKRP)

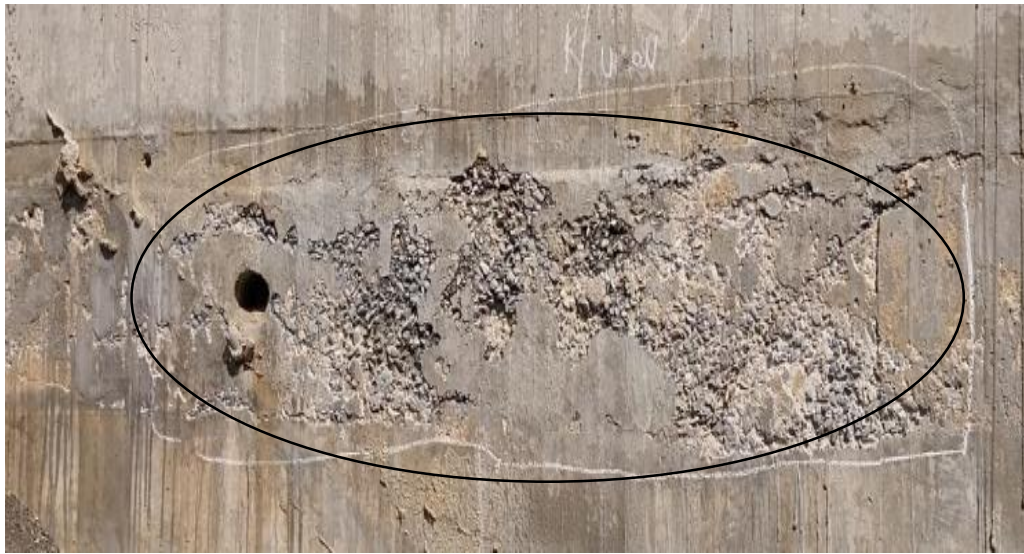
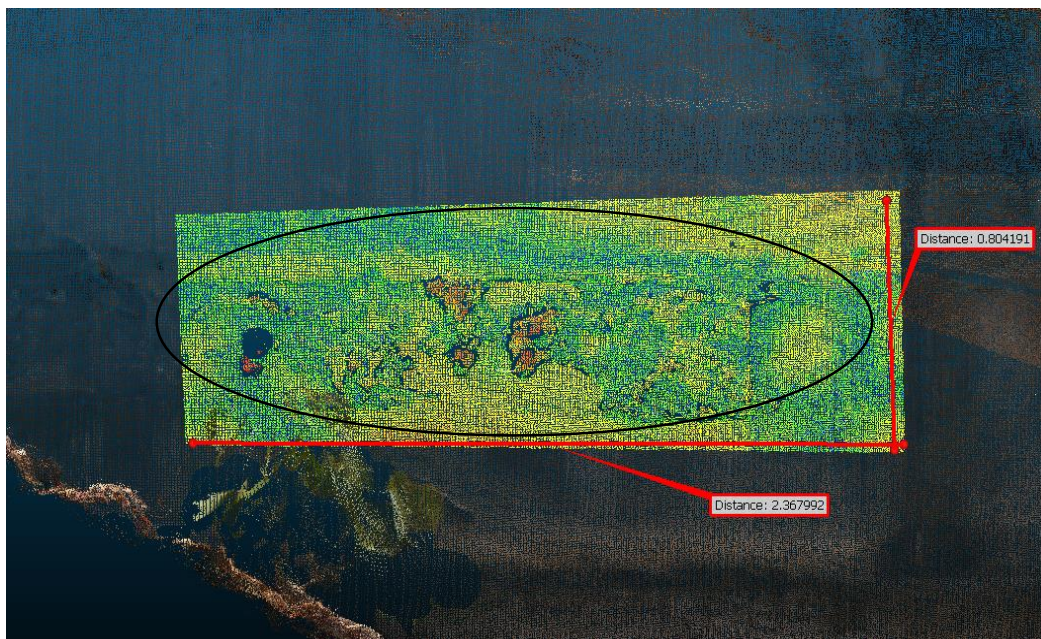
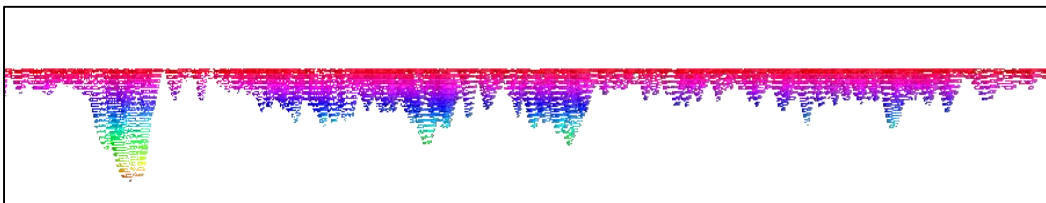
| Element Name | Observation | Location of Distress | Photo No. | Units | Distress Details | | | Area of Repair (Sq./RM T/m3) |
|---|---|---|---|---|---|---|---|---|
| Wing wall | Honey Combing | | 1 | | 2.36 | 0.80 | | 1.888 |

**1. Honey Combing observed on Abutment 2 LHS retaining wall , measuring 2.36 m in length and 0.80 m in width, covering an area of 1.888 m<sup>2</sup>.**

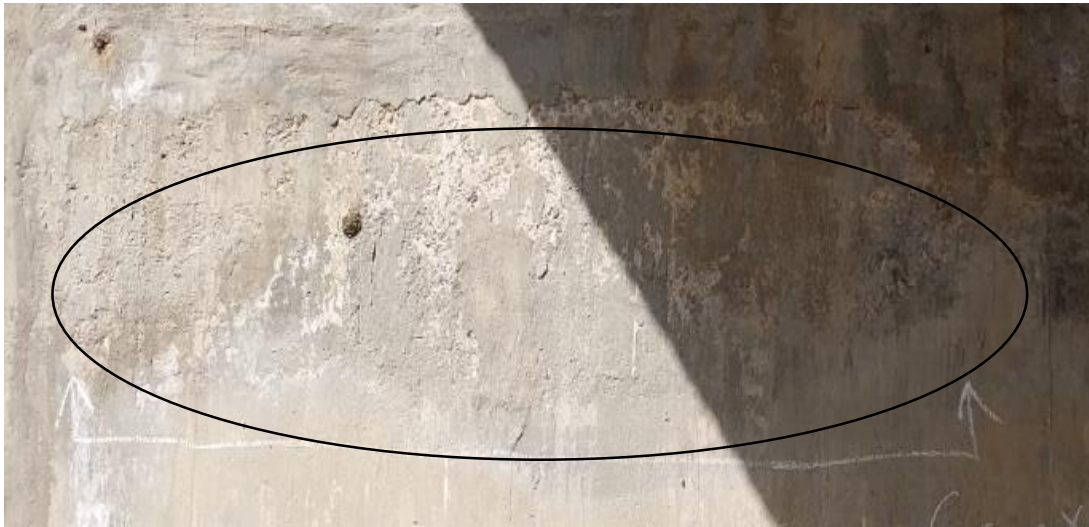
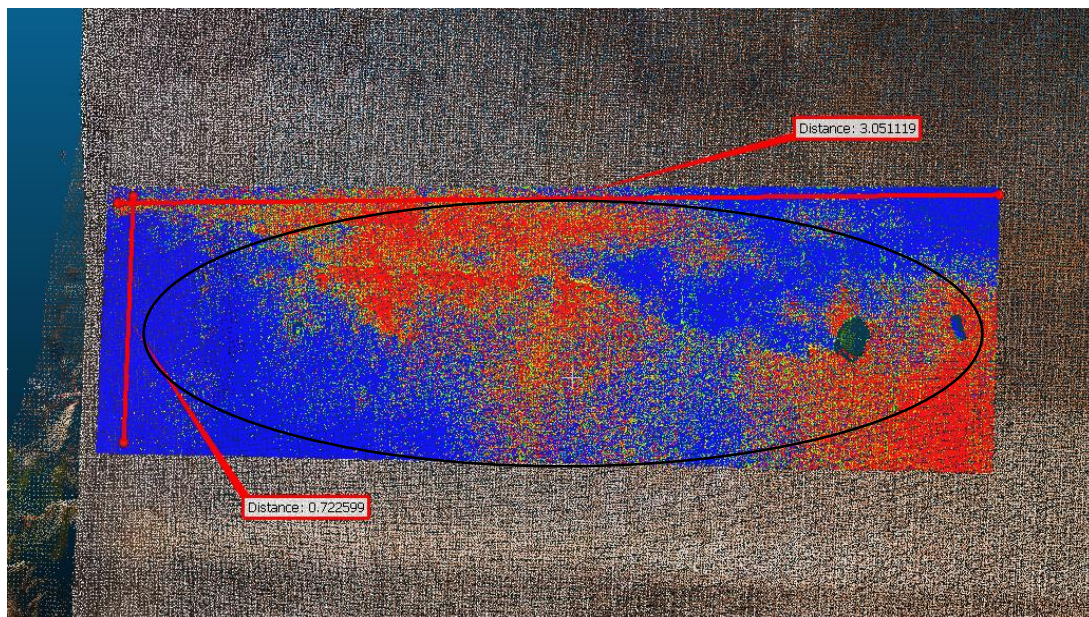
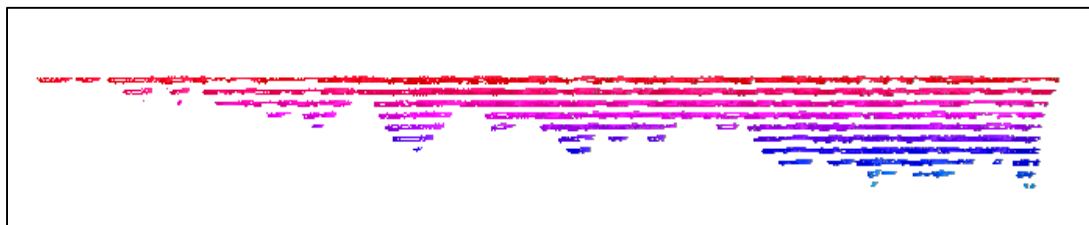
| Element Name | Observation | Location of Distress | Photo No. | Units | Distress Details | | | Area of Repair (Sq./RM T/m3) |
|---|---|---|---|---|---|---|---|---|
| Abutment 2 | Scaling | | 2 | | 3.05 | 0.72 | | 2.196 |

**2. Scaling observed on Abutment 2 LHS , measuring 3.05 m in length and 0.72 m in width, covering an area of 2.196 m<sup>2</sup>**

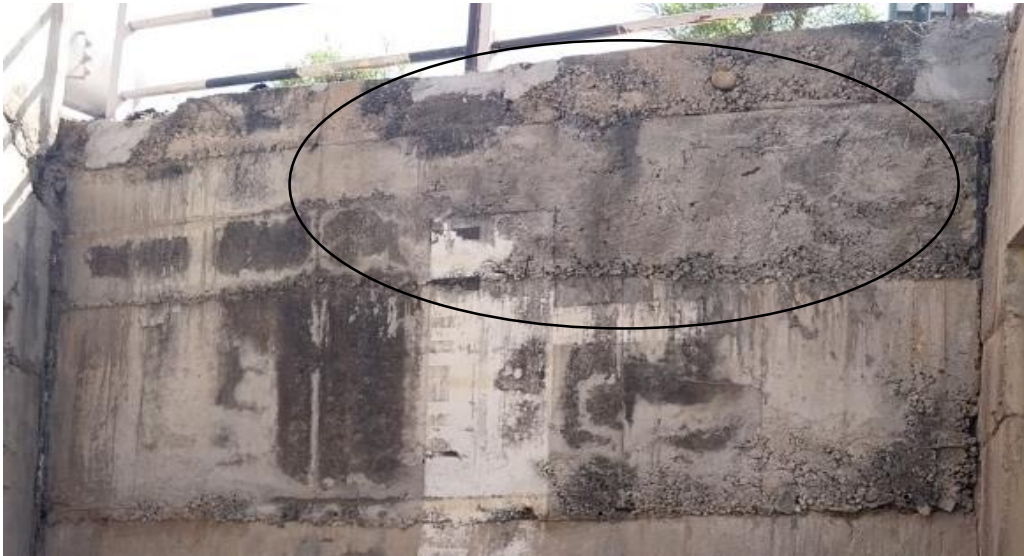
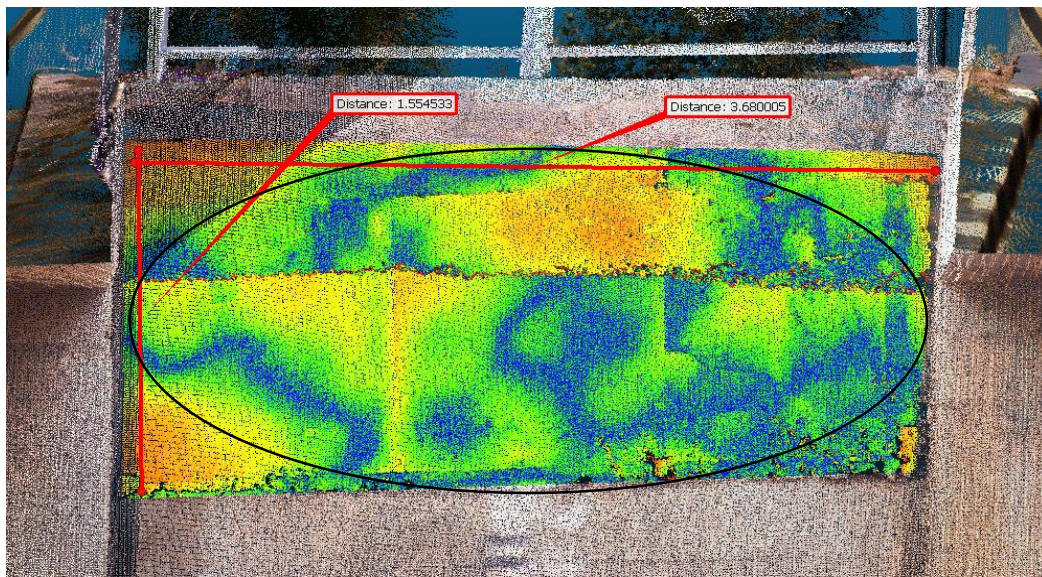
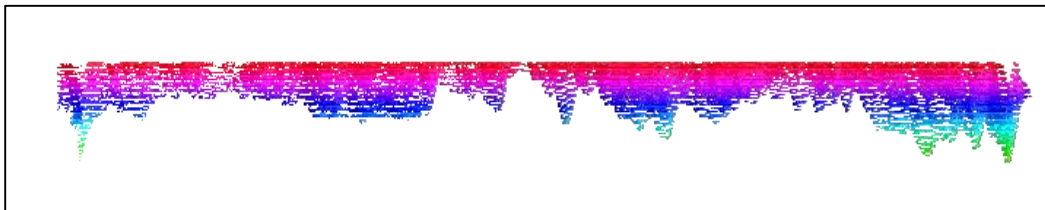
| Element Name | Observation | Location of Distress | Photo No. | Units | Distress Details | | | Area of Repair (Sq./RM T/m3) |
|---|---|---|---|---|---|---|---|---|
| Abutment 1 | Honey Combing | | 3 | | 3.68 | 1.55 | | 5.702 |

- 2. Honey Combing and spalling observed on Abutment 1 median , measuring 3.68 m in length and 1.55 m in width, covering an area of 5.702 m<sup>2</sup>.**

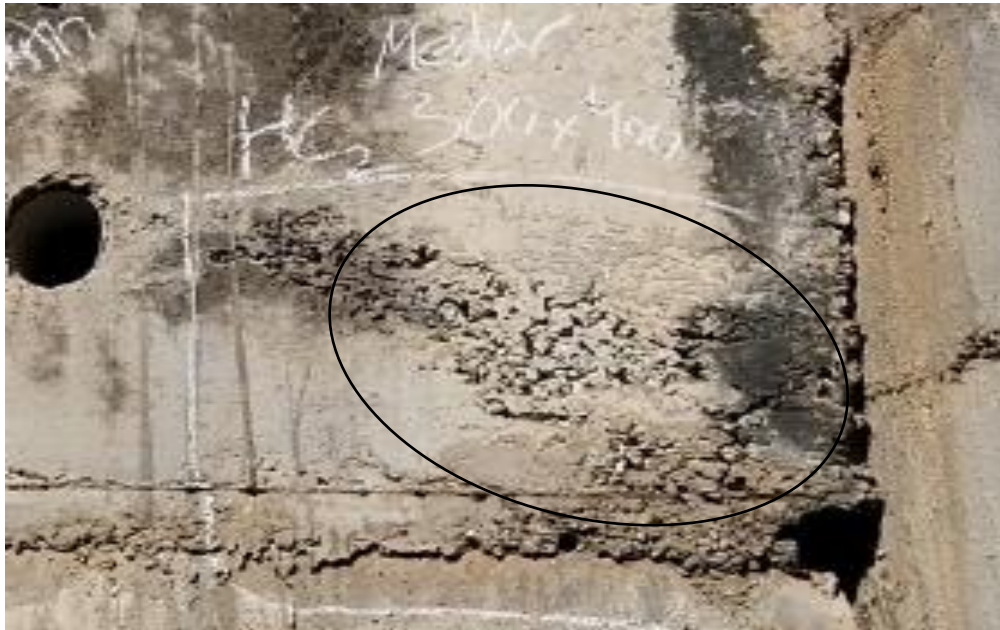
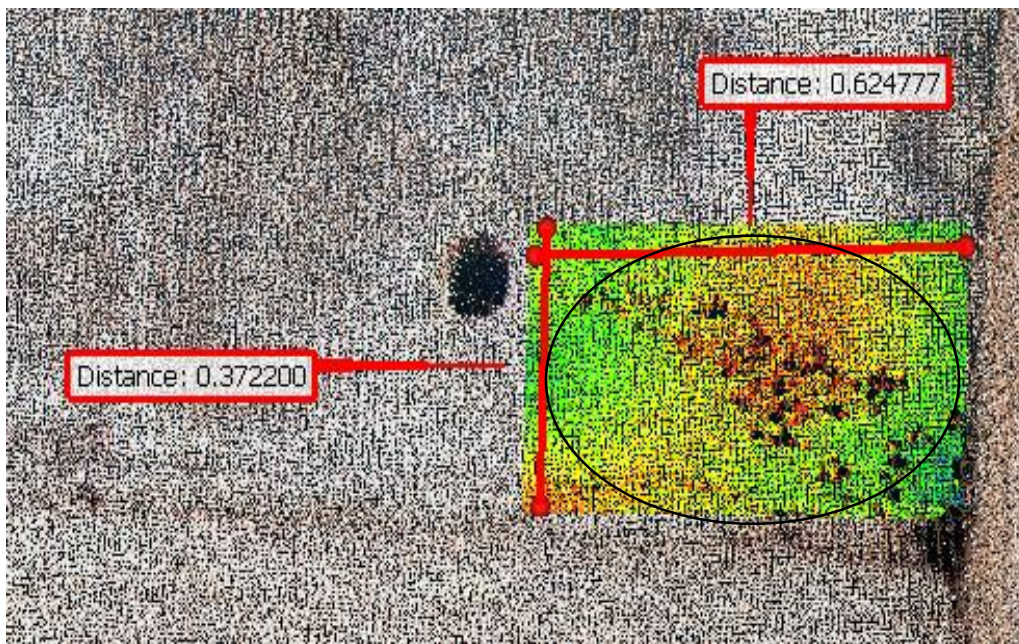
| Element Name | Observation | Location of Distress | Photo No. | Units | Distress Details | | | Area of Repair (Sq./RM T/m3) |
|---|---|---|---|---|---|---|---|---|
| Abutment 2 | Honey Combing | | 4 | | 0.62 | 0.37 | | 0.2294 |

**4. Hollow crack observed on Abutment 2 median, measuring 0.62 m in length and 0.37 m in width, covering an area of 0.2294 m<sup>2</sup>.**

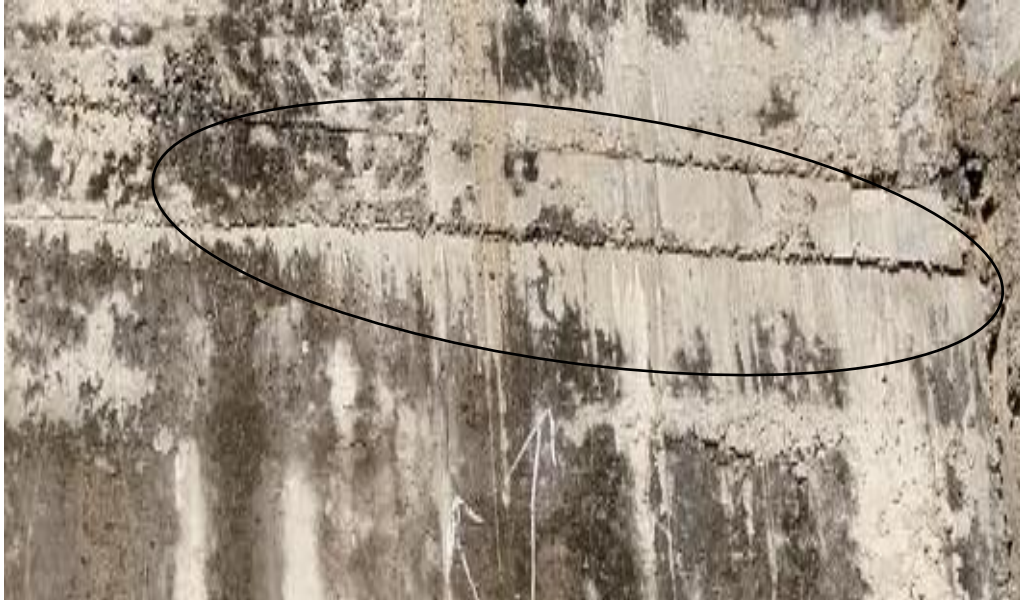
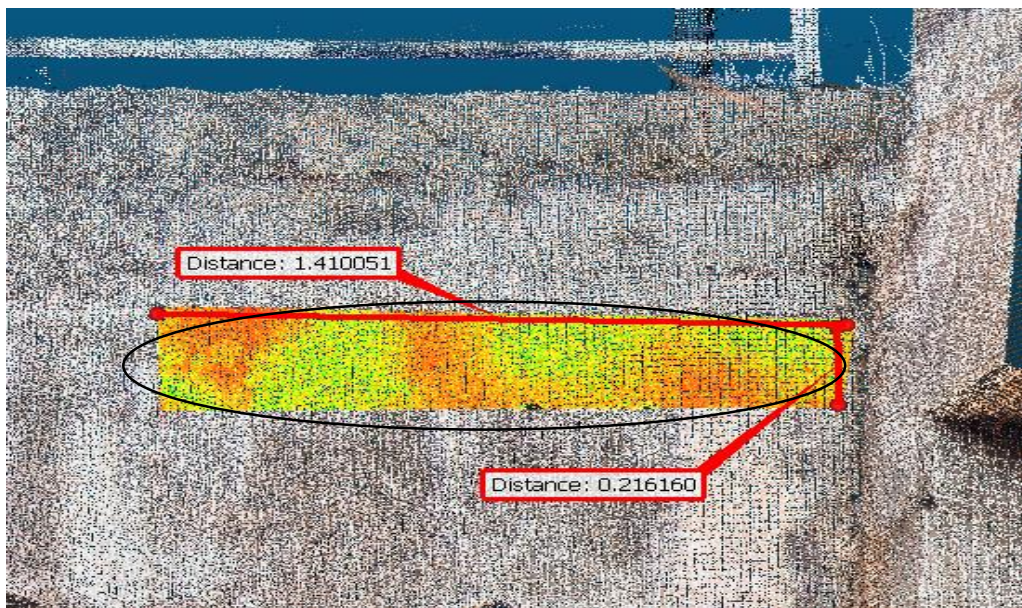
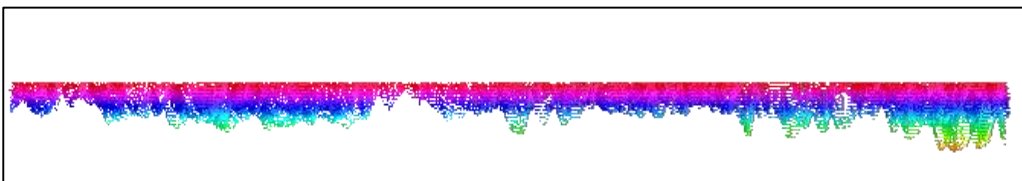
| Element Name | Observation | Location of Distress | Photo No. | Units | Distress Details | | | Area of Repair (Sq./RM T/m3) |
|---|---|---|---|---|---|---|---|---|
| Abutment 2 | Honey Combing | | 5 | | 1.41 | 0.21 | | 0.2961 |

**5. Honey Combing observed on Abutment 2 median , measuring 1.41 m in length and 0.21 m in width, covering an area of 0.2961 m<sup>2</sup>.**

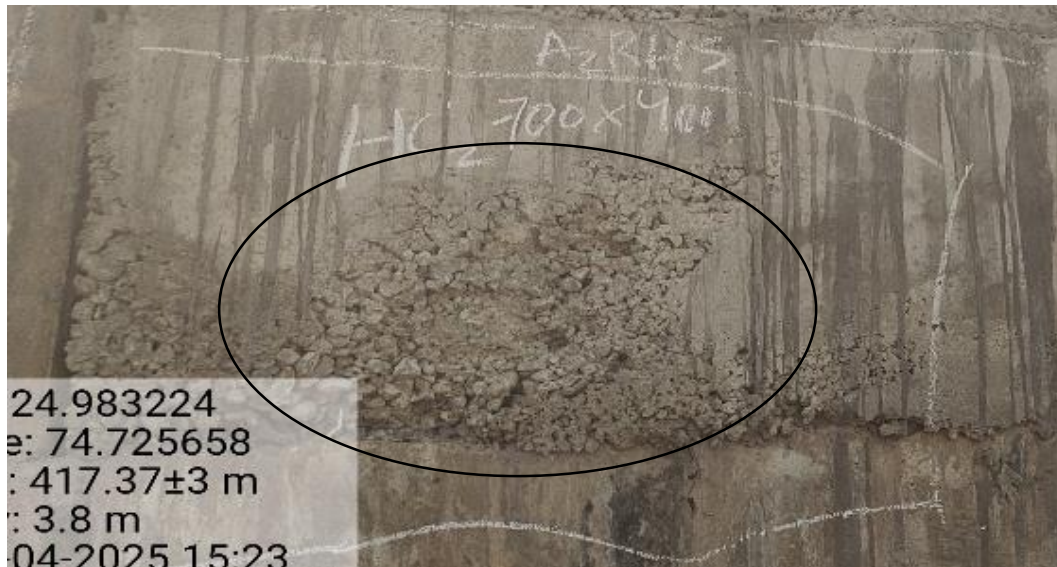
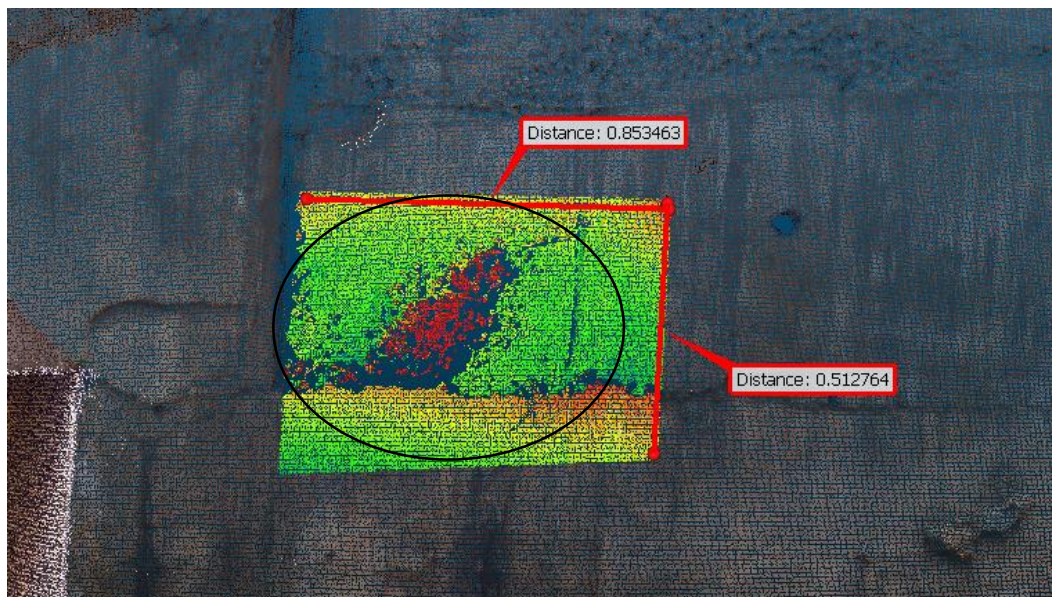
| Element Name | Observation | Location of Distress | Photo No. | Units | Distress Details | | | Area of Repair (Sq./RM T) |
|---|---|---|---|---|---|---|---|---|
| Wing Wall | Honey Combing | | 6 | | 0.85 | 0.51 | | 0.4335 |

**6. Honey Combing observed on Abutment 2 RHS retaining wall, measuring 0.85 m in length and 0.51 m in width, covering an area of 0.4335 m<sup>2</sup>.**

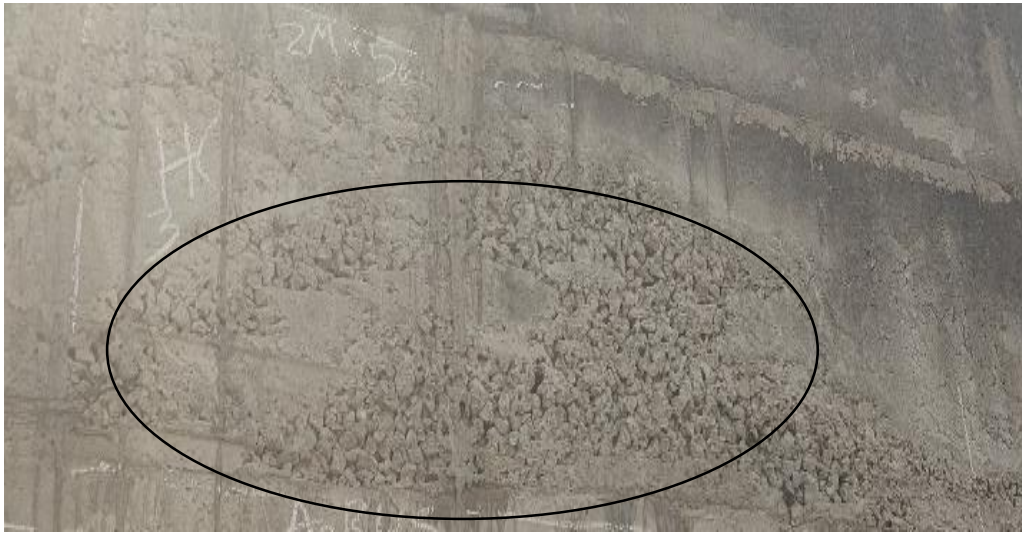
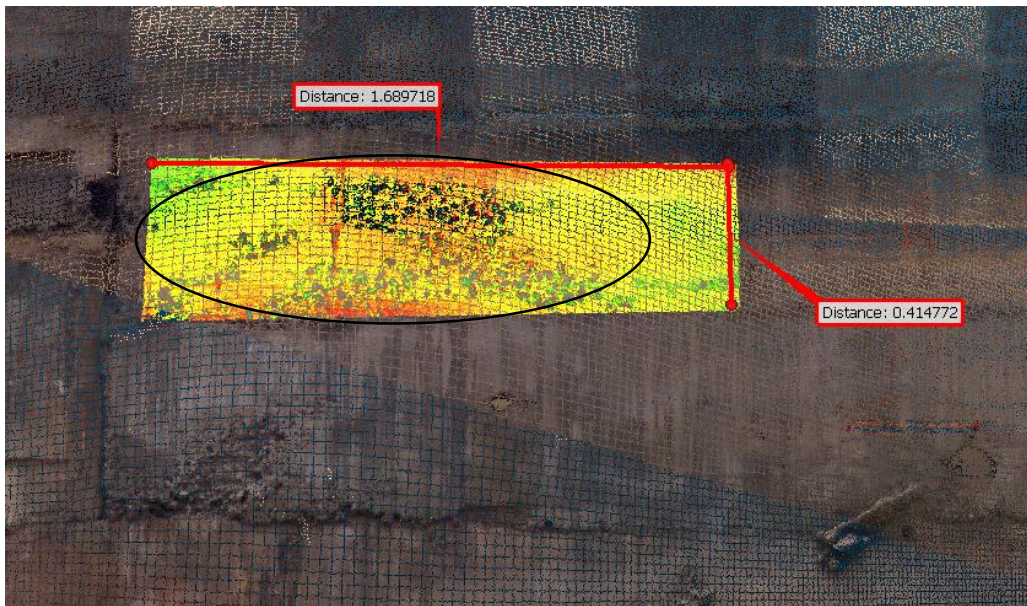
| Element Name | Observation | Location of Distress | Photo No. | Units | Distress Details | | | Area of Repair (Sq./RM T) |
|---|---|---|---|---|---|---|---|---|
| Wing Wall | Honey Combing | | 7 | | 1.68 | 0.41 | | 0.6888 |

**7. Honey Combing observed on Abutment 2 RHS retaining wall, measuring 1.68 m in length and 0.41 m in width, covering an area of 0.6888 m<sup>2</sup>.**

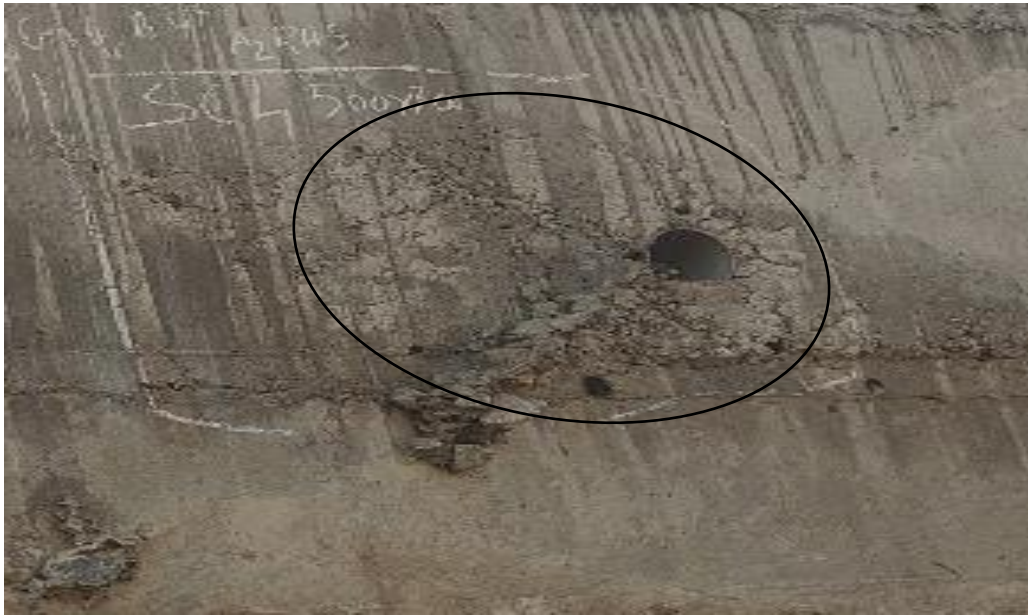
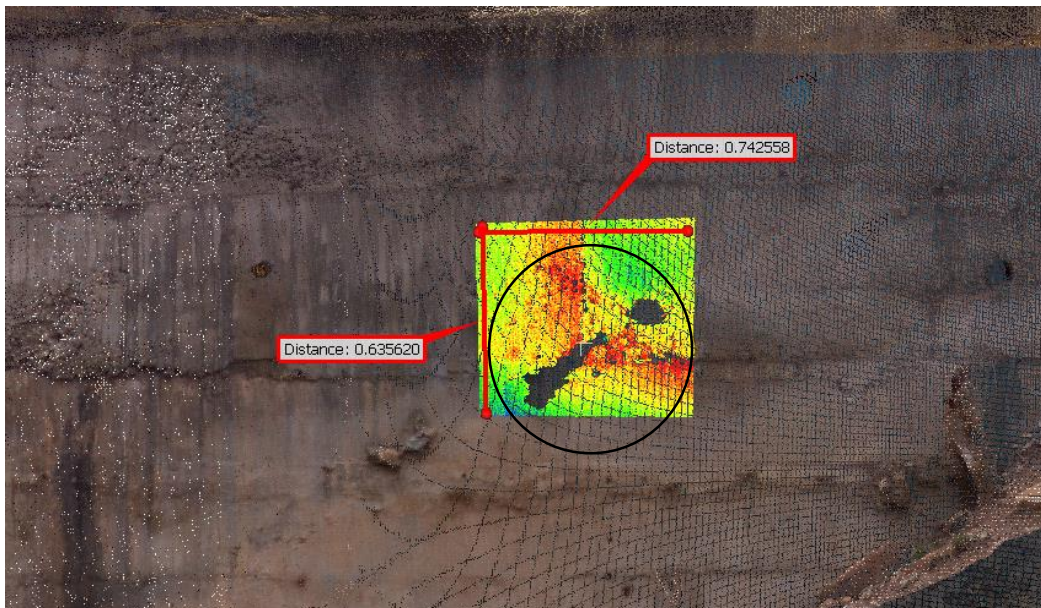
| Element Name | Observation | Location of Distress | Photo No. | Units | Distress Details | | | Area of Repair (Sq./RM T) |
|---|---|---|---|---|---|---|---|---|
| Abutment 2 | Hollow section | | 8 | | 0.74 | 0.63 | | 0.4662 |

**8. Scaling observed on Abutment 2 RHS , measuring 0.74 m in length and 0.63 m in width, covering an area of 0.4662 m<sup>2</sup>.**

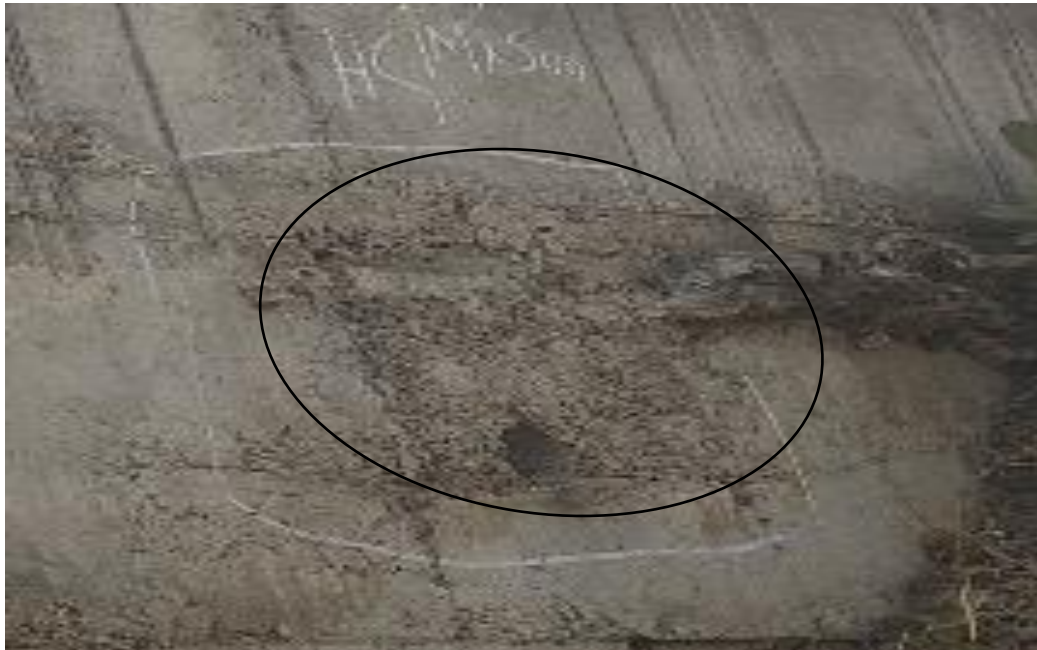
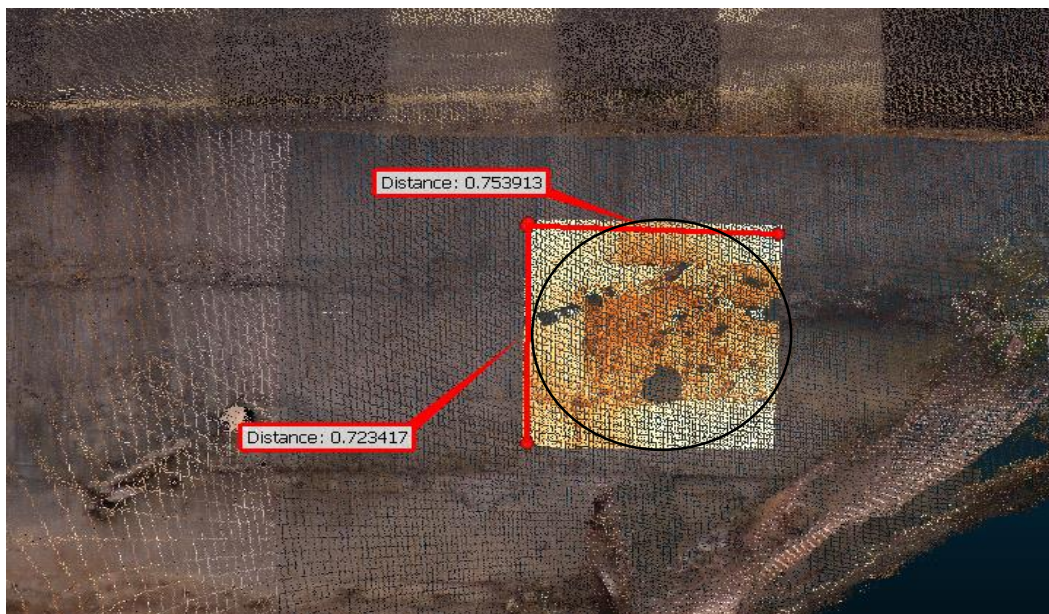
| Element Name | Observation | Location of Distress | Photo No. | Units | Distress Details | | | Area of Repair (Sq./RM T) |
|---|---|---|---|---|---|---|---|---|
| Wing Wall | Honey Combing | | 9 | | 0.75 | 0.73 | | 0.5475 |

**9. Honey combing observed on Abutment 2 RHS retaining wall, measuring 0.75 m in length and 0.73 m in width, covering an area of 0.5475 m<sup>2</sup>.**

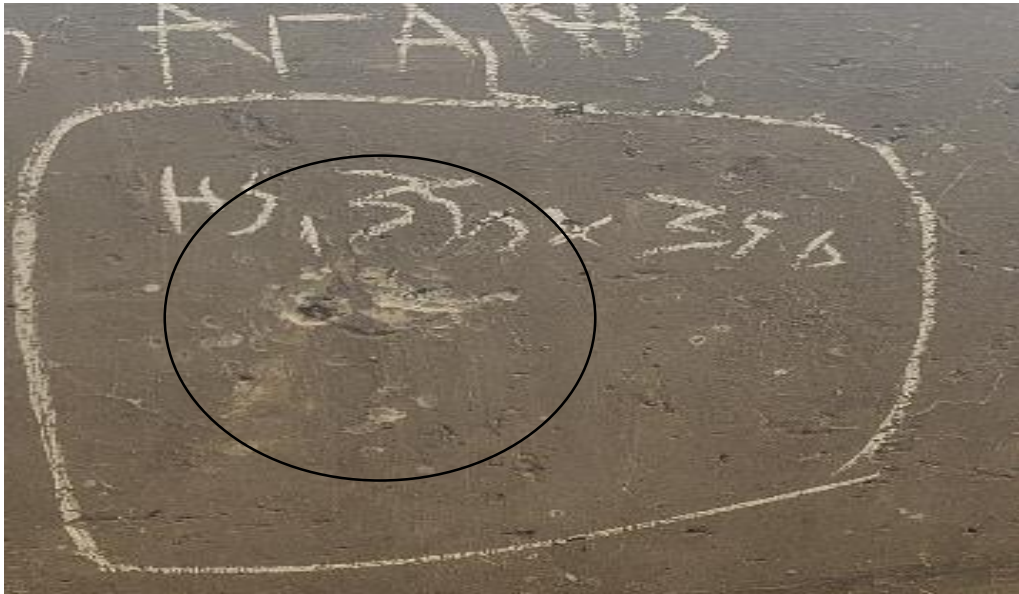
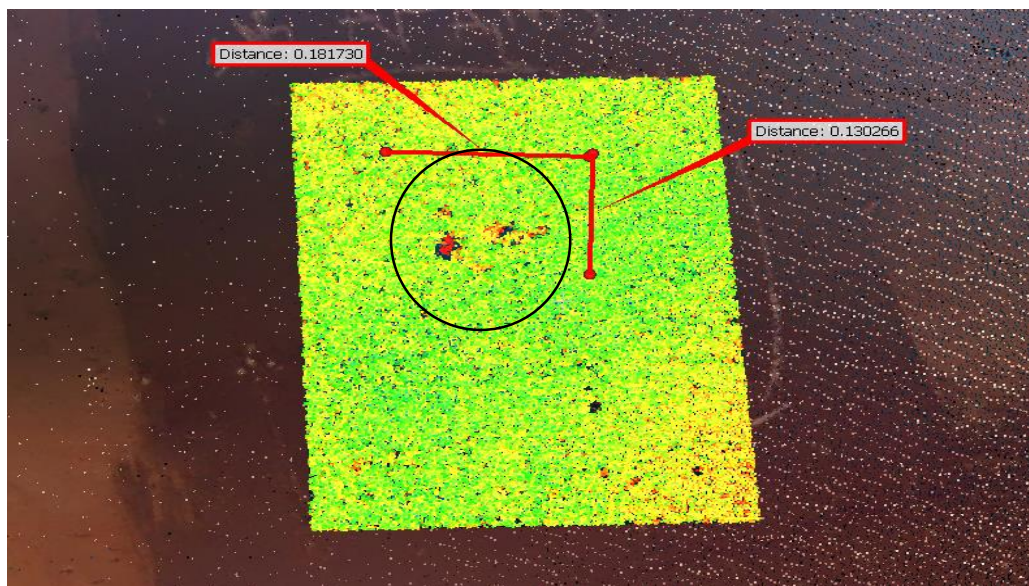
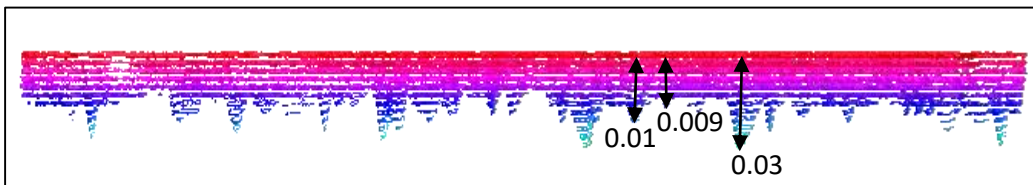
| Element Name | Observation | Location of Distress | Photo No. | Units | Distress Details | | | Area of Repair (Sq./RM T) |
|---|---|---|---|---|---|---|---|---|
| Abutment 1 | Hollow section | | 10 | | 0.18 | 0.13 | 0.01 | 0.0002 |

**10. Hollow Section observed on Abutment 1 RHS, measuring 0.18 m in length and 0.13 m in width, Depth ranges from 0.009 m (min) to 0.03 m (max), with an average depth of 0.01 m. The calculated volume of the distress is 0.0002 m<sup>3</sup>.**
