# LIDAR Inspection Report of **Box Culvert** ch.918+119

**Bridge Chainage:** 918+119 (CKRP)

- **CKRP:** Chittorgarh to kota
- **State:** Rajasthan NH 27
- **Zone:** RJ-06

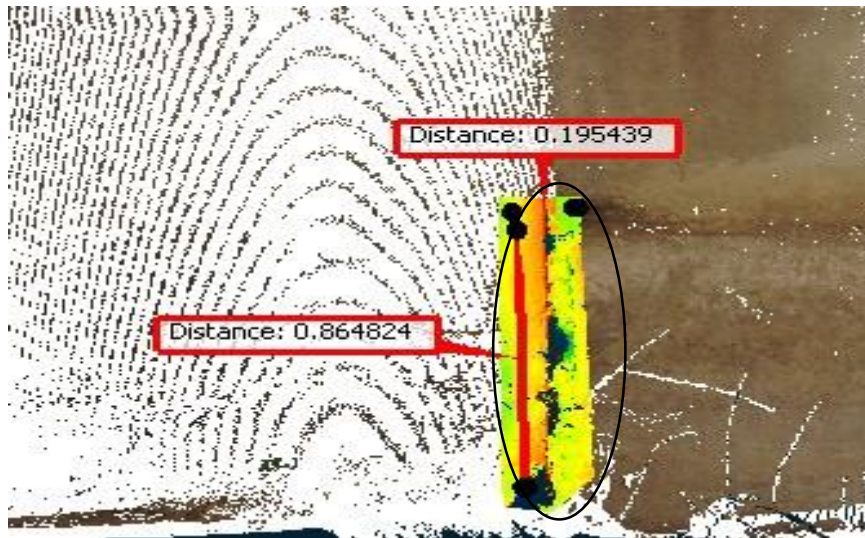
| Element Name | Observation | Location of Distress | Photo No. | Units | Distress Details | | | Area of Repair (Sq.m/ RMT/ m3) |
|---|---|---|---|---|---|---|---|---|
| Wing Wall | Damage | - | 1 | M | 0.19 | 0.86 | | 0.1634 |

**1. Wing wall damage observed, measuring 0.19 m in length and 0.86 m in width, covering an area of 0.1634 m<sup>2</sup>.**

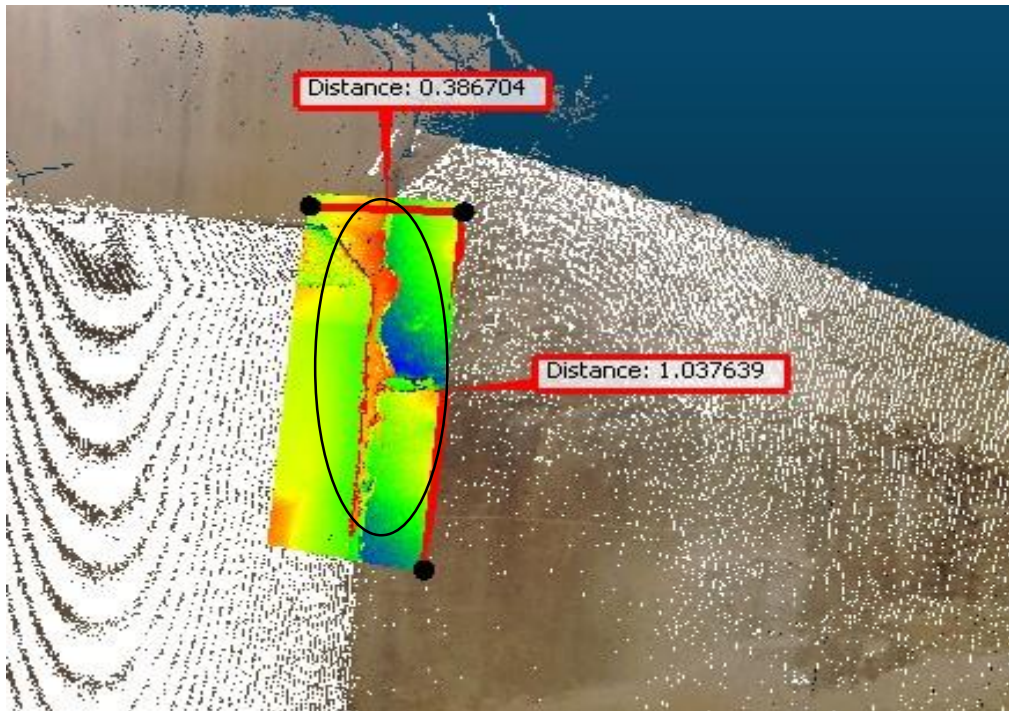
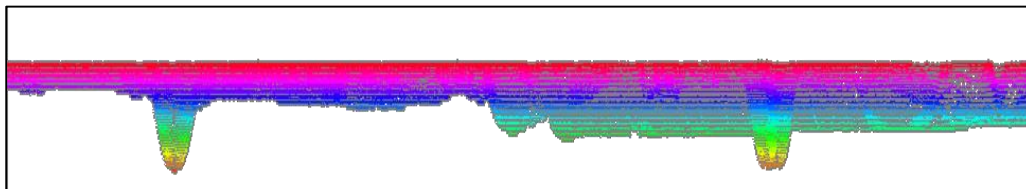
| Element Name | Observation | Location of Distress | Photo No. | Units | Distress Details | | | Area of Repair (Sq.m/ RMT/ m3) |
|---|---|---|---|---|---|---|---|---|
| Wing Wall | Damage | - | 2 | M | 0.38 | 1.03 | | 0.3914 |

**2. Wing wall damage observed, measuring 0.38 m in length and 1.03 m in width, covering an area of 0.3914 m<sup>2</sup>.**

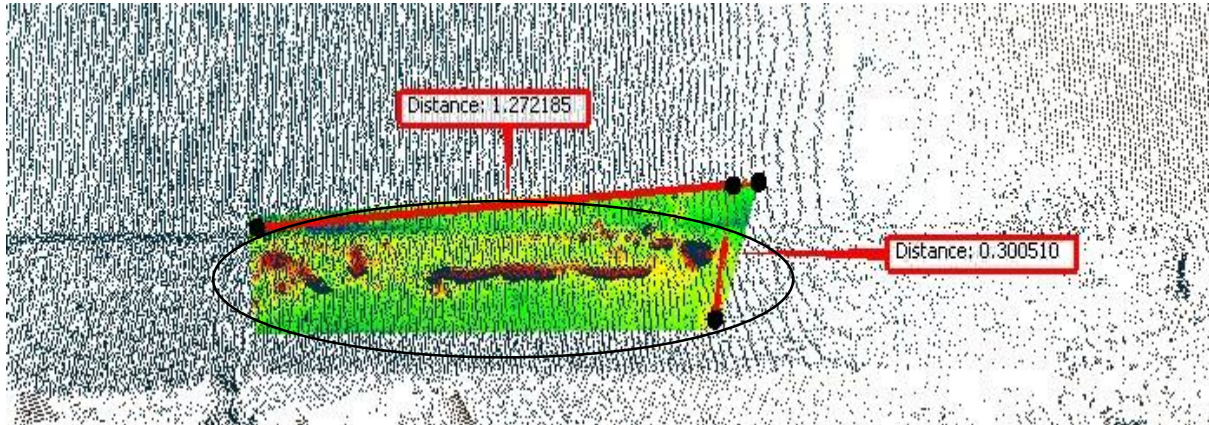
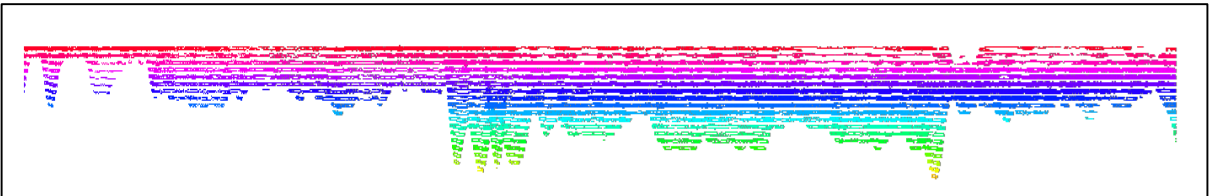
| Element Name | Observation | Location of Distress | Photo No. | Units | Distress Details | | | Area of Repair (Sq.m/ RMT/ m3) |
|---|---|---|---|---|---|---|---|---|
| Abutment Wall | Scaling | - | 3 | M | 1.27 | 0.30 | | 0.381 |

**3. Abutment wall scaling observed, measuring 1.27 m in length and 0.30 m in width, covering an area of 0.381 m<sup>2</sup>.**

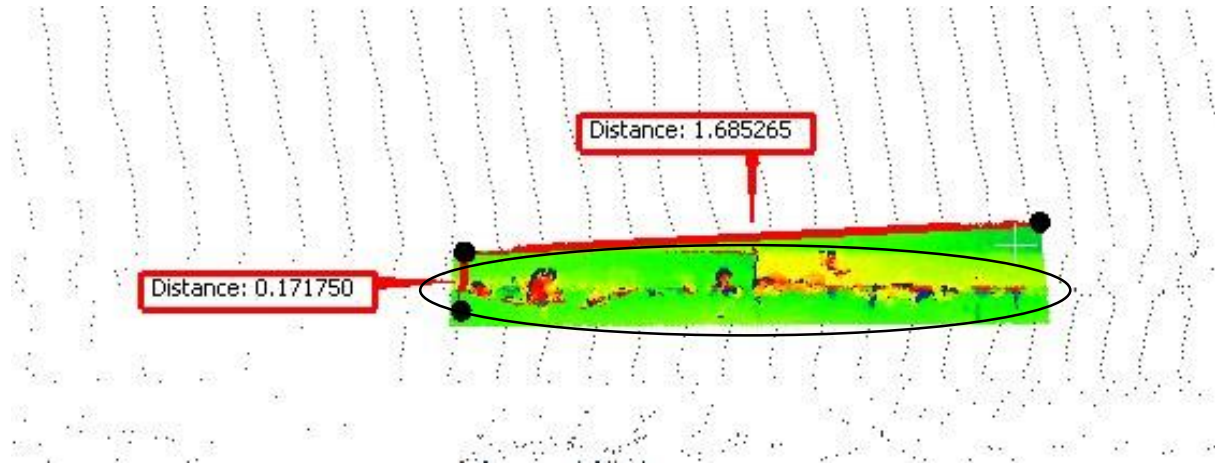
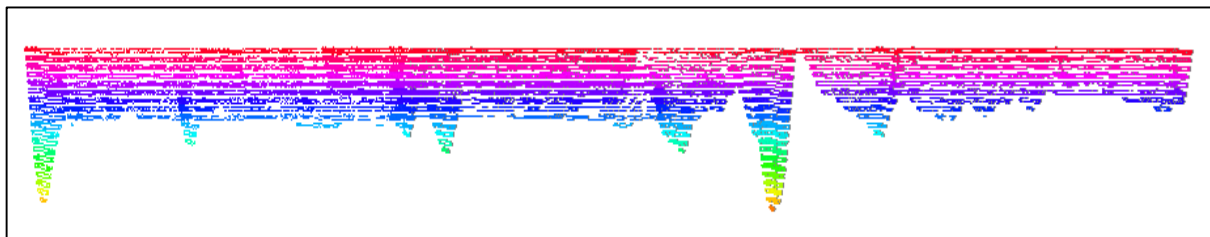
| Element Name | Observation | Location of Distress | Photo No. | Units | Distress Details | | | Area of Repair (Sq.m/ RMT/ m3) |
|---|---|---|---|---|---|---|---|---|
| Abutment Wall | Scaling | - | 4 | M | 1.68 | 0.17 | | 0.2856 |

**4. Abutment wall scaling observed, measuring 1.68 m in length and 0.17 m in width, covering an area of 0.2856 m<sup>2</sup>.**

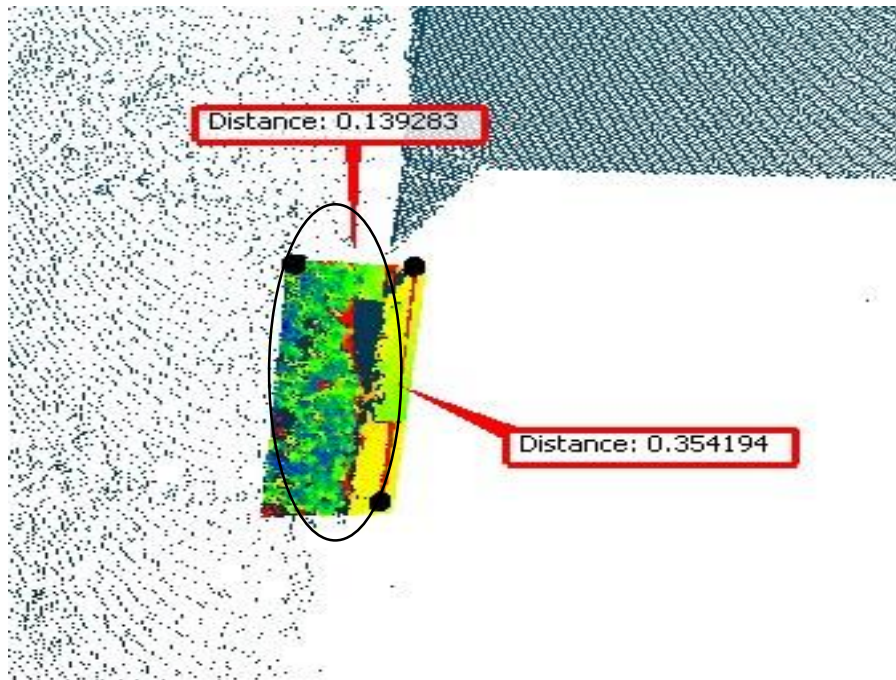
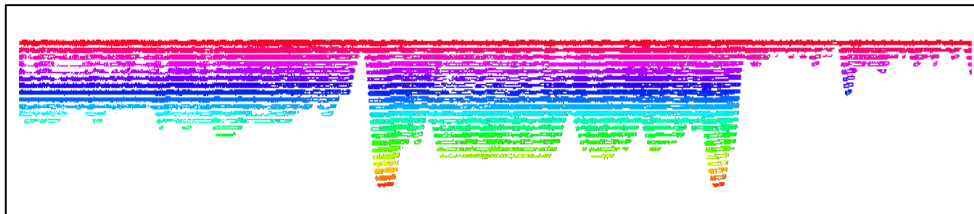
| Element Name | Observation | Location of Distress | Photo No. | Units | Distress Details | | | Area of Repair (Sq.m/ RMT/ m3) |
|---|---|---|---|---|---|---|---|---|
| Wing Wall | Damage | - | 5 | M | 0.13 | 0.35 | | 0.0455 |

**5. Wing wall damage observed, measuring 0.13 m in length and 0.35 m in width, covering an area of 0.0455 m<sup>2</sup>.**

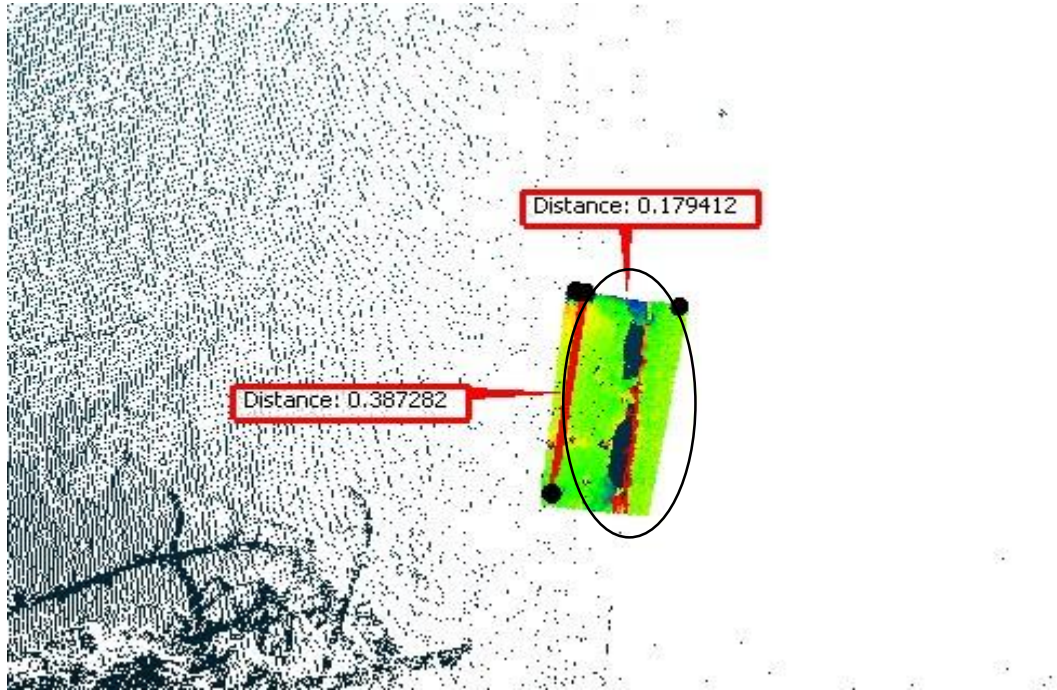
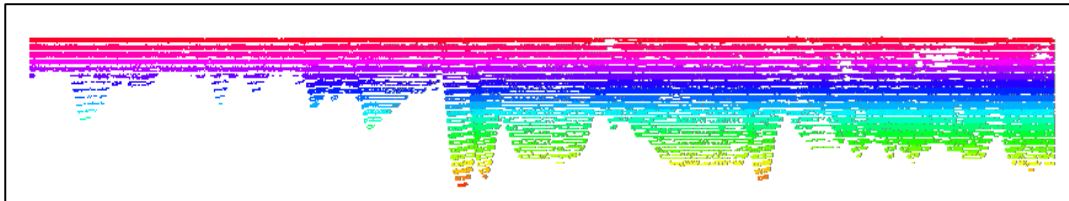
| Element Name | Observation | Location of Distress | Photo No. | Units | Distress Details | | | Area of Repair (Sq.m/ RMT/ m3) |
|---|---|---|---|---|---|---|---|---|
| Wing Wall | Damage | - | 6 | M | 0.17 | 0.38 | | 0.0646 |

**6. Wing wall damage observed, measuring 0.17 m in length and 0.38 m in width, covering an area of 0.0646 m<sup>2</sup>.**

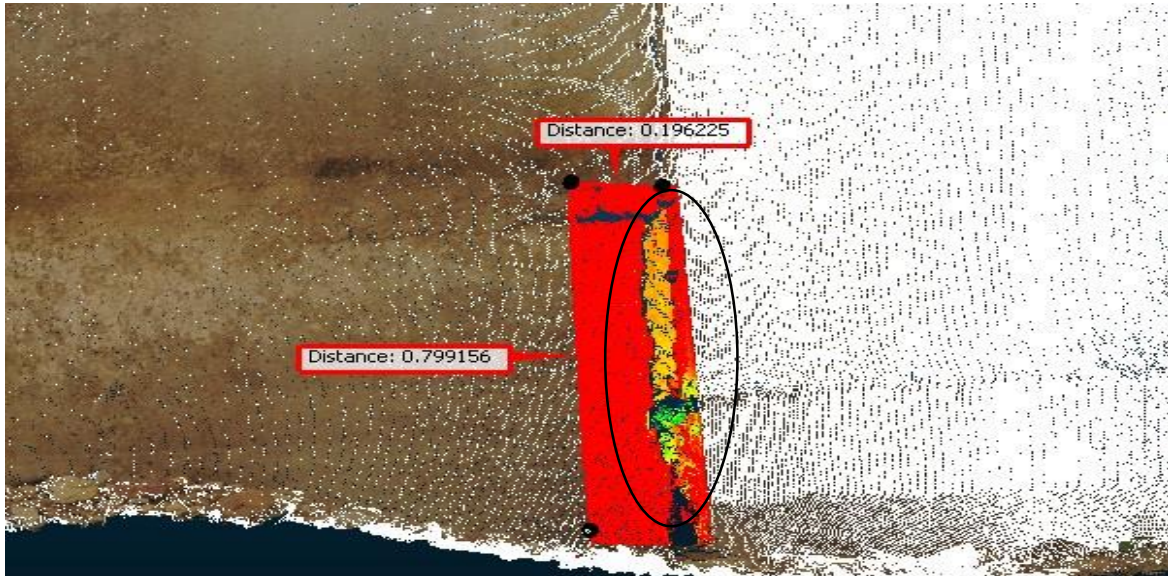
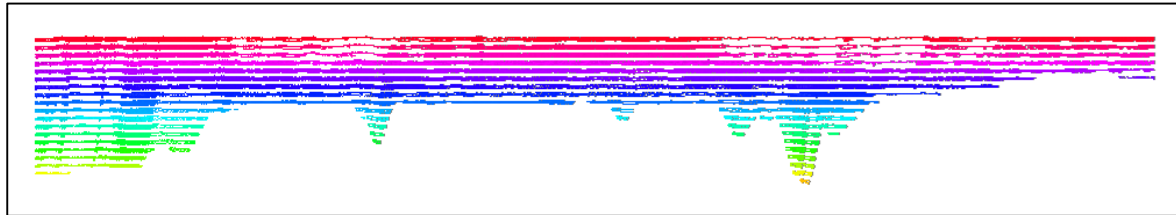
| Element Name | Observation | Location of Distress | Photo No. | Units | Distress Details | | | Area of Repair (Sq.m/ RMT/ m3) |
|---|---|---|---|---|---|---|---|---|
| Wing Wall | Damage | - | 7 | M | 0.19 | 0.79 | | 0.1501 |

**7. Wing wall damage observed, measuring 0.19 m in length and 0.79 m in width, covering an area of 0.1501 m<sup>2</sup>.**
