# **LIDAR Inspection Report of Box Culvert ch.918+775**

**Bridge Chainage:** 918+775

- **CKRP:** Chittorgarh to kota
- **State:** Rajasthan NH 27
- **Zone:** RJ-20

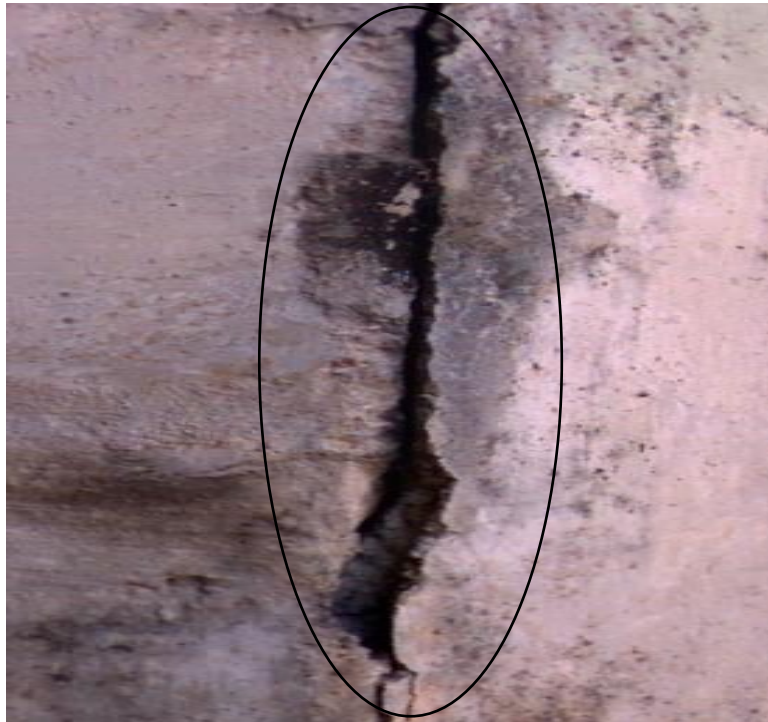
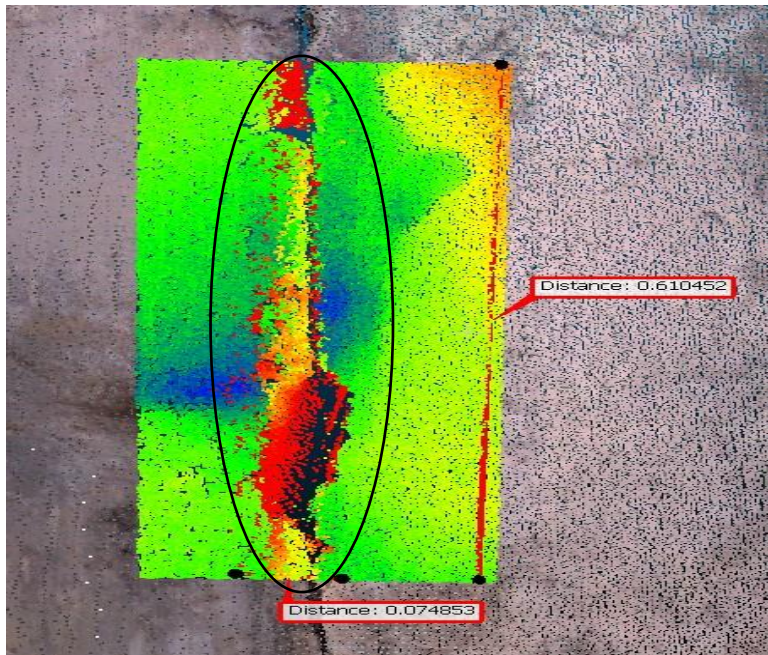
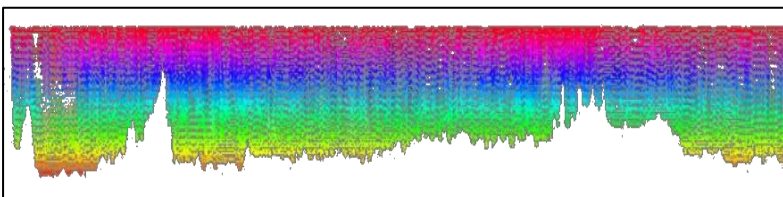
| Element Name | Observation | Location of Distress | Photo No. | Units | Distress Details | | | Area of Repair (Sq.m/R MT/m3) |
|---|---|---|---|---|---|---|---|---|
| Wing Wall | Damage | - | 1 | Sq m | 0.61 | 0.07 | - | 0.04 |

**1.Damage observed on wing wall corner RHS side, measuring 0.61 m in length and 0.07 m in width, covering an area of 0.04 m<sup>2</sup>.**
