# LIDAR Inspection Report of **Box Culvert** ch.919+380

**Bridge Chainage:** 919+380 (CKRP)

# **CH: 919+380– Box CULVERT**

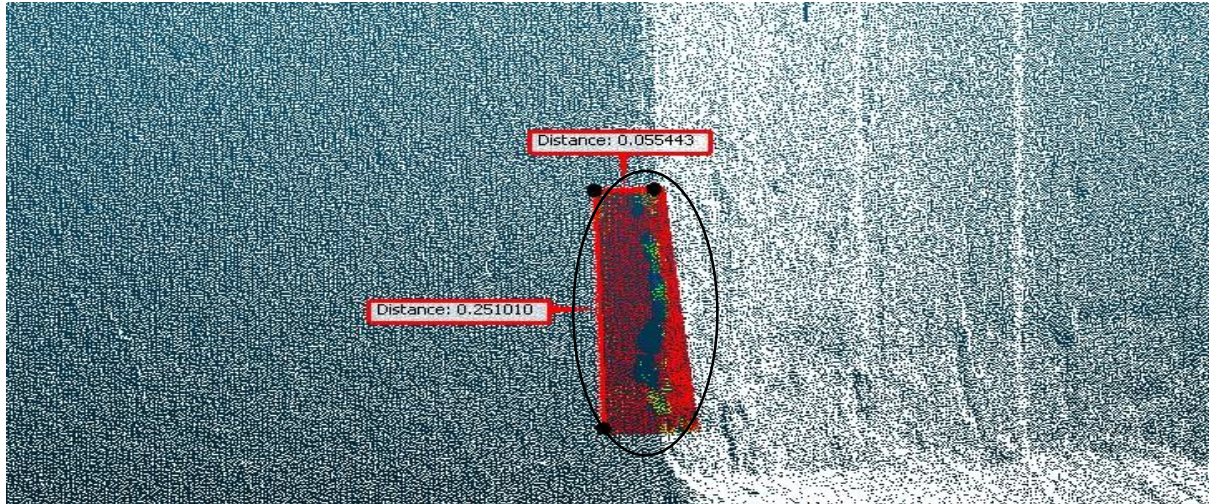
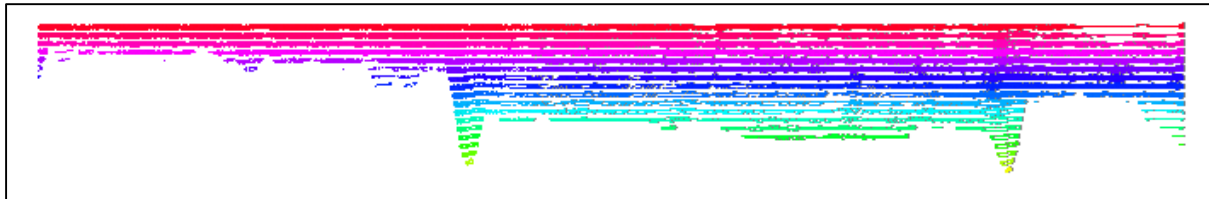
| Element Name | Observation | Location of Distress | Photo No. | Units | Distress Details | | | Area of Repair (Sq.m/ RMT/ m3) |
|---|---|---|---|---|---|---|---|---|
| Wing Wall | Damage | - | 1 | M | 0.05 | 0.25 | | 0.012 |

**1. Wing wall damage observed, measuring 0.05 m in length and 0.25 m in width, covering an area of 0.012 m<sup>2</sup>.**

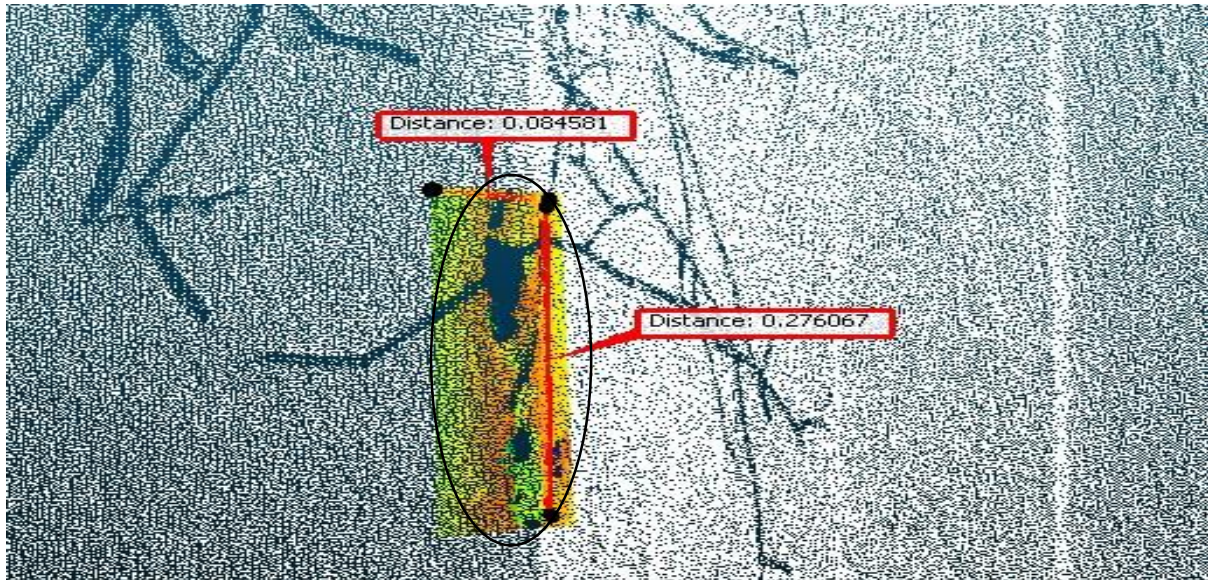
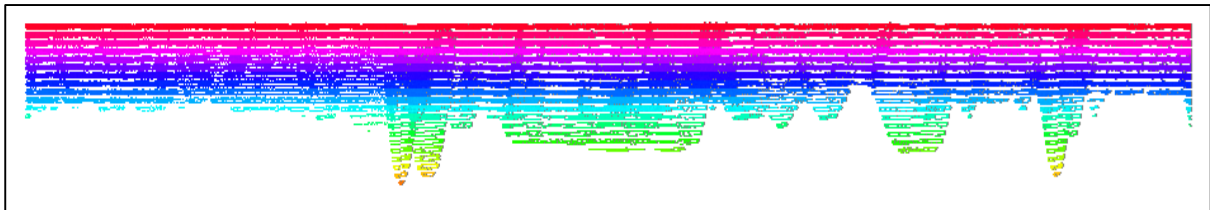
| Element Name | Observation | Location of Distress | Photo No. | Units | Distress Details | | | Area of Repair (Sq.m/ RMT/ m3) |
|---|---|---|---|---|---|---|---|---|
| Wing Wall | Damage | - | 2 | M | 0.08 | 0.27 | | 0.021 |

**2. Wing wall damage observed, measuring 0.08 m in length and 0.27 m in width, covering an area of 0.021 m<sup>2</sup>.**

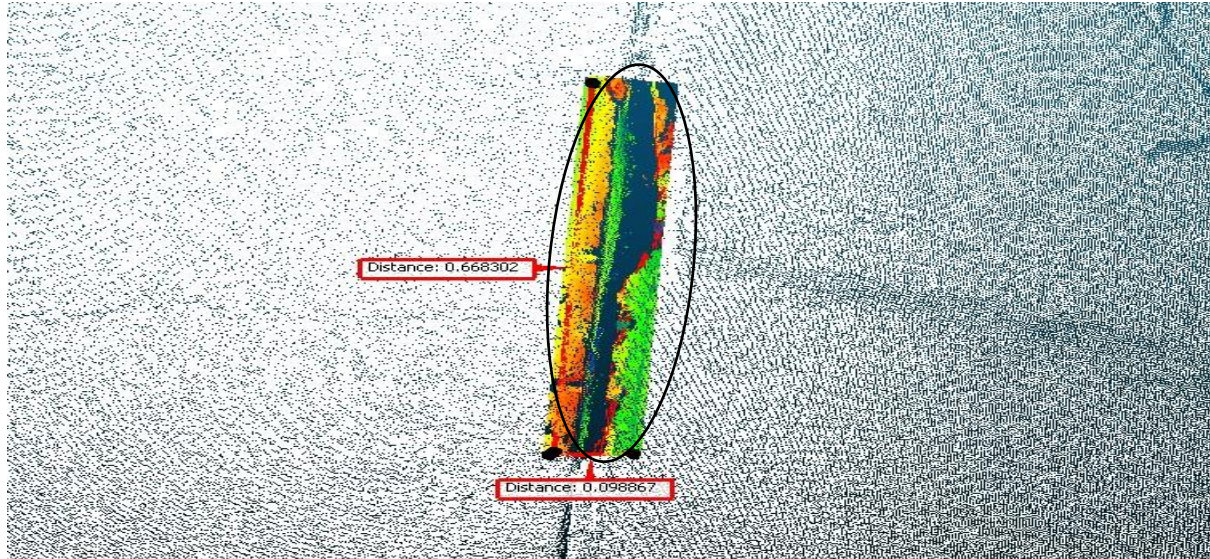
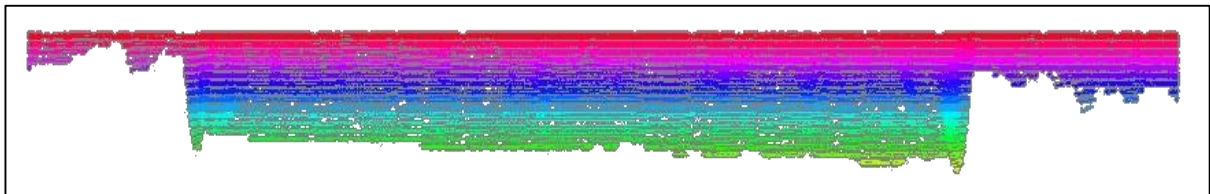
| Element Name | Observation | Location of Distress | Photo No. | Units | Distress Details | | | Area of Repair (Sq.m/ RMT/ m3) |
|---|---|---|---|---|---|---|---|---|
| Wing Wall | Damage | - | 3 | M | 0.09 | 0.66 | | 0.059 |

**3. Wing wall damage observed, measuring 0.09 m in length and 0.66 m in width, covering an area of 0.059 m<sup>2</sup>.**

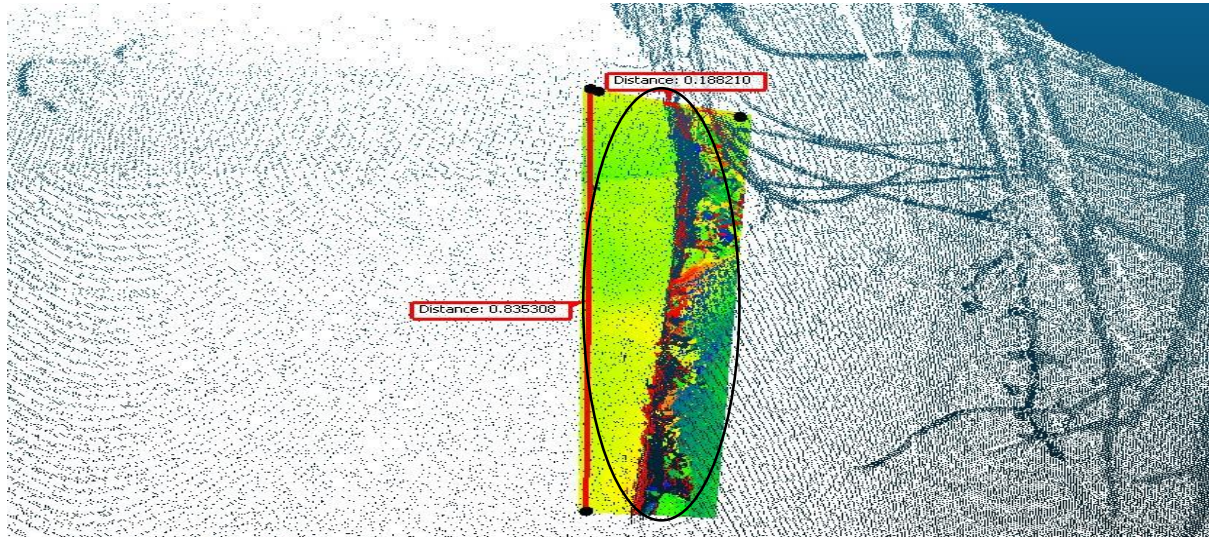
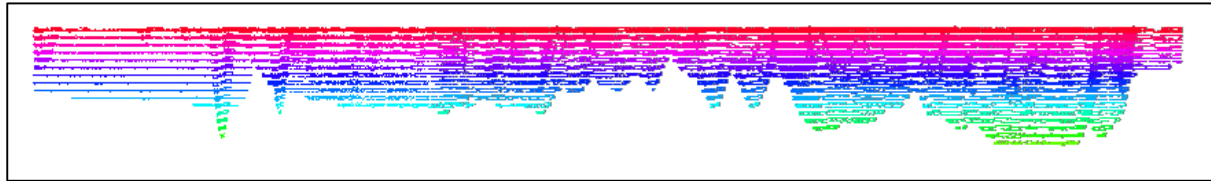
| Element Name | Observation | Location of Distress | Photo No. | Units | Distress Details | | | Area of Repair (Sq.m/ RMT/ m3) |
|---|---|---|---|---|---|---|---|---|
| Wing Wall | Damage | - | 4 | M | 0.18 | 0.83 | | 0.149 |

**4. Wing wall damage observed, measuring 0.18 m in length and 0.83 m in width, covering an area of 0.149 m<sup>2</sup>.**

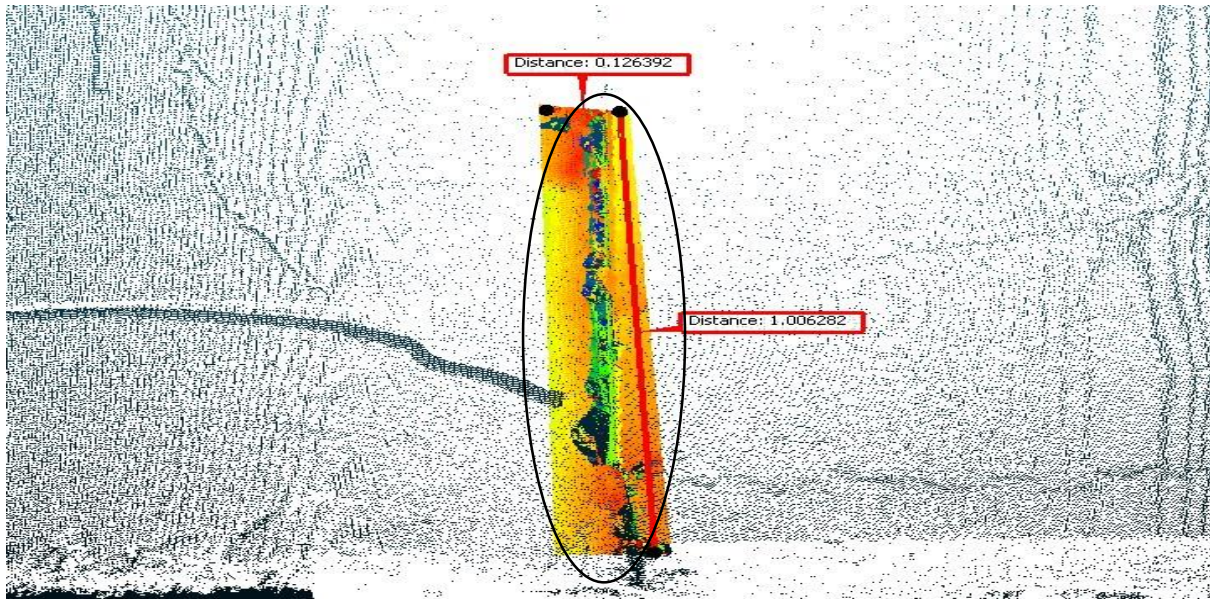
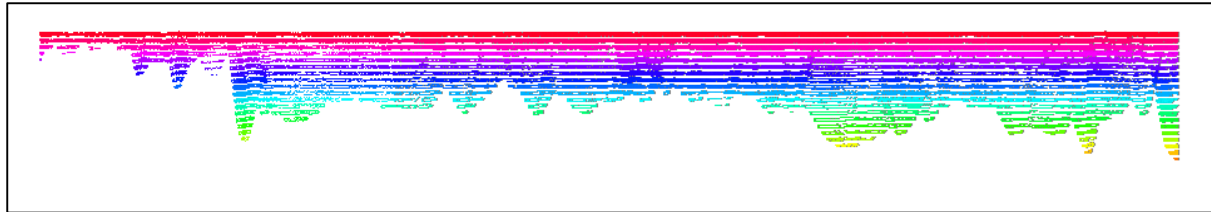
| Element Name | Observation | Location of Distress | Photo No. | Units | Distress Details | | | Area of Repair (Sq.m/ RMT/ m3) |
|---|---|---|---|---|---|---|---|---|
| Wing Wall | Damage | - | 5 | M | 0.12 | 1.00 | | 0.12 |

**5. Wing wall damage observed, measuring 0.12 m in length and 1.00 m in width, covering an area of 0.12 m<sup>2</sup>.**

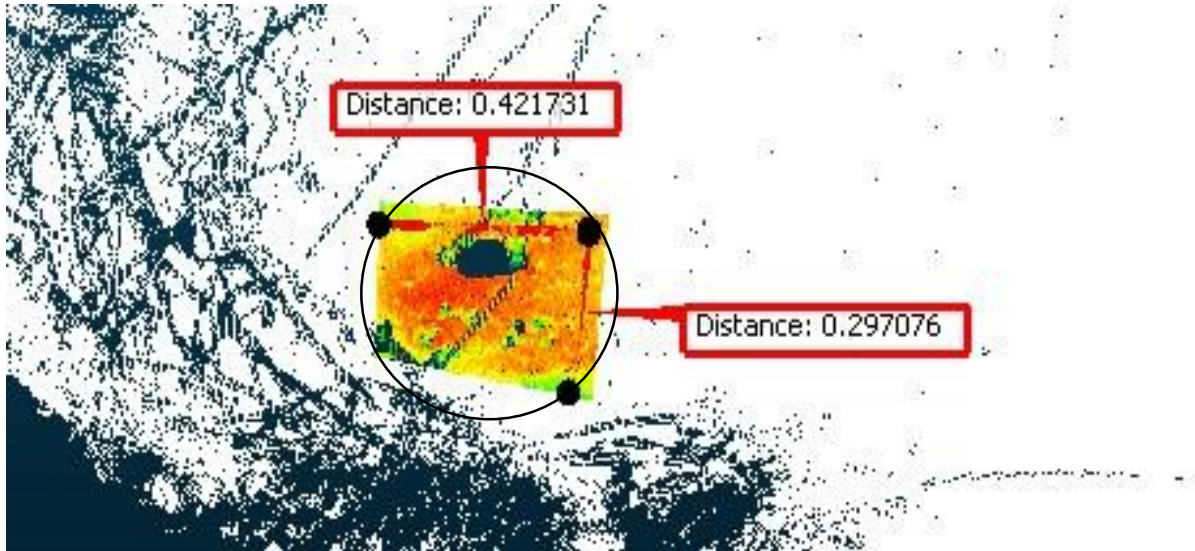
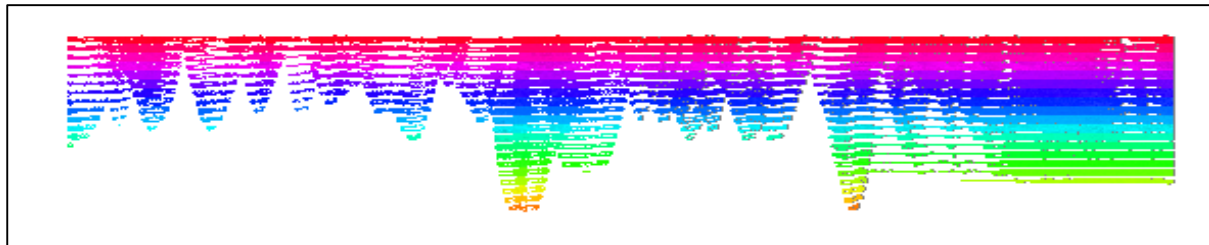
| Element Name | Observation | Location of Distress | Photo No. | Units | Distress Details | | | Area of Repair (Sq.m/ RMT/ m3) |
|---|---|---|---|---|---|---|---|---|
| Wing Wall | Damage | - | 6 | M | 0.42 | 0.29 | | 0.1218 |

**6. Wing wall damage observed, measuring 0.42 m in length and 0.29 m in width, covering an area of 0.1218 m<sup>2</sup>.**

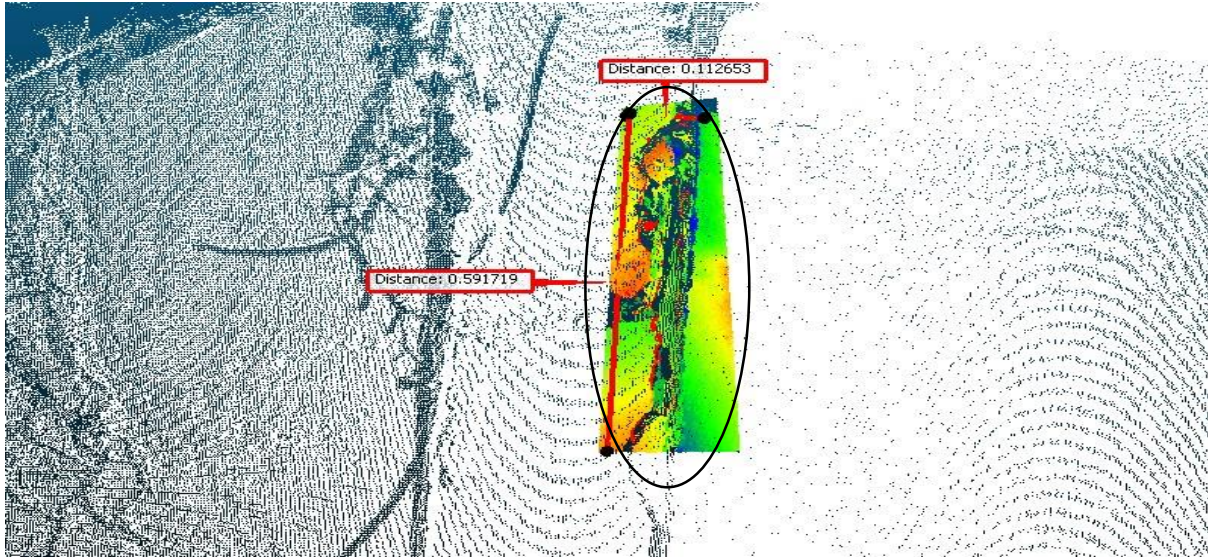
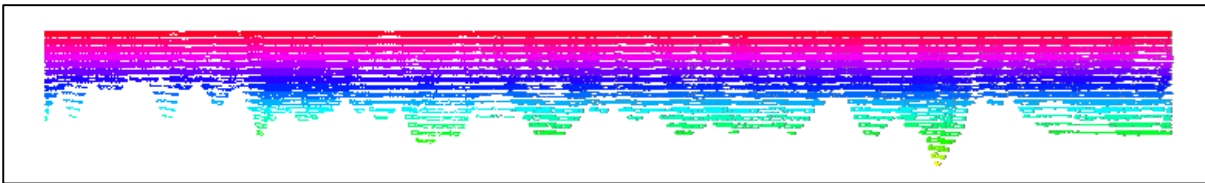
| Element Name | Observation | Location of Distress | Photo No. | Units | Distress Details | | | Area of Repair (Sq.m/ RMT/ m3) |
|---|---|---|---|---|---|---|---|---|
| Wing Wall | Damage | - | 7 | M | 0.11 | 0.59 | | 0.064 |

**7. Wing wall damage observed, measuring 0.11 m in length and 0.59 m in width, covering an area of 0.064 m<sup>2</sup>.**

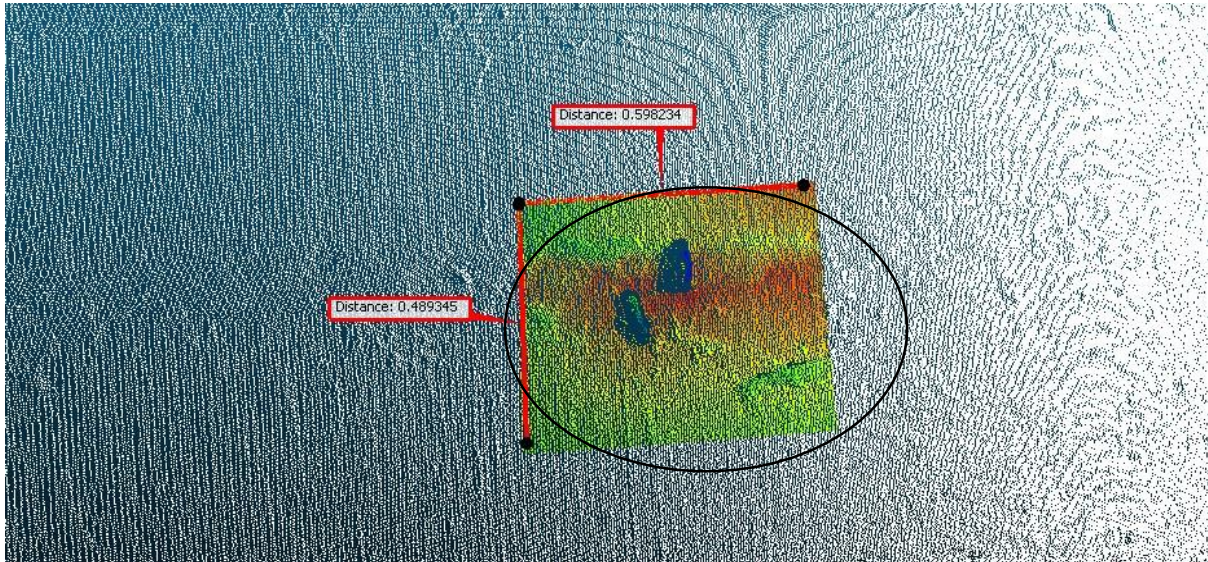
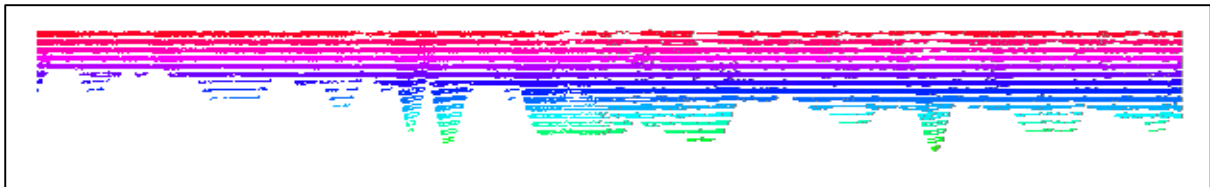
| Element Name | Observation | Location of Distress | Photo No. | Units | Distress Details | | | Area of Repair (Sq.m/ RMT/ m3) |
|---|---|---|---|---|---|---|---|---|
| Abutment Wall | Damage | - | 8 | M | 0.59 | 0.48 | | 0.283 |

**8. Abutment wall damage observed, measuring 0.59 m in length and 0.48 m in width, covering an area of 0.283 m<sup>2</sup>.**

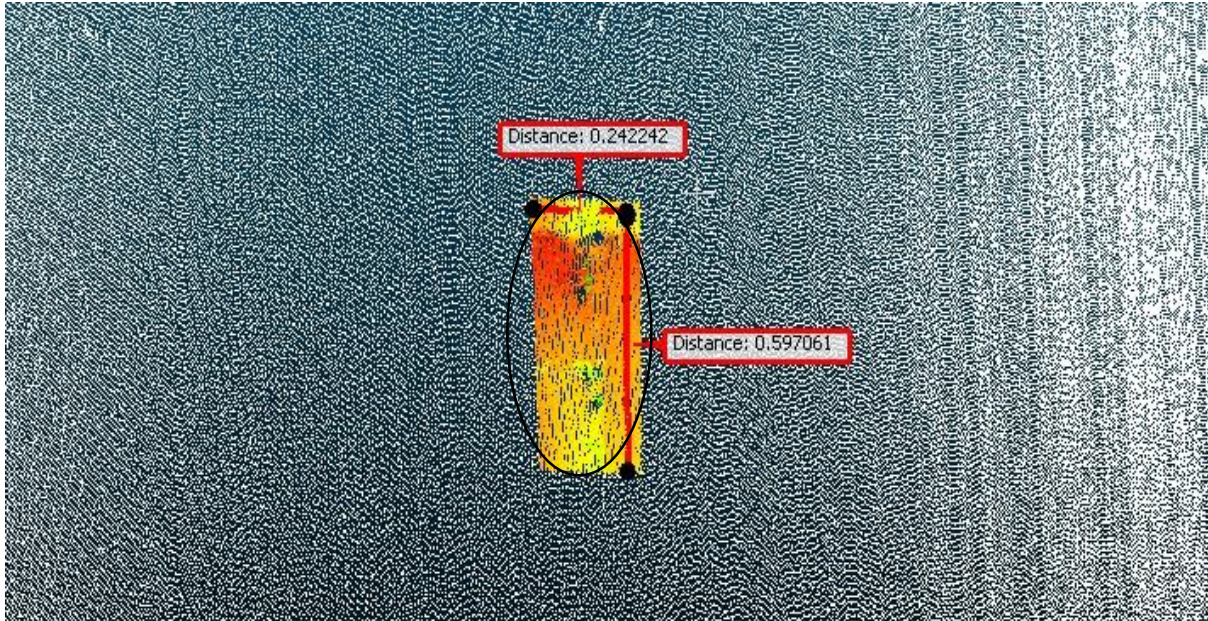
| Element Name | Observation | Location of Distress | Photo No. | Units | Distress Details | | | Area of Repair (Sq.m/ RMT/ m3) |
|---|---|---|---|---|---|---|---|---|
| Abutment Wall | Damage | - | 9 | M | 0.24 | 0.59 | | 0.1416 |

**9. Abutment wall damage observed, measuring 0.24 m in length and 0.59 m in width, covering an area of 0.1416 m<sup>2</sup>.**
