# **LIDAR Inspection Report of VUP ch.919+580**

**Bridge Chainage:** 919+580 (CKRP)

- **Bridge No:** -
- **Chainage:** 919+580
- **Structure type:** VUP

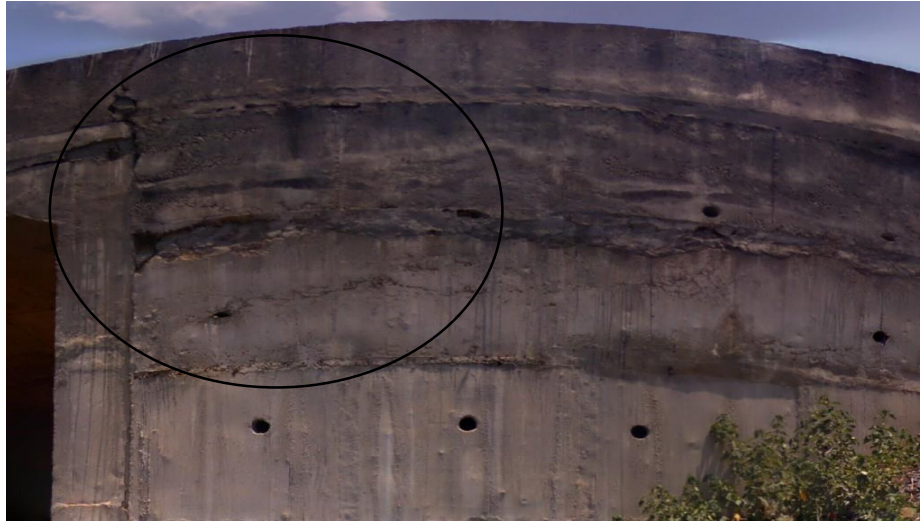
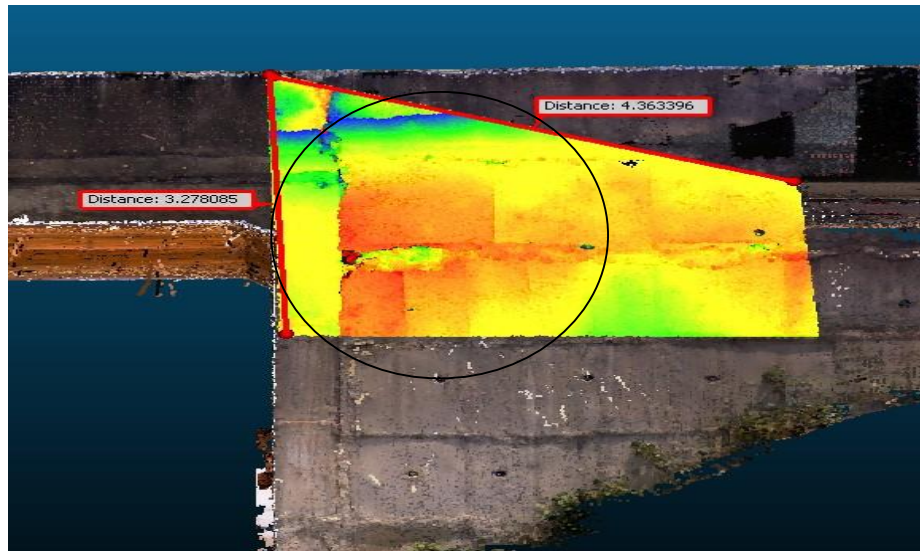
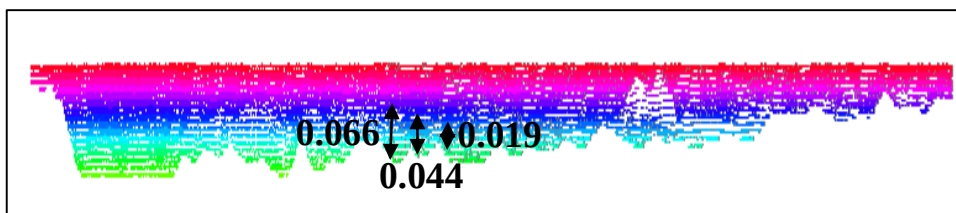
| Element Name | Observation | Location of Distress | Photo No. | Units | Distress Details | | | Area of Repair (Sq.m/RT/m3) |
|---|---|---|---|---|---|---|---|---|
| Abutment 1 | Damage | - | 1 | M | 4.36 | 3.27 | 0.044 | 0.627 |

**1. Wing wall damage observed on LHS Abutment 1, measuring 4.36 m in length and 3.27 m in width. Depth ranges from 0.019(min) to 0.066 m (max), with an average depth of 0.044m. The calculated volume of the distress is 0.627m<sup>3</sup>.**

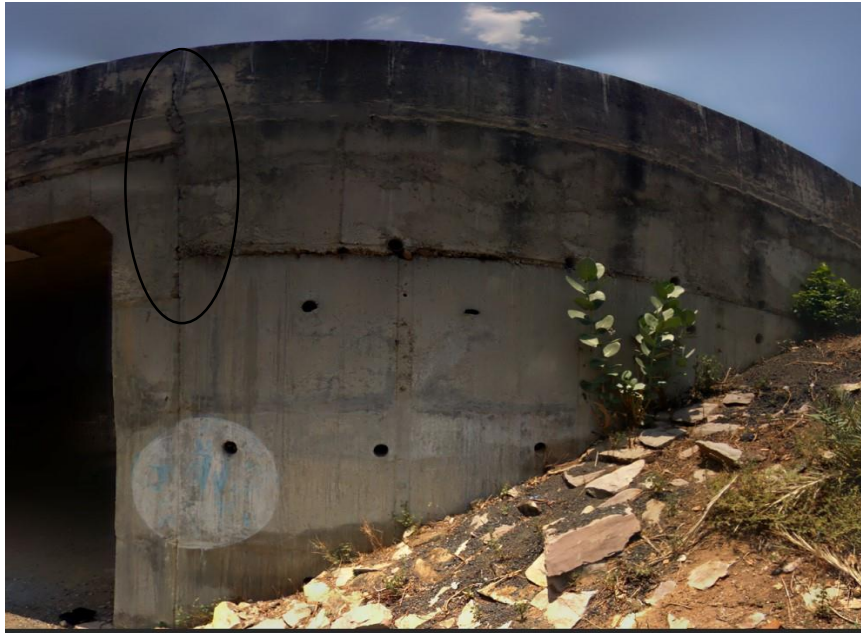
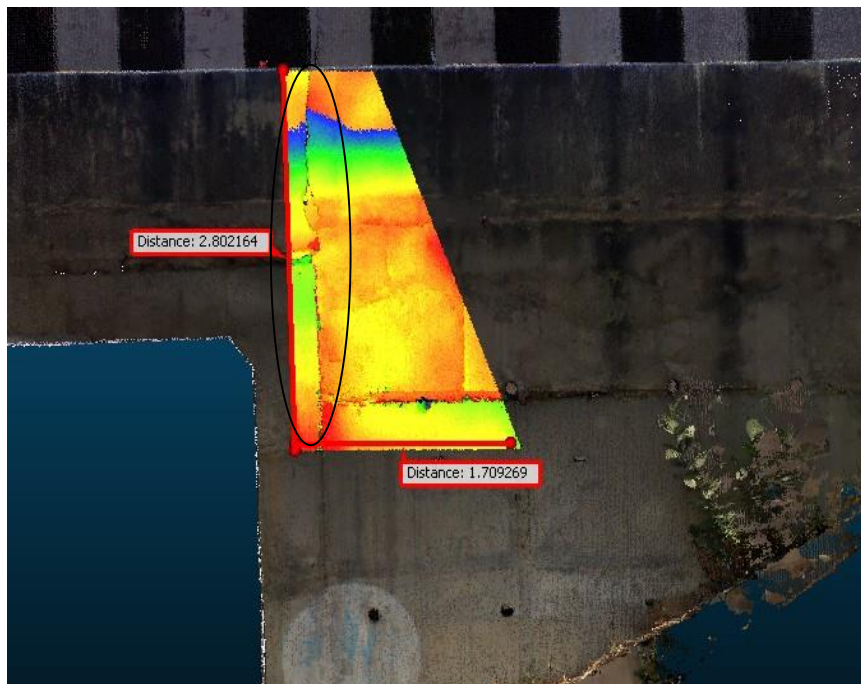
| Element Name | Observation | Location of Distress | Photo No. | Units | Distress Details | | | Area of Repair (Sq.m/RT/m3) |
|---|---|---|---|---|---|---|---|---|
| Abutment 2 | Damage | - | 2 | M | 1.70 | 2.80 | - | 4.76 |

**2. Wing wall damage observed on RHS A2, measuring 1.70 m in length and 2.80 m in width, covering an area of 4.76 m<sup>2</sup>.**
