# **LIDAR Inspection Report of VUP ch.919+840**

**Bridge Chainage:** 919+840 (CKRP)

**Latitude/Longitude:** 24.997148,74.732454

# **CH: 919+840– VUP**

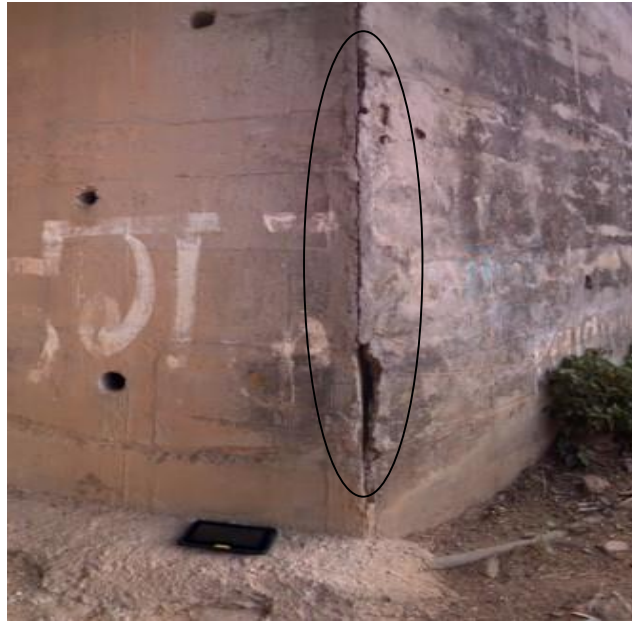
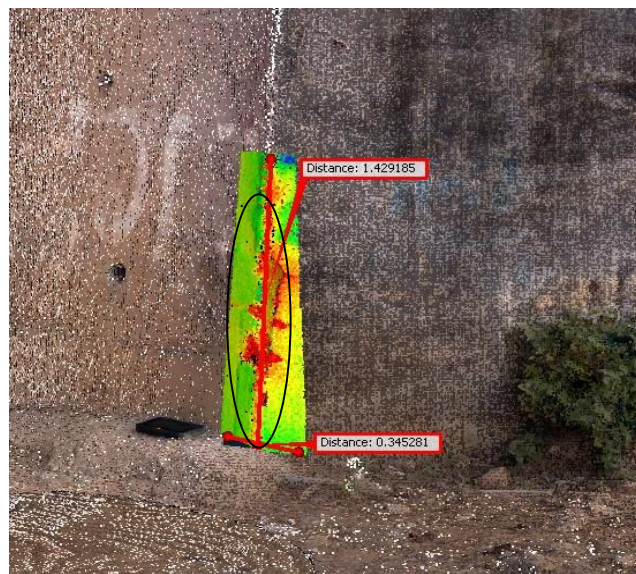
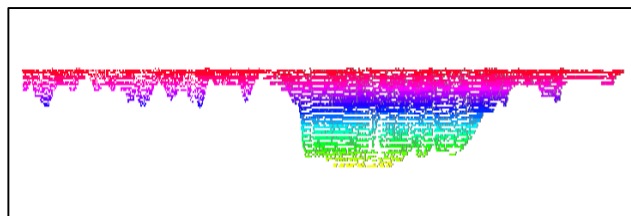
| Element Name | Observation | Location of Distress | Photo No. | Units | Distress Details | | | Area of Repair (Sq.m/R MT/m3) |
|---|---|---|---|---|---|---|---|---|
| Abutment 1 wall | Damage | - | 1 | M | 1.42 | 0.34 | - | 0.482 |

**1. Wing wall damage observed on RHS A1, measuring 1.42 m in length and 0.34 m in width, covering an area of 0.482 m<sup>2</sup>.**
