# **Satellite Structural Inspection Interferometric Synthetic Aperture Radar (InSAR) Based**

Bridge No. – 899/1

Project - Chittorgarh to Kota

Structure Type – VUP

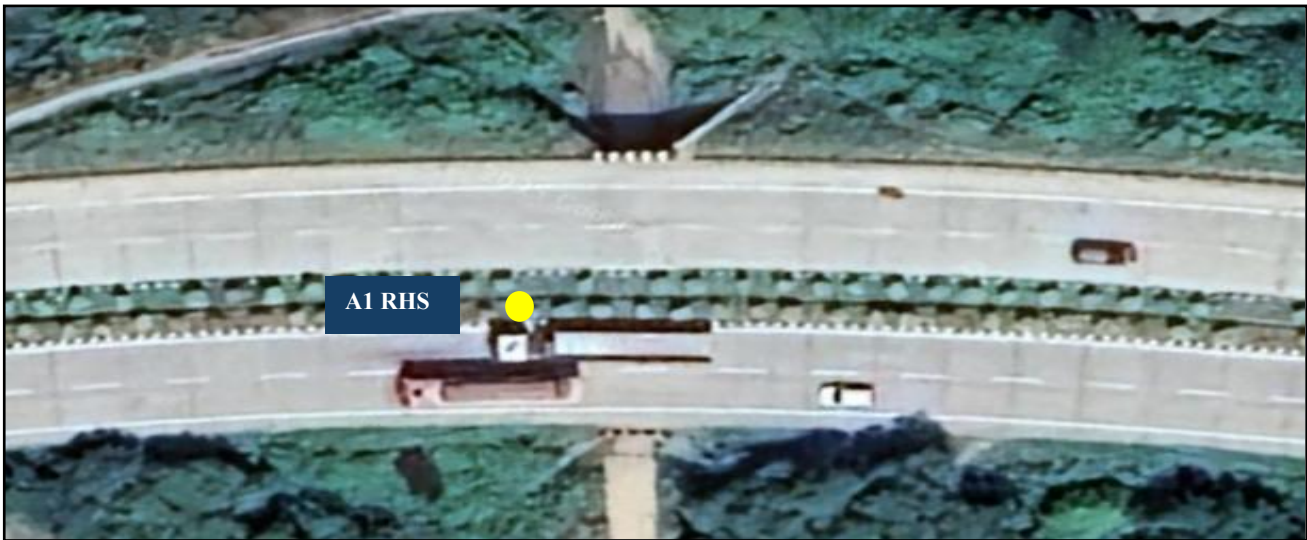
A1 RHS (24.997072652244107, 74.73243857466198)

- **Horizontal displacement (VH)** Horizontal displacement exhibits noticeable variability, ranging approximately from -14 mm to +5 mm.
- **Vertical displacement (VV)** Vertical displacement ranges approximately from -15 mm to +5 mm, showing moderate vertical movement with alternating uplift and settlement phases over the monitoring period.

- **February 2025:** A sharp negative VH dip occurs while VV remains near neutral to slightly positive, suggesting a localized lateral disturbance without significant vertical coupling.
- **March 2025:** VH reaches a local positive peak (around +5 mm) concurrent with VV transitioning downward, indicating a shift from uplift to settlement-dominated behaviour.
- **June 2025:** Both VH and VV stabilize near small negative to neutral values, indicating reduced displacement activity and overall stabilization of the structure.

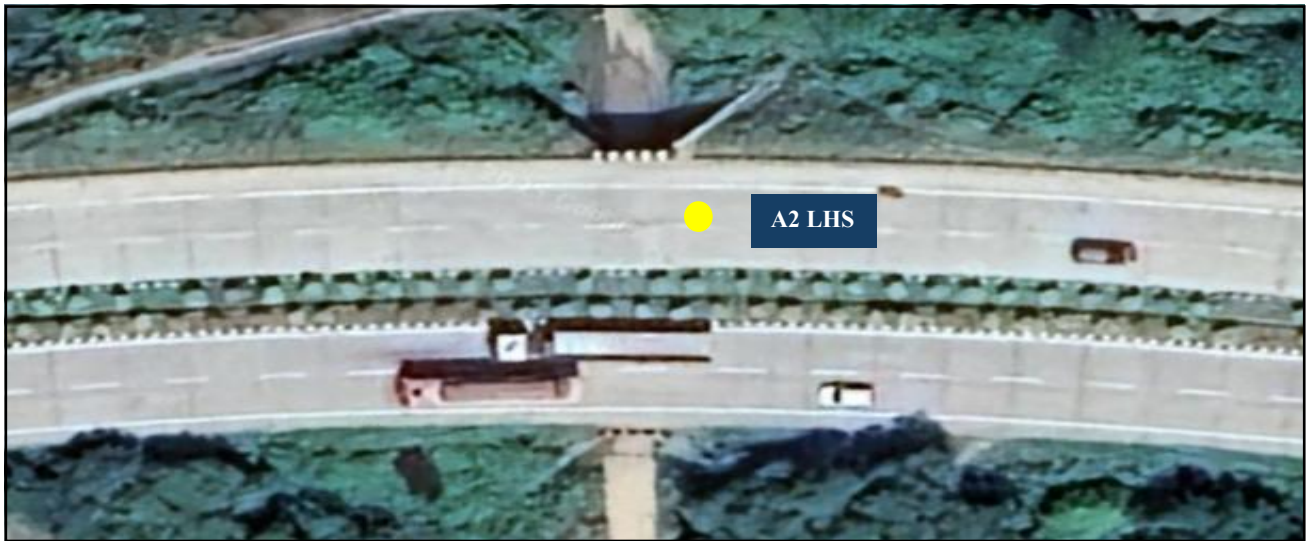
A2 LHS (24.997215224902444, 74.7324558860547)

- **Horizontal displacement (VH)** Horizontal displacement shows a strong and progressive negative trend, transitioning from positive values to significant negative magnitudes.
- **Vertical Displacement (VV)** at A2 LHS exhibits alternating uplift and settlement phases, but with a clear dominance of negative values across most of the monitoring period.

- **January 2025:** VH starts at a positive peak, while VV is slightly negative, indicating initial lateral movement opposite to later trends, with minimal vertical settlement.
- **June 2025:** VH partially recovers to -12 mm, but VV stays negative, confirming no full structural recovery by the end of monitoring.

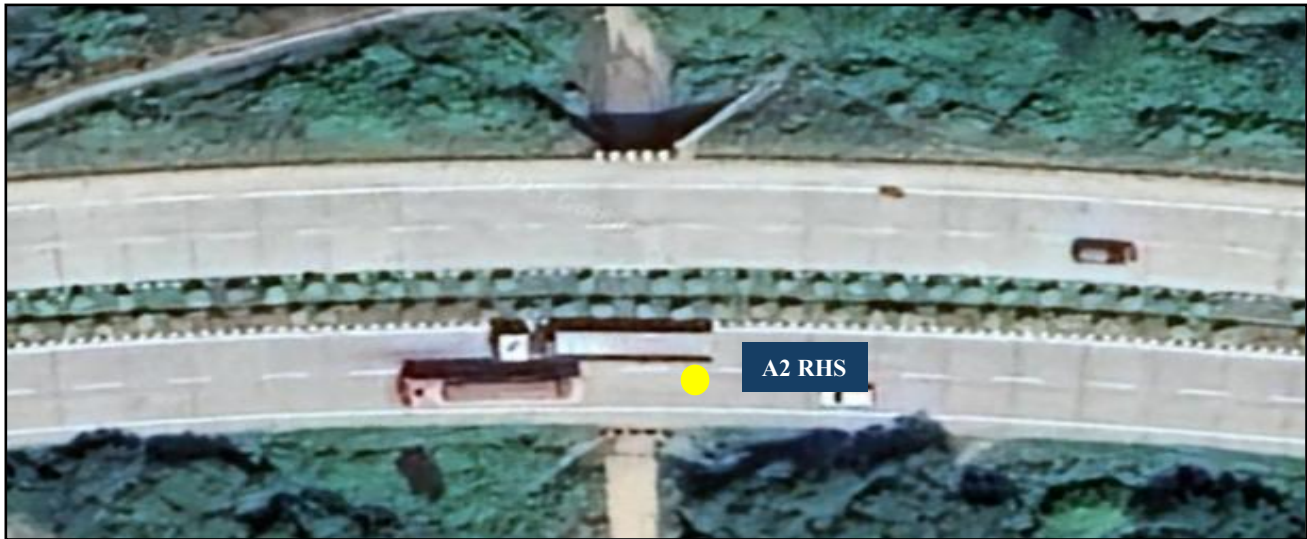
A2 RHS (24.997107442716654, 74.7325048095558)

- **Vertical (VV) displacement** Vertical displacement at A2 RHS exhibits alternating uplift and settlement behaviour, with values ranging approximately between +8 mm uplift and -15 mm settlement.
- **Horizontal (VH) displacement** Horizontal displacement shows moderate to high variability, ranging from approximately +8 mm to -15 mm.

- **January 2025:** VH starts in the negative range, while VV is slightly positive (+1 mm), indicating initial lateral offset with minimal vertical disturbance.
- **May 2025:** VH shows a short recovery to +3 mm, while VV approaches 0 mm, marking a brief stabilization window.
- **June 2025:** Both VH and VV remain negative, confirming no full recovery by the end of the monitoring period.
