# **LIDAR Inspection Report of MNB ch.920+200**

**Bridge No:** 920/1

**Bridge Chainage:** 920+200

- **CKRP:** Chittorgarh to kota
- **State:** Rajasthan NH 27
- **Zone:** RJ-20

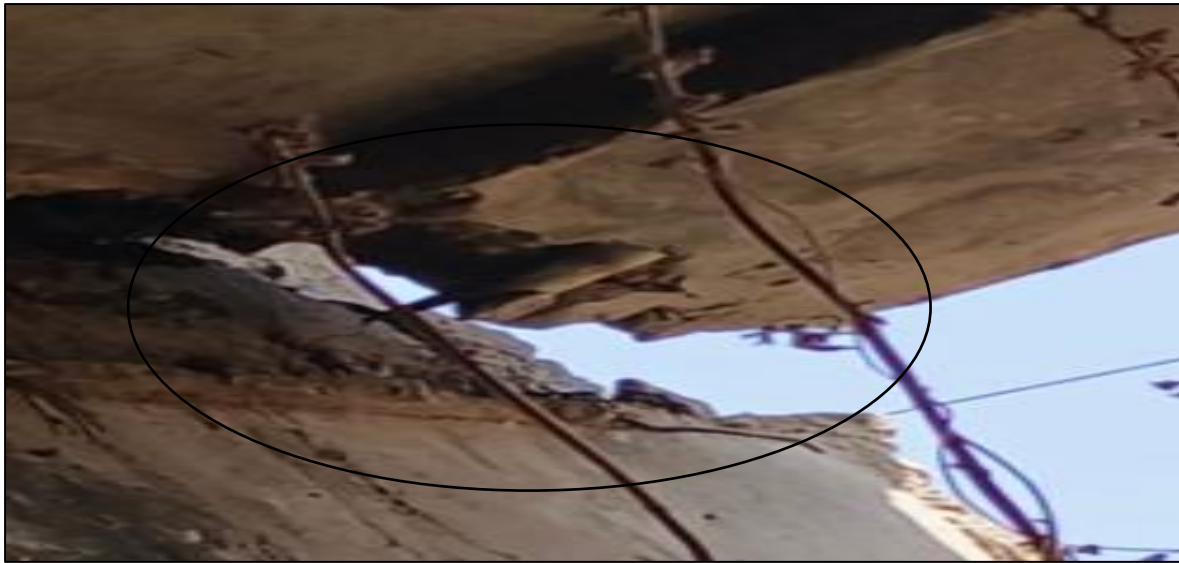
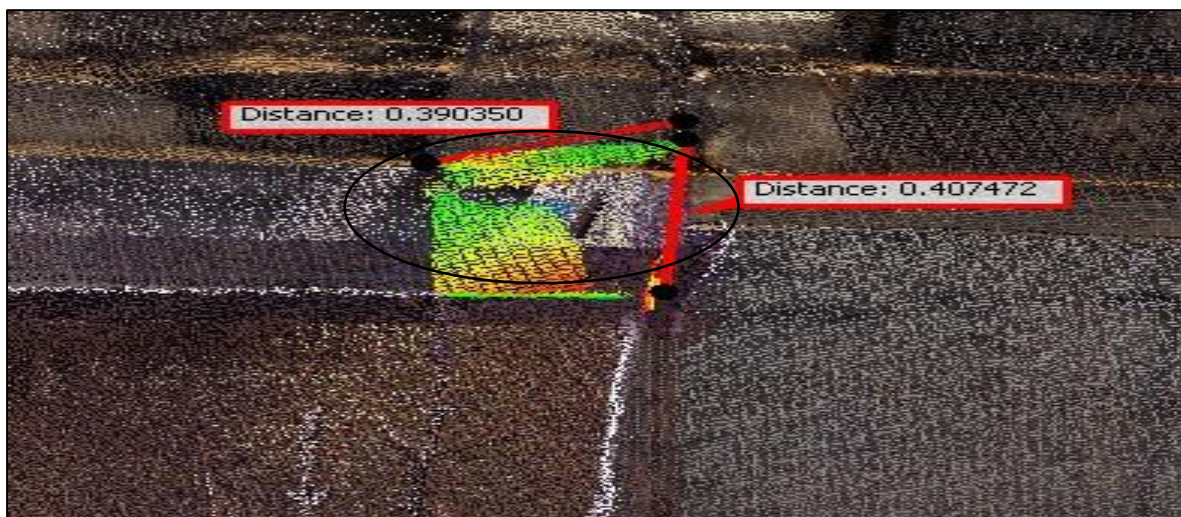
| Element Name | Observation | Location of Distress | Photo No. | Units | Distress Details | | | Area of Repair (Sq./RM T/m3) |
|---|---|---|---|---|---|---|---|---|
| Abutment 2 | Damage | | 1 | Cu m | 0.4074 | 0.3903 | 0.022 | 0.00349 |

**1. Toe Side Damage observed on A2 (RHS), measuring 0.4074 m in length and 0.3903 m in width, covering an area of 0.00349 m<sup>2</sup>, with an average depth of 0.022 m.**

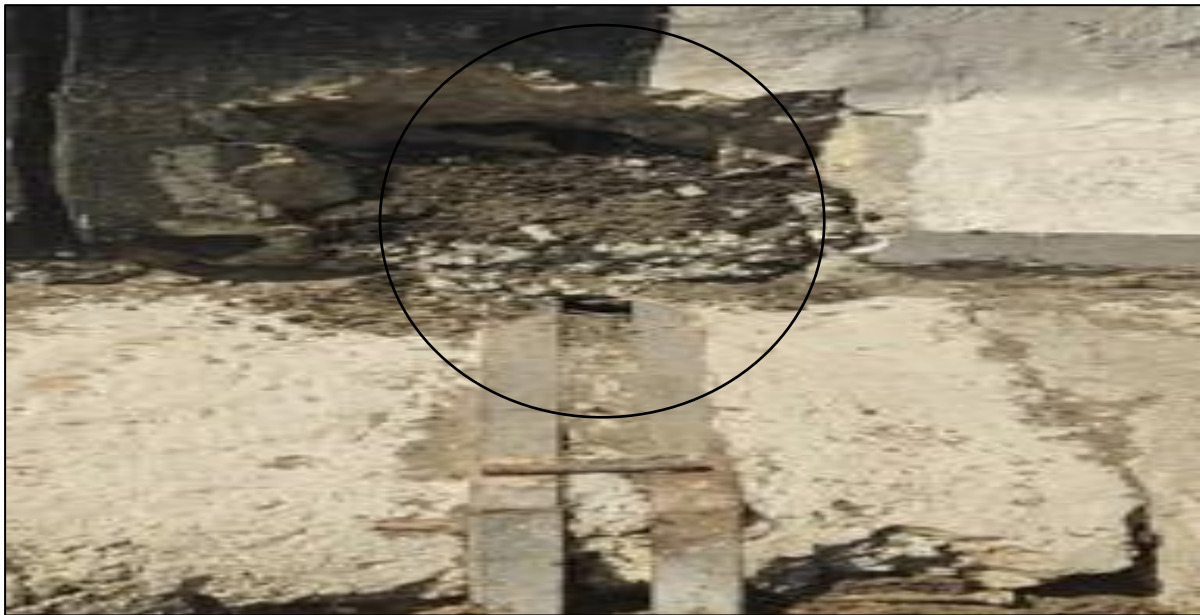
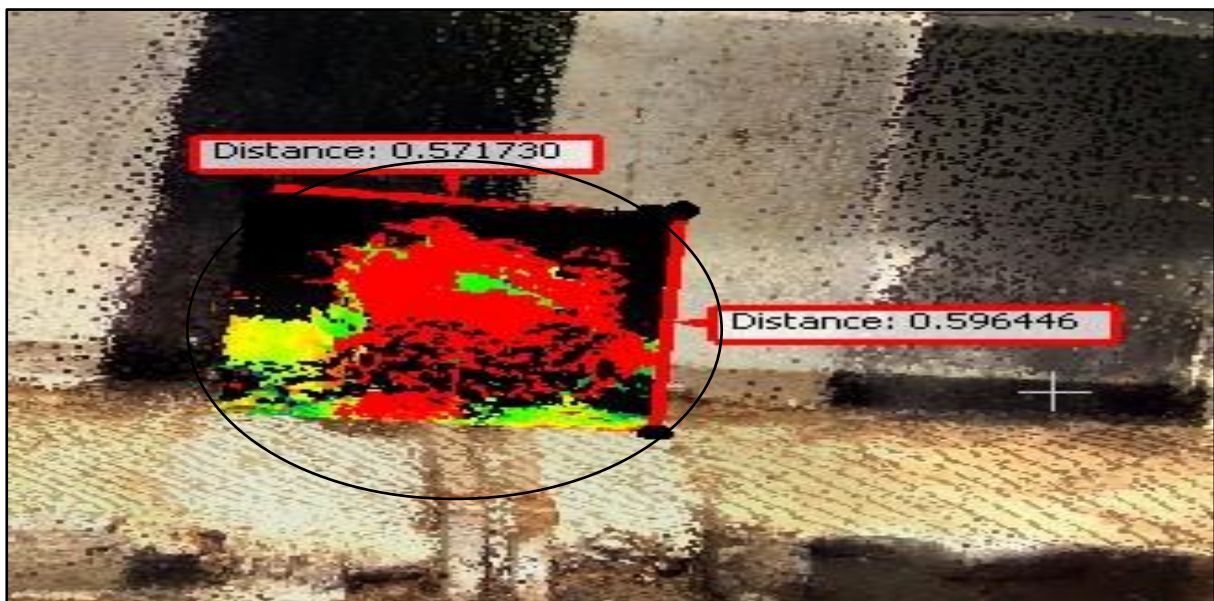
| Element Name | Observation | Location of Distress | Photo No. | Units | Distress Details | | | Area of Repair (Sq./RM T) |
|---|---|---|---|---|---|---|---|---|
| Crash Barrier | Damage | | 2 | Cu m | 0.5964 | 0.5717 | 0.028 | 0.00954 |

2. Crash Barrier Damage observed on the LHS, measuring 0.5964 m in length and 0.5717 m in width, covering an area of 0.00954 m<sup>2</sup>, with an average depth of 0.028 m.
