# **Satellite Structural Inspection Interferometric Synthetic Aperture Radar (InSAR) Based**

Bridge No. – 899/1

Bridge Chainage – 920+200

Project - Chittorgarh to Kota

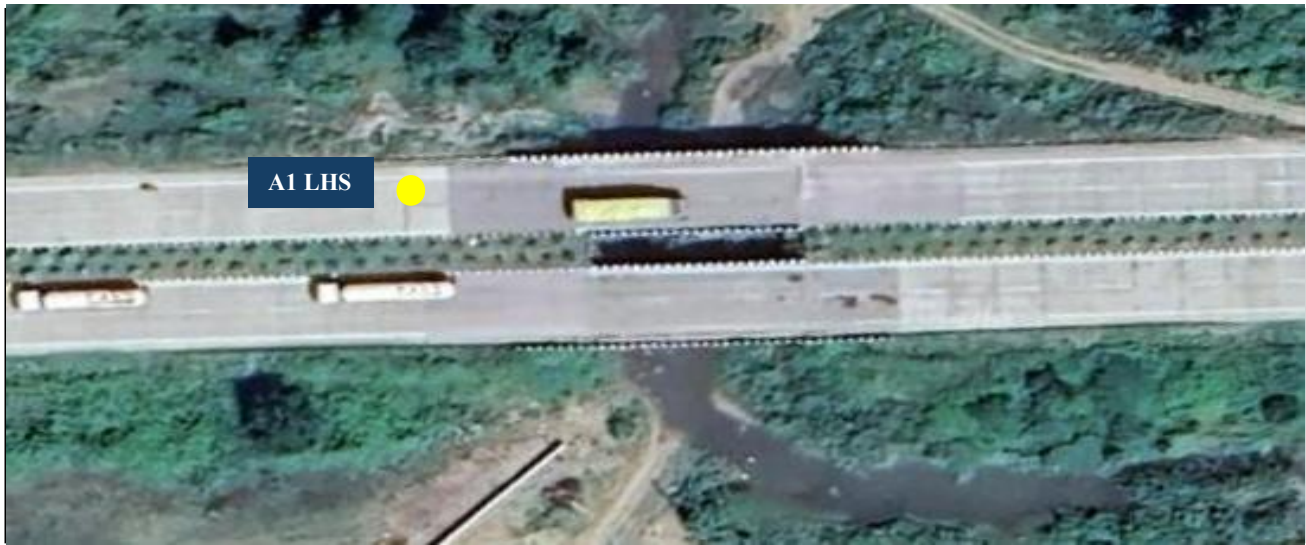
A1 LHS (24.99799006438882, 74.73597932346847)

- **Vertical Displacement (VV)** values are predominantly positive, ranging approximately from +2 mm to +19 mm, indicating overall upward movement or uplift response at A1 LHS.
- **Horizontal Displacement (VH)** values remain consistently positive throughout the monitoring period, generally ranging between approximately +8 mm and +24 mm

- **March 2025:** Both VH and VV increase concurrently, indicating combined lateral and vertical response, potentially influenced by temperature rise or increased service loading.
- **May 2025:** VH reaches its highest recorded value while VV remains elevated, suggesting a peak structural response phase rather than isolated movement
- **June 2025:** VH drops again to -12 mm, while VV stabilizes near +5 mm, confirming continued lateral settlement toward the end of the monitoring period.

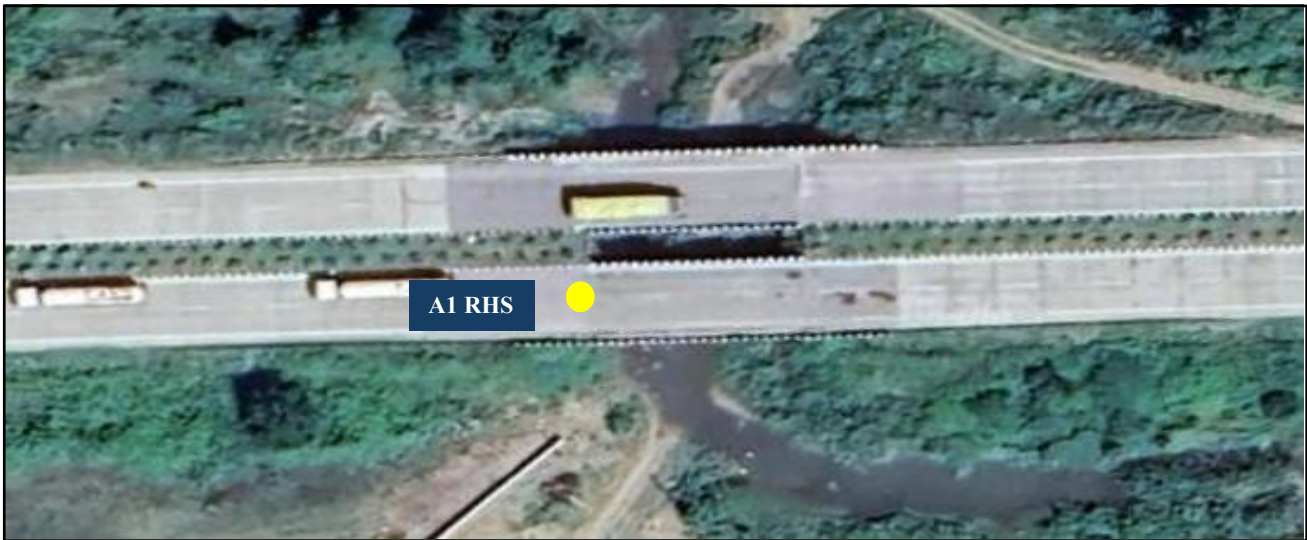
A1 RHS (24.997873378895036, 74.73600011058873)

- **Horizontal displacement (VH)** values exhibit bidirectional behaviour, fluctuating between approximately -10 mm and +6 mm, indicating alternating lateral movement directions at A1 RHS.
- **Vertical displacement (VV)** values remain predominantly positive throughout the monitoring period, ranging approximately from +3 mm to +18 mm, indicating consistent upward movement / uplift behaviour at A1 RHS.

- **May 2025:** A sudden reversal in VH direction is observed, transitioning to notable negative displacement while VV continues its upward trend. This indicates decoupled vertical and horizontal behaviour, not associated with structural distress.
- **June 2025:** VV reaches its highest magnitude, while VH remains within moderate limits, confirming dominant vertical response during this period.

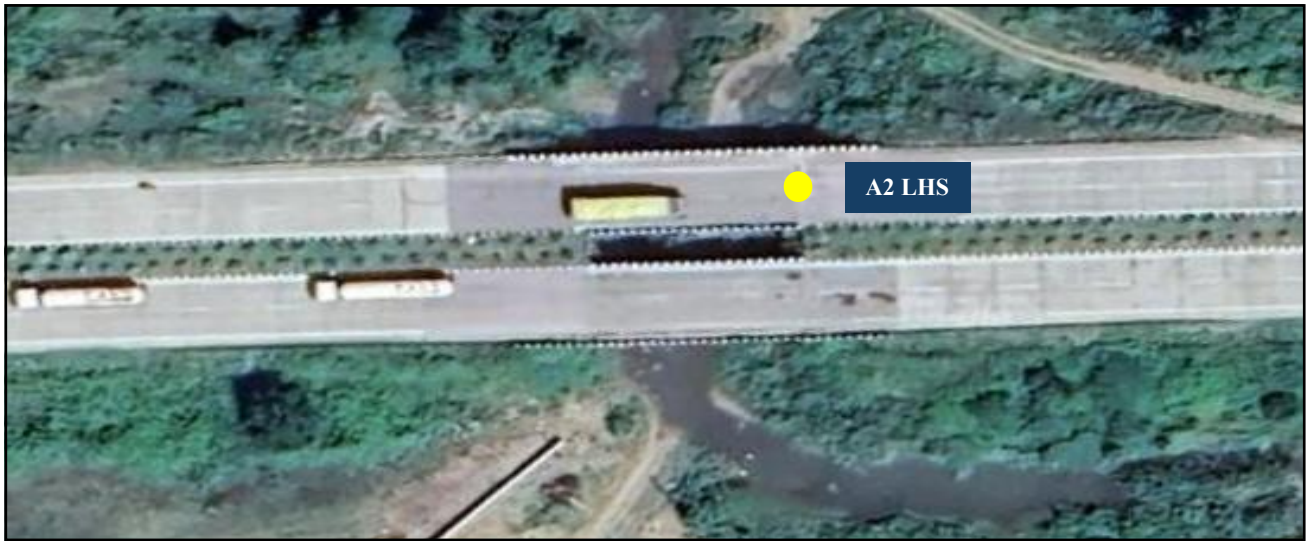
A2 LHS (24.99802895952878, 74.73617646583487)

- **Horizontal displacement (VH)** Horizontal displacement exhibits moderate variability, ranging approximately from -3 mm to +17 mm, showing bidirectional lateral movement with a dominant positive trend.
- **Vertical Displacement (VV)** Vertical displacement values show predominantly positive behaviour, ranging approximately from -4 mm to +13 mm, indicating overall uplift-dominated vertical response at A2 LHS.

- **March 2025:** A pronounced positive VH peak occurs while VV remains moderate and stable, suggesting a temporary lateral influence, likely driven by thermal effects or transient loading.
- **April-May 2025:** Both VH and VV show a simultaneous reduction, indicating a short-term relaxation phase rather than structural distress.
- **May 2025:** VV reaches its maximum uplift, while VH remains moderate, highlighting dominant vertical response during this period.

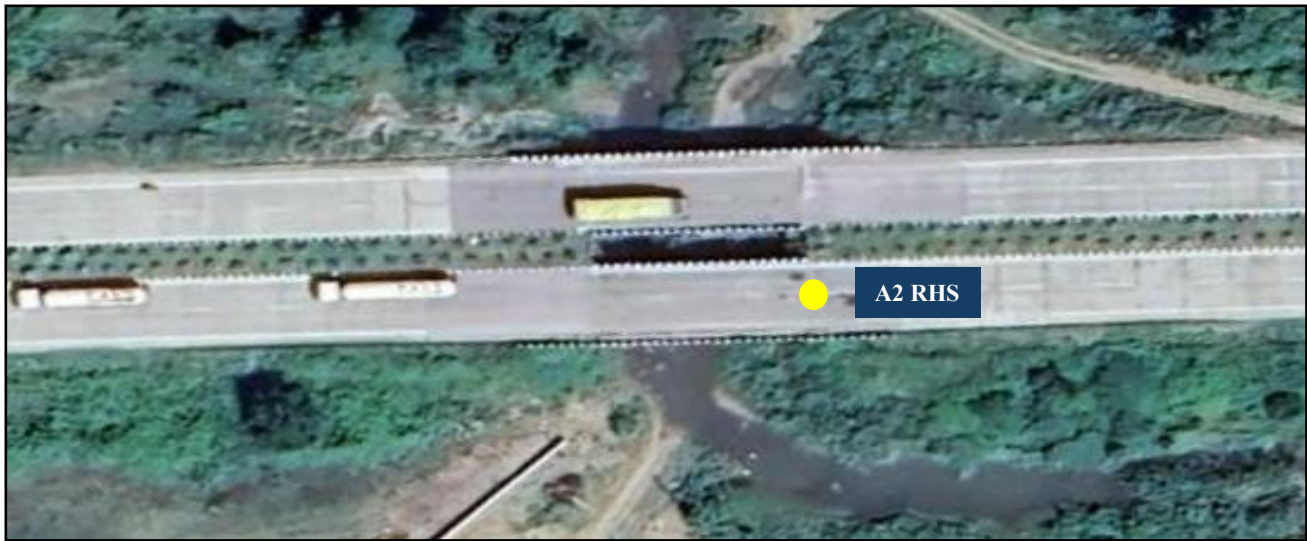
A2 RHS (24.99791102629953, 74.73620560268711)

- **Vertical (VV) displacement** Vertical displacement values are predominantly negative, ranging approximately from  $-4$  mm to  $-26$  mm, indicating overall settlement-dominated vertical behaviour at A2 RHS.
- **Horizontal (VH) displacement** Horizontal displacement exhibits moderate to high variability, ranging approximately from  $-4$  mm to  $+18$  mm, with a clear predominance of positive lateral movement.

- **May 2025:** A simultaneous VH peak and sharp VV drop is observed, indicating a combined lateral shift and vertical settlement event, likely driven by temperature variation, bearing response, or transient loading effects.
- **June 2025:** Partial vertical recovery combined with stable positive VH indicates elastic behaviour rather than progressive distress.
