# **LIDAR Inspection Report of Slab Culvert ch.920 + 631**

**Bridge Chainage:** 920 + 631 (CKRP)

- **Bridge No:** -
- **Chainage:** 920 + 631
- **Structure type:** Slab Culvert

- **CKRP:** Chittorgarh to kota
- **State:** Rajasthan NH 27
- **Zone:** RJ-06

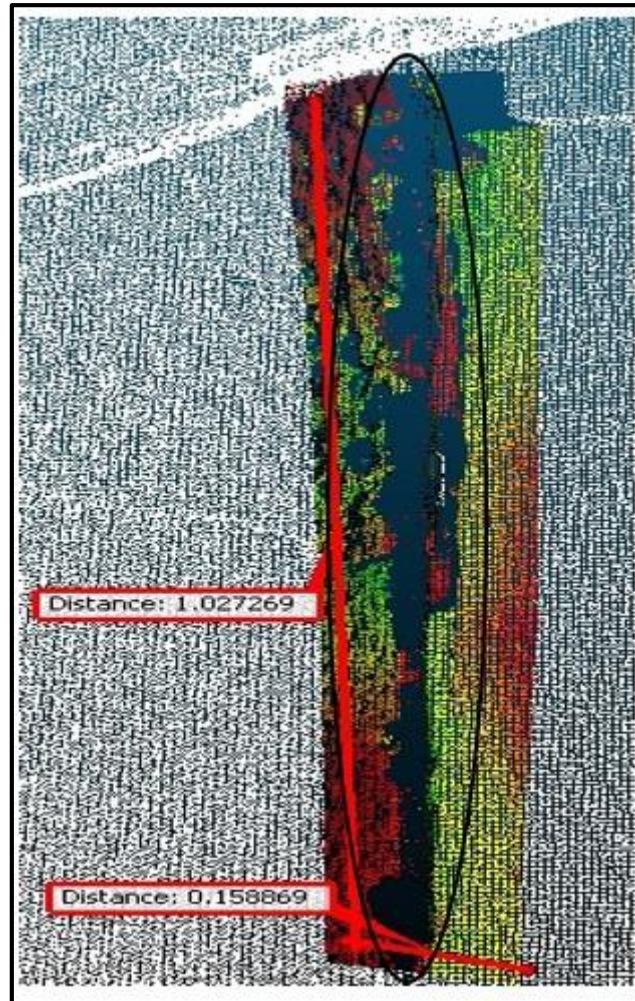
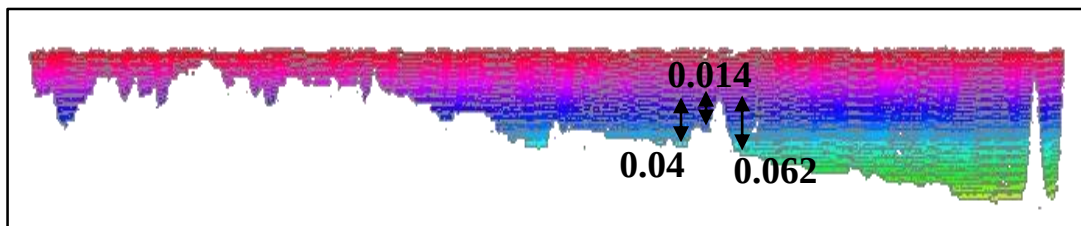
1. Wing wall damage observed on LHS, measuring 1.02 m in length and 0.15 m in width, covering an area of 0.153 m<sup>2</sup>. Depth ranges from 0.04 (min) to 0.062 m (max), with an average depth of 0.014 m. The calculated volume of the distress is 0.002 m<sup>3</sup>.

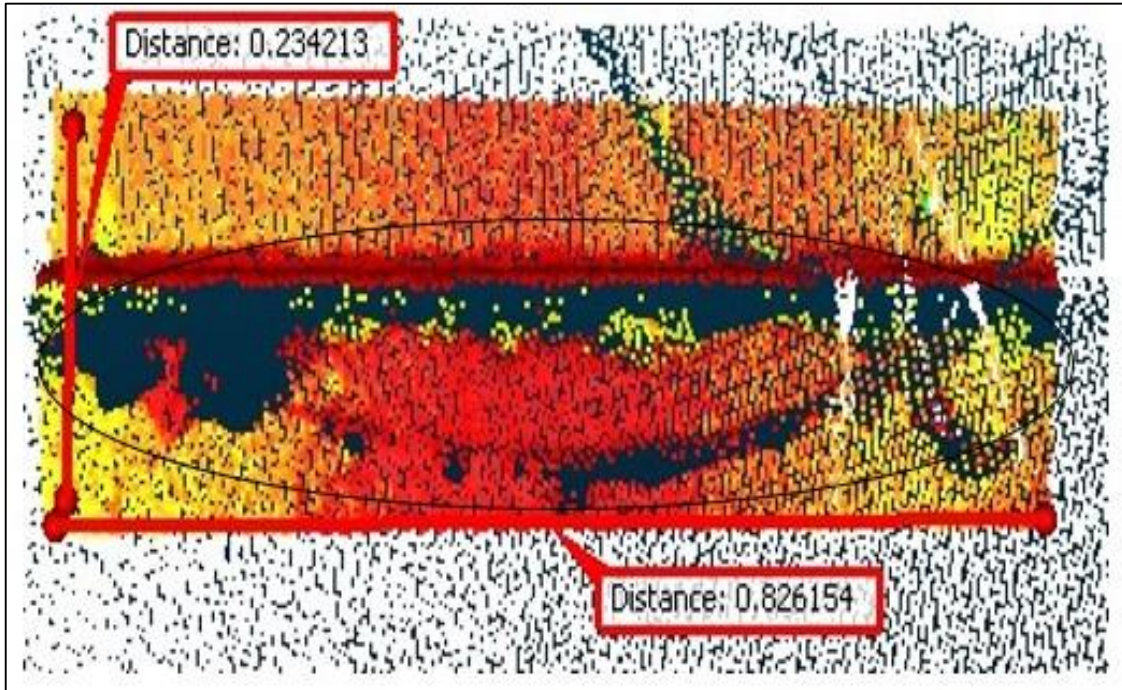
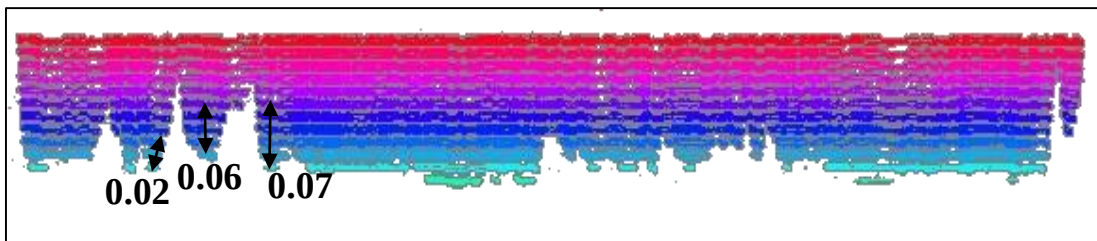
2. Abutment wall damage observed on LHS, measuring 0.82 m in length and 0.23 m in width, covering an area of 0.1886 m<sup>2</sup>. Depth ranges from 0.02 (min) to 0.07 m (max), with an average depth of 0.06 m. The calculated volume of the distress is 0.011 m<sup>3</sup>.

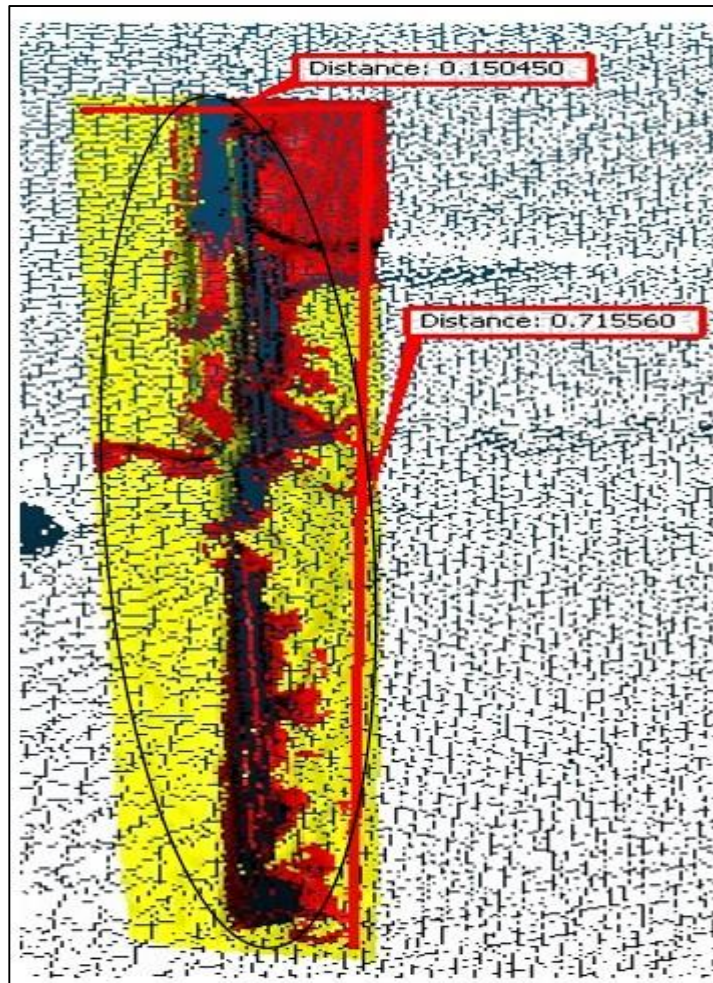
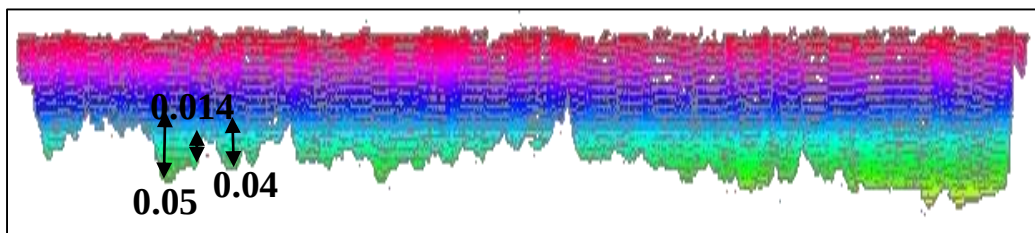
3. Wing wall damage observed on LHS, measuring 0.71 m in length and 0.15 m in width, covering an area of 0.1065 m<sup>2</sup>. Depth ranges from 0.04 (min) to 0.014 m (max), with an average depth of 0.05 m. The calculated volume of the distress is 0.005 m<sup>3</sup>.
