# **LIDAR Inspection Report of VUP ch.921+350**

**Bridge Chainage:** 921+350 (CKRP)

- **Bridge No:** -
- **Chainage:** 921+350
- **Structure type:** VUP

- **CKRP:** Chittorgarh to kota
- **State:** Rajasthan NH 27
- **Zone:** RJ-06

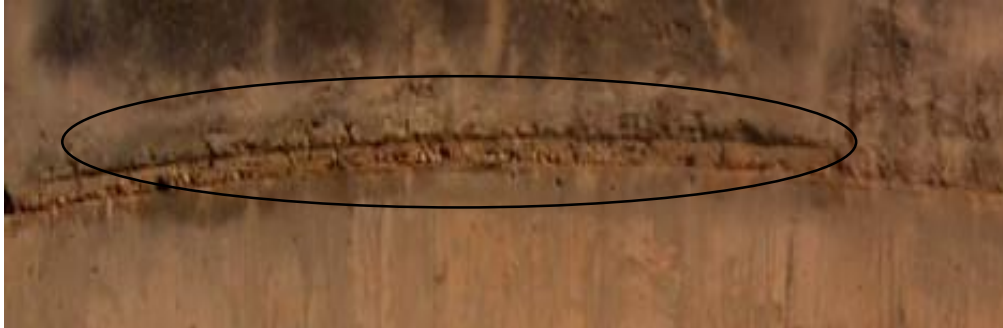
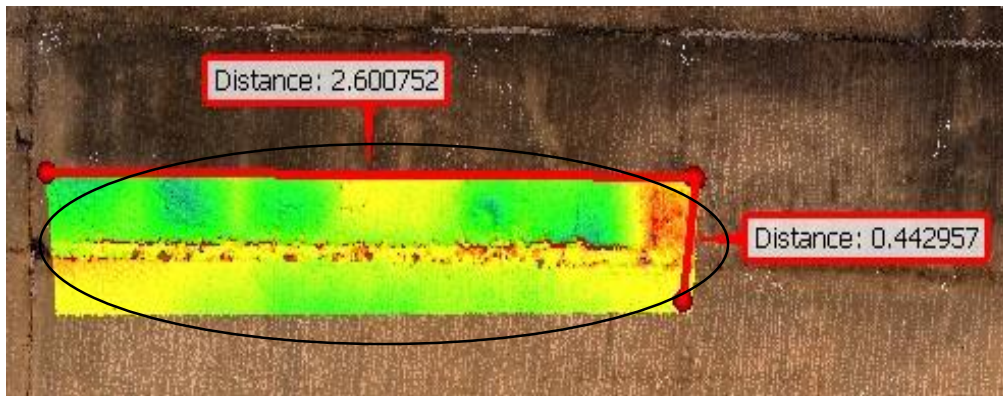
| Element Name | Observation | Location of Distress | Photo No. | Units | Distress Details | | | Area of Repair (Sq.m/ RMT/ m3) |
|---|---|---|---|---|---|---|---|---|
| Abutment 1 | Honeycombing | - | 1 | M | 2.60 | 0.44 | | 1.14 |

**1. Honeycombing observed on LHS Abutment 1 Wall, measuring 2.60 m in length and 0.44 m in width, covering an area of 1.14 m<sup>2</sup>.**

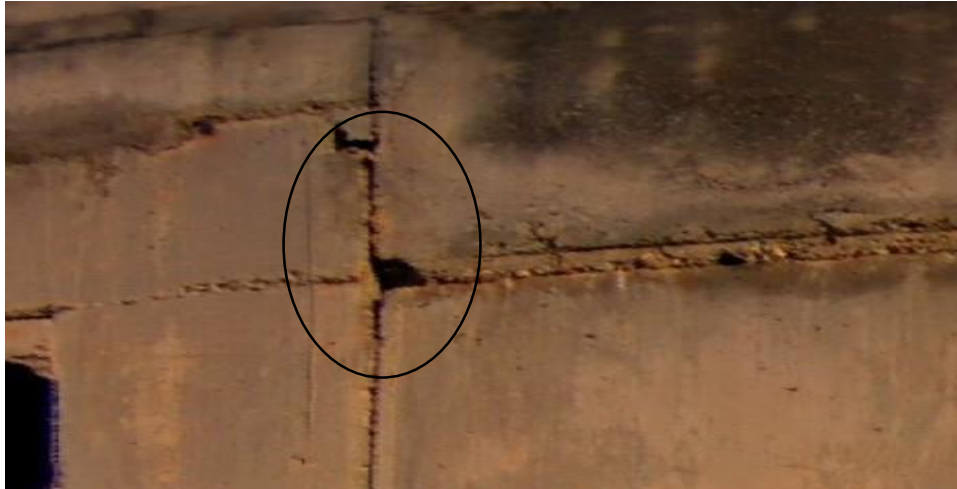
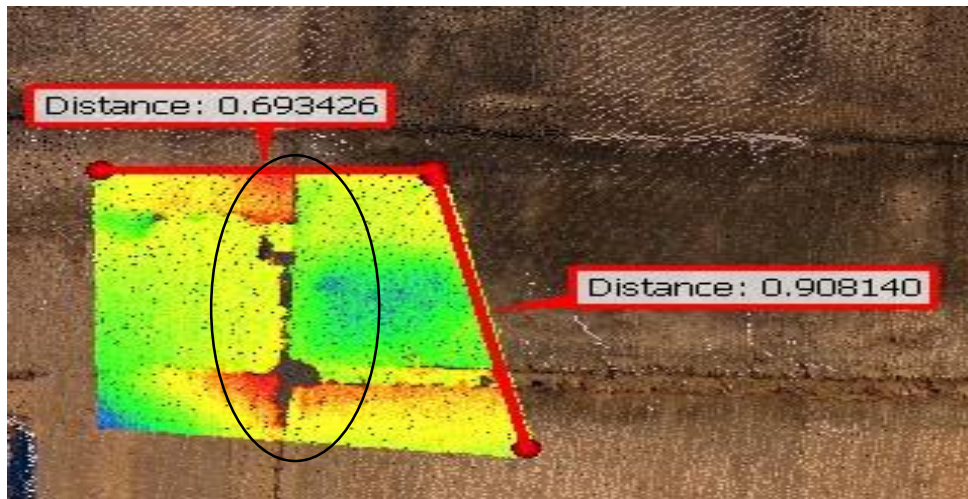
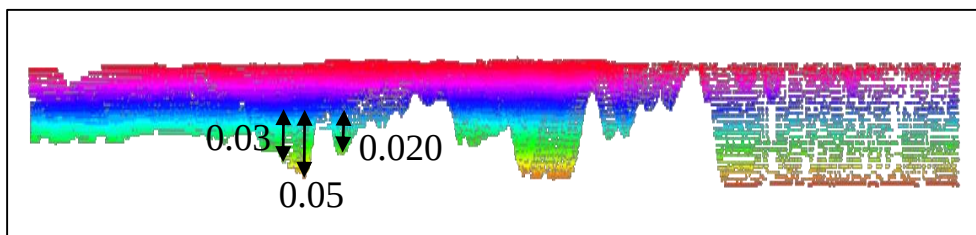
| Element Name | Observation | Location of Distress | Photo No. | Units | Distress Details | | | Area of Repair (Sq.m/ RMT/ m3) |
|---|---|---|---|---|---|---|---|---|
| Abutment 1 | Damage | - | 2 | M | 0.69 | 0.90 | 0.03 | 0.018 |

**2. Damage observed on LHS Abutment 1 Wall, measuring 0.69 m in length and 0.90 m in width, Depth ranges from 0.020 (min) to 0.05 m (max), with an average depth of 0.03m. The calculated volume of the distress is 0.018 m<sup>3</sup>.**

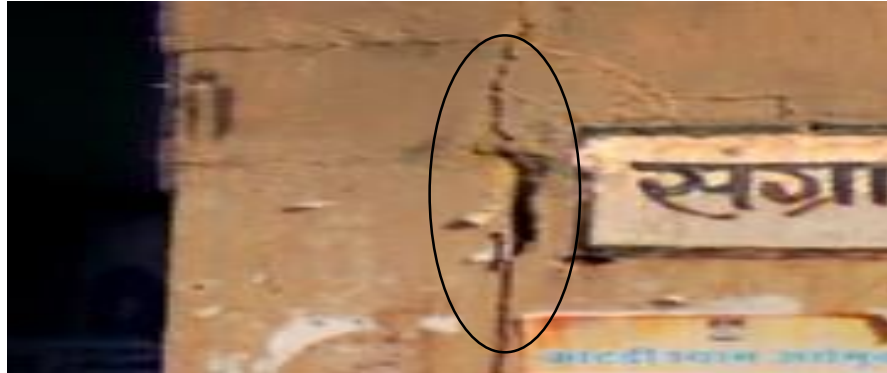
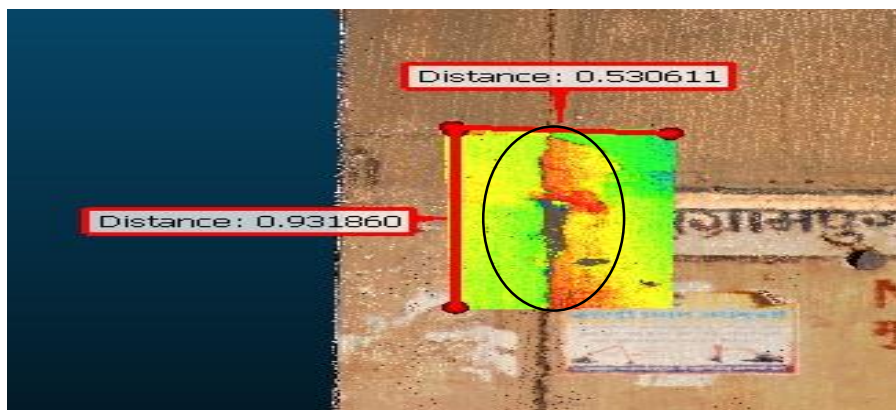
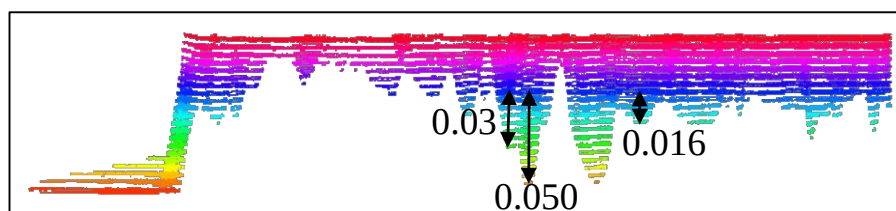
| Element Name | Observation | Location of Distress | Photo No. | Units | Distress Details | | | Area of Repair (Sq.m/ RMT/ m3) |
|---|---|---|---|---|---|---|---|---|
| Abutment 1 | Damage | | 3 | M | 0.53 | 0.93 | 0.03 | 0.014 |

**3. Damage observed on LHS Abutment 1 Wall, measuring 0.53 m in length and 0.93 m in width, Depth ranges from 0.016 (min) to 0.050 m (max), with an average depth of 0.03. The calculated volume of the distress is 0.014 m<sup>3</sup>.**

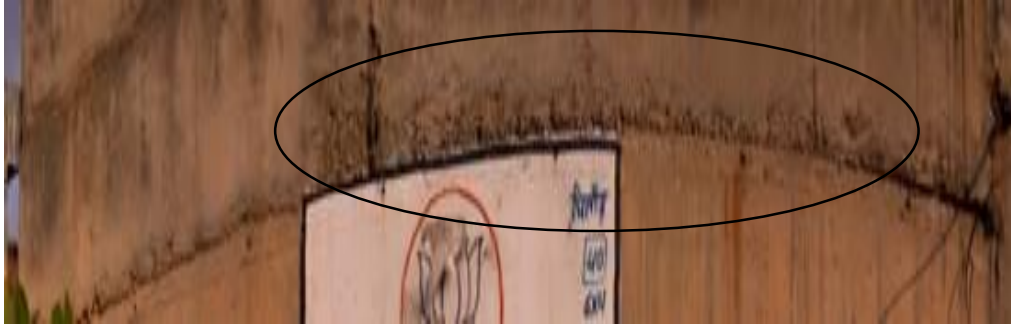
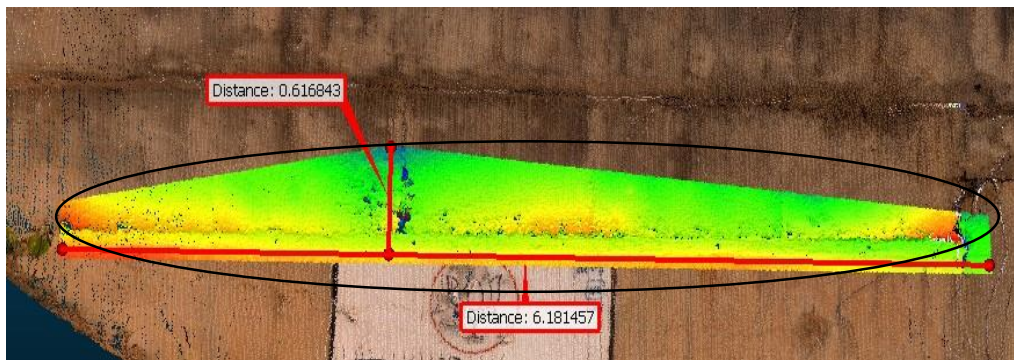
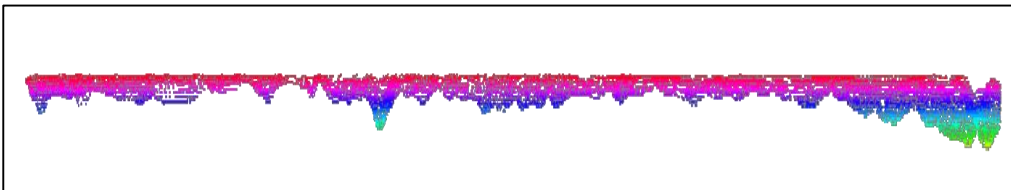
| Element Name | Observation | Location of Distress | Photo No. | Units | Distress Details | | | Area of Repair (Sq.m/ RMT/ m3) |
|---|---|---|---|---|---|---|---|---|
| Abutment 2 | Honeycombing | | 4 | M | 6.18 | 0.61 | | 3.76 |

**4. Honeycombing observed on LHS Abutment 2, measuring 6.18 m in length and 0.61 m in width, covering an area of 3.76 m<sup>2</sup>.**

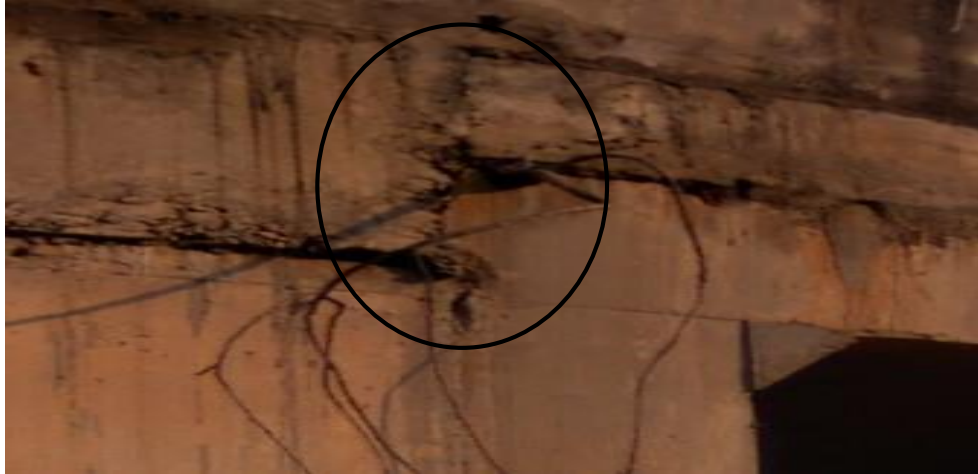
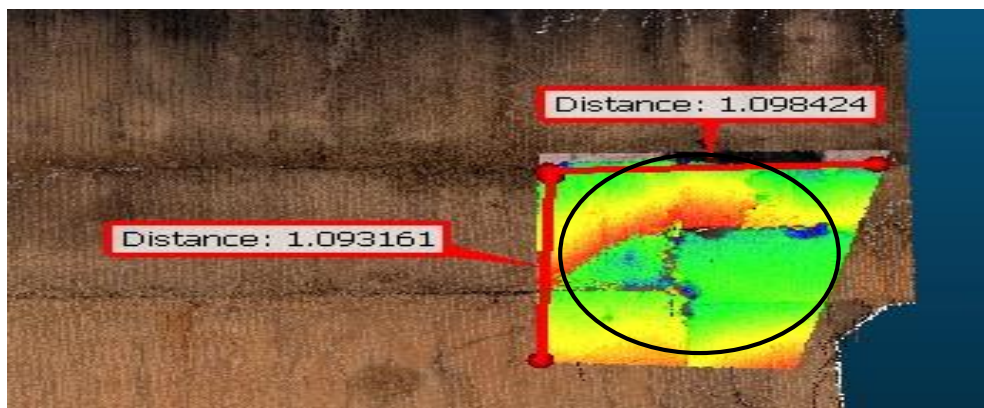
| Element Name | Observation | Location of Distress | Photo No. | Units | Distress Details | | | Area of Repair (Sq.m/ RMT/ m3) |
|---|---|---|---|---|---|---|---|---|
| Abutment 2 | Damage | | 5 | M | 1.09 | 1.09 | | 1.18 |

**5. Damage observed on LHS Abutment 2 Wall, measuring 1.09 m in length and 1.09 m in width, covering an area of 1.18 m<sup>2</sup>.**

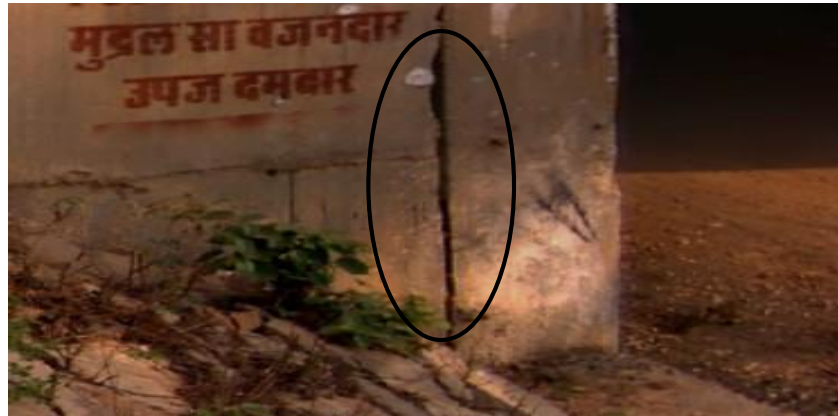
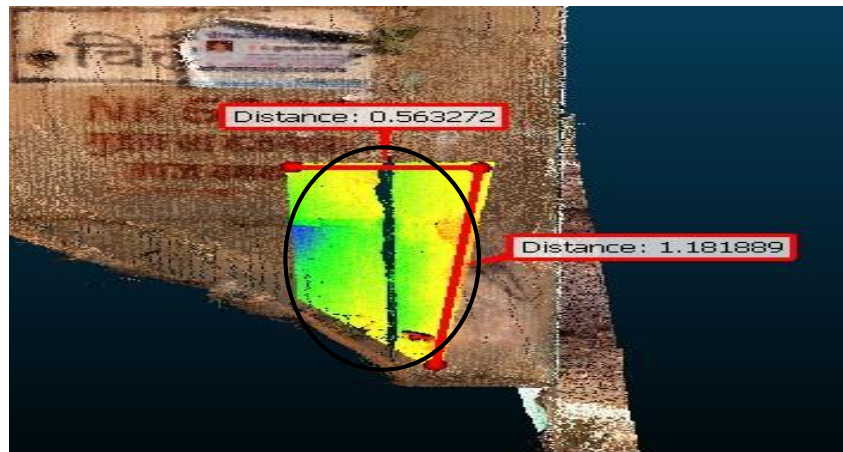
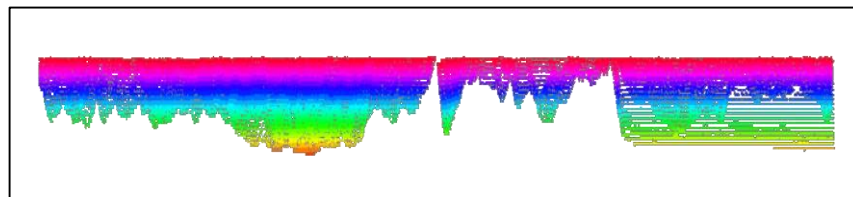
| Element Name | Observation | Location of Distress | Photo No. | Units | Distress Details | | | Area of Repair (Sq.m/ RMT/ m3) |
|---|---|---|---|---|---|---|---|---|
| Abutment 2 | Crack | | 6 | M | 0.56 | 1.18 | | 0.6608 |

**6. Crack observed on LHS Abutment 2 Wall, measuring 0.56 m in length and 1.18 m in width, covering an area of 0.6608 m<sup>2</sup>.**

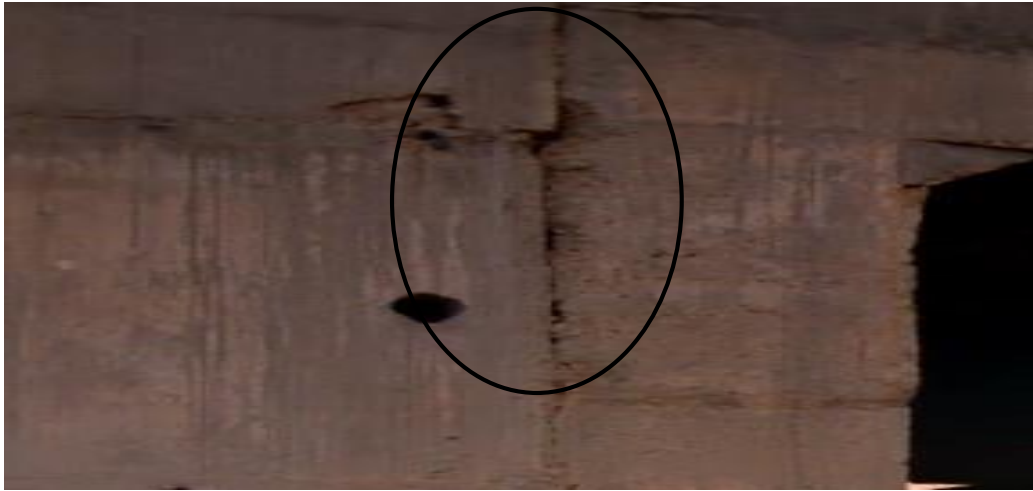
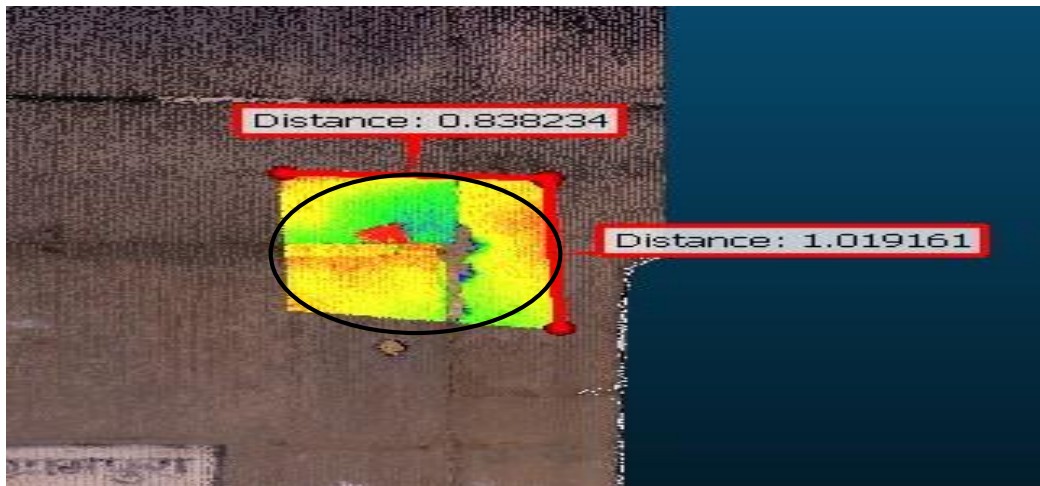
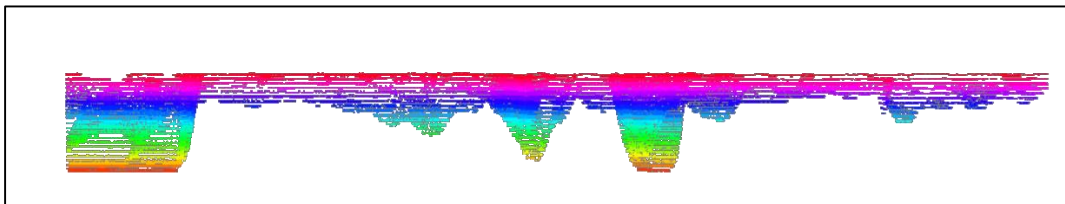
| Element Name | Observation | Location of Distress | Photo No. | Units | Distress Details | | | Area of Repair (Sq.m/ RMT/ m3) |
|---|---|---|---|---|---|---|---|---|
| Abutment 1 | Damage | - | 7 | M | 0.83 | 1.01 | | 0.8383 |

**7. Damage observed on RHS Abutment 1 Wall, measuring 0.83 m in length and 1.01 m in width, covering an area of 0.8383 m<sup>2</sup>.**

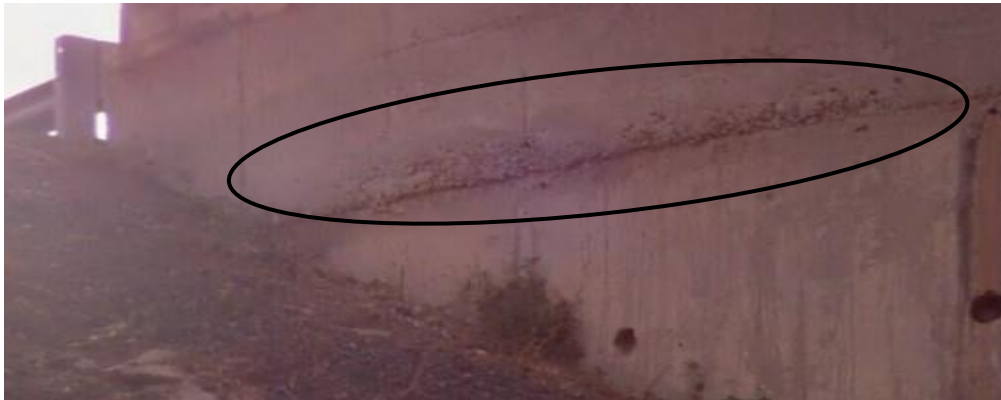
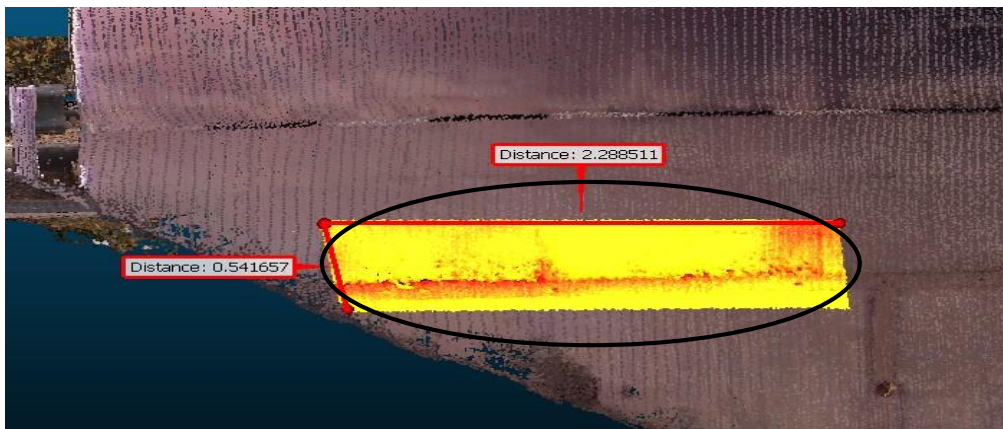
| Element Name | Observation | Location of Distress | Photo No. | Units | Distress Details | | | Area of Repair (Sq.m/ RMT/ m3) |
|---|---|---|---|---|---|---|---|---|
| Abutment 1 | Honeycombing | | 8 | M | 2.28 | 0.54 | | 1.23 |

**8. Honeycombing observed on RHS Abutment 1 Wall, measuring 2.28 m in length and 0.54 m in width, covering an area of 1.23 m<sup>2</sup>.**

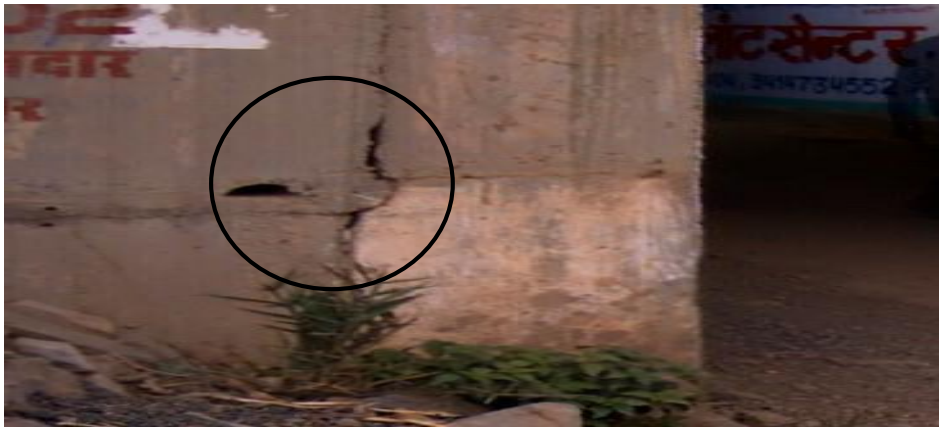
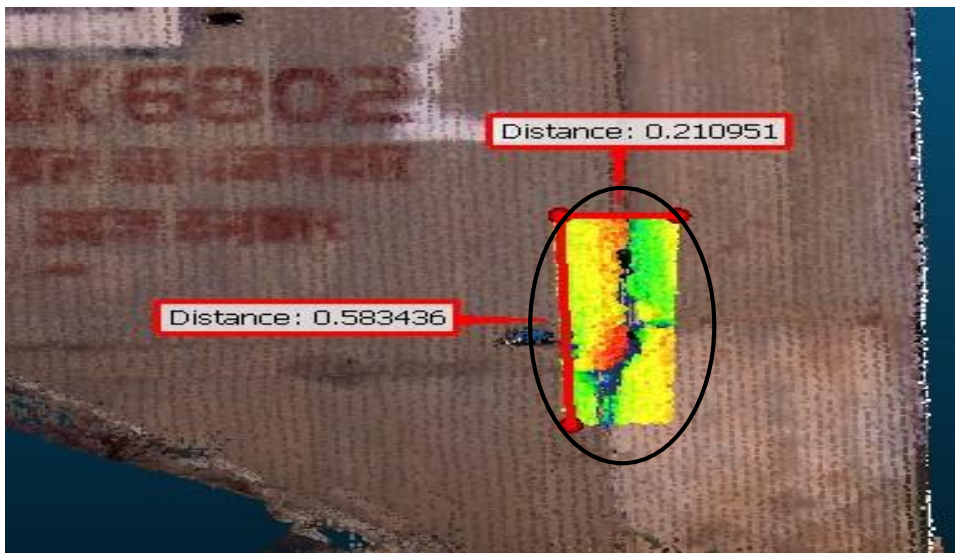
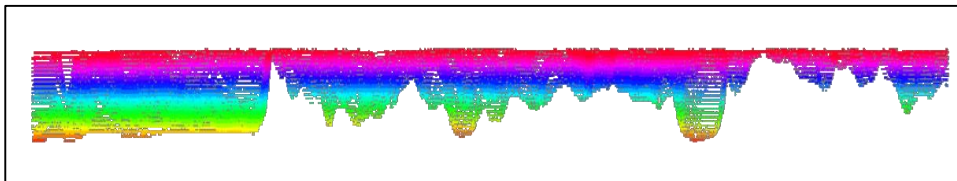
| Element Name | Observation | Location of Distress | Photo No. | Units | Distress Details | | | Area of Repair (Sq.m/ RMT/ m3) |
|---|---|---|---|---|---|---|---|---|
| Abutment 1 | Crack | | 9 | M | 0.21 | 0.58 | | 0.1218 |

**9. Crack observed on RHS Abutment 1 Wall, measuring 0.21 m in length and 0.58 m in width, covering an area of 0.1218 m<sup>2</sup>.**

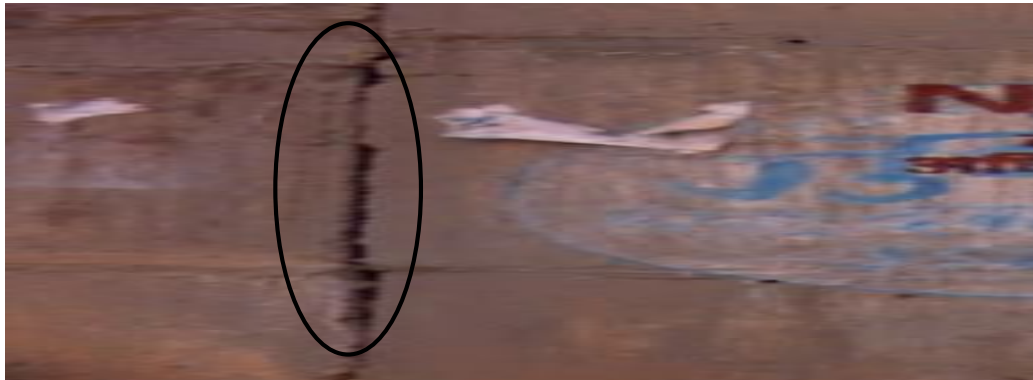
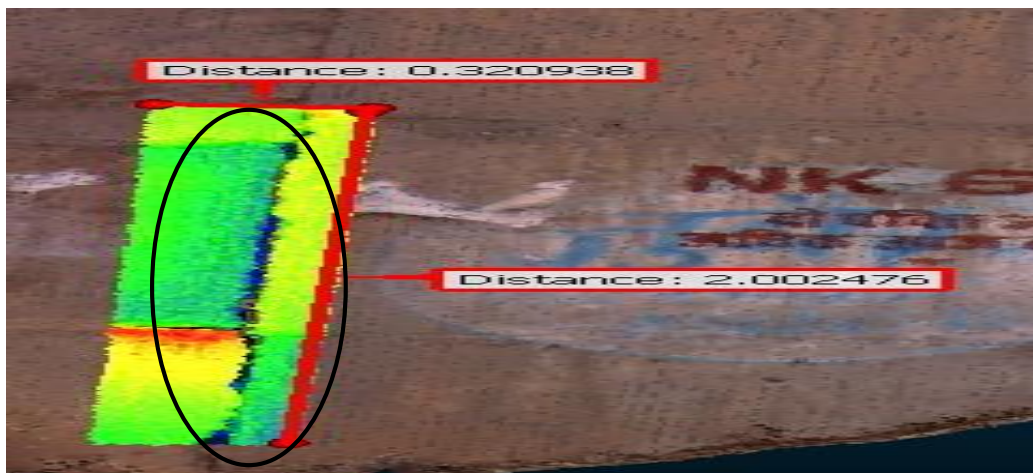
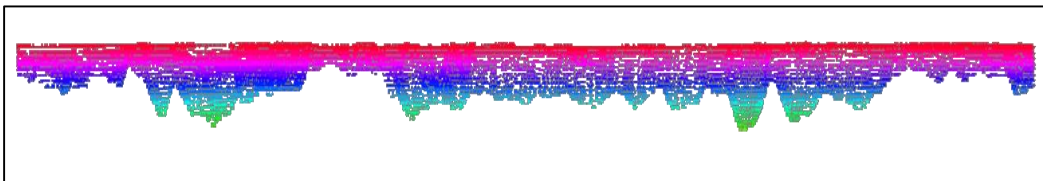
| Element Name | Observation | Location of Distress | Photo No. | Units | Distress Details | | | Area of Repair (Sq.m/ RMT/ m3) |
|---|---|---|---|---|---|---|---|---|
| Abutment 2 | Crack | | 10 | M | 0.32 | 2.00 | | 0.64 |

**10. Crack observed on RHS Abutment 2 Wall, measuring 0.32 m in length and 2.00 m in width, covering an area of 0.64 m<sup>2</sup>.**

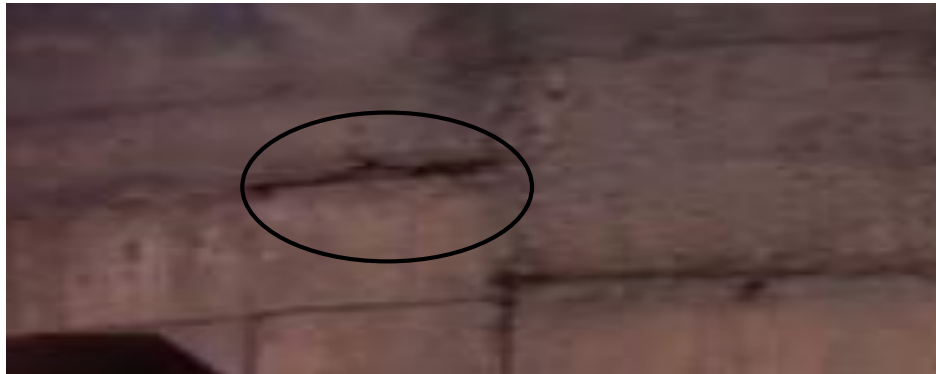
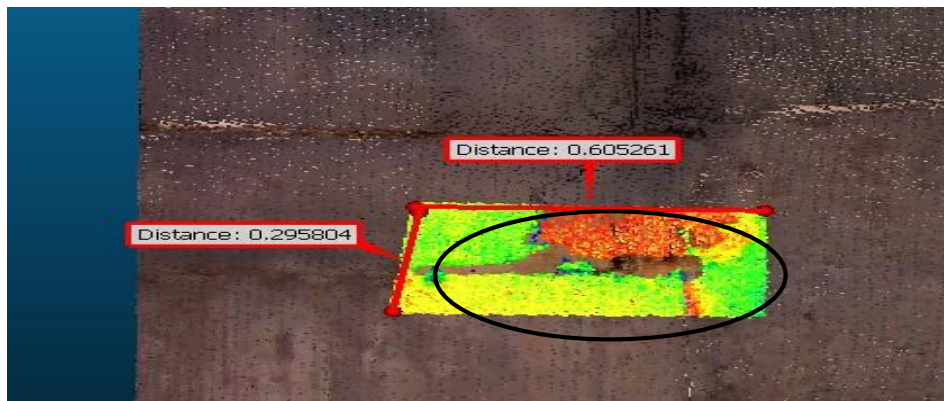
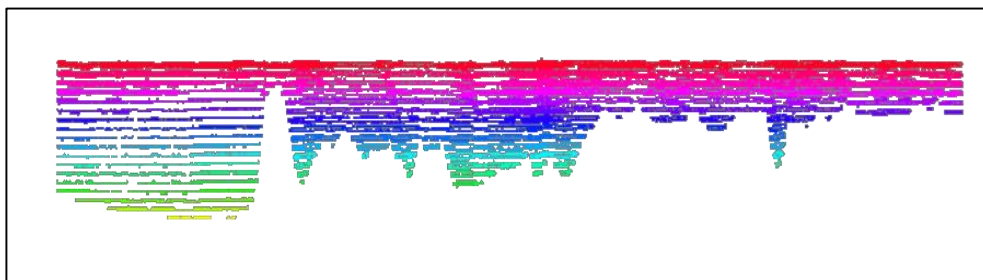
| Element Name | Observation | Location of Distress | Photo No. | Units | Distress Details | | | Area of Repair (Sq.m/ RMT/ m3) |
|---|---|---|---|---|---|---|---|---|
| Abutment 2 | Damage | | 11 | M | 0.60 | 0.29 | | 0.174 |

**11. Damage observed on RHS Abutment 2 Wall, measuring 0.60 m in length and 0.29 m in width, covering an area of 0.174 m<sup>2</sup>.**
