# LIDAR Inspection Report of **Box Culvert** ch.921+365

**Bridge Chainage:** 921+365 (CKRP)

# **CH: 921+365– Box CULVERT**

DISTRESS PHOTOS

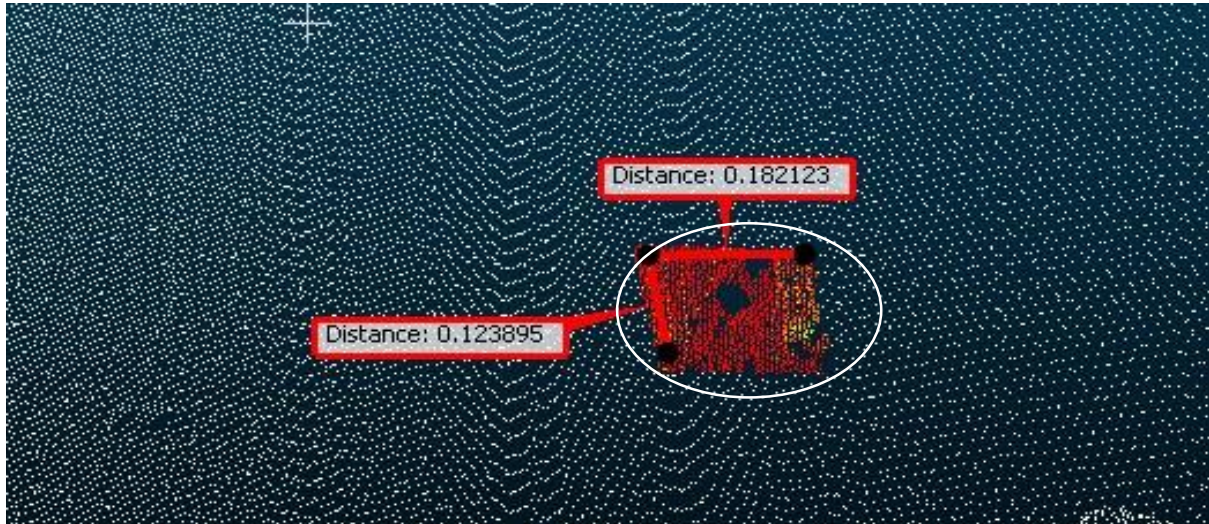
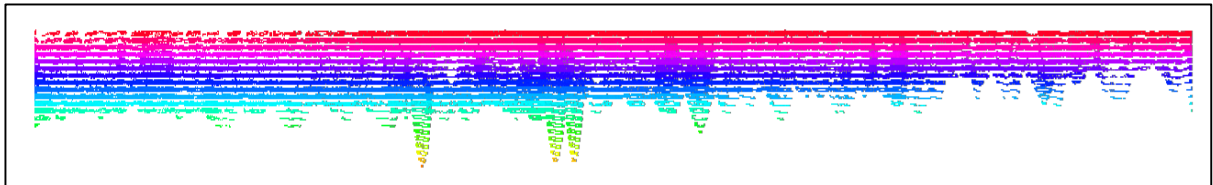
| Element Name | Observation | Location of Distress | Photo No. | Units | Distress Details | | | Area of Repair (Sq.m/ RMT/ m3) |
|---|---|---|---|---|---|---|---|---|
| Abutment Wall | Damage | - | 1 | M | 0.18 | 0.12 | | 0.0216 |

**1. Abutment wall damage observed, measuring 0.18 m in length and 0.12 m in width, covering an area of 0.0216 m<sup>2</sup>.**

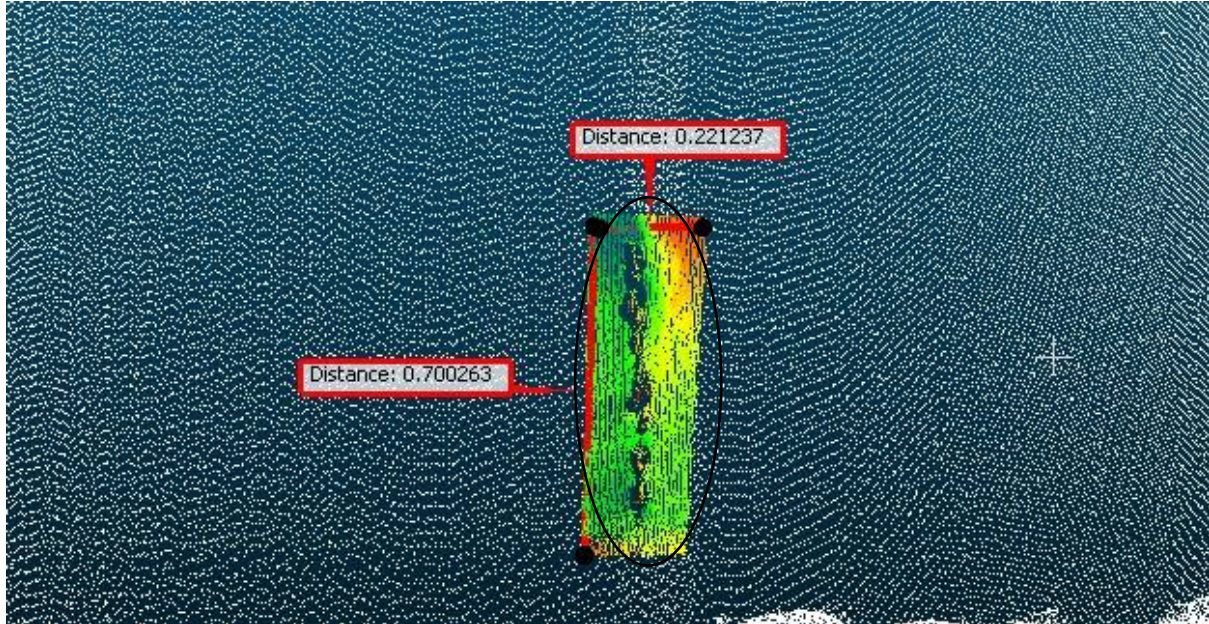
| Element Name | Observation | Location of Distress | Photo No. | Units | Distress Details | | | Area of Repair (Sq.m/ RMT/ m3) |
|---|---|---|---|---|---|---|---|---|
| Abutment Wall | Damage | - | 2 | M | 0.22 | 0.70 | | 0.154 |

**2A**butment wall damage observed, measuring 0.22 m in length and 0.70 m in width, covering an area of 0.154 m<sup>2</sup>.

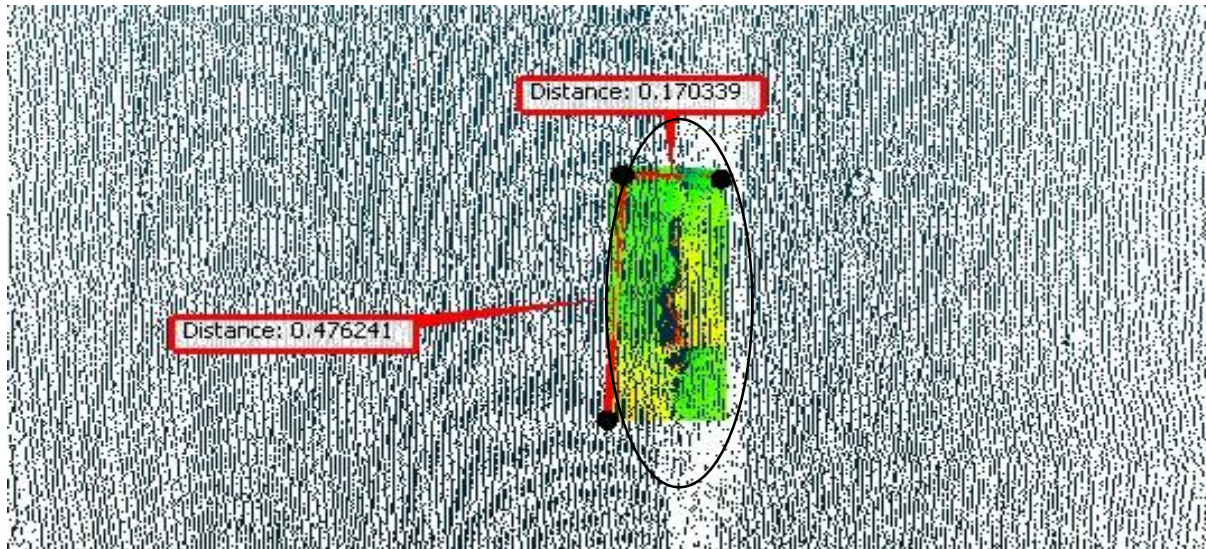
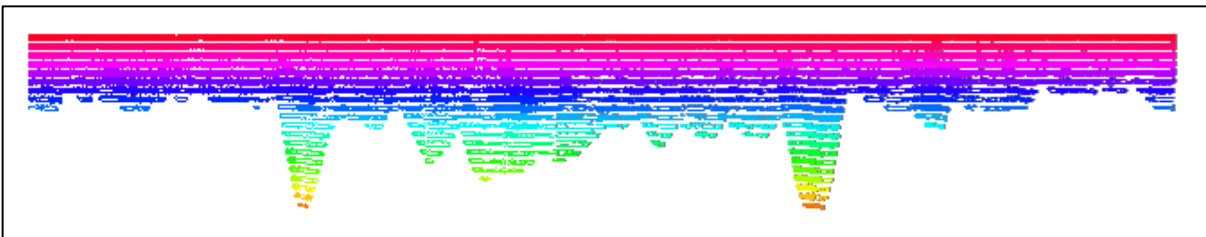
| Element Name | Observation | Location of Distress | Photo No. | Units | Distress Details | | | Area of Repair (Sq.m/ RMT/ m3) |
|---|---|---|---|---|---|---|---|---|
| Abutment Wall | Damage | - | 3 | M | 0.17 | 0.47 | | 0.079 |

**3. Abutment wall damage observed, measuring 0.17 m in length and 0.47 m in width, covering an area of 0.079 m<sup>2</sup>.**

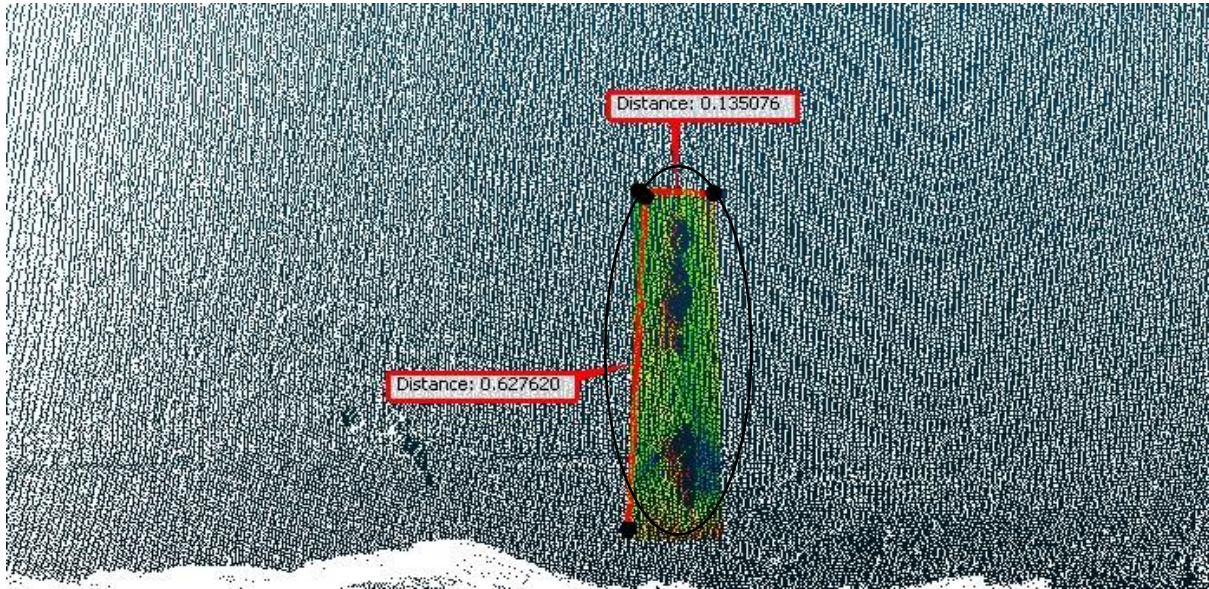
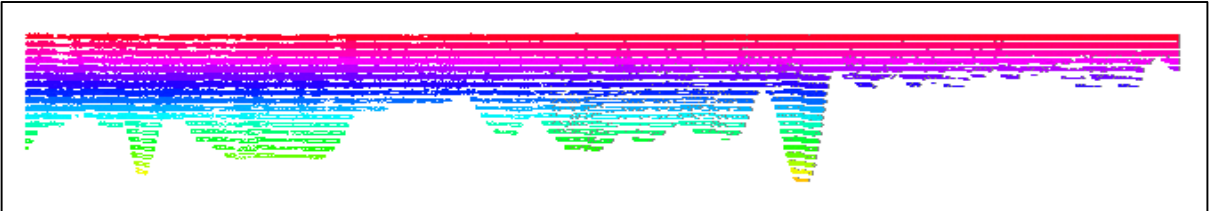
| Element Name | Observation | Location of Distress | Photo No. | Units | Distress Details | | | Area of Repair (Sq.m/ RMT/ m3) |
|---|---|---|---|---|---|---|---|---|
| Abutment Wall | Damage | - | 4 | M | 0.13 | 0.62 | | 0.0806 |

**4. Abutment wall damage observed, measuring 0.13 m in length and 0.62 m in width, covering an area of 0.0806 m<sup>2</sup>.**

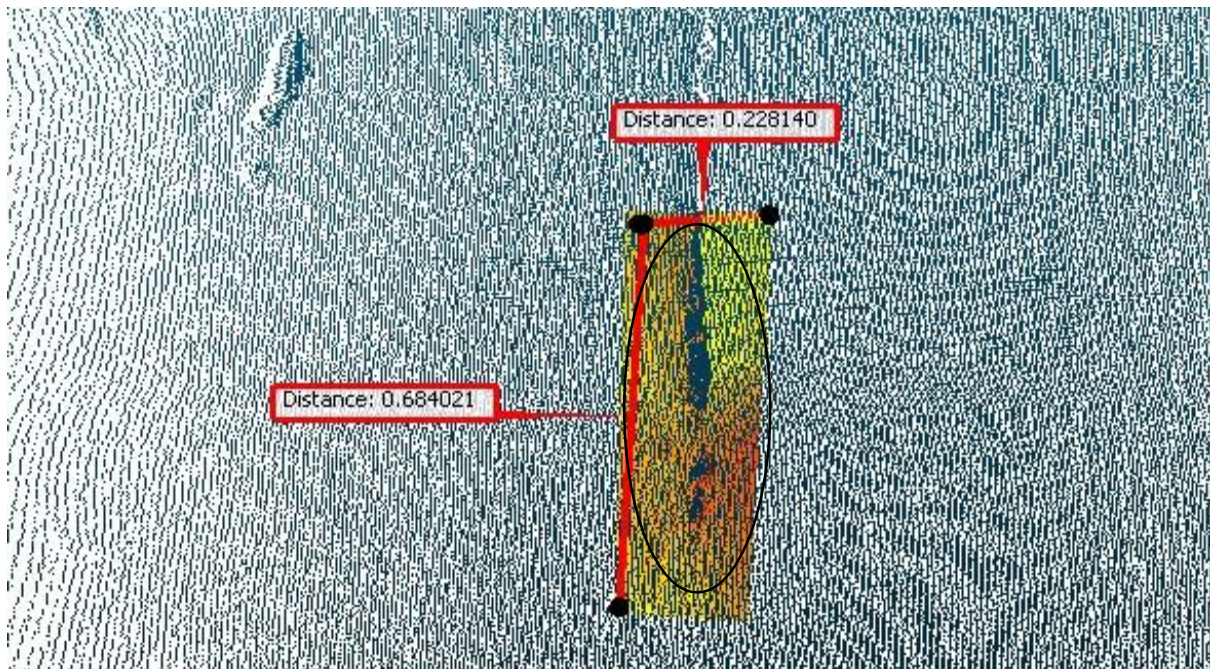
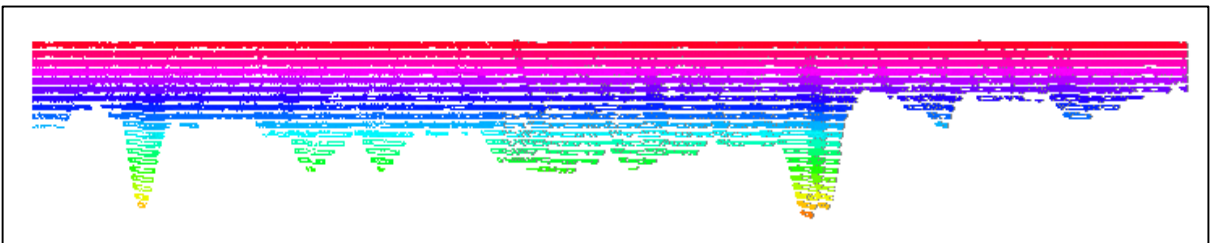
| Element Name | Observation | Location of Distress | Photo No. | Units | Distress Details | | | Area of Repair (Sq.m/ RMT/ m3) |
|---|---|---|---|---|---|---|---|---|
| Abutment Wall | Damage | - | 5 | M | 0.22 | 0.68 | | 0.1496 |

**5. Abutment wall damage observed, measuring 0.22 m in length and 0.68 m in width, covering an area of 0.1496 m<sup>2</sup>.**

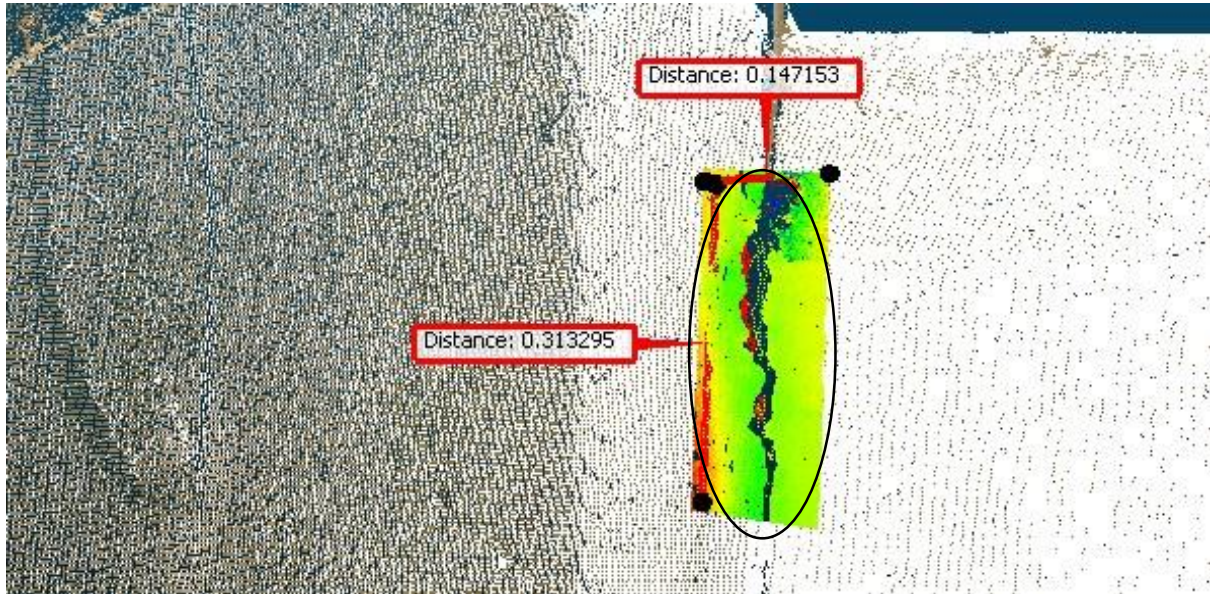
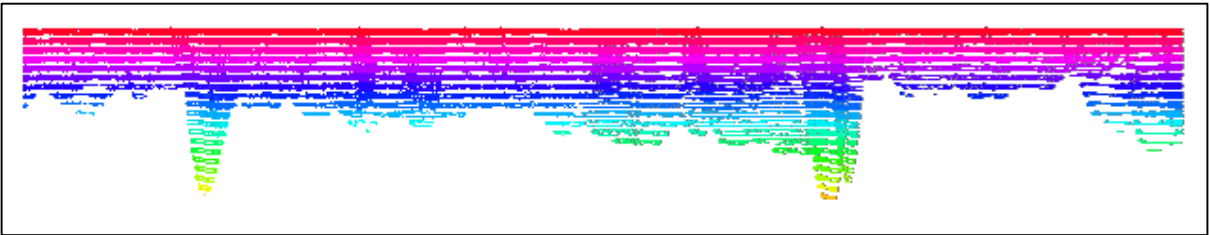
| Element Name | Observation | Location of Distress | Photo No. | Units | Distress Details | | | Area of Repair (Sq.m/ RMT/ m3) |
|---|---|---|---|---|---|---|---|---|
| Wing Wall | Damage | - | 6 | M | 0.14 | 0.31 | | 0.0434 |

**6. Wing wall damage observed, measuring 0.14 m in length and 0.31 m in width, covering an area of 0.0434 m<sup>2</sup>.**
