# **LIDAR Inspection Report of Slab Culvert ch.922 + 419**

**Bridge Chainage:** 922 + 419 (CKRP)

# **CH: 922 + 419 – SLAB CULVERT**

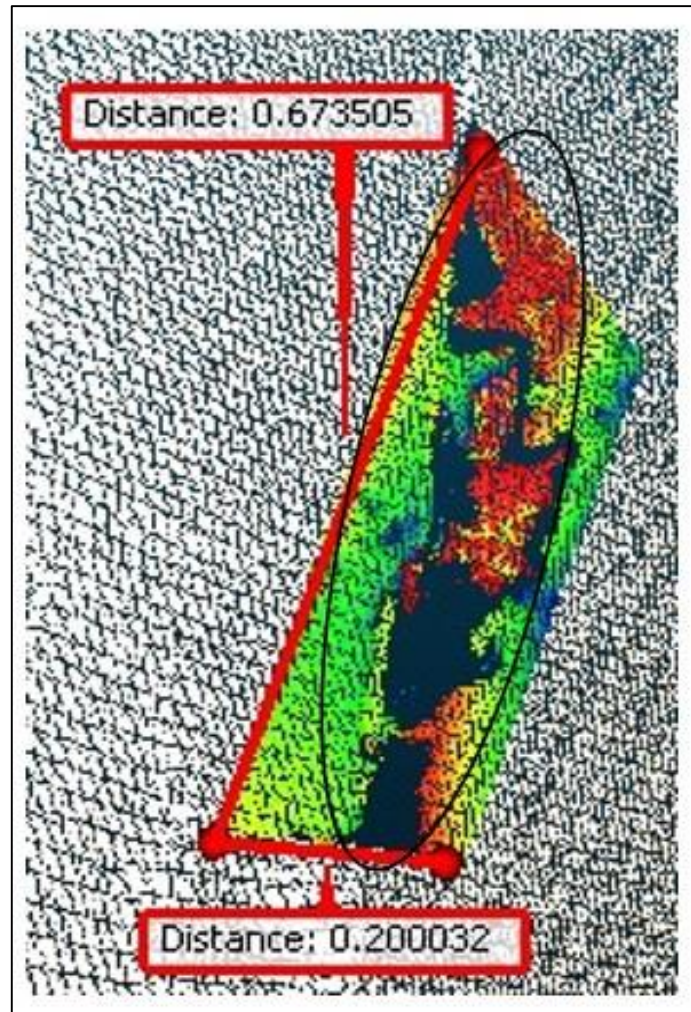
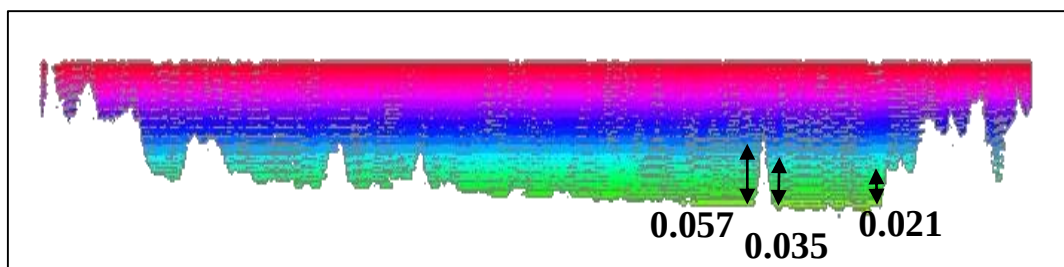
| Sr. No. | Description | Distress Notation | Observation | Location | | Distress Details | | | Area of Repair |
|---|---|---|---|---|---|---|---|---|---|
| 1 | Return wall | | DAMAGE (LHS) | | | | | | |

1. Wing wall damage observed on LHS, measuring 0.67 m in length and 0.20 m in width, covering an area of 0.134 m<sup>2</sup>." Depth ranges from 0.021 (min) to 0.057 m (max), with an average depth of 0.035 m. The calculated volume of the distress is 0.004 m<sup>3</sup>.

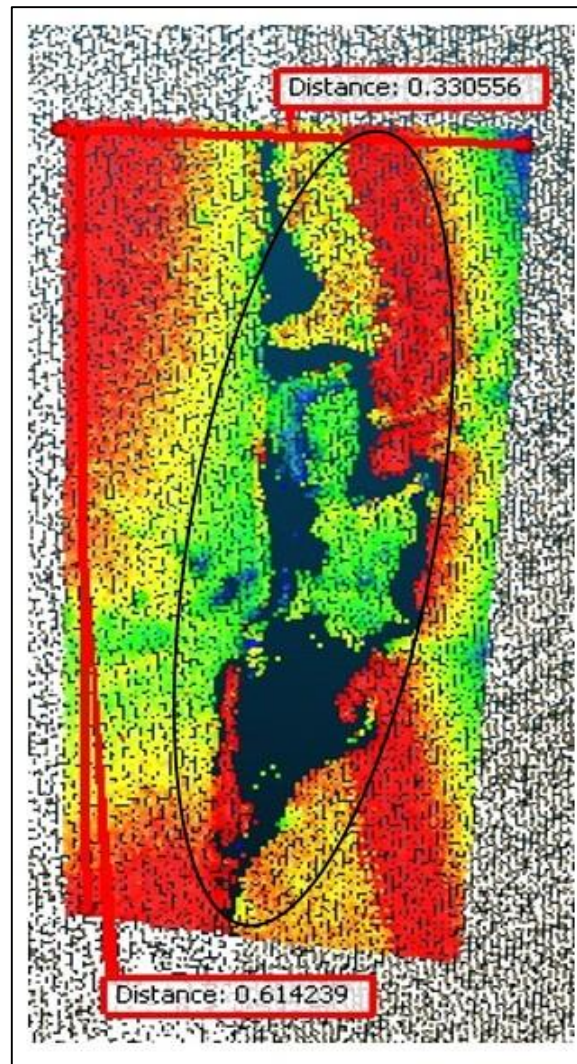
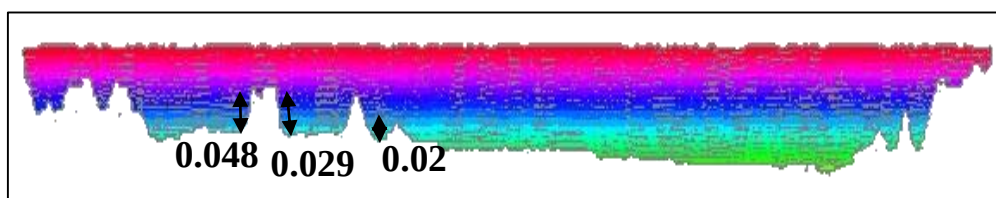
2. Wing wall damage observed, measuring 0.61 m in length and 0.33 m in width, covering an area of 0.2013 m<sup>2</sup>. Depth ranges from 0.02 (min) to 0.048 m (max), with an average depth of 0.029 m. The calculated volume of the distress is 0.005 m<sup>3</sup>.
