# **LIDAR Inspection Report of VUP ch.923+500**

**Bridge Chainage:** 923+500 (CKRP)

# **CH: 923+500– VUP**

**DISTRESS PHOTOS**

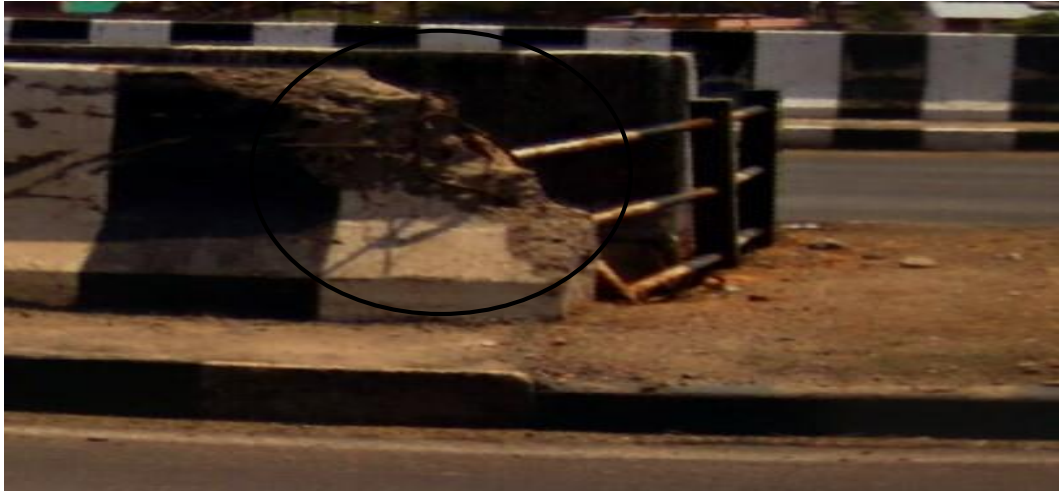
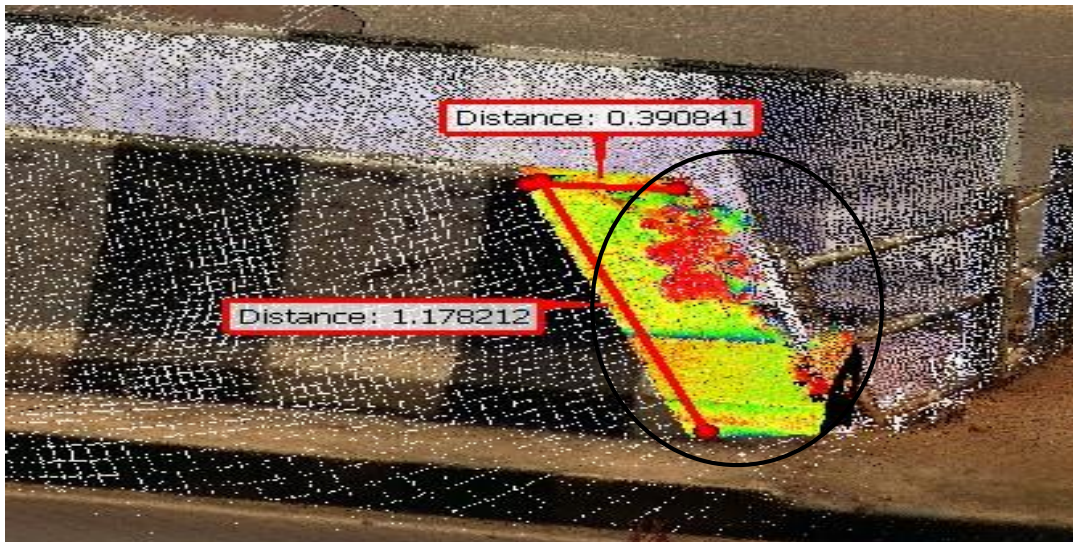
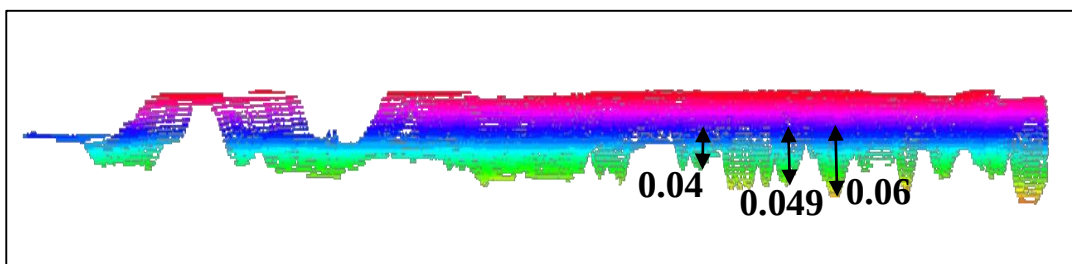
| Element Name | Observation | Location of Distress | Photo No. | Units | Distress Details | | | Area of Repair (Sq.m/RM T/m3) |
|---|---|---|---|---|---|---|---|---|
| Median Side Barrier | Damage | - | 1 | M | 0.39 | 1.17 | 0.04 | 0.018 |

| Sr. No. | Description | Distress Notation | Observation | Location | | Distress Details | | | Area of Repair |
|---|---|---|---|---|---|---|---|---|---|
| 9 | Crash barrier | | Damaged (LHS) | | | | | | |

**1. Damage observed on LHS Median Side Crash Barrier, measuring 0.39 m in length and 1.17 m in width, Depth ranges from 0.04 m (min) to 0.06 m (max), with an average depth of 0.049 m. The calculated volume of the distress is 0.018 m<sup>3</sup>.**

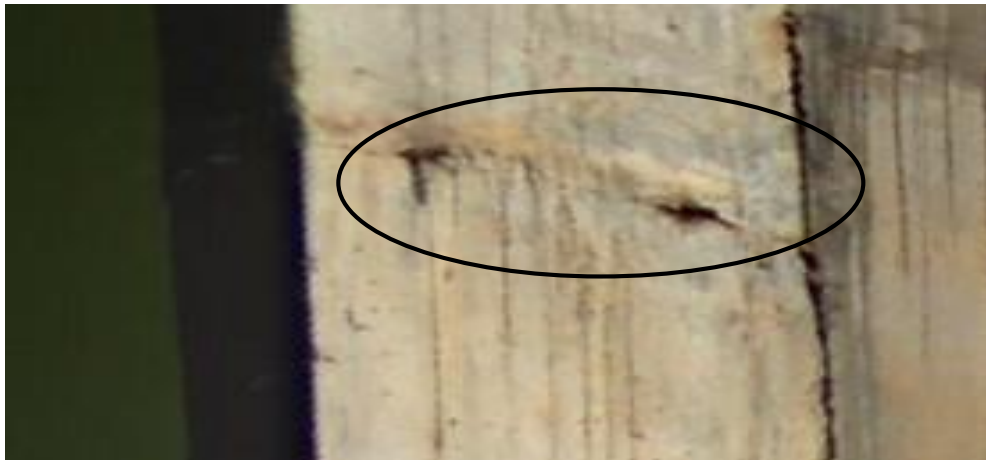
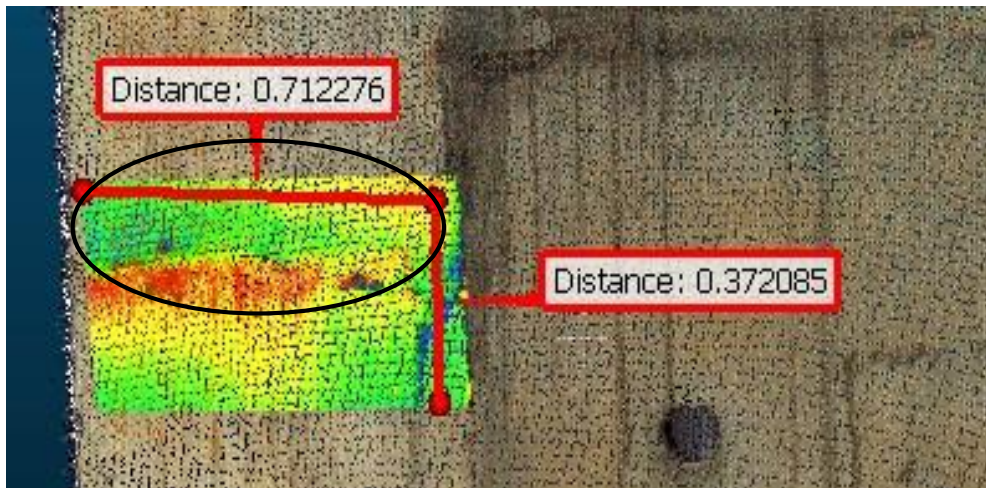
| Element Name | Observation | Location of Distress | Photo No. | Units | Distress Details | | | Area of Repair (Sq.m/R MT/m3) |
|---|---|---|---|---|---|---|---|---|
| Abutment 2 | Scaling | - | 2 | M | 0.71 | 0.37 | | 0.2627 |

**2. Scaling observed on Abutment 2 RHS, measuring 0.71 m in length and 0.37 m in width, covering an area of 0.2627 m<sup>2</sup>.**

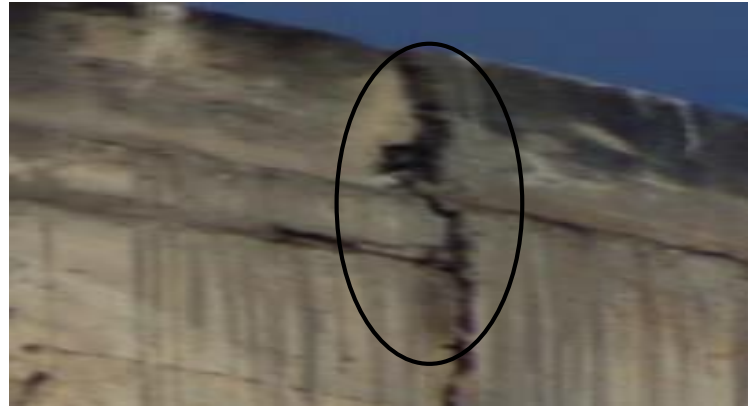
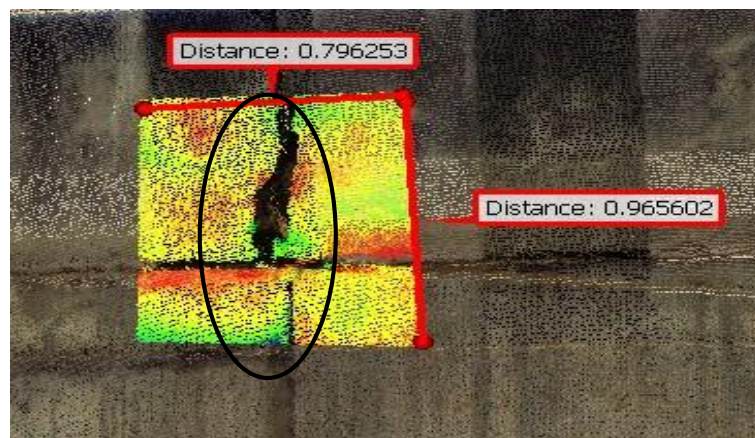
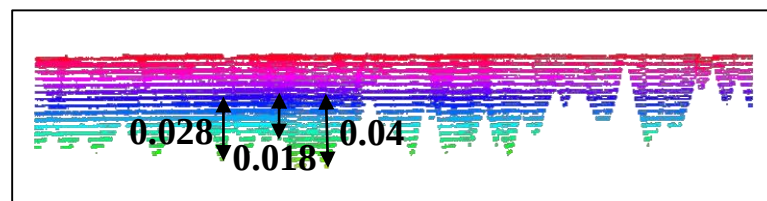
| Element Name | Observation | Location of Distress | Photo No. | Units | Distress Details | | | Area of Repair (Sq.m/R MT/m3) |
|---|---|---|---|---|---|---|---|---|
| Abutment 2 Parapet wall | Damage | - | 3 | M | 0.79 | 0.96 | 0.028 | 0.0212 |

**3. Damage observed on Abutment 2 RHS Parapet wall, measuring 0.79 m in length and 0.96 m in width, Depth ranges from 0.018 (min) to 0.04 m (max), with an average depth of 0.028 m. The calculated volume of the distress is 0.0212 m<sup>3</sup>.**
