# **LIDAR Inspection Report of VUP ch.923+880**

**Bridge Chainage:** 923+880 (CKRP)

- **Bridge No:** -
- **Chainage:** 923+880
- **Structure type:** VUP

- **CKRP:** Chittorgarh to kota
- **State:** Rajasthan NH 27
- **Zone:** RJ-06

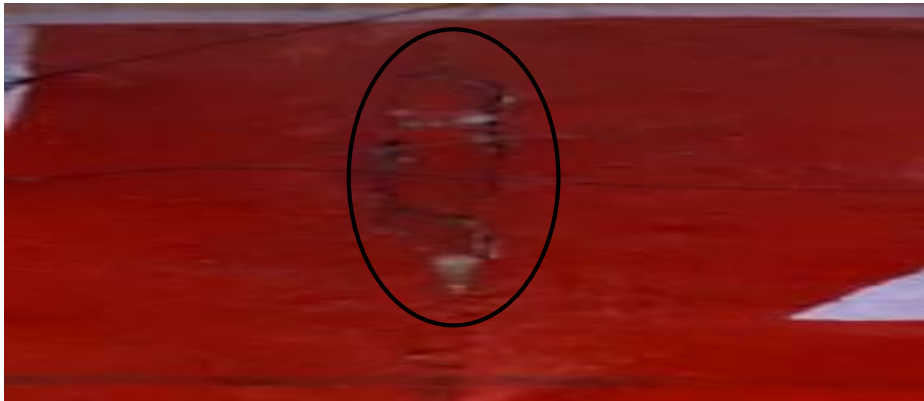
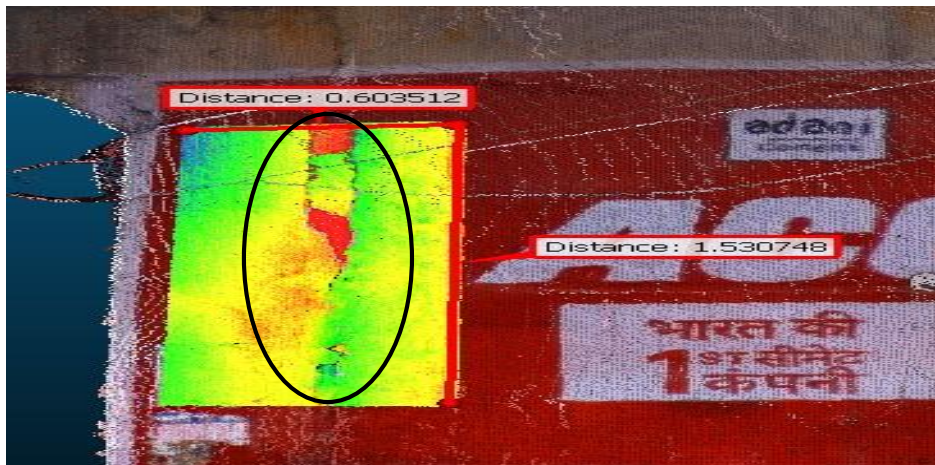
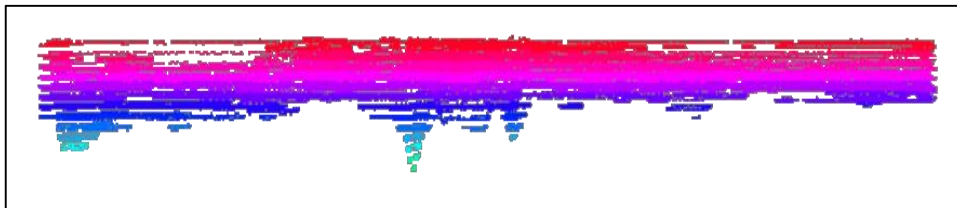
| Element Name | Observation | Location of Distress | Photo No. | Units | Distress Details | | | Area of Repair (Sq.m/ RMT/ m3) |
|---|---|---|---|---|---|---|---|---|
| Abutment 1 | Damage | - | 1 | M | 0.60 | 1.53 | | 0.918 |

**1. Wall damage observed on LHS Abutment 1, measuring 0.60 m in length and 1.53 m in width, covering an area of 0.918 m<sup>2</sup>.**

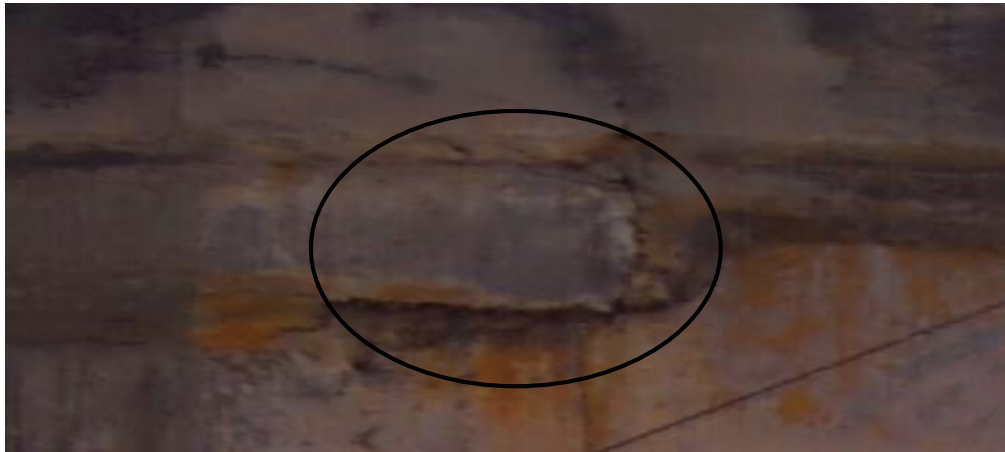
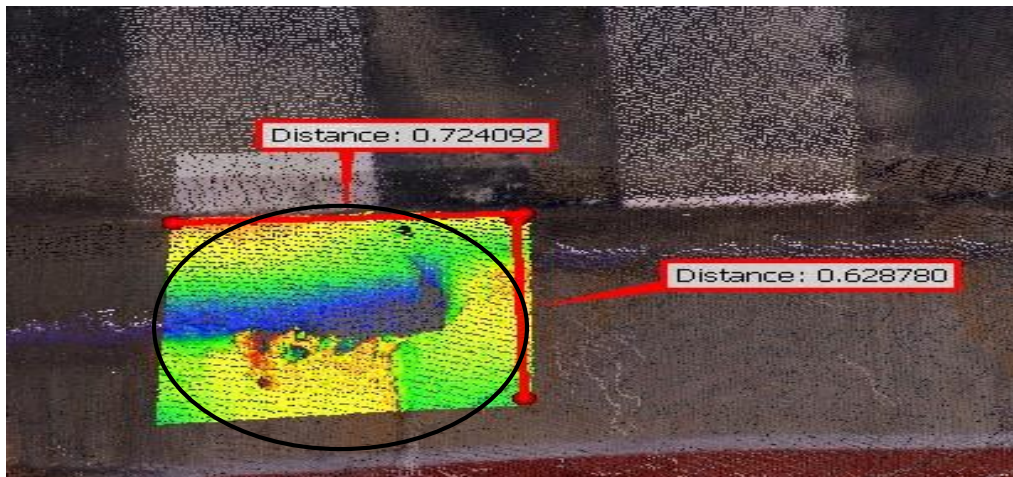
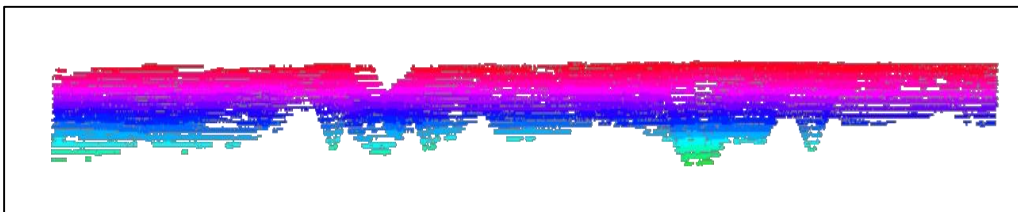
| Element Name | Observation | Location of Distress | Photo No. | Units | Distress Details | | | Area of Repair (Sq.m/ RMT/ m3) |
|---|---|---|---|---|---|---|---|---|
| Abutment 1 | Damage | - | 2 | M | 0.72 | 0.62 | | 0.4464 |

**2. Wall damage observed on LHS Abutment 1, measuring 0.72 m in length and 0.62 m in width, covering an area of 0.4464 m<sup>2</sup>.**

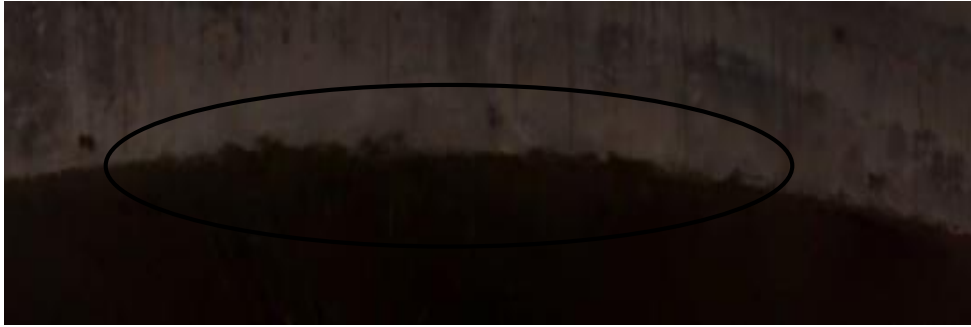
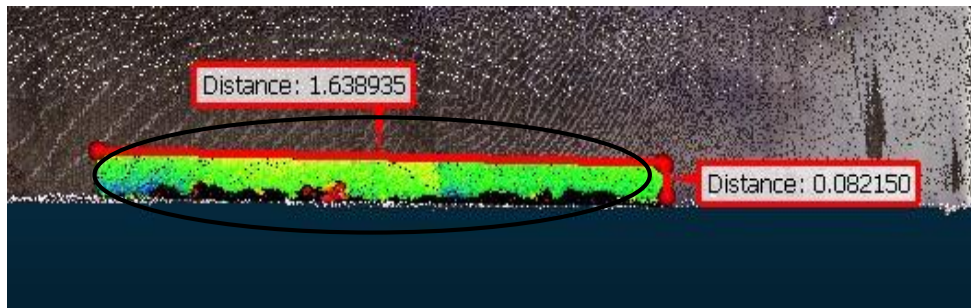
| Element Name | Observation | Location of Distress | Photo No. | Units | Distress Details | | | Area of Repair (Sq.m/ RMT/ m3) |
|---|---|---|---|---|---|---|---|---|
| Deck Slab | Damage | | 3 | M | 1.63 | 0.08 | | 0.1304 |

**3. Damage observed on LHS side deck slab, measuring 1.63 m in length and 0.08 m in width, covering an area of 0.1304 m<sup>2</sup>.**

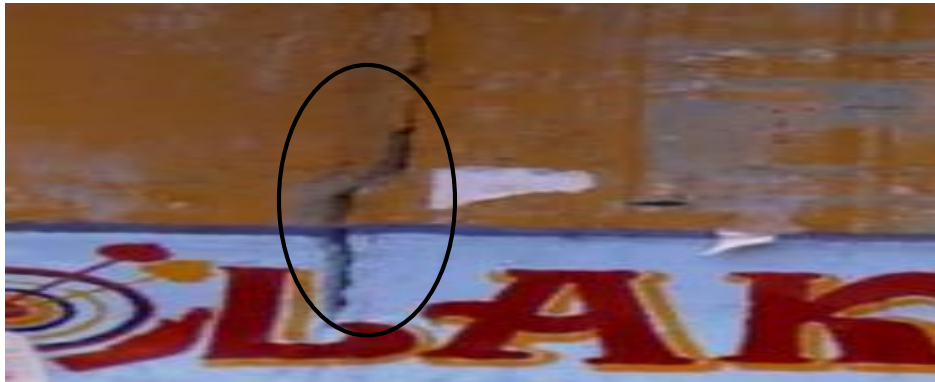
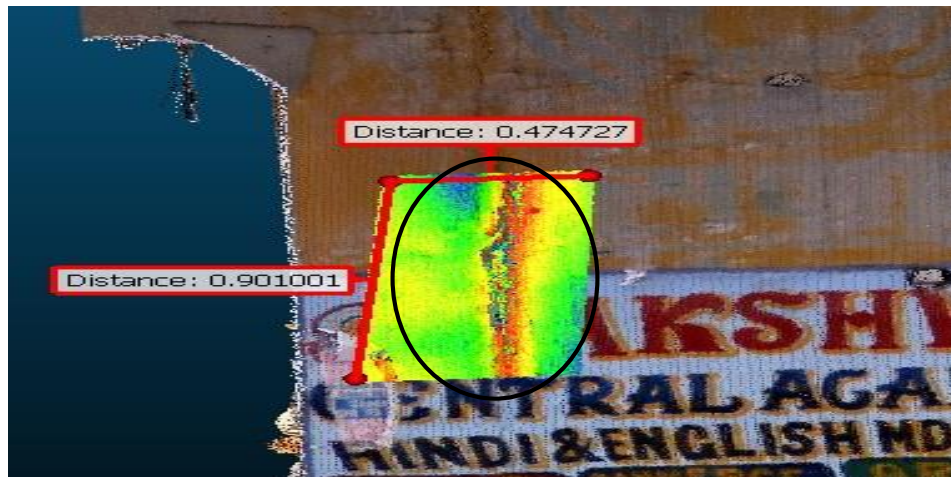
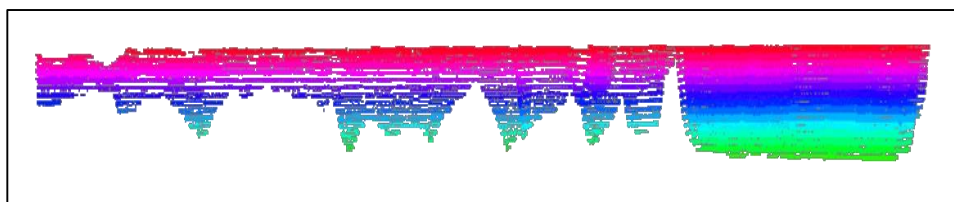
| Element Name | Observation | Location of Distress | Photo No. | Units | Distress Details | | | Area of Repair (Sq.m/ RMT/ m3) |
|---|---|---|---|---|---|---|---|---|
| Abutment 2 | Crack | - | 4 | M | 0.47 | 0.90 | | 0.423 |

**4. Crack observed on RHS Abutment 2, measuring 0.47 m in length and 0.90 m in width, covering an area of 0.423 m<sup>2</sup>.**

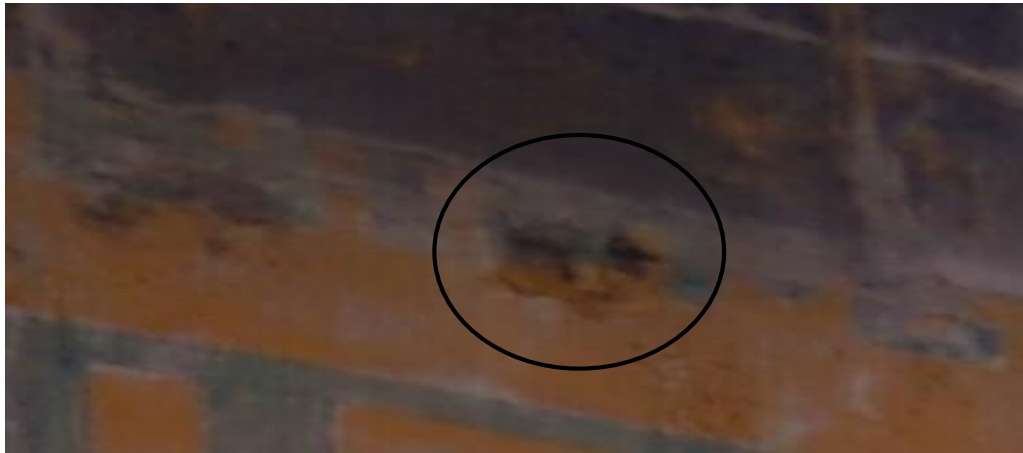
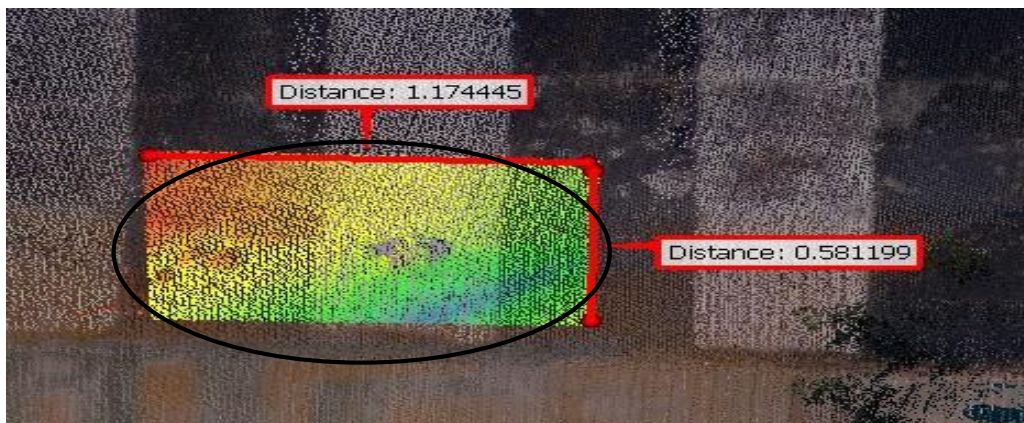
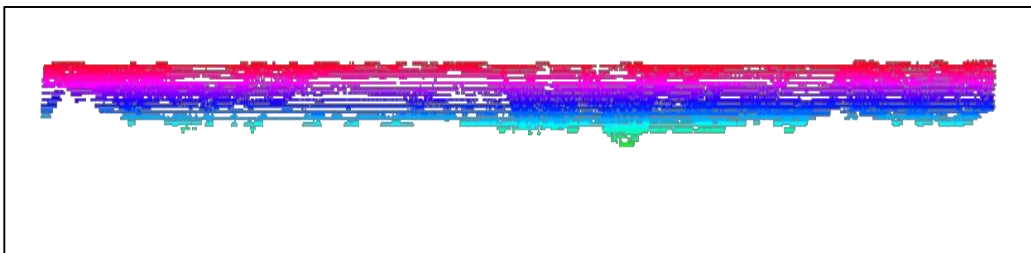
| Element Name | Observation | Location of Distress | Photo No. | Units | Distress Details | | | Area of Repair (Sq.m/ RMT/ m3) |
|---|---|---|---|---|---|---|---|---|
| Abutment 2 | Damage | | 5 | M | 1.17 | 0.58 | | 0.6786 |

**5. Wall damage observed on RHS Abutment2, measuring 1.17 m in length and 0.58 m in width, covering an area of 0.6786 m<sup>2</sup>.**

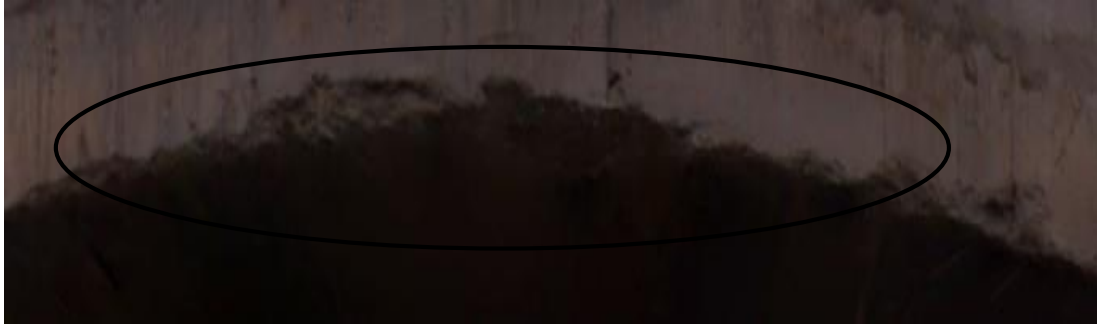
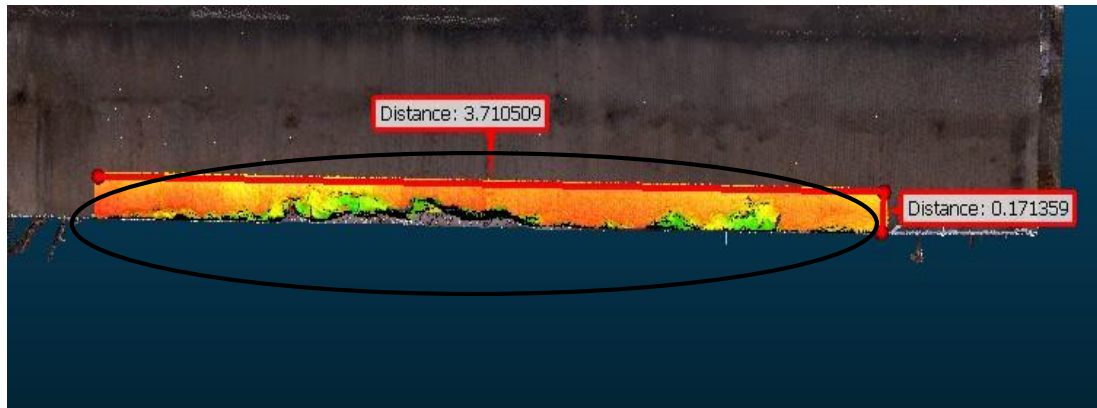
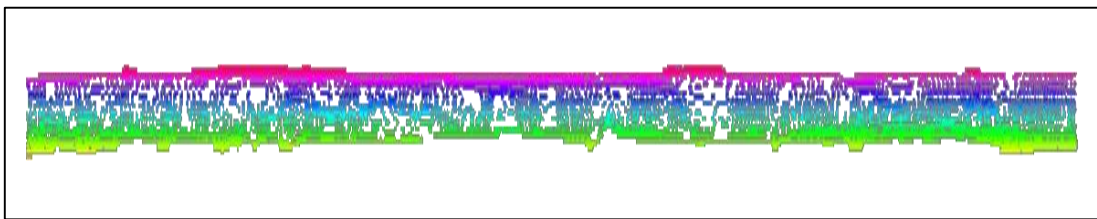
| Element Name | Observation | Location of Distress | Photo No. | Units | Distress Details | | | Area of Repair (Sq.m/ RMT/ m3) |
|---|---|---|---|---|---|---|---|---|
| Deck Slab | Damage | | 6 | M | 3.71 | 0.17 | | 0.6307 |

**6. Damage observed on RHS deck slab, measuring 3.71 m in length and 0.17 m in width, covering an area of 0.6307 m<sup>2</sup>.**

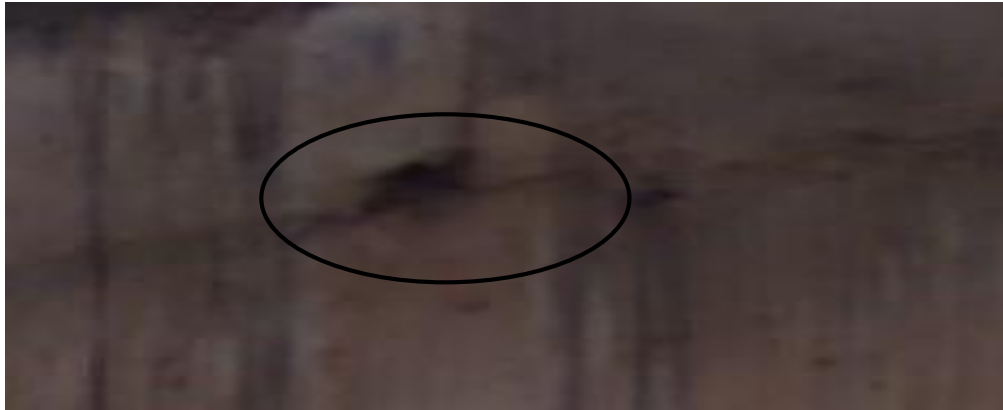
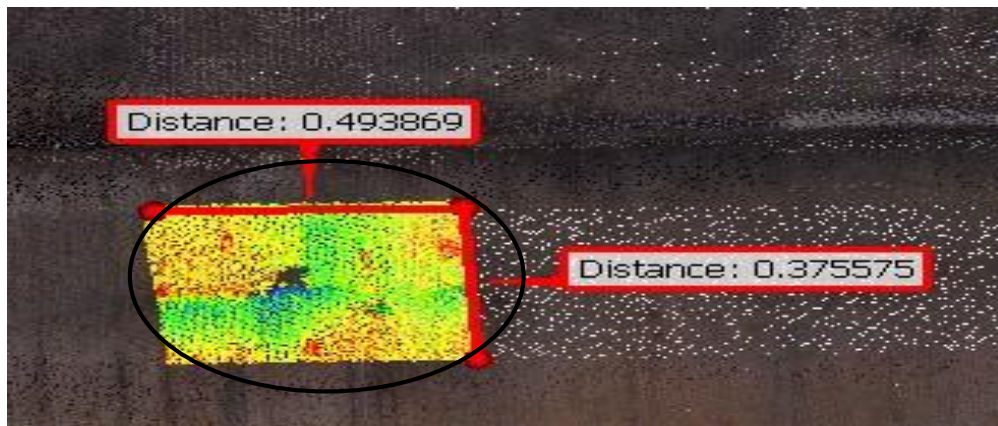
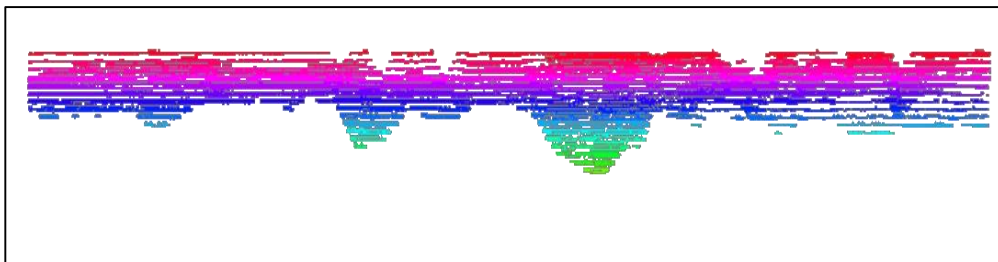
| Element Name | Observation | Location of Distress | Photo No. | Units | Distress Details | | | Area of Repair (Sq.m/ RMT/ m3) |
|---|---|---|---|---|---|---|---|---|
| Deck Slab | Damage | | 7 | M | 0.49 | 0.37 | | 0.1813 |

**7. Damage observed on RHS side deck slab, measuring 0.49 m in length and 0.37 m in width, covering an area of 0.1813 m<sup>2</sup>.**

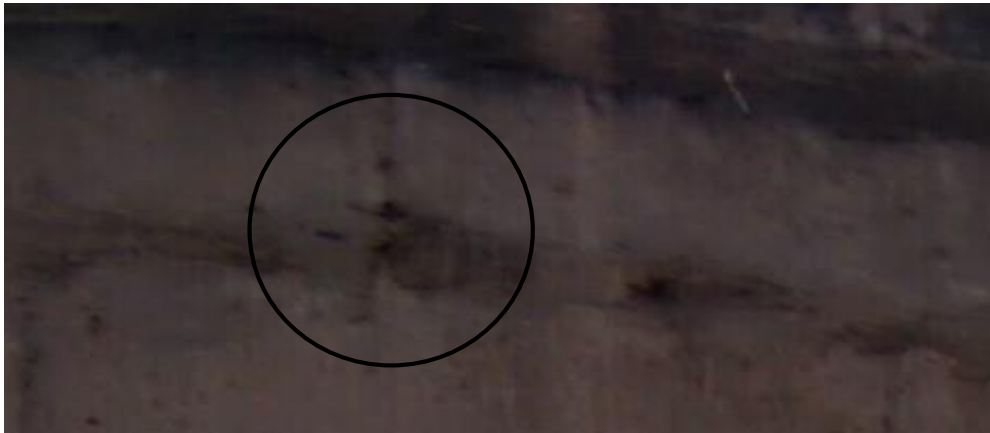
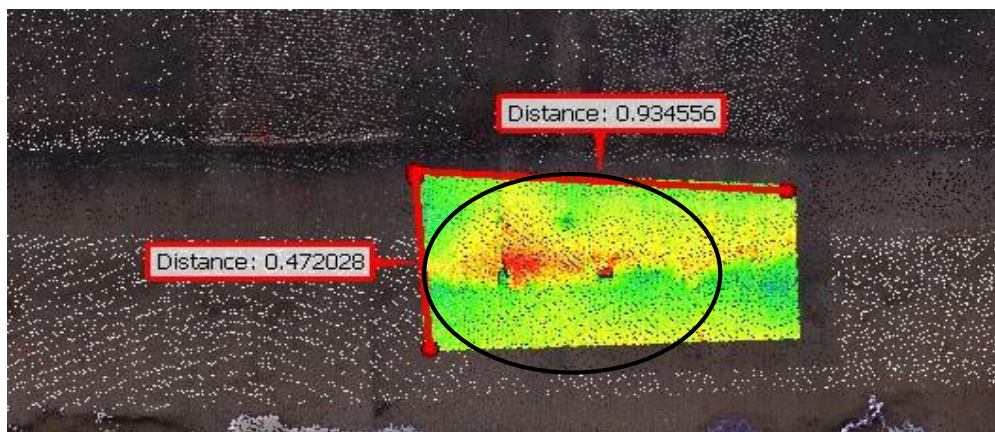
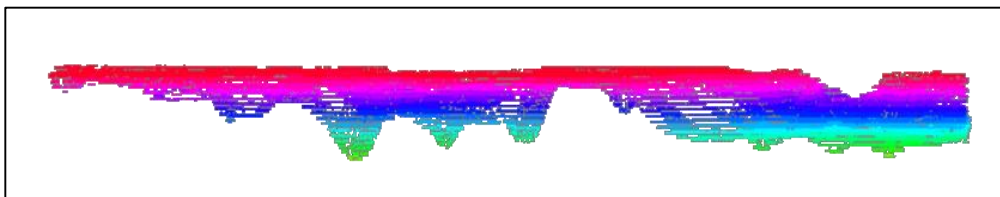
| Element Name | Observation | Location of Distress | Photo No. | Units | Distress Details | | | Area of Repair (Sq.m/ RMT/ m3) |
|---|---|---|---|---|---|---|---|---|
| Deck Slab | Scaling | | 8 | M | 0.93 | 0.47 | | 0.4371 |

**8. Scaling observed on RHS side deck slab, measuring 0.93 m in length and 0.47 m in width, covering an area of 0.4371 m<sup>2</sup>.**
