# **LIDAR Inspection Report of PUP ch.924+500**

**Bridge Chainage:** 924+500(CKRP)

- **Bridge No:** -
- **Chainage:** 924+500
- **Structure type:** PUP

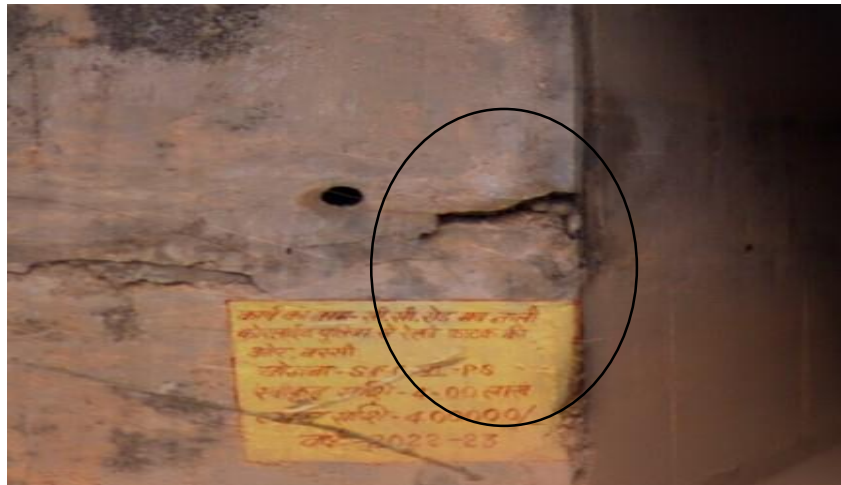
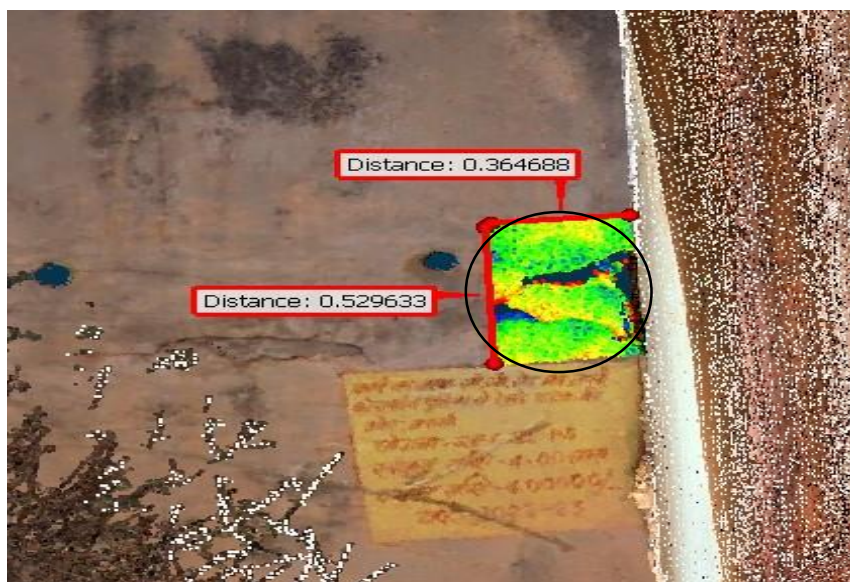
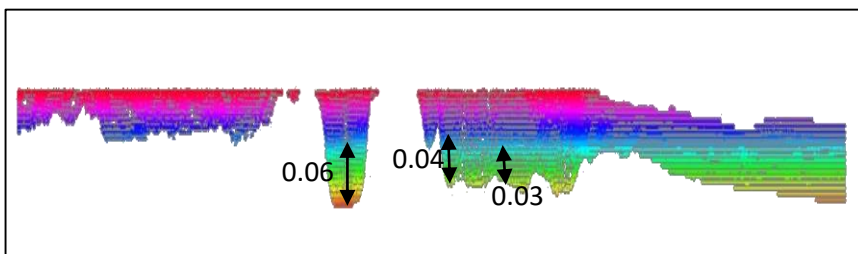
| Element Name | Observation | Location of Distress | Photo No. | Units | Distress Details | | | Area of Repair (Sq.m/R MT/m3) |
|---|---|---|---|---|---|---|---|---|
| Abutment2 | Damage | - | 1 | M | 0.36 | 0.52 | 0.45 | 0.08424 |

**1. Damage observed on LHS Abutment 2, measuring 0.36 m in length and 0.52 m in width, Depth ranges from 0.03 (min) to 0.06 m (max), with an average depth of 0.04 m. The calculated volume of the distress is 0.08424 m<sup>3</sup>.**

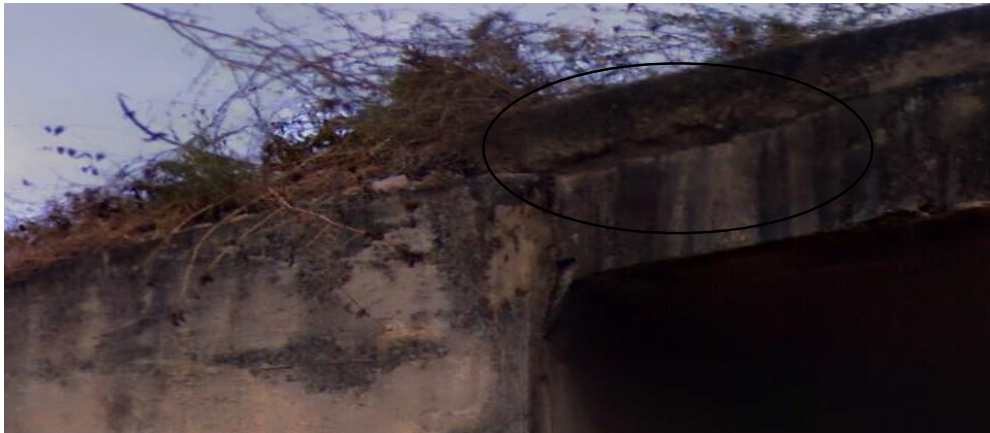
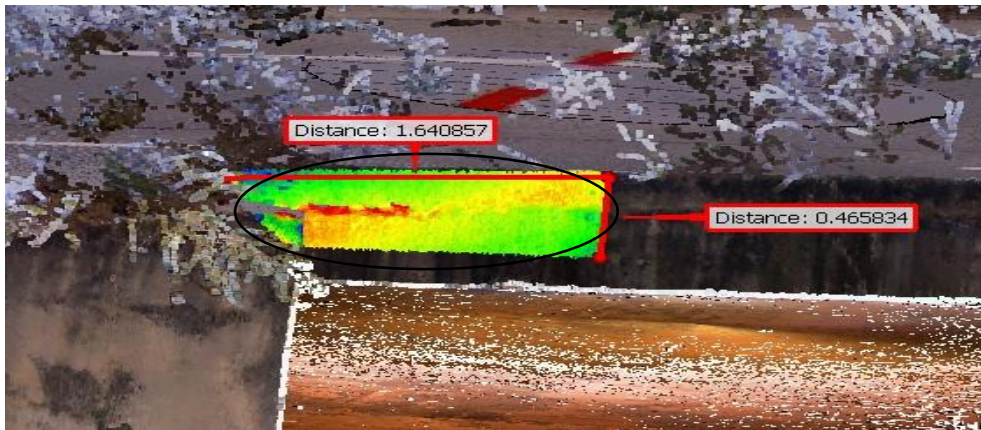
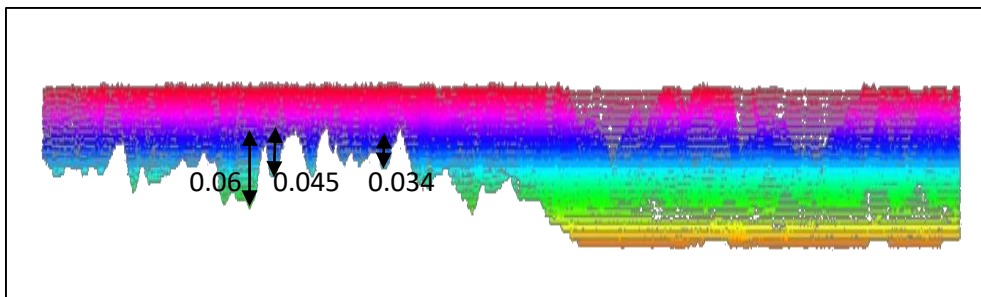
| Element Name | Observation | Location of Distress | Photo No. | Units | Distress Details | | | Area of Repair (Sq.m/R MT/m3) |
|---|---|---|---|---|---|---|---|---|
| Abutment 2 | Damage | - | 2 | M | 1.64 | 0.46 | 0.045 | 0.0339 |

**2.Damage observed on LHS Abutment , measuring 1.64 m in length and 0.46 m in width. Depth ranges from 0.034m (min) to 0.06 m (max), with an average depth of 0.045 m. The calculated volume of the distress is 0.0339 m<sup>3</sup>.**

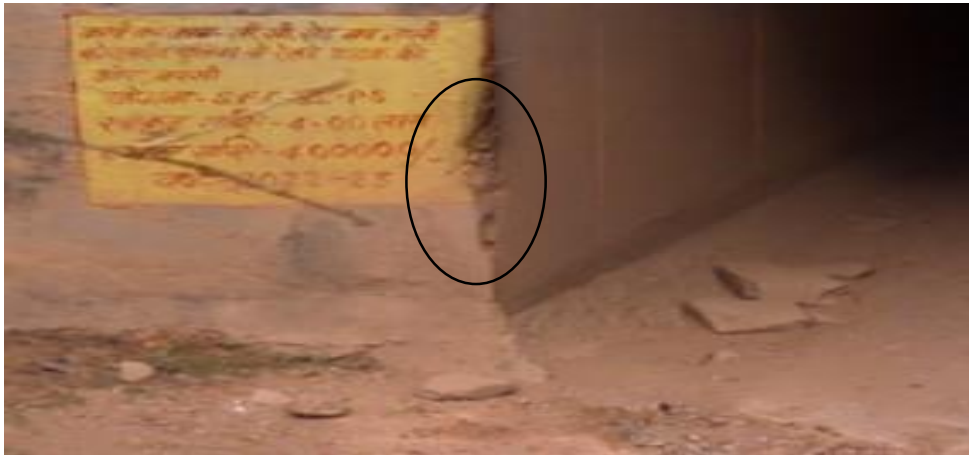
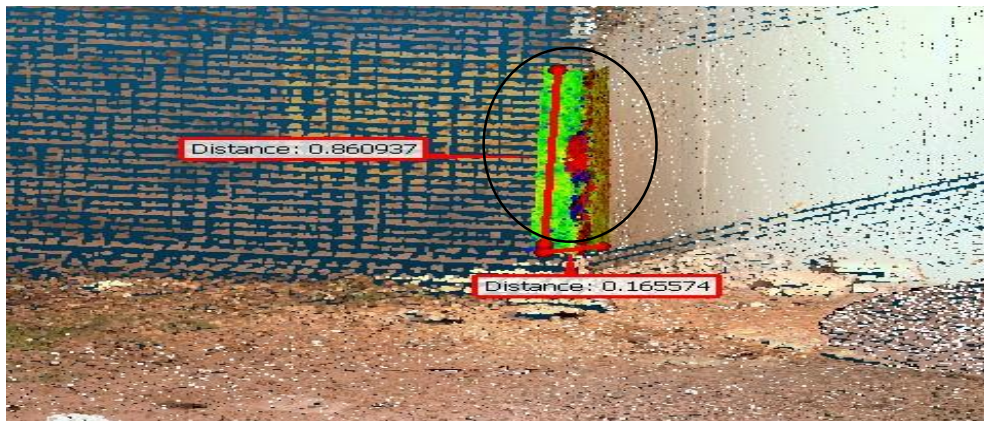
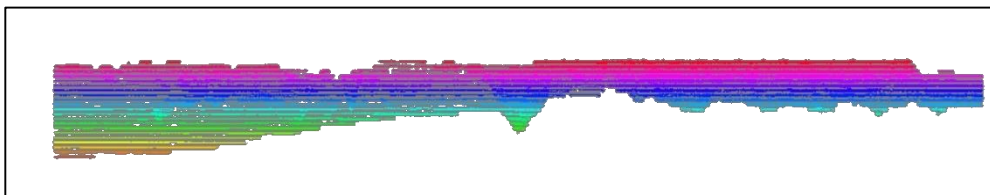
| Element Name | Observation | Location of Distress | Photo No. | Units | Distress Details | | | Area of Repair (Sq.m/R MT/m3) |
|---|---|---|---|---|---|---|---|---|
| Abutment 2 | Damage | - | 4 | M | 0.16 | 0.86 | | 0.1376 |

**4.Damage observed on LHS Abutment 2, measuring 0.16 m in length and 0.86 m in width, covering an area of 0.1376 m<sup>2</sup>.**

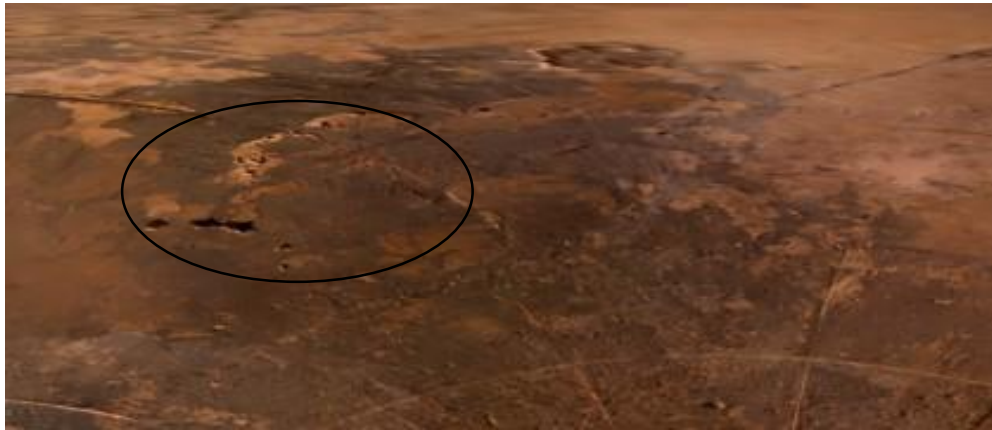
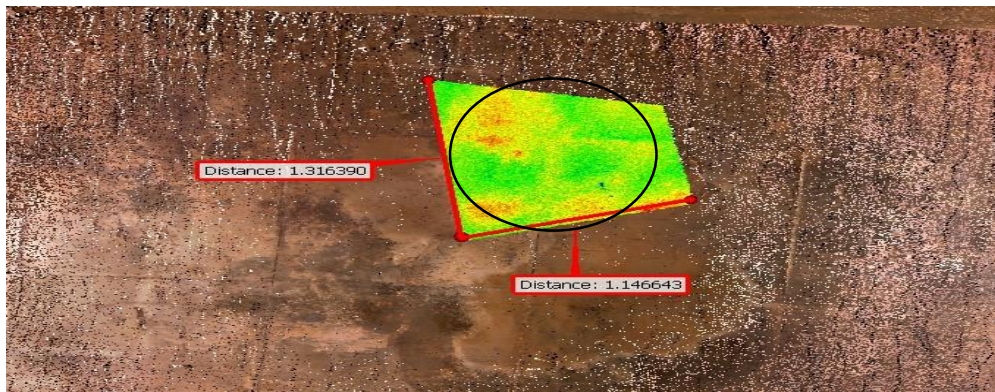
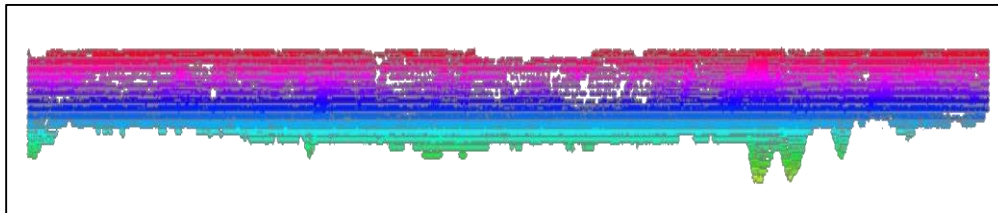
| Element Name | Observation | Location of Distress | Photo No. | Units | Distress Details | | | Area of Repair (Sq.m/R MT/m3) |
|---|---|---|---|---|---|---|---|---|
| Slab | Scaling | - | 5 | M | 1.14 | 1.31 | | 1.49 |

**5. Scaling observed on LHS slab, measuring 1.14 m in length and 1.31 m in width, covering an area of 1.49 m<sup>2</sup>.**

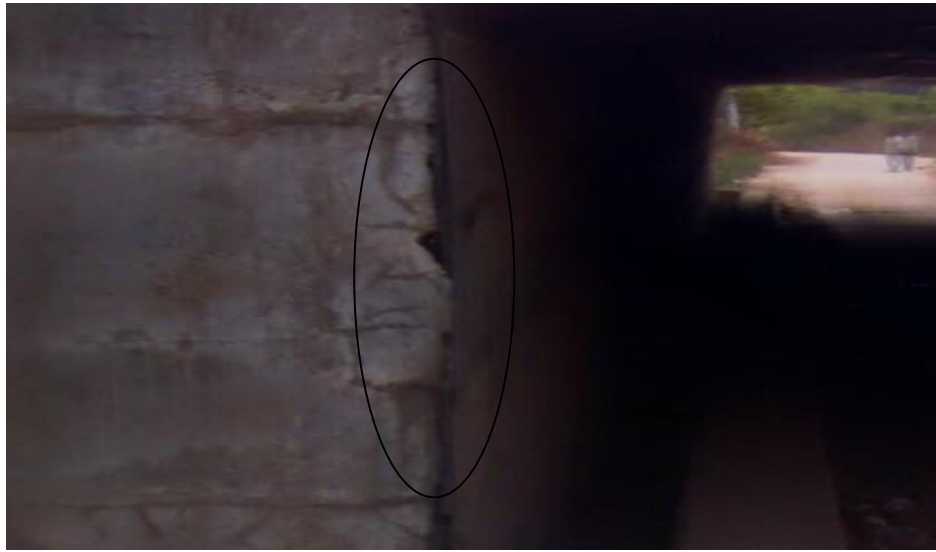
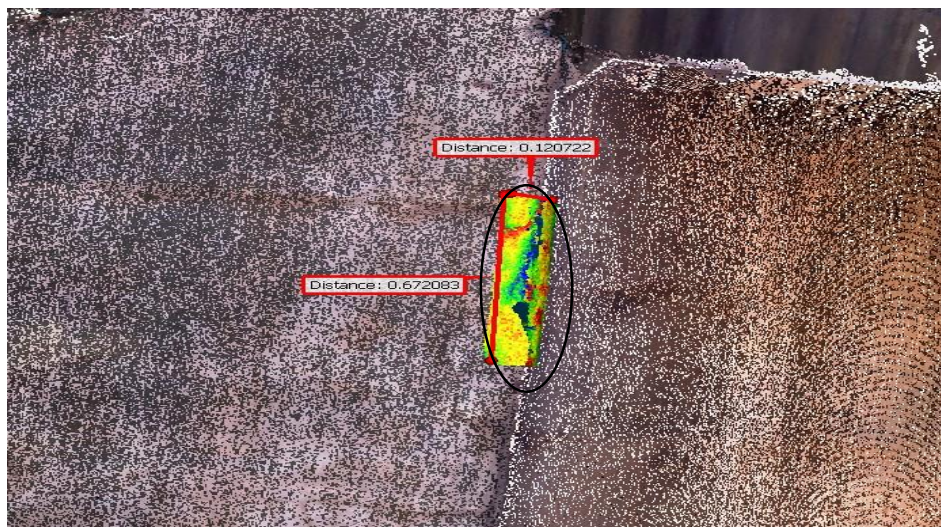
| Element Name | Observation | Location of Distress | Photo No. | Units | Distress Details | | | Area of Repair (Sq.m/ RMT/ m3) |
|---|---|---|---|---|---|---|---|---|
| Abutment 1 | Damage | - | 6 | M | 0.12 | 0.67 | | 0.0804 |

**6. Damage observed on RHS Abutment 1, measuring 0.12 m in length and 0.67 m in width, covering an area of 0.0804 m<sup>2</sup>.**
