# **LIDAR Inspection Report of MNB ch.924+690**

**Bridge No:** MNB - 925/2

**Bridge Chainage:** 924+690 (CKRP)

- CKRP: Chittorgarh to kota
- State: Rajasthan NH 27
- Zone: RJ-20

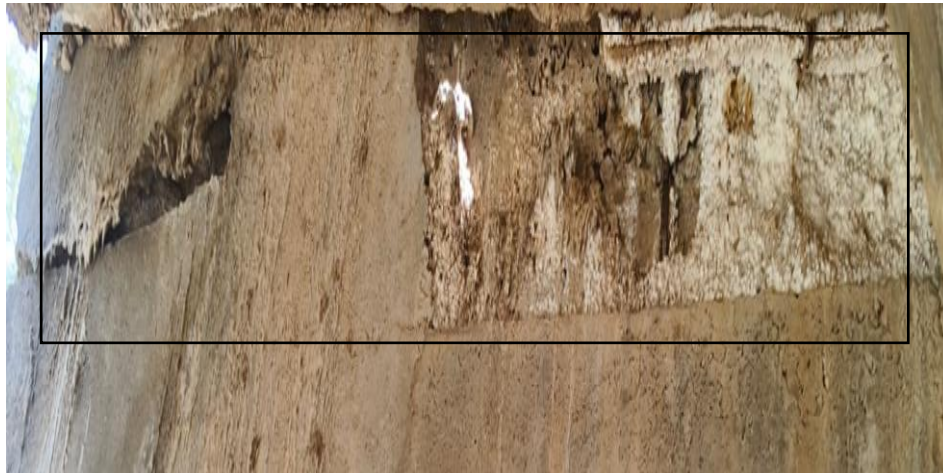
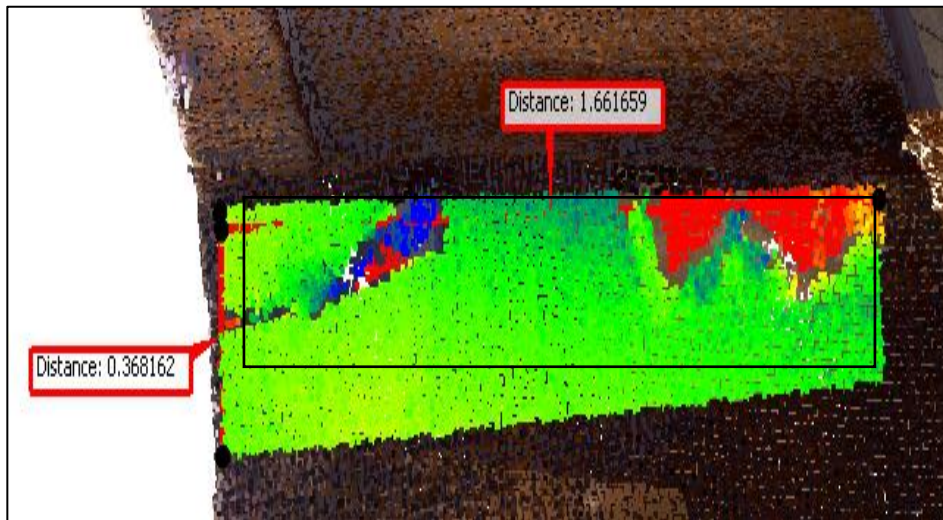
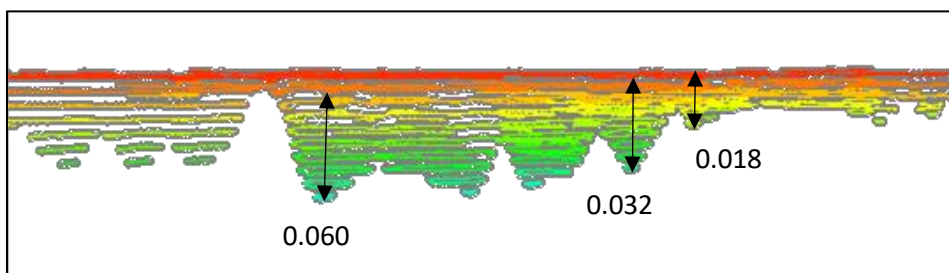
| Element Name | Observation | Location of Distress | Photo No. | Units | Distress Details | | | Area of Repair (Sq.m/R MT) |
|---|---|---|---|---|---|---|---|---|
| Abutment 2 | Damage | - | 1 | M | 1.66 | 0.36 | 0.032 | 0.191 |

- 1. Abutment 2 LHS damage observed, measuring 1.66 m in length and 0.36 m in width, Depth ranges from 0.018 m min to 0.060 m max, with an average depth of 0.032 m. The calculated volume of the distress is 0.0191m<sup>3</sup>.**

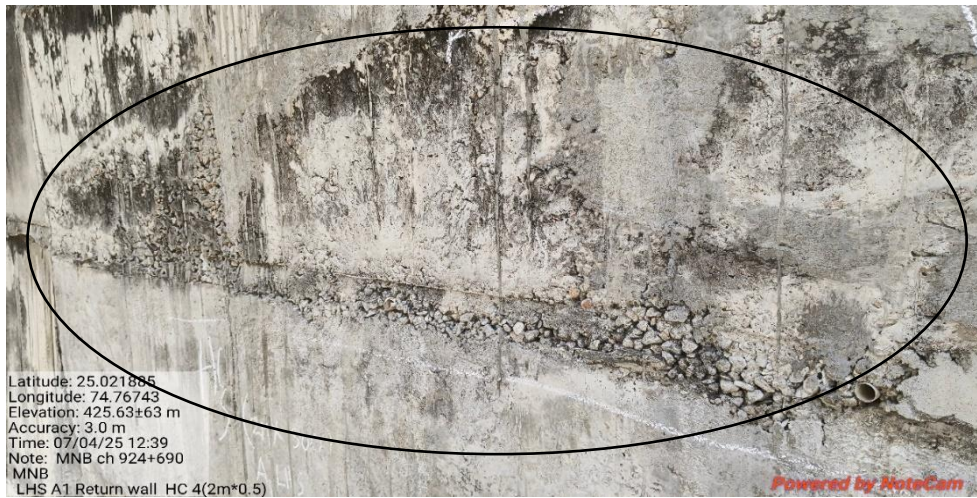
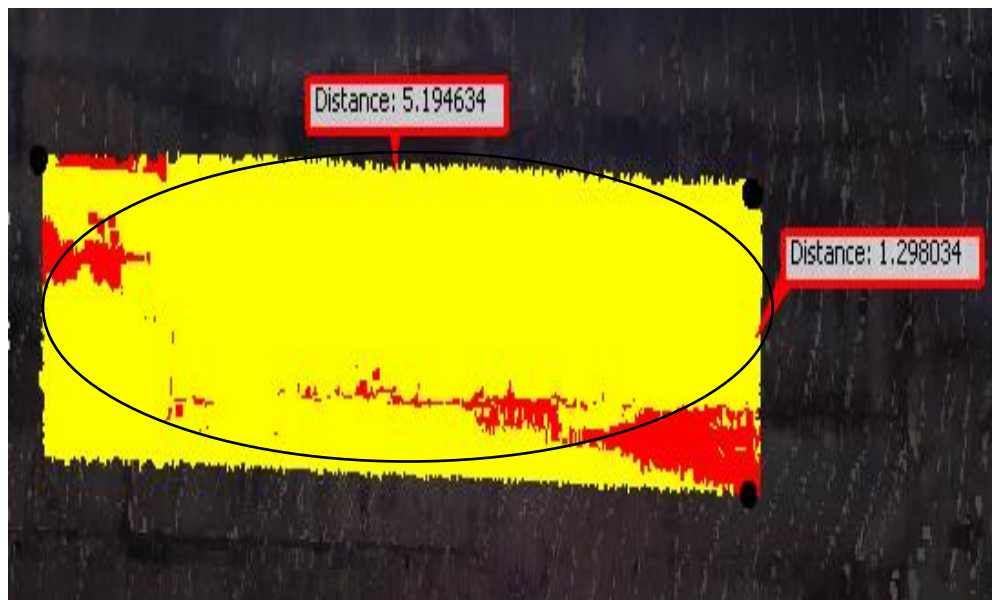
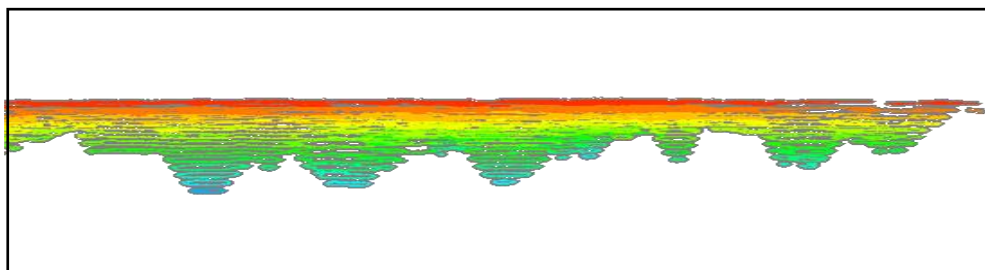
| Element Name | Observation | Location of Distress | Photo No. | Units | Distress Details | | | Area of Repair (Sq.m/R MT) |
|---|---|---|---|---|---|---|---|---|
| Return Wall | Honeycombing | - | 2 | M | 5.19 | 1.29 | - | 6.69 |

- 2. Honeycombing observed on Abutment 1 LHS return wall, measuring 5.19 m in length and 1.29 m in width, covering an area of 6.69 m<sup>2</sup>.**

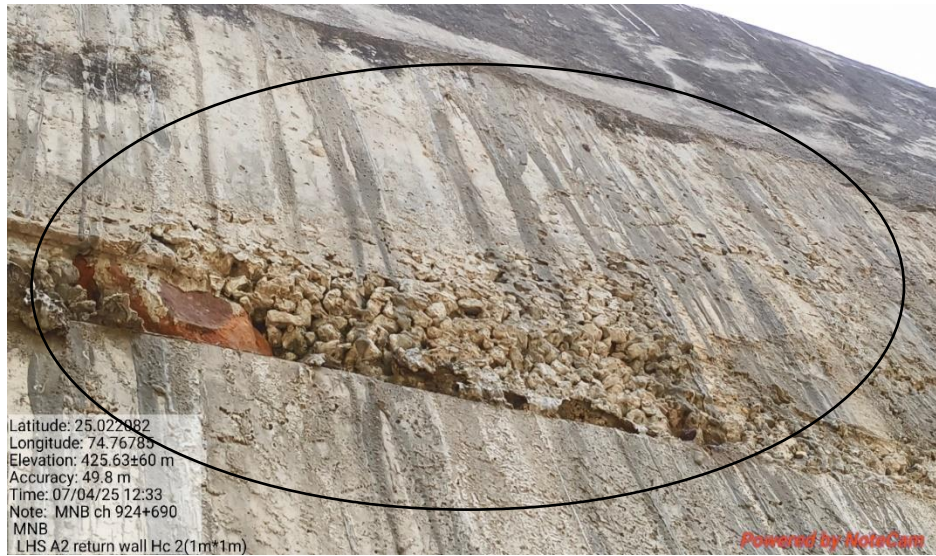
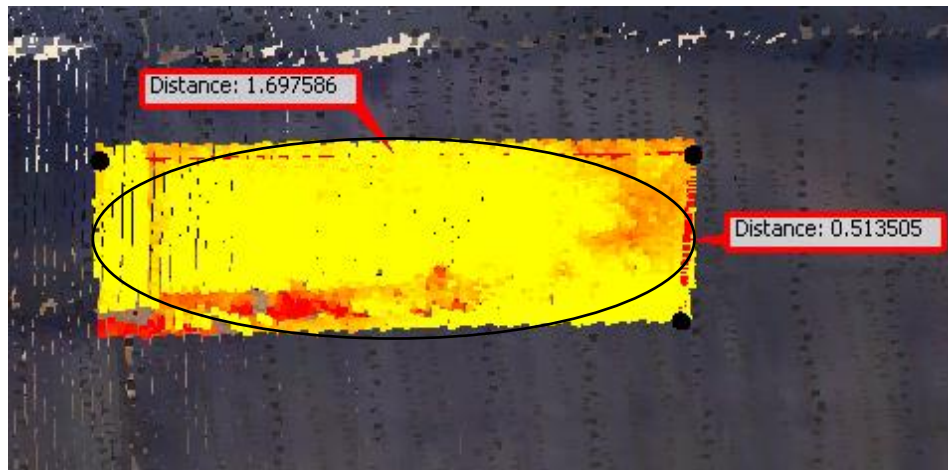
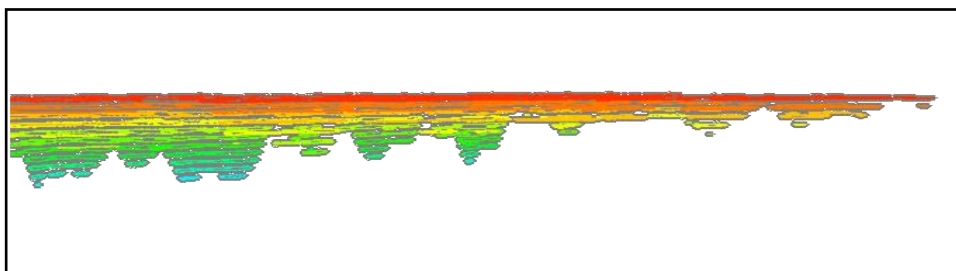
| Element Name | Observation | Location of Distress | Photo No. | Units | Distress Details | | | Area of Repair (Sq.m/R MT) |
|---|---|---|---|---|---|---|---|---|
| Abutment 2 | Honeycombing | - | 3 | M | 1.69 | 0.51 | - | 0.86 |

- 3. Honeycombing observed on Abutment 2 LHS return wall , measuring 1.69 m in length and 0.51 m in width, covering an area of 0.86 m<sup>2</sup>.**

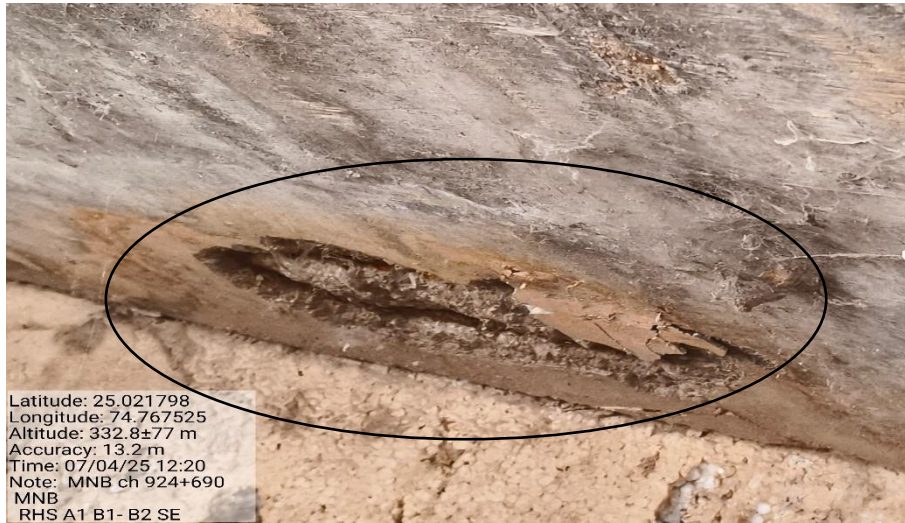
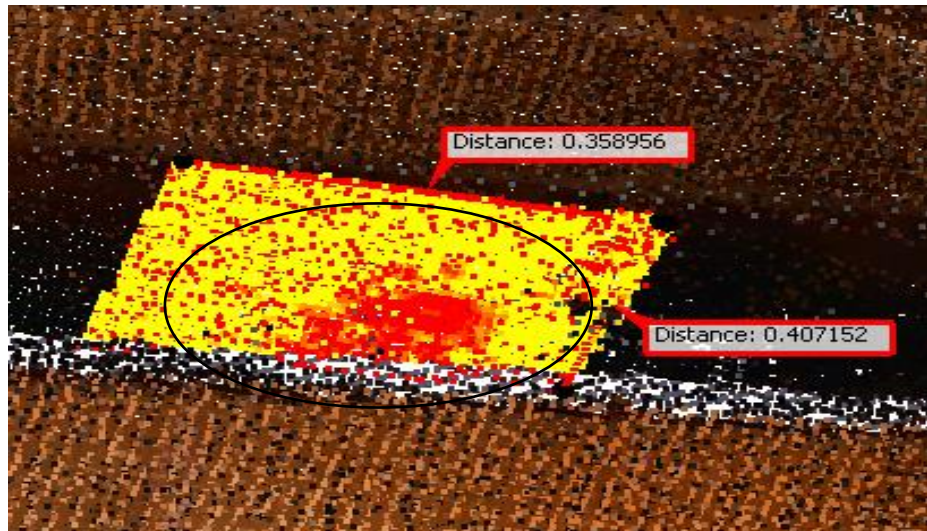
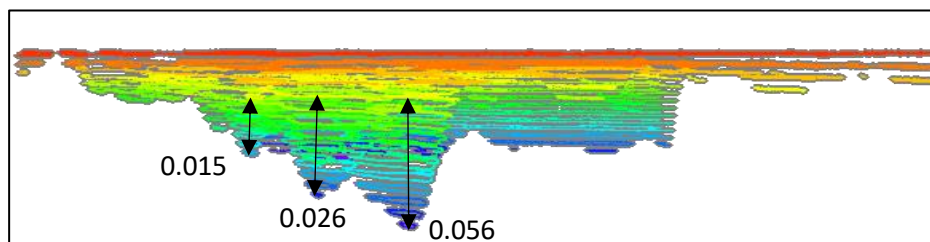
| Element Name | Observation | Location of Distress | Photo No. | Units | Distress Details | | | Area of Repair (Sq.m/R MT) |
|---|---|---|---|---|---|---|---|---|
| Bearing | Steel Exposed | - | 4 | M | 0.40 | 0.35 | 0.026 | 0.0036 |

- 4. Steel exposed on RHS of Abutment 1 between Bearing 1 and Bearing 2, measuring 0.40 m in length and 0.35 m in width, Depth ranges from 0.015 m min to 0.056 m max, with an average depth of 0.026 m. The calculated volume of the distress is 0.0036 m<sup>3</sup>.**

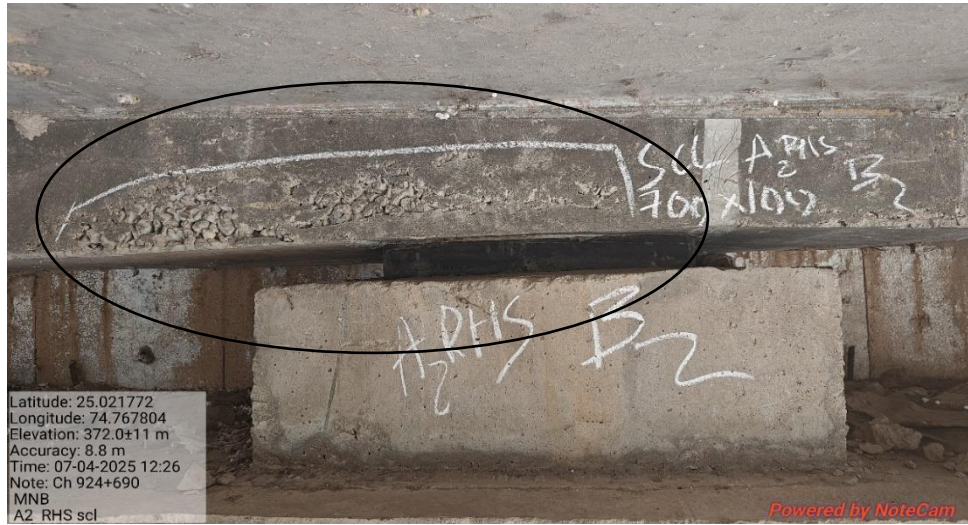
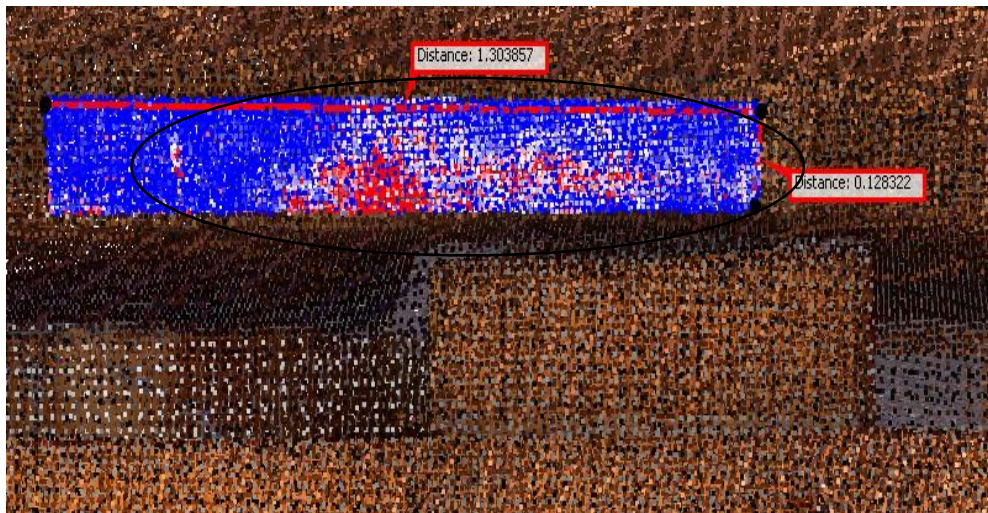
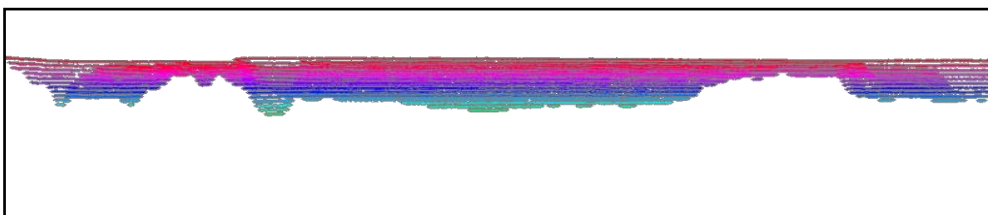
| Element Name | Observation | Location of Distress | Photo No. | Units | Distress Details | | | Area of Repair (Sq.m/R MT) |
|---|---|---|---|---|---|---|---|---|
| Abutment 2 | Scaling | - | 5 | M | 1.30 | 0.12 | - | 0.156 |

5. **Scaling observed on RHS of Abutment 2, measuring 1.30 m in length and 0.12 m in width, covering an area of 0.156 m<sup>2</sup>.**

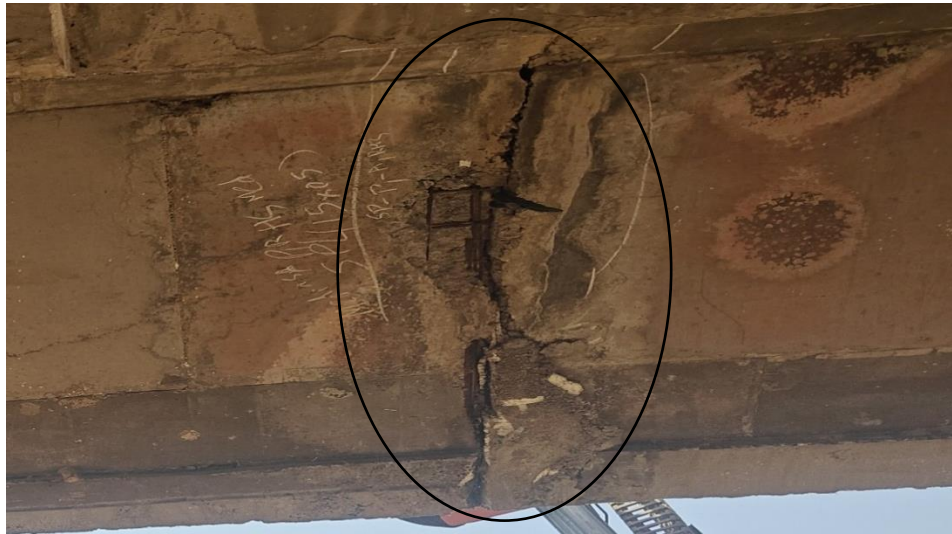
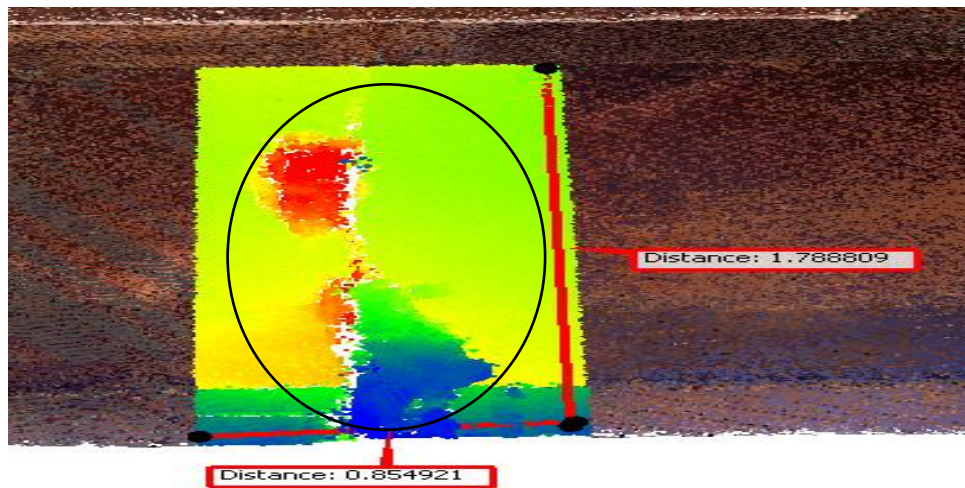
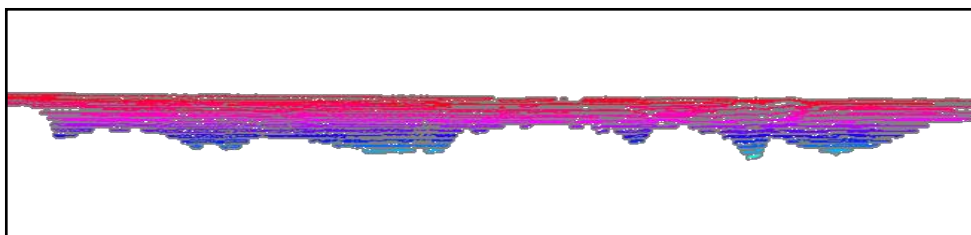
| Element Name | Observation | Location of Distress | Photo No. | Units | Distress Details | | | Area of Repair (Sq.m/R MT) |
|---|---|---|---|---|---|---|---|---|
| Pier 1 | Spalling | - | 6 | M | 1.78 | 0.85 | - | 1.51 |

- 6. Spalling observed on Pier 1 RHS median side, measuring 1.78 m in length and 0.85 m in width, covering an area of 1.51 m<sup>2</sup>.**

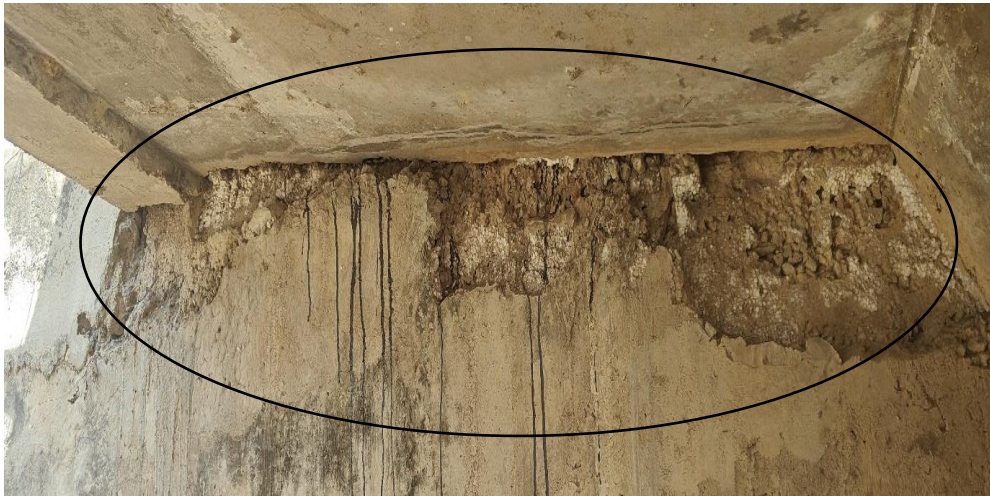
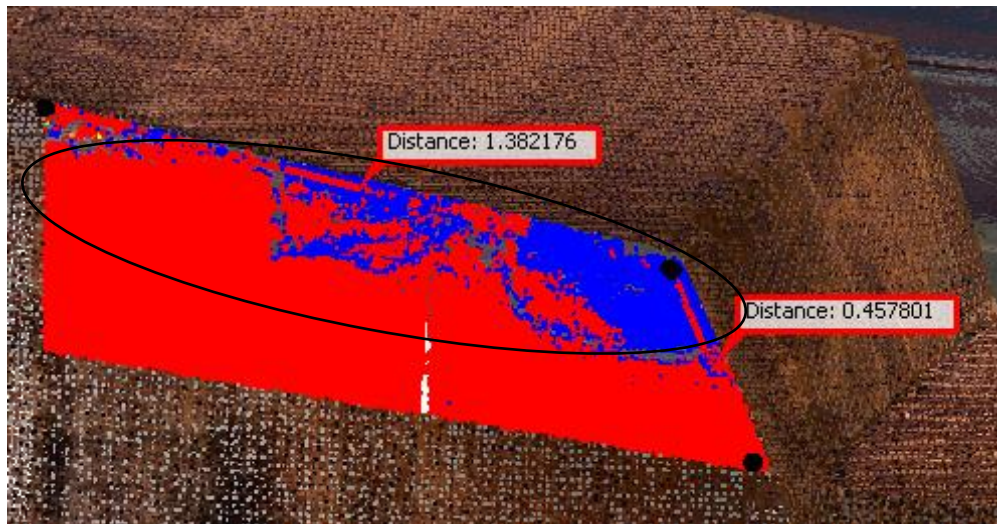
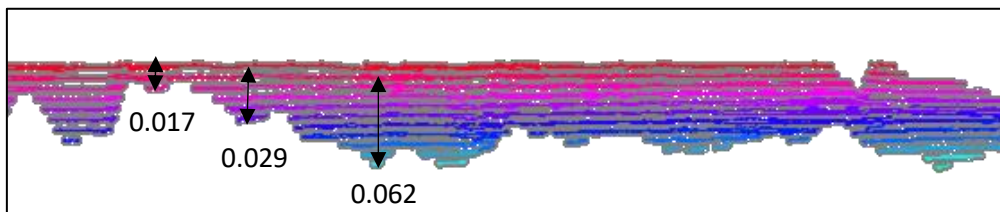
| Element Name | Observation | Location of Distress | Photo No. | Units | Distress Details | | | Area of Repair (Sq.m/R MT) |
|---|---|---|---|---|---|---|---|---|
| Dirt Wall | Damage | - | 7 | M | 1.38 | 0.45 | 0.029 | 0.0180 |

**7. Damage observed on RHS dirt wall of Abutment 2, measuring 1.38 m in length and 0.45 m in width, Depth ranges from 0.017 m (min) to 0.062 m (max), with an average depth of 0.029 m. The calculated volume of the distress is 0.0180m<sup>3</sup>.**
