# **LIDAR Inspection Report of PUP ch.925 + 160**

**Bridge Chainage:** 925 + 160 (CKRP)

- **CKRP:** Chittorgarh to kota
- **State:** Rajasthan NH 27
- **Zone:** RJ-06

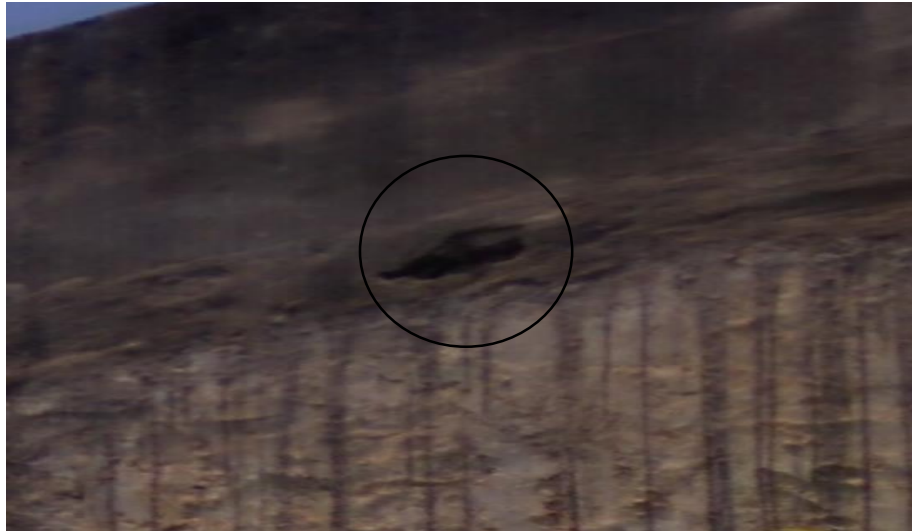
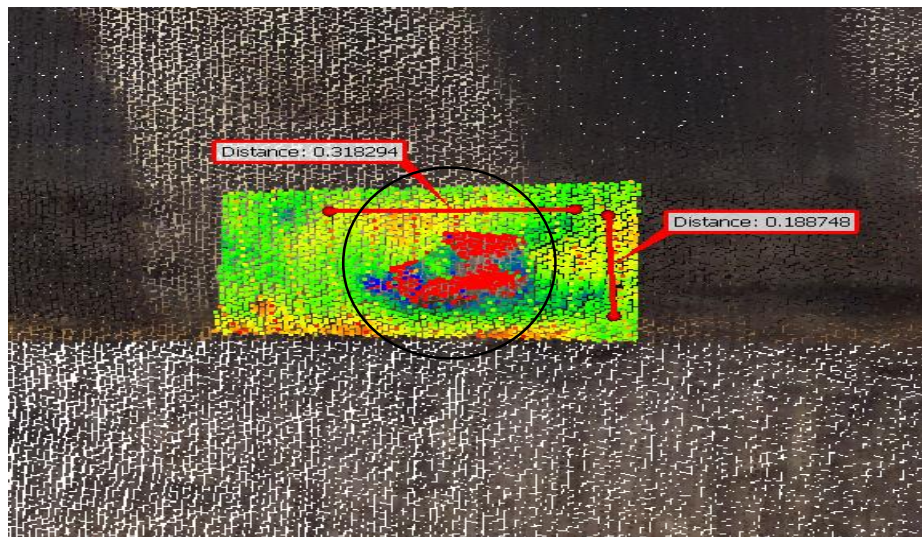
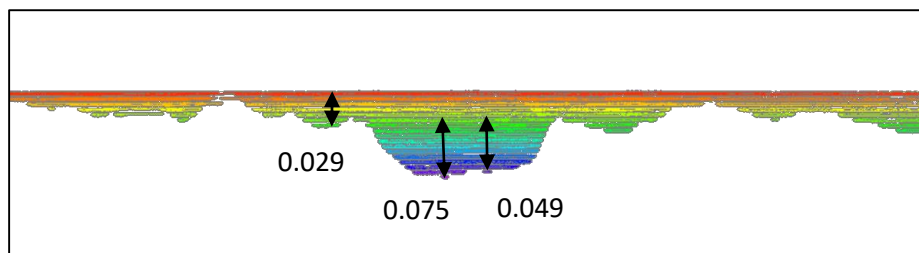
| Element Name | Observation | Location of Distress | Photo No. | Units | Distress Details | | | Area of Repair (Sq.m/R MT/m3) |
|---|---|---|---|---|---|---|---|---|
| Wing Wall | Damage | | 1 | M | 0.31 | 0.18 | 0.049 | 0.0027 |

1. Wing wall damage observed on RHS Abutment 1, measuring 0.31 m in length and 0.18 m in width, Depth ranges from 0.029 m (min) to 0.075 m (max), with an average depth of 0.049 m. The calculated volume of the distress is 0.0027 m<sup>3</sup>.

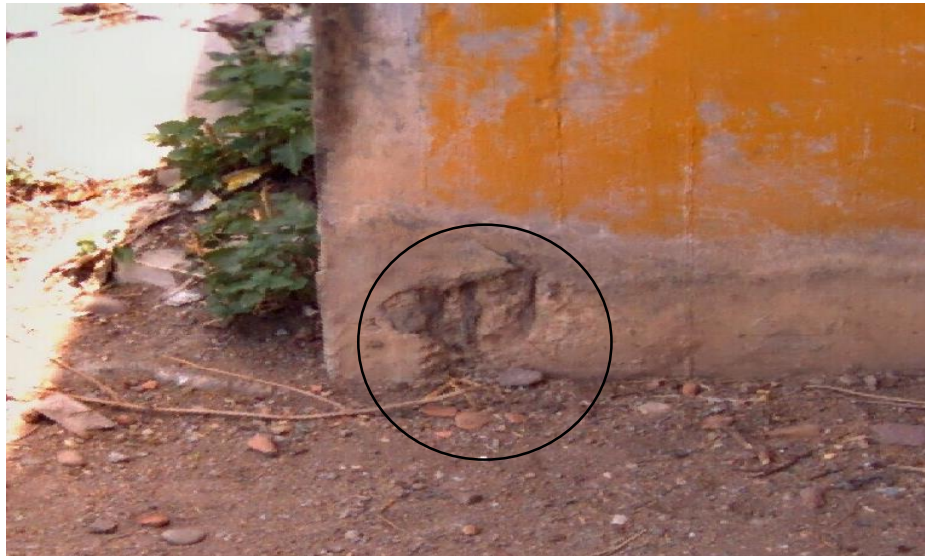
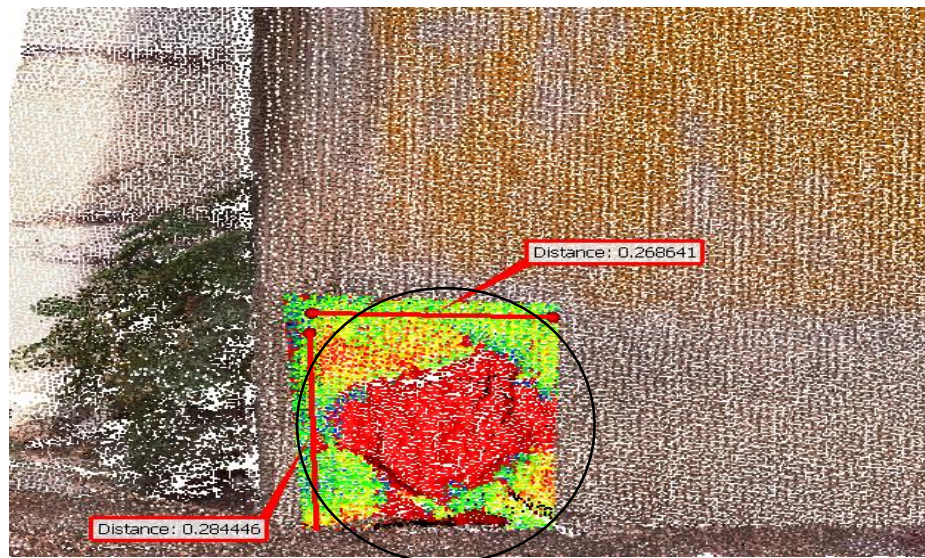
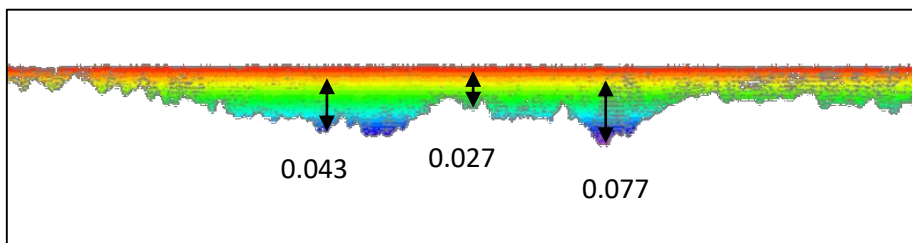
| Element Name | Observation | Location of Distress | Photo No. | Units | Distress Details | | | Area of Repair (Sq.m/R MT/m3) |
|---|---|---|---|---|---|---|---|---|
| Abutment 2 | Damage | | 2 | M | 0.28 | 0.26 | 0.043 | 0.0031 |

**2.Spalling/edge damage observed on LHS Abutment 2, measuring 0.28 m in length and 0.26 m in width, Depth ranges from 0.027 m (min) to 0.077 m (max), with an average depth of 0.043 m. The calculated volume of the distress is 0.0031 m<sup>3</sup>.**
