# **LIDAR Inspection Report of Box Culvert ch.925+533**

**Bridge Chainage:** 925+533

- **Bridge No:** -
- **Chainage:** 925+533
- **Structure type:** Box Culvert

- **CKRP:** Chittorgarh to kota
- **State:** Rajasthan NH 27
- **Zone:** RJ-20

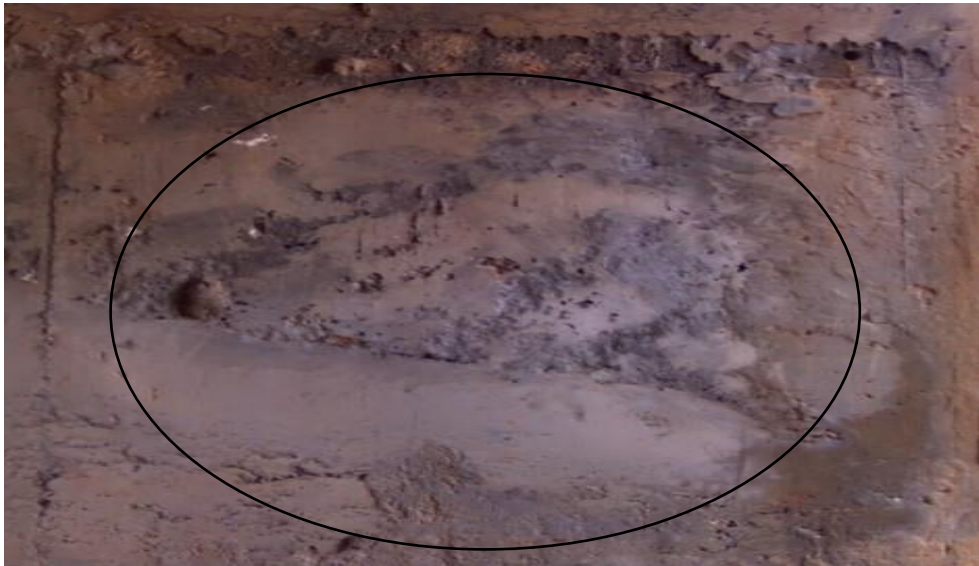
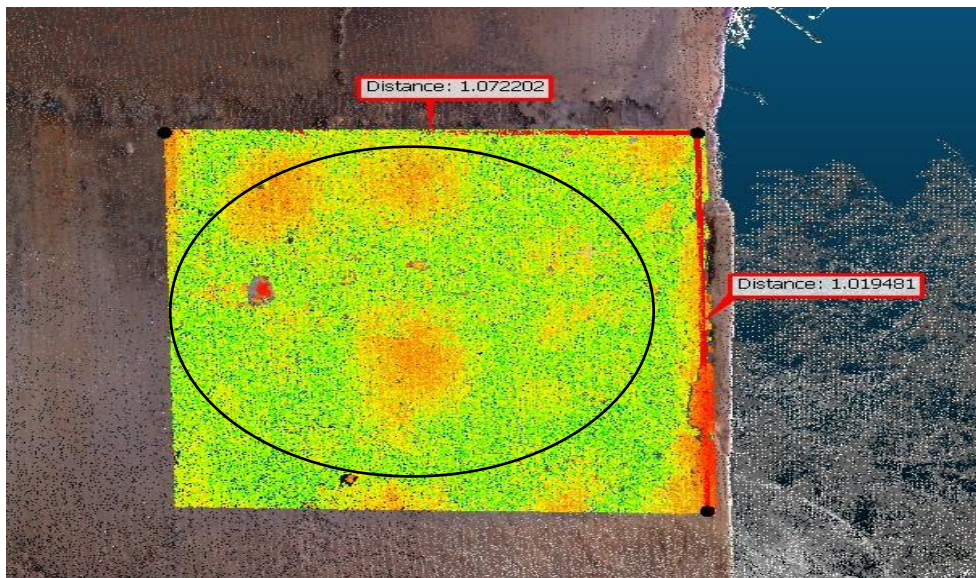
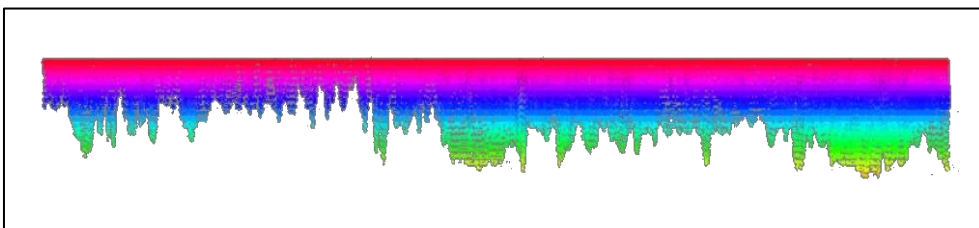
| Element Name | Observation | Location of Distress | Photo No. | Units | Distress Details | | | Area of Repair (Sq.m/R MT/m3) |
|---|---|---|---|---|---|---|---|---|
| Abutment 2 | Scalling | - | 1 | Sq m | 1.07 | 1.01 | - | 1.08 |

**1. Scaling observed on Abutment 2 RHS side, measuring 1.07 m in length and 1.01 m in width, covering an area of 1.08 m<sup>2</sup>.**

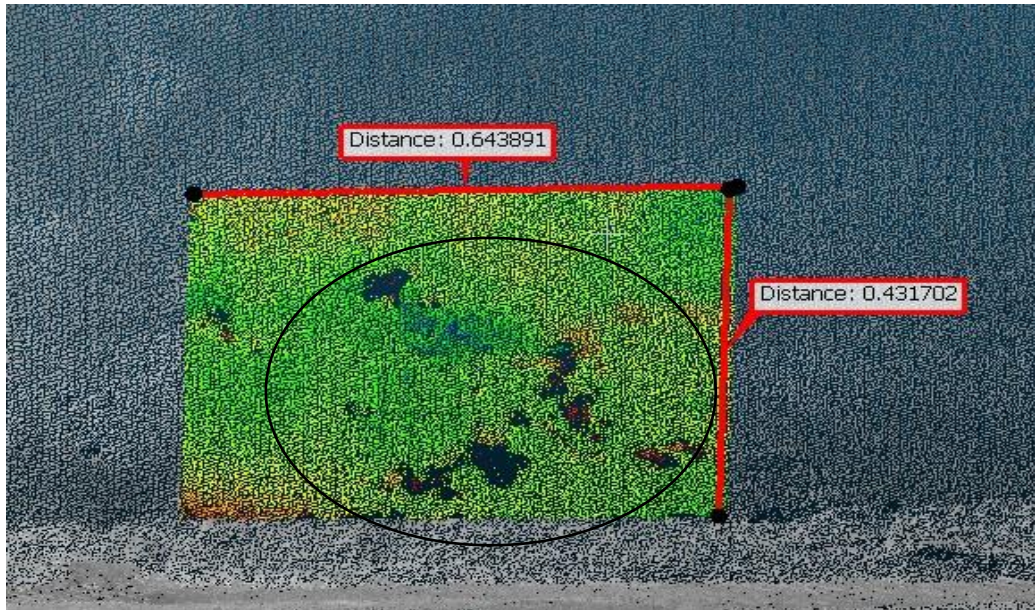
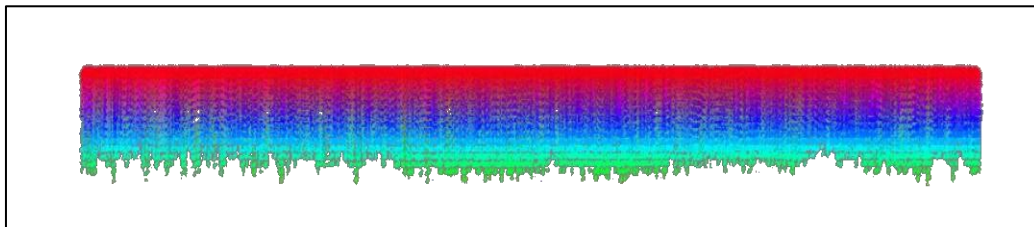
| Element Name | Observation | Location of Distress | Photo No. | Units | Distress Details | | | Area of Repair (Sq.m/R MT/m3) |
|---|---|---|---|---|---|---|---|---|
| Abutment 1 | Scalling | - | 2 | Sq m | 0.64 | 0.43 | - | 0.27 |

**2. Scaling observed on Abutment 1 LHS side, measuring 0.64 m in length and 0.43 m in width, covering an area of 0.27 m<sup>2</sup>.**
