# **LIDAR Inspection Report of MNB ch.926+250**

**Bridge No:** MNB - 927/1

**Bridge Chainage:** 926 + 250 (CKRP)

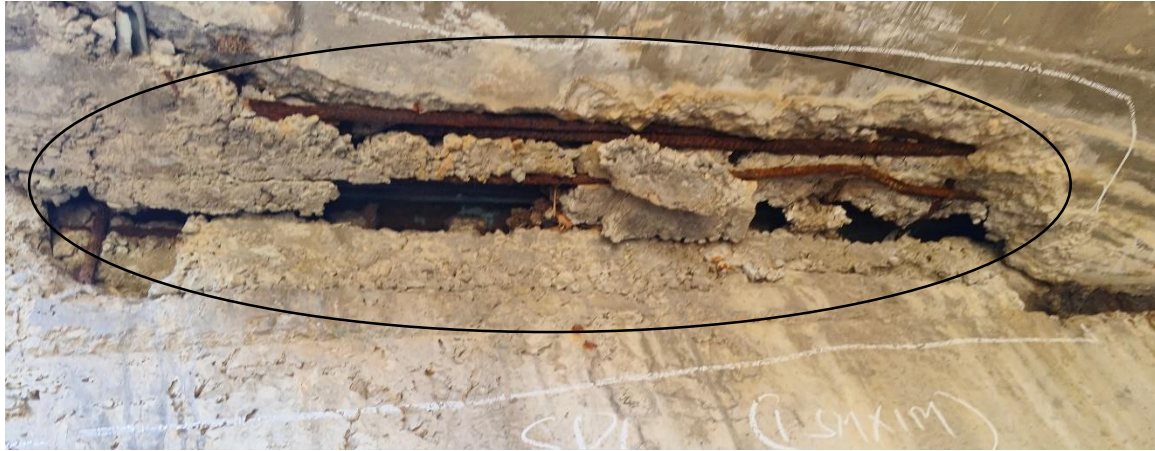
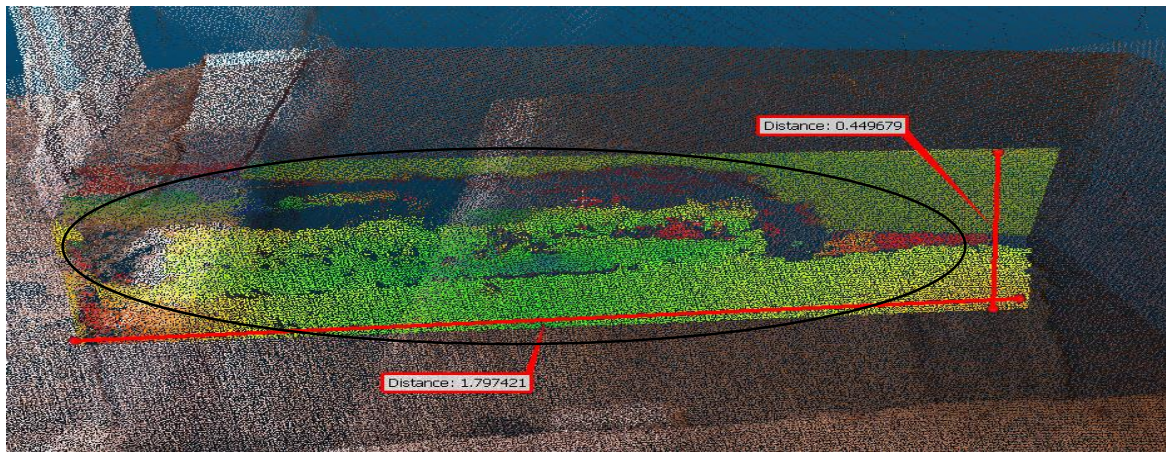
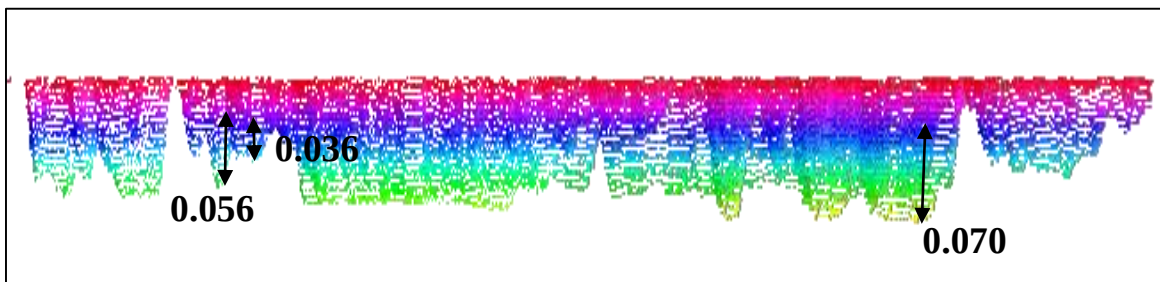
| Element Name | Observation | Location of Distress | Photo No. | Units | Distress Details | | | Area of Repair (Sq./RM T/m3) |
|---|---|---|---|---|---|---|---|---|
| Abutment 1 | Spalling | | 1 | | 1.79 | 0.44 | 0.056 | 0.044 |

1. Spalling observed at LHS A1, measuring 1.79 m in length and 0.44 m in width, Depth ranges from 0.036 (min) to 0.070 m (max), with an average depth of 0.056 m. The calculated volume of the distress is 0.044 m<sup>3</sup>.

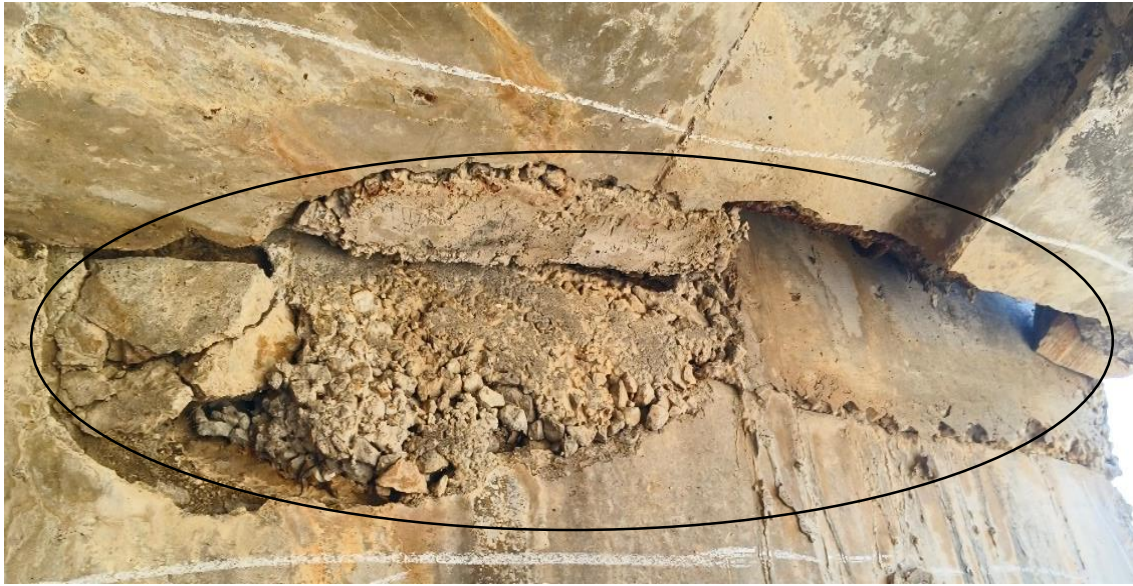
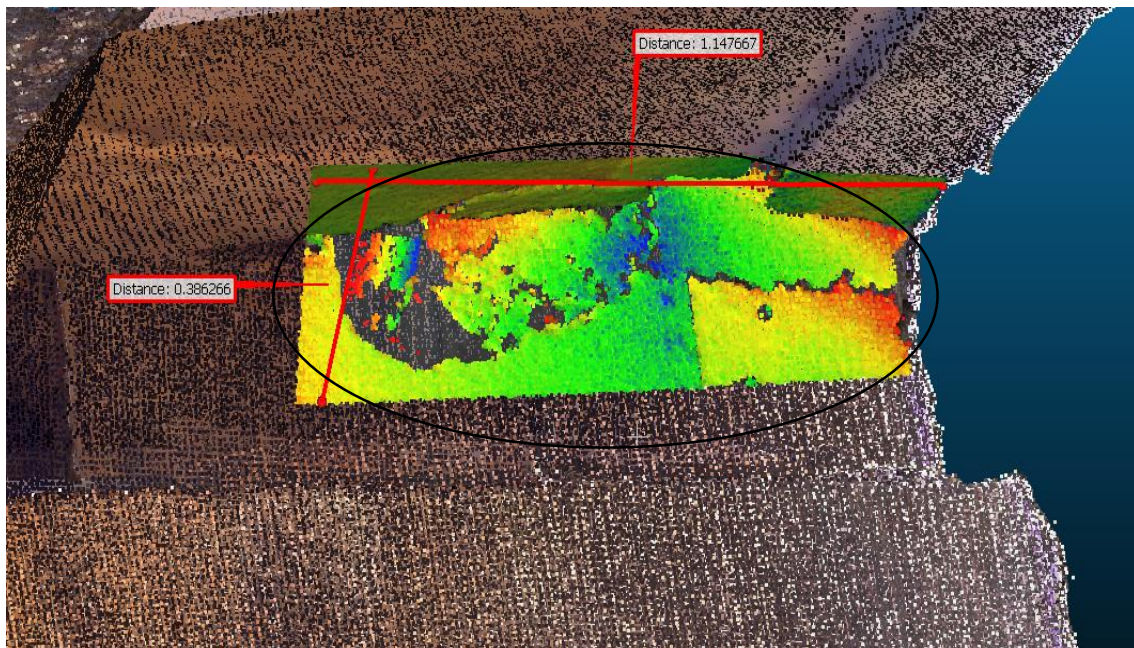
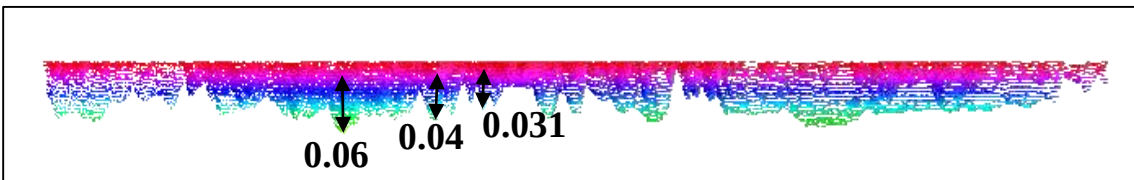
| Element Name | Observation | Location of Distress | Photo No. | Units | Distress Details | | | Area of Repair (Sq./RM T/m3) |
|---|---|---|---|---|---|---|---|---|
| Abutment 1 | Spalling | | 2 | | 1.14 | 0.38 | 0.04 | 0.017 |

**2. Spalling observed at LHS A1, measuring 1.14 m in length and 0.38 m in width, Depth ranges from 0.031 (min) to 0.06 m (max), with an average depth of 0.04 m. The calculated volume of the distress is 0.017 m<sup>3</sup>.**

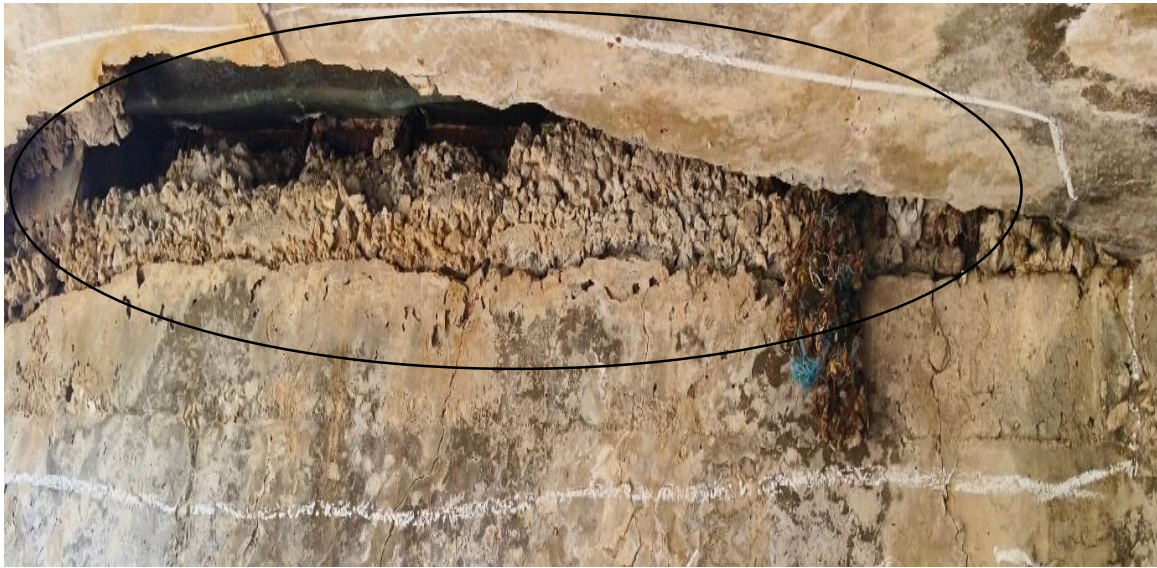
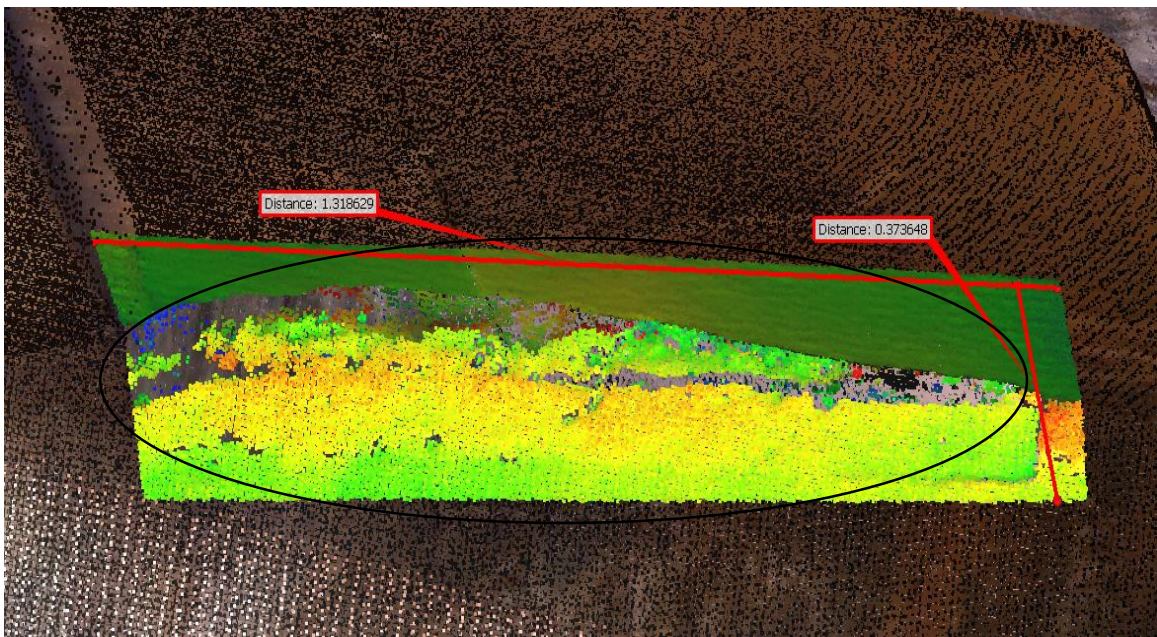
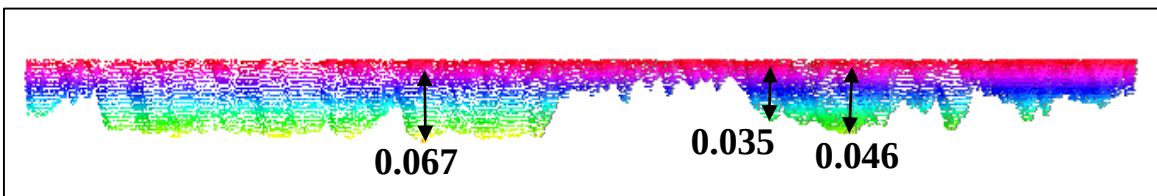
| Element Name | Observation | Location of Distress | Photo No. | Units | Distress Details | | | Area of Repair (Sq./RM T/m3) |
|---|---|---|---|---|---|---|---|---|
| Abutment 2 | Spalling | | 3 | | 1.31 | 0.37 | 0.046 | 0.022 |

**3. Spalling observed at LHS A2 (toe side), measuring 1.31 m in length and 0.37 m in width, Depth ranges from 0.035 (min) to 0.067 m (max), with an average depth of 0.46 m. The calculated volume of the distress is 0.022 m<sup>3</sup>.**

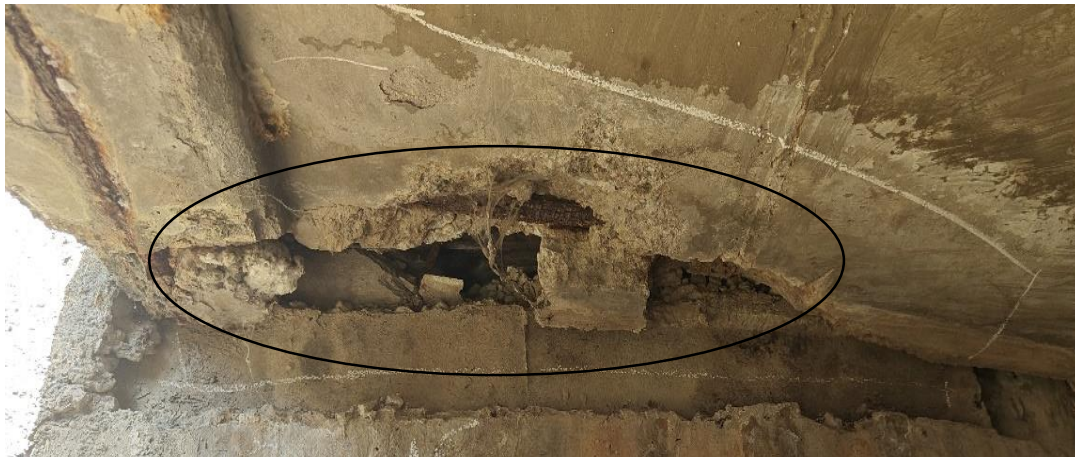
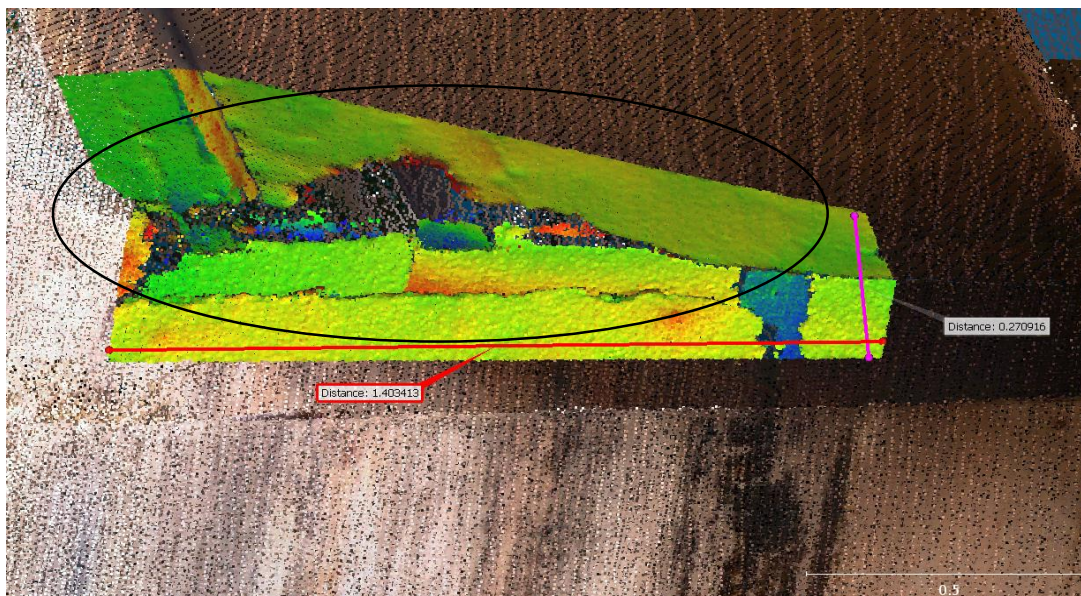
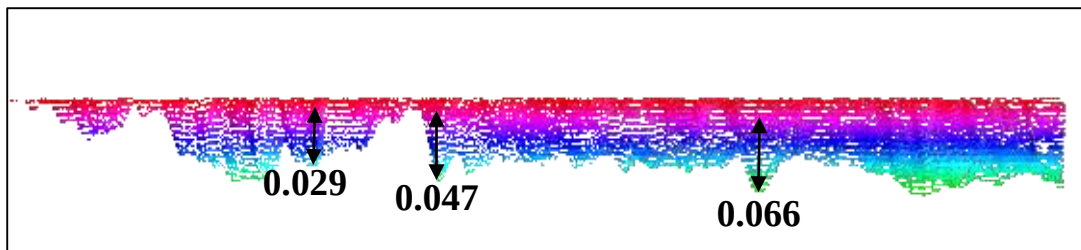
| Element Name | Observation | Location of Distress | Photo No. | Units | Distress Details | | | Area of Repair (Sq./RM T) |
|---|---|---|---|---|---|---|---|---|
| Median | Spalling | | 4 | | 1.40 | 0.27 | 0.047 | 0.017 |

**4. Spalling observed at RHS A2 (median side), measuring 1.40 m in length and 0.27 m in width, Depth ranges from 0.029 (min) to 0.066 m (max), with an average depth of 0.047 m. The calculated volume of the distress is 0.017 m<sup>3</sup>.**

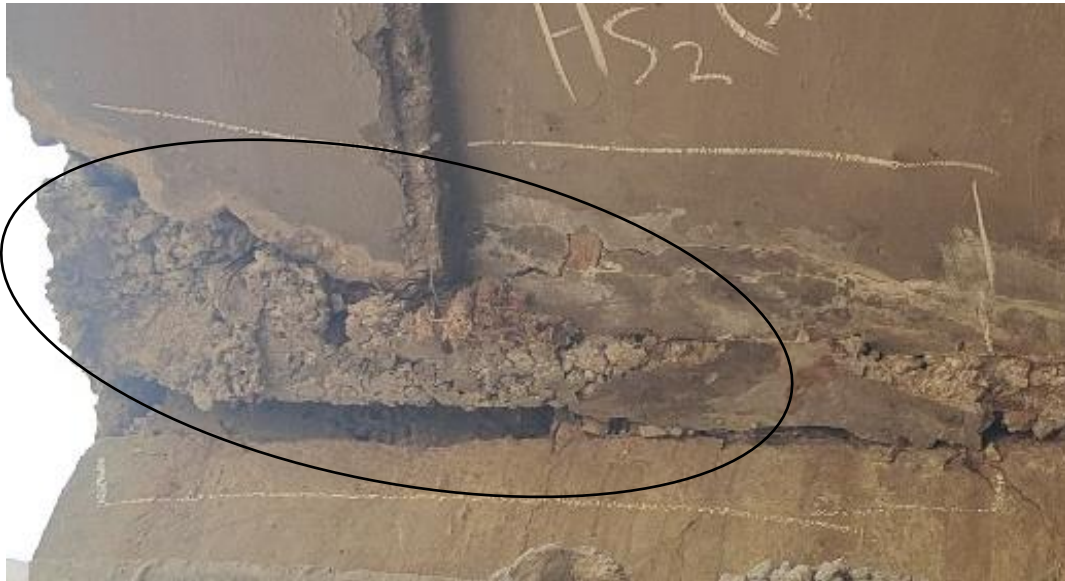
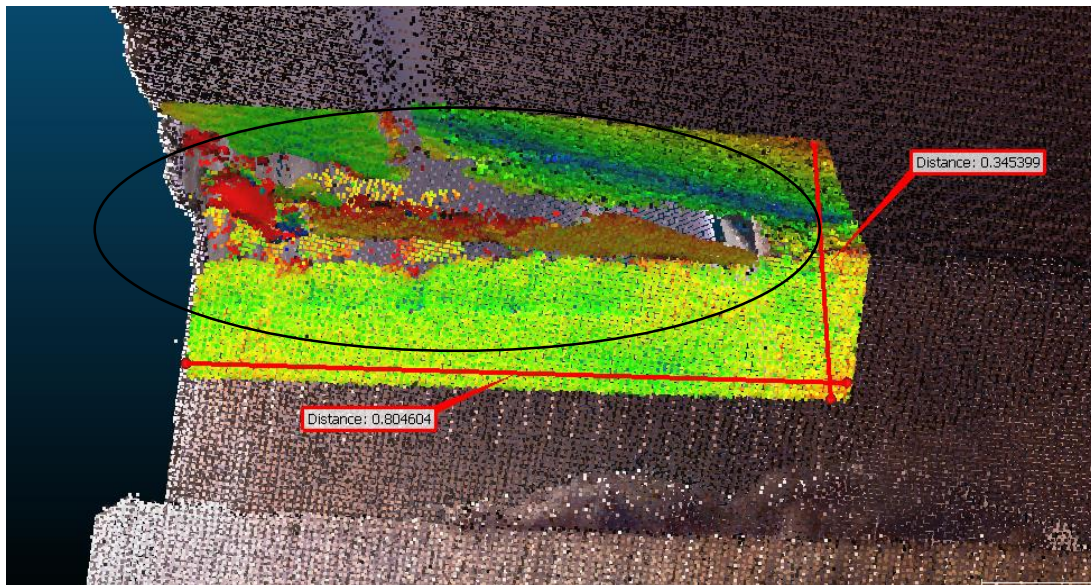
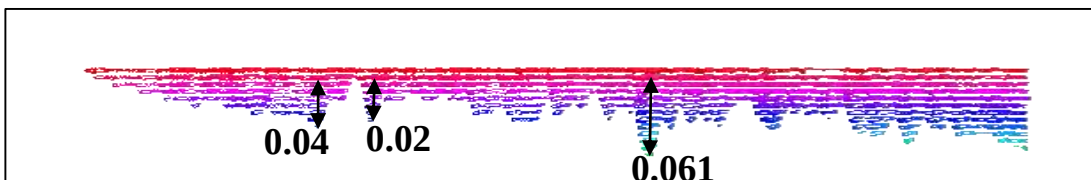
| Element Name | Observation | Location of Distress | Photo No. | Units | Distress Details | | | Area of Repair (Sq./RM T) |
|---|---|---|---|---|---|---|---|---|
| Abutment 1 | Hollow section | | 5 | | 0.80 | 0.34 | 0.04 | 0.010 |

**5. Hollow section observed at RHS A1, measuring 0.80 m in length and 0.34 m in width, Depth ranges from 0.02 (min) to 0.061 m (max), with an average depth of 0.4 m. The calculated volume of the distress is 0.010 m<sup>3</sup>.**

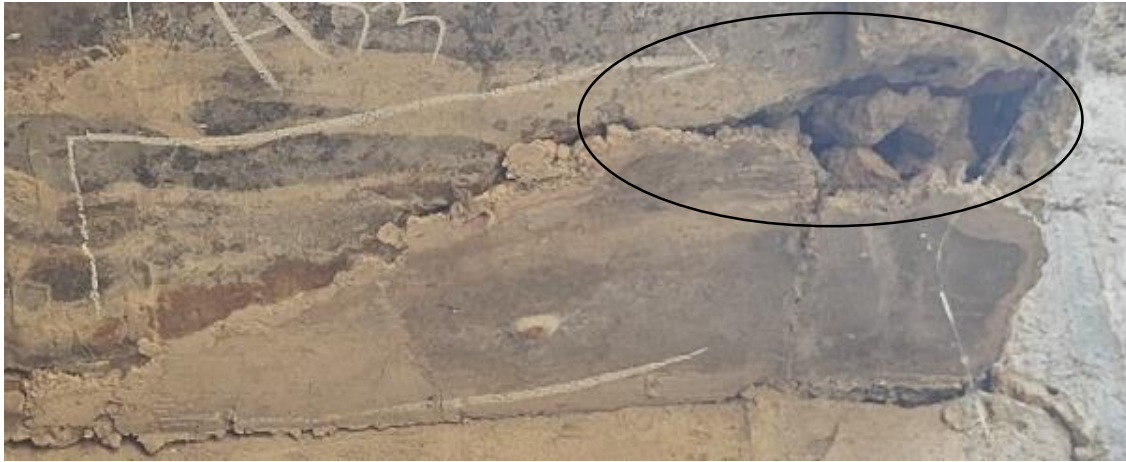
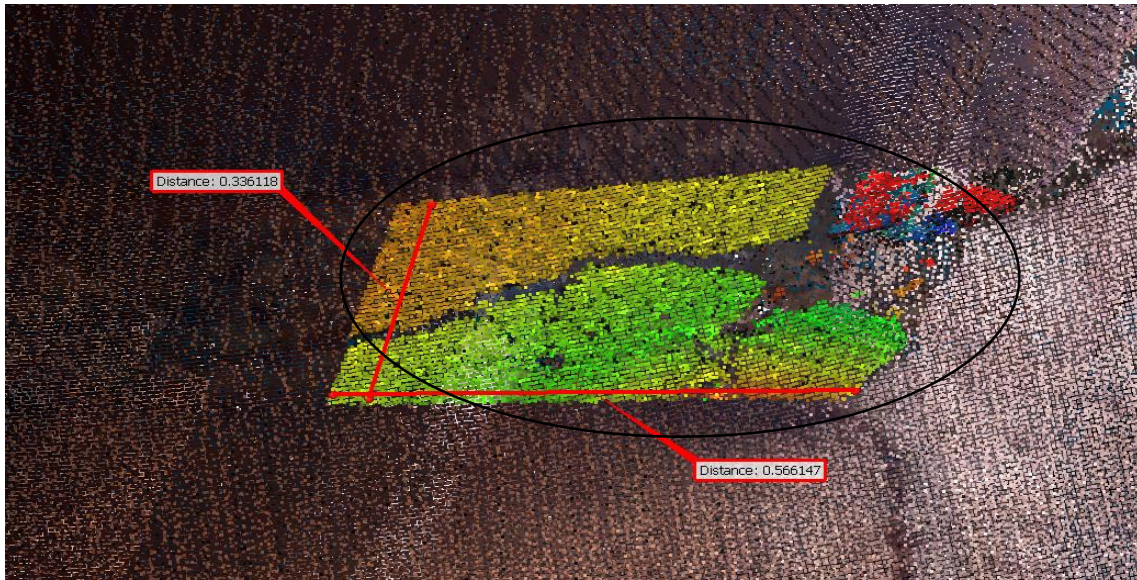
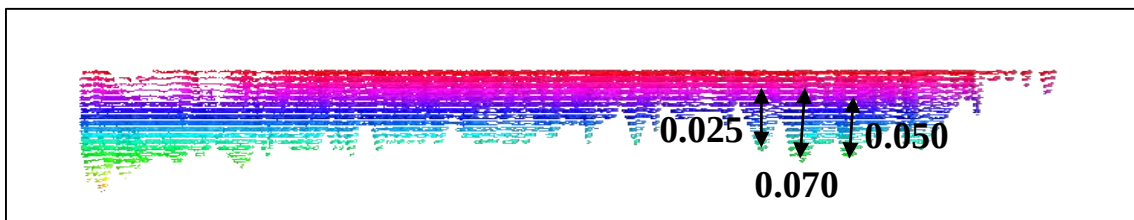
| Element Name | Observation | Location of Distress | Photo No. | Units | Distress Details | | | Area of Repair (Sq./RM T) |
|---|---|---|---|---|---|---|---|---|
| Median | Hollow section | | 6 | | 0.56 | 0.33 | 0.050 | 0.009 |

**6. Hollow Section observed at RHS A1 (slab median side, approach bottom), measuring 0.56 m in length and 0.33 m in width, Depth ranges from 0.025 (min) to 0.070 m (max), with an average depth of 0.050 m. The calculated volume of the distress is 0.009 m<sup>3</sup>.**

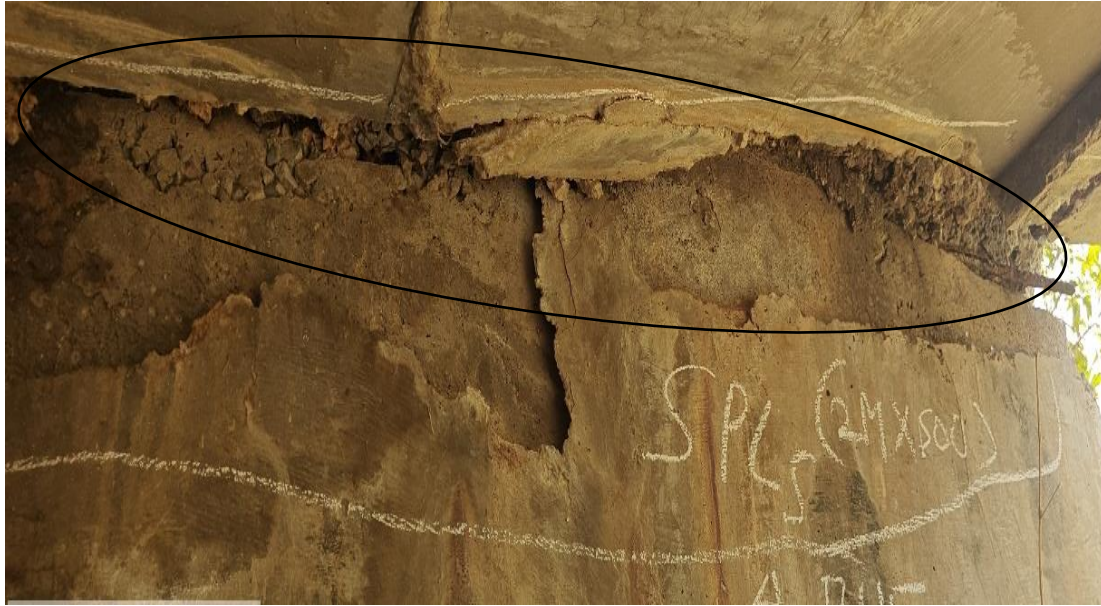
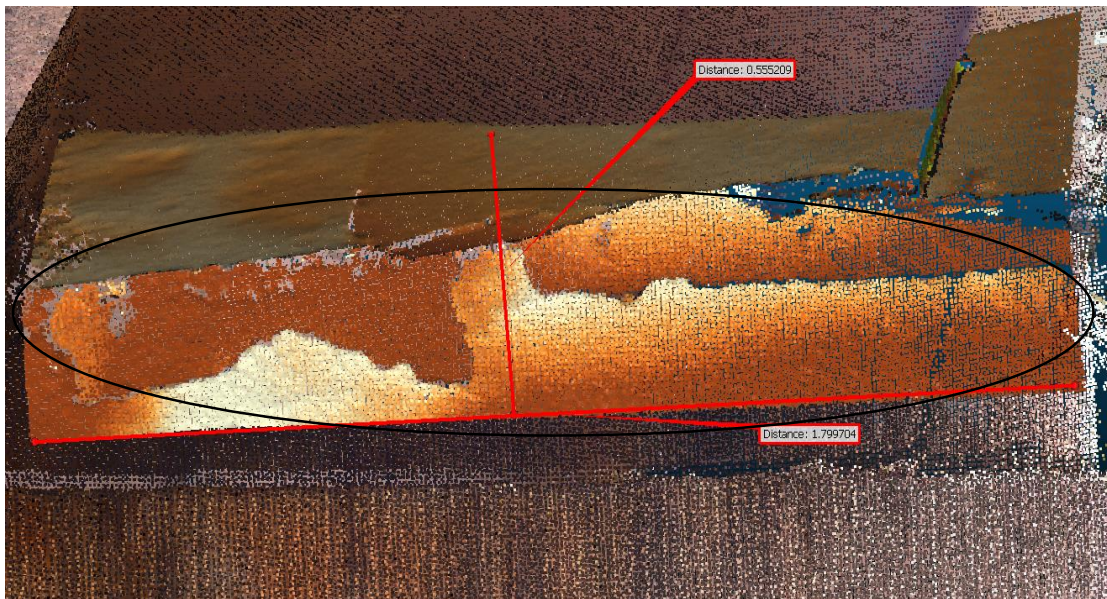
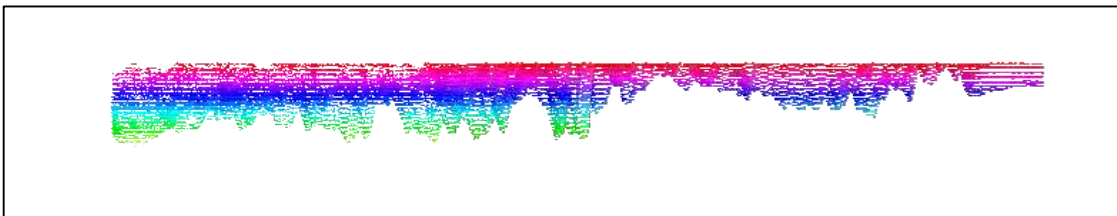
| Element Name | Observation | Location of Distress | Photo No. | Units | Distress Details | | | Area of Repair (Sq./RM T) |
|---|---|---|---|---|---|---|---|---|
| Abutment 2 | Spalling | | 7 | | 1.79 | 0.55 | | 0.9845 |

**7. Spalling observed at RHS A2 SPL5, measuring 1.79 m in length and 0.55 m in width, covering an area of 0.9845 m<sup>2</sup>.**

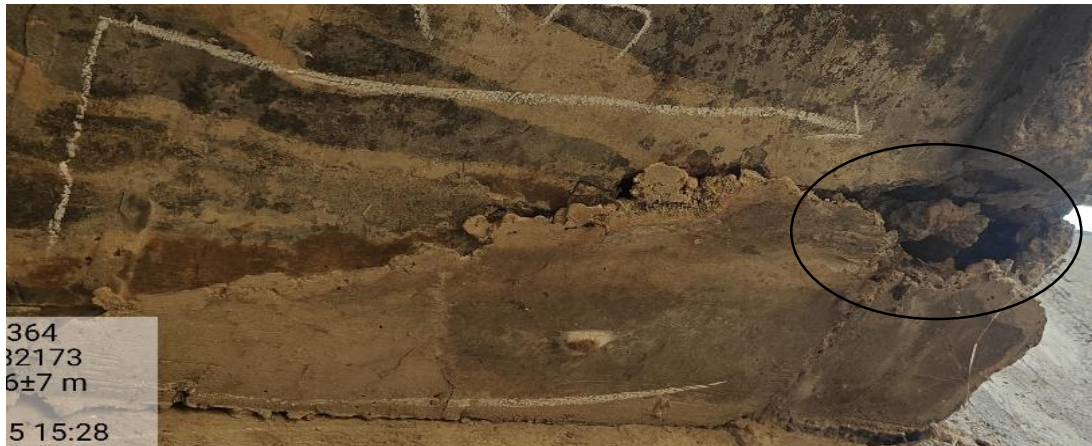
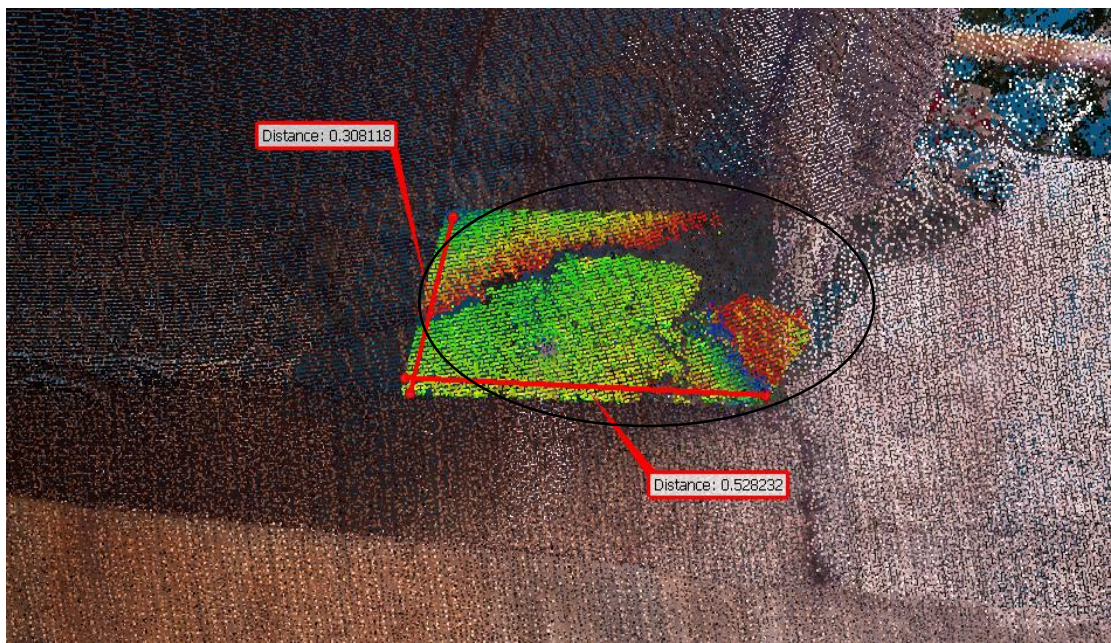
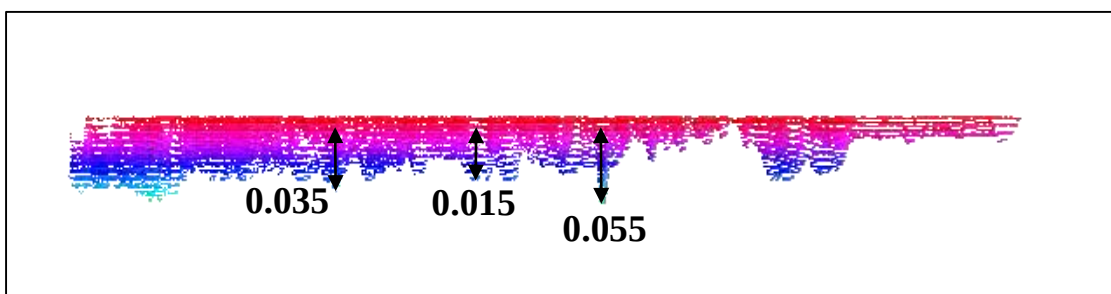
| Element Name | Observation | Location of Distress | Photo No. | Units | Distress Details | | | Area of Repair (Sq./RM T) |
|---|---|---|---|---|---|---|---|---|
| Abutment 1 | Hollow section | | 8 | | 0.52 | 0.30 | 0.035 | 0.005 |

**8. Surface distress observed at RHS A1 HS3, measuring 0.52 m in length and 0.30 m in width, Depth ranges from 0.015 (min) to 0.055 m (max), with an average depth of 0.035 m. The calculated volume of the distress is 0.005 m<sup>3</sup>.**

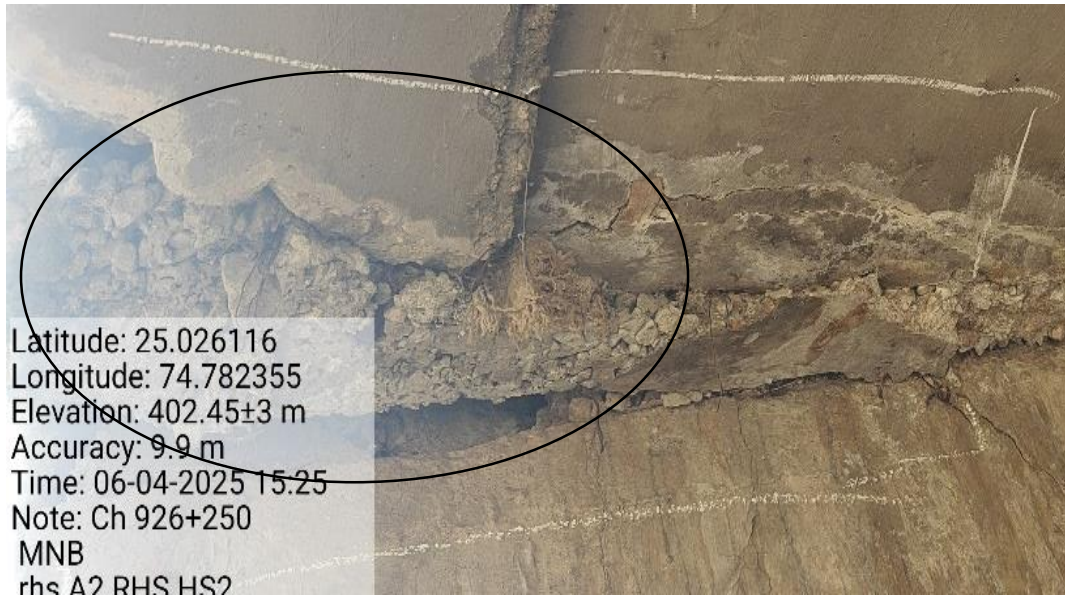
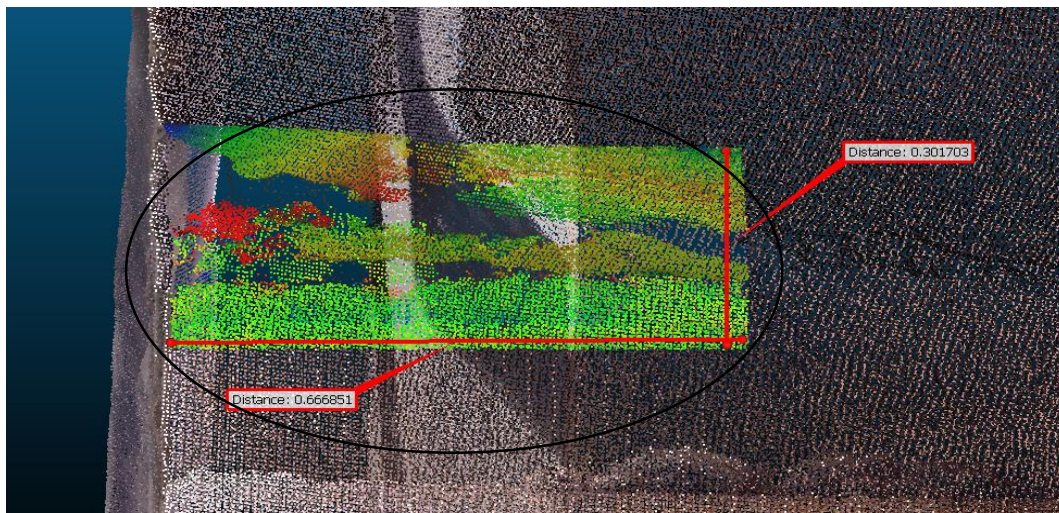
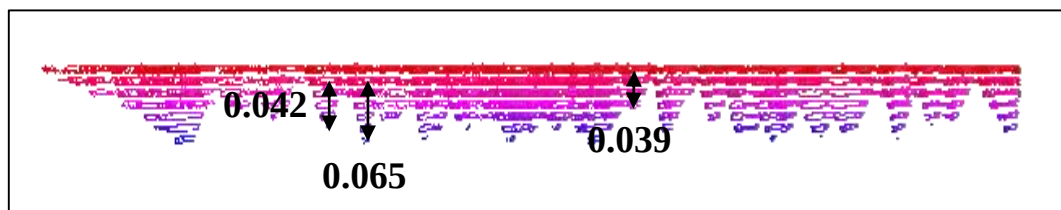
| Element Name | Observation | Location of Distress | Photo No. | Units | Distress Details | | | Area of Repair (Sq./RM T) |
|---|---|---|---|---|---|---|---|---|
| Abutment 2 | Hollow section | | 9 | | 0.66 | 0.30 | 0.042 | 0.008 |

**9. Hollow Section observed at RHS A2 HS2, measuring 0.66 m in length and 0.30 m in width, Depth ranges from 0.039 (min) to 0.065 m (max), with an average depth of 0.042 m. The calculated volume of the distress is 0.008 m<sup>3</sup>.**
