# **LIDAR Inspection Report of Box Culvert ch.926+395**

**Bridge Chainage:** 926+395

- **Bridge No:** -
- **Chainage:** 926+395
- **Structure type:** Box Culvert

- **CKRP:** Chittorgarh to kota
- **State:** Rajasthan NH 27
- **Zone:** RJ-20

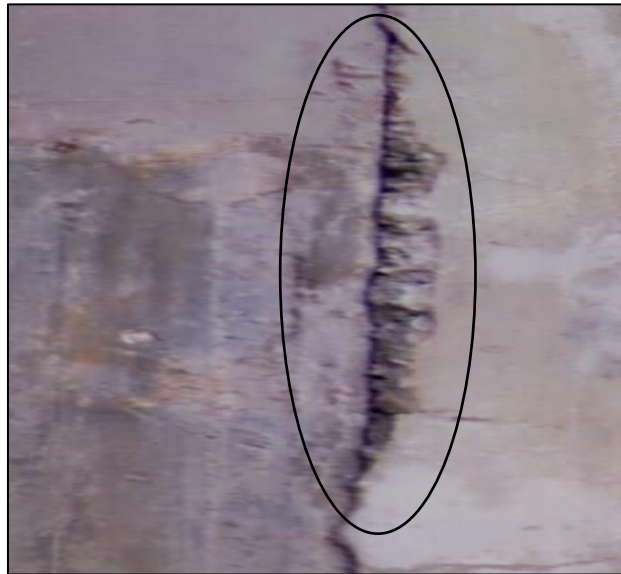
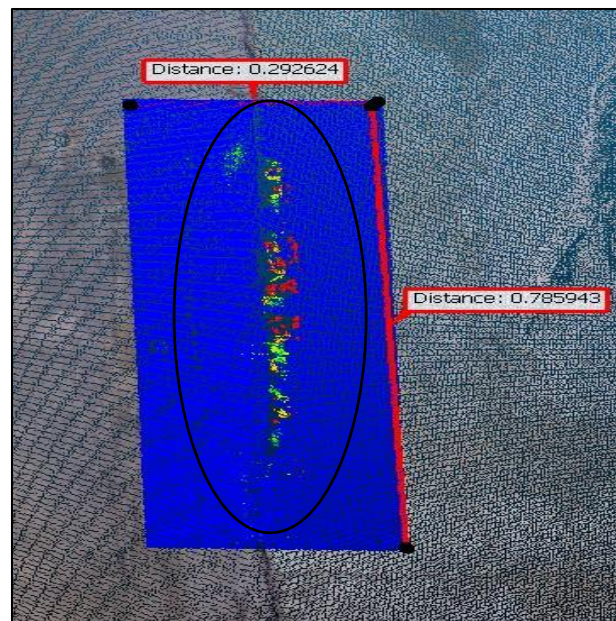
| Element Name | Observation | Location of Distress | Photo No. | Units | Distress Details | | | Area of Repair (Sq.m/R MT/m3) |
|---|---|---|---|---|---|---|---|---|
| Abutment 2 | Damage | - | 1 | Sq m | 0.78 | 0.29 | - | 0.22 |

**1.Damage observed on Abutment 2 RHS side, measuring 0.78 m in length and 0.29 m in width, covering an area of 0.22 m<sup>2</sup>.**

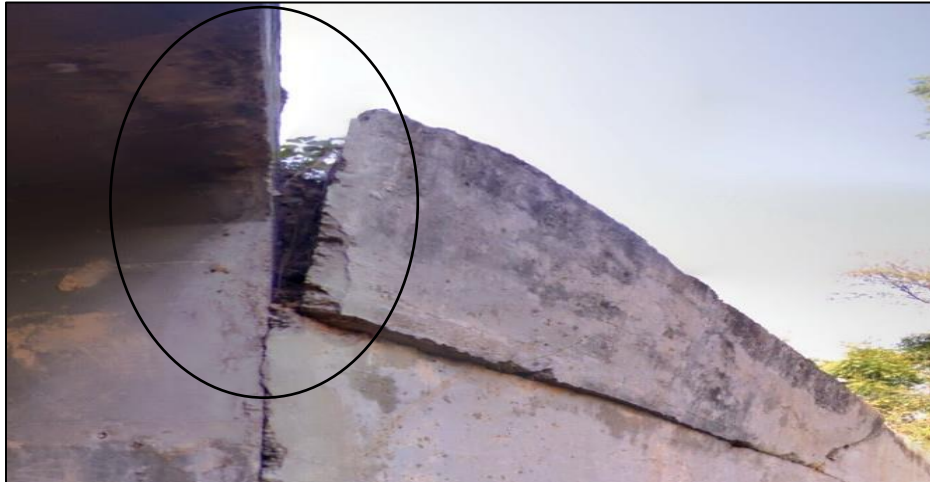
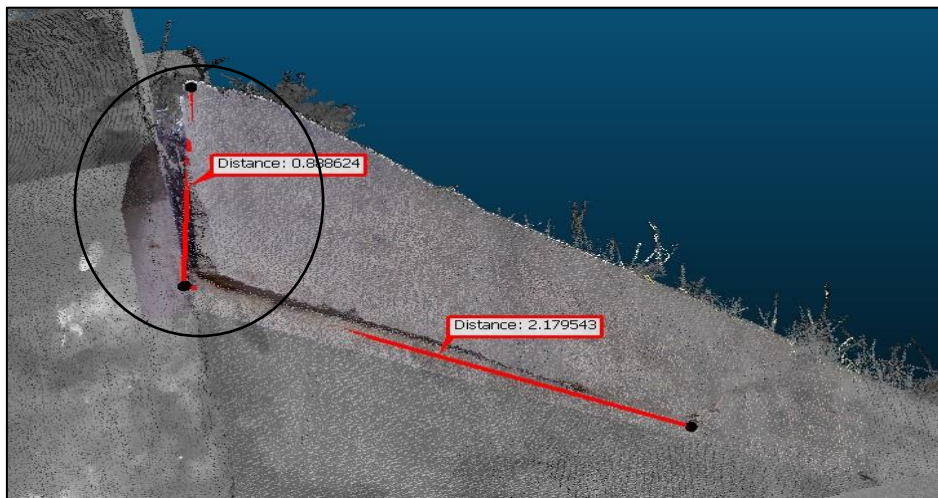
| Element Name | Observation | Location of Distress | Photo No. | Units | Distress Details | | | Area of Repair (Sq.m/R MT/m3) |
|---|---|---|---|---|---|---|---|---|
| Abutment 2 | Damage | - | 2 | Sq m | 2.17 | 0.88 | - | 1.90 |

**2.Damage observed on Abutment 2 RHS, measuring 2.17 m in length and 0.88 m in width, covering an area of 1.90 m<sup>2</sup>.**

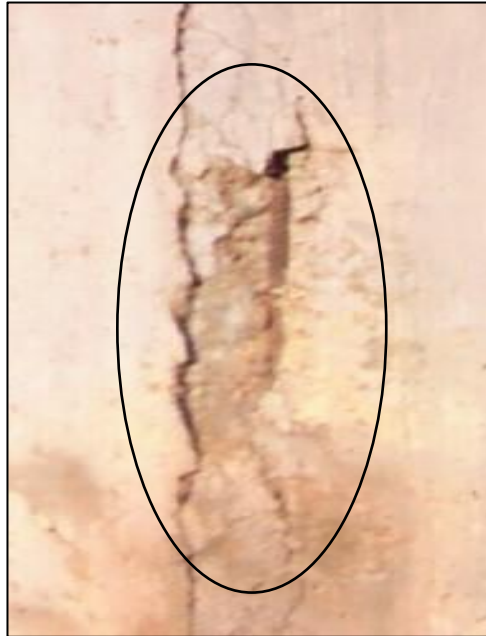
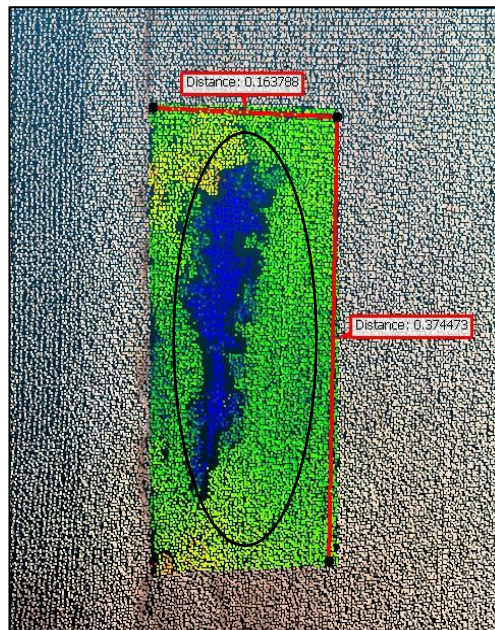
| Element Name | Observation | Location of Distress | Photo No. | Units | Distress Details | | | Area of Repair (Sq.m/R MT/m3) |
|---|---|---|---|---|---|---|---|---|
| Return Wall | Steel Exposure | - | 3 | Sq m | 0.37 | 0.16 | - | 0.05 |

**3. Steel exposure observed on Abutment 1 to return wall corner, measuring 0.37 m in length and 0.16 m in width, covering an area of 0.05 m**
