# **LIDAR Inspection Report of PUP ch.926+980**

**Bridge Chainage:** 926+ 980 (CKRP)

- **Bridge No:** -
- **Chainage:** 926+ 980
- **Structure type:** PUP

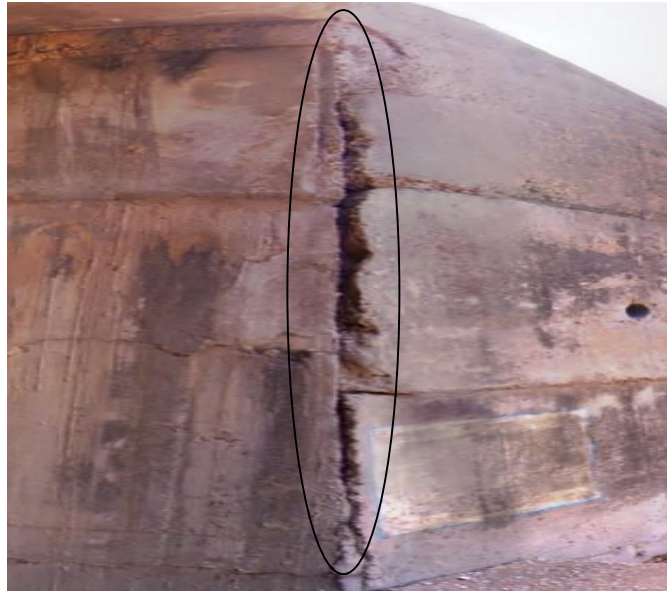
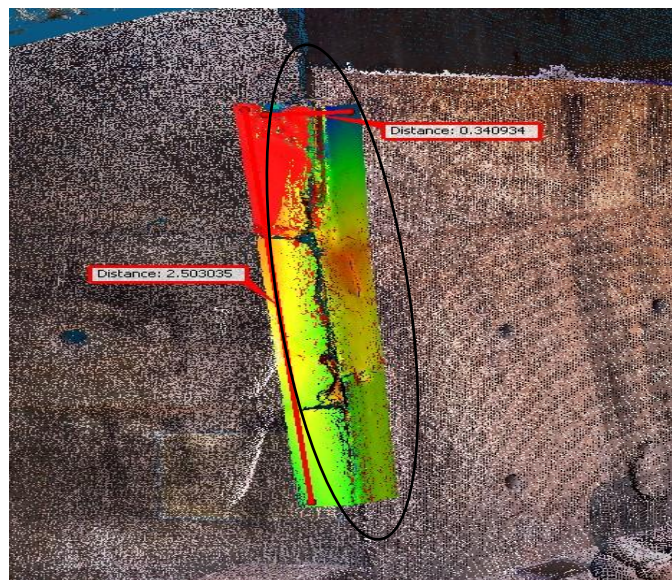
| Element Name | Observation | Location of Distress | Photo No. | Units | Distress Details | | | Area of Repair (Sq.m/R MT/m3) |
|---|---|---|---|---|---|---|---|---|
| Abutment wing Wall | Damage | - | 1 | M | 2.50 | 0.34 | - | 0.85 |

**1. Damage observed on Wing Wall, measuring 2.50 m in length and 0.34 m in width, covering an area of 0.85 m<sup>2</sup>.**

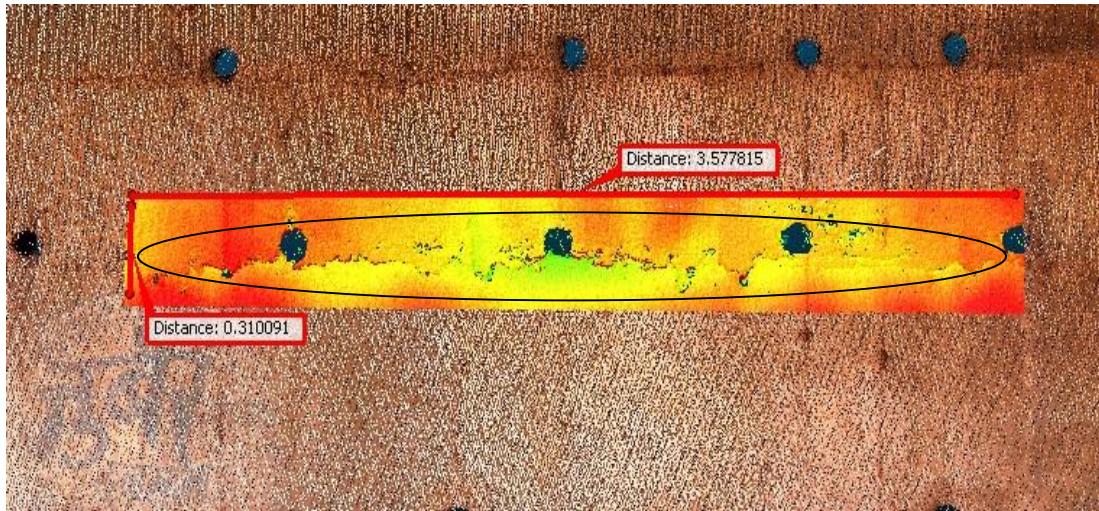
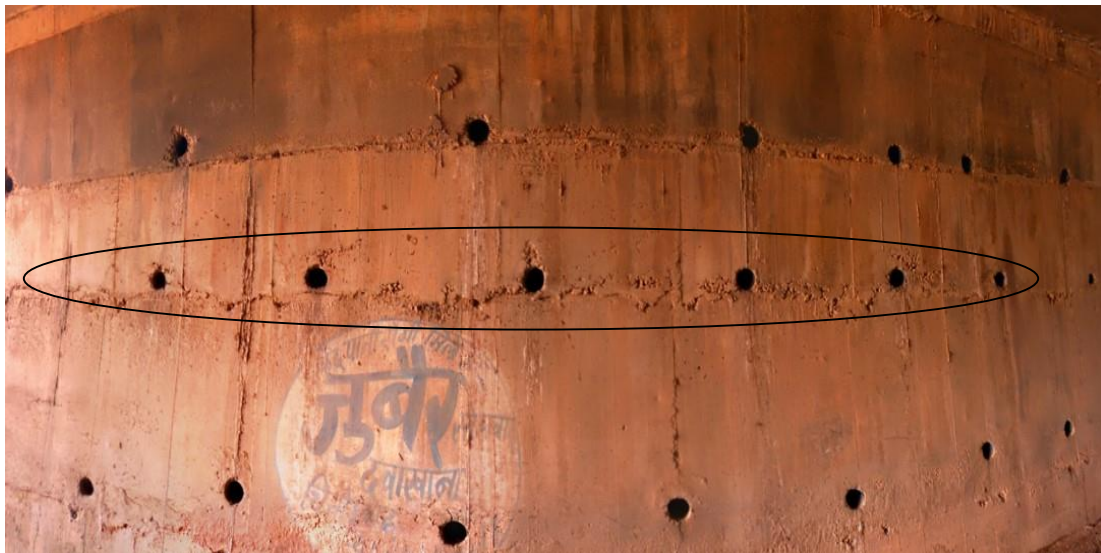
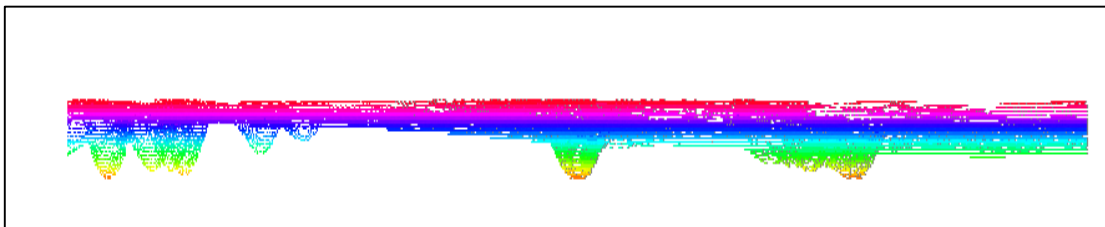
| Element Name | Observation | Location of Distress | Photo No. | Units | Distress Details | | | Area of Repair (Sq.m/R MT/m3) |
|---|---|---|---|---|---|---|---|---|
| Abutment Wing Wall | Damage | - | 2 | M | 3.57 | 0.31 | - | 1.106 |

**2. Concrete damage observed on Wall, measuring 3.57 m in length and 0.31 m in width, covering an area of 1.11 m<sup>2</sup>**
