# **LIDAR Inspection Report of PUP ch.927+700**

**Bridge Chainage:** 927+700

- **Bridge No:** -
- **Chainage:** 927+700
- **Structure type:** PUP

- **CKRP:** Chittorgarh to kota
- **State:** Rajasthan NH 27
- **Zone:** RJ-20

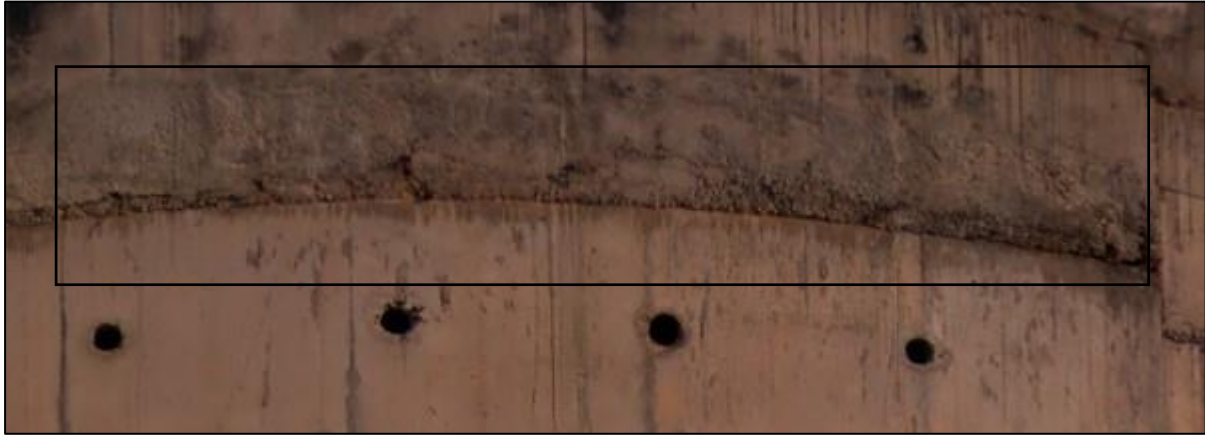
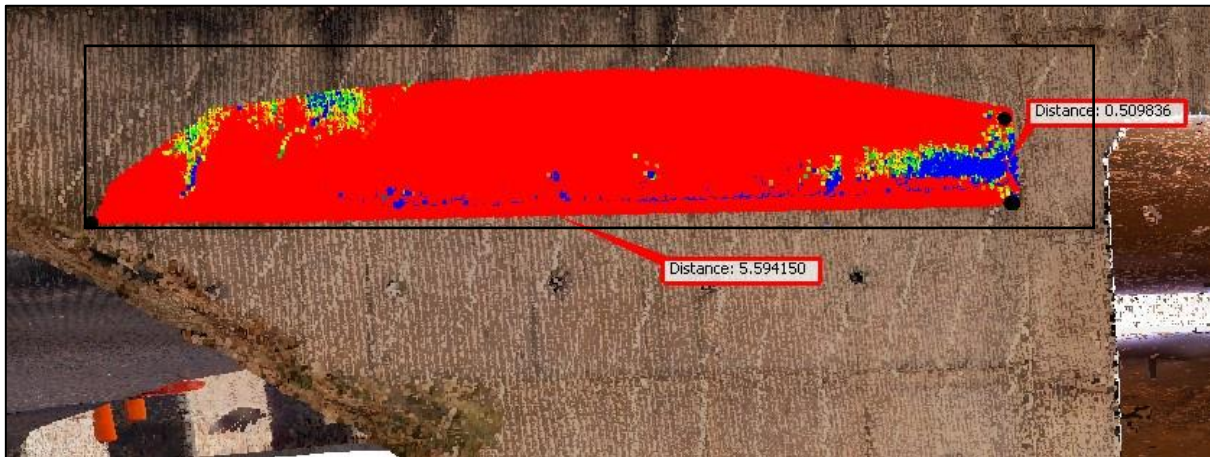
| Element Name | Observation | Location of Distress | Photo No. | Units | Distress Details | | | Area of Repair (Sq.m/R MT/m3) |
|---|---|---|---|---|---|---|---|---|
| Wing Wall | Damage | - | 1 | Sq m | 5.5494 | 0.5098 | | 2.829 |

| Sl. No. | Description | Distress Notation | Observation | Location | | Distress Details | | | Area of Repair |
|---|---|---|---|---|---|---|---|---|---|
| 3 | Wing wall | | Damaged (LHS/RHS) | | | | | | |

- 1. Wing Wall Damage** observed on A2 (LHS), measuring 5.5494 m in length and 0.5098 m in width, covering an area of 2.829 m<sup>2</sup>.
