# LIDAR Inspection Report of **Box Culvert** ch.927+846

**Bridge Chainage:** 927+846 (CKRP)

**Latitude/Longitude:** 25.030905/74.798861

# **CH: 927+846 – Box CULVERT**

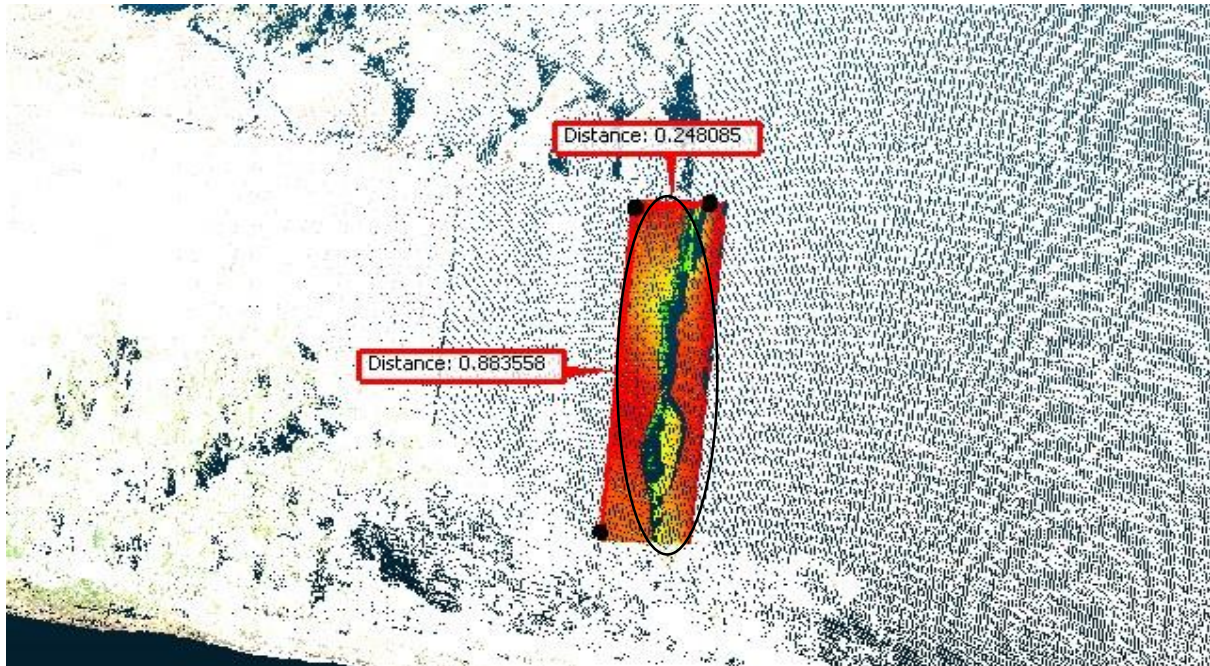
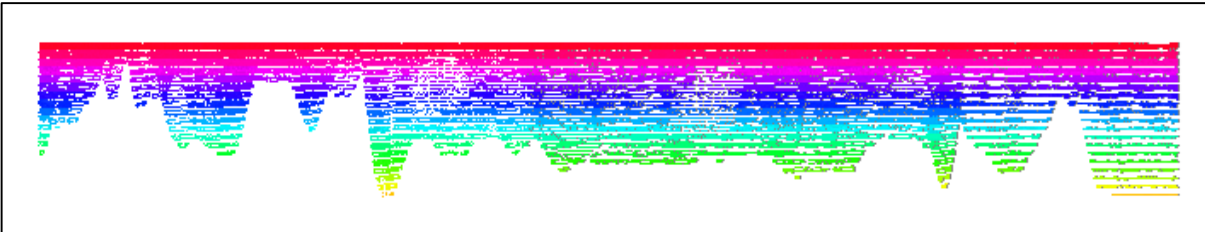
| Element Name | Observation | Location of Distress | Photo No. | Units | Distress Details | | | Area of Repair (Sq.m/ RMT/ m3) |
|---|---|---|---|---|---|---|---|---|
| Abutment Wall | Damage | - | 1 | M | 0.24 | 0.88 | | 0.2112 |

**1. Abutment wall damage observed, measuring 0.24 m in length and 0.88 m in width, covering an area of 0.2112 m<sup>2</sup>.**

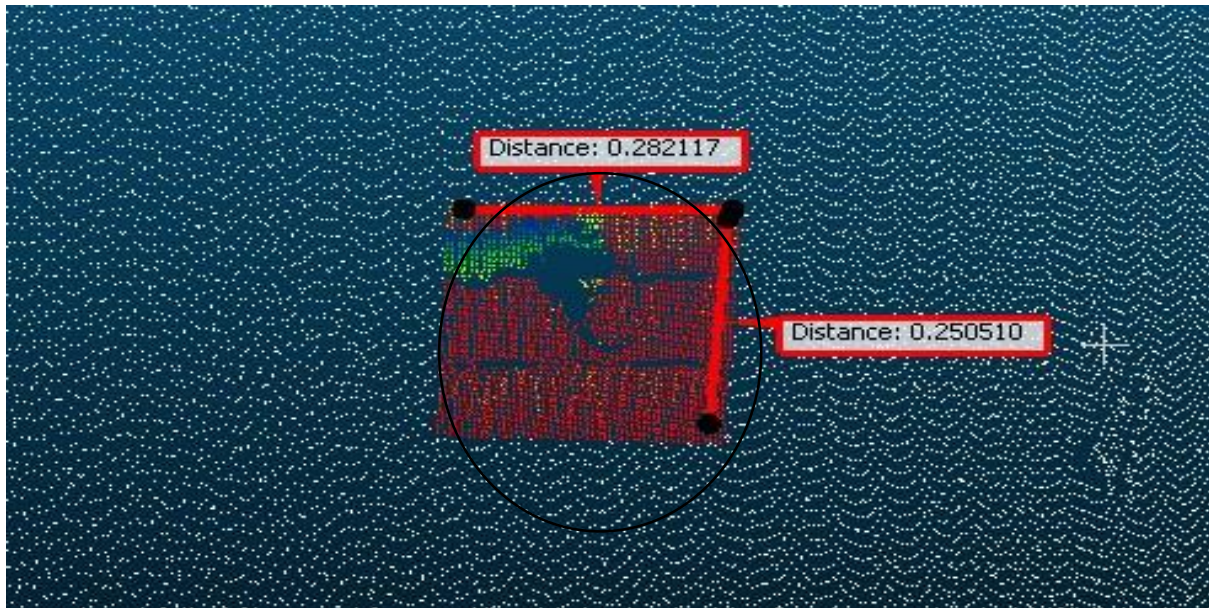
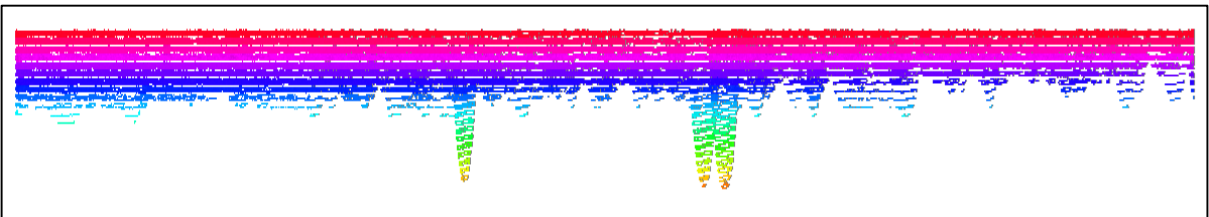
| Element Name | Observation | Location of Distress | Photo No. | Units | Distress Details | | | Area of Repair (Sq.m/ RMT/ m3) |
|---|---|---|---|---|---|---|---|---|
| Abutment Wall | Damage | - | 2 | M | 0.28 | 0.25 | | 0.07 |

**2. Abutment wall damage observed, measuring 0.28 m in length and 0.25 m in width, covering an area of 0.07 m<sup>2</sup>.**

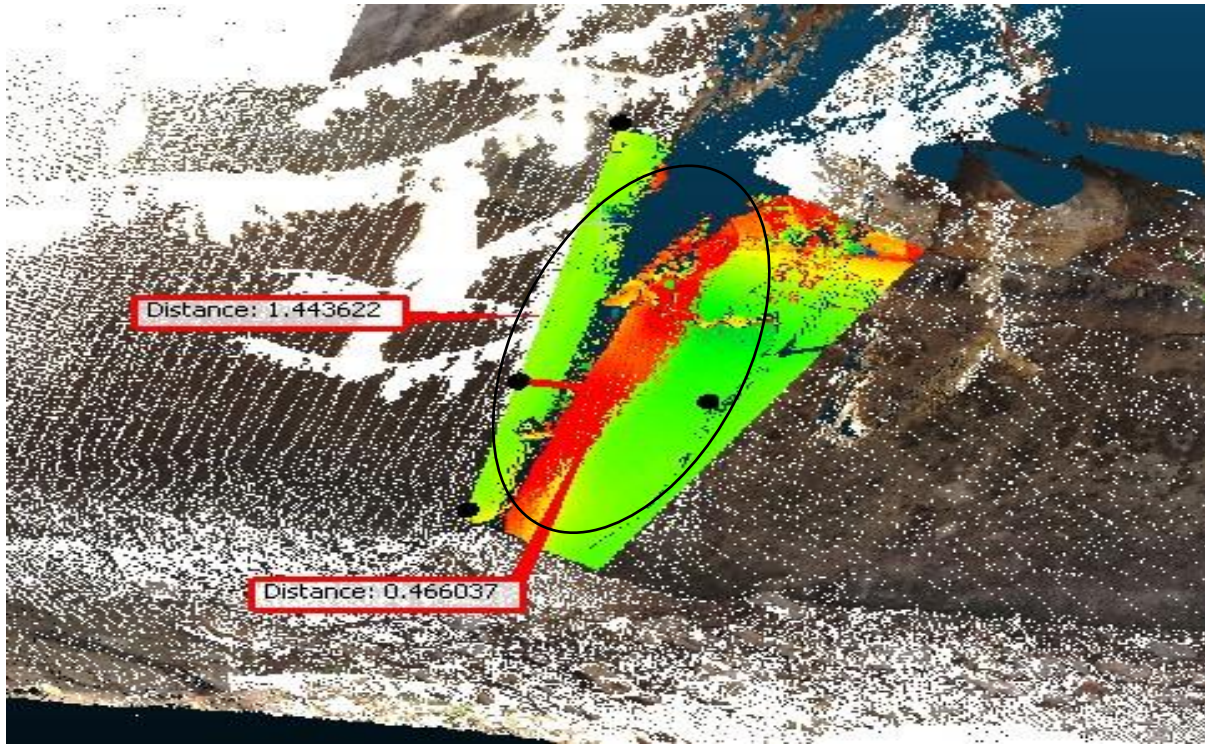
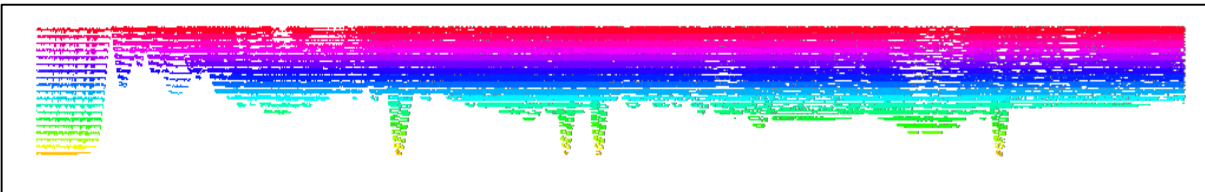
| Element Name | Observation | Location of Distress | Photo No. | Units | Distress Details | | | Area of Repair (Sq.m/ RMT/ m3) |
|---|---|---|---|---|---|---|---|---|
| Wing Wall | Damage | - | 3 | M | 0.46 | 1.44 | | 0.6624 |

**3. Wing wall damage observed, measuring 0.46 m in length and 1.44 m in width, covering an area of 0.6624 m<sup>2</sup>.**

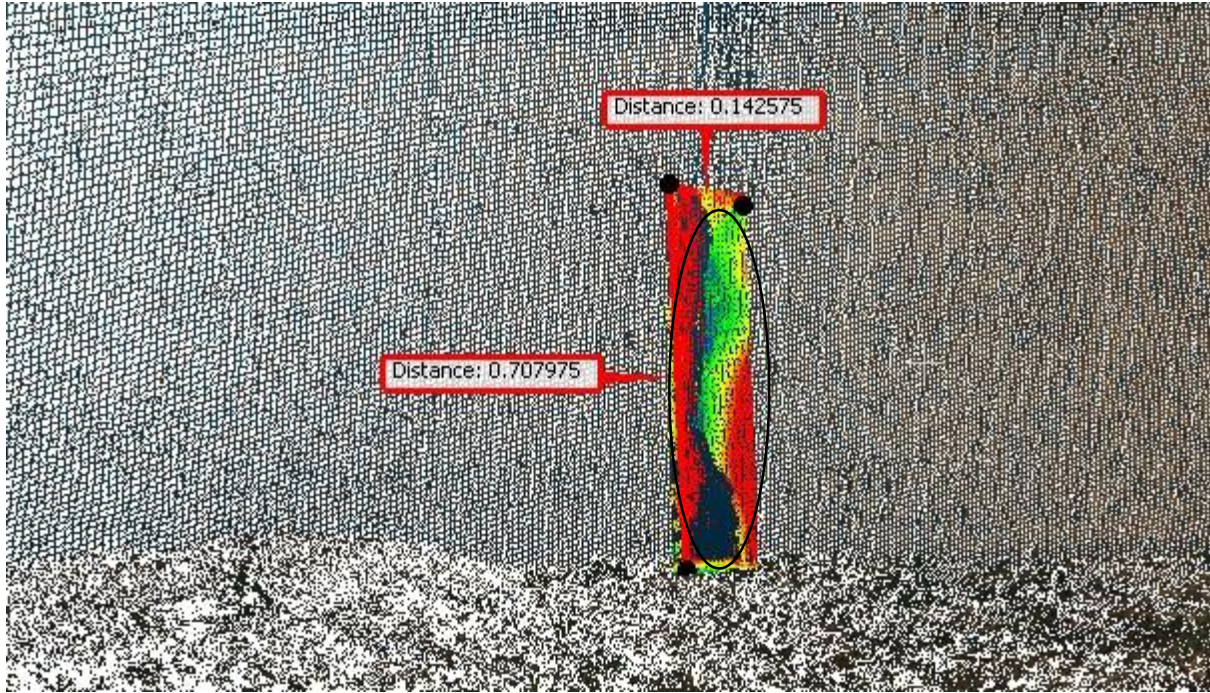
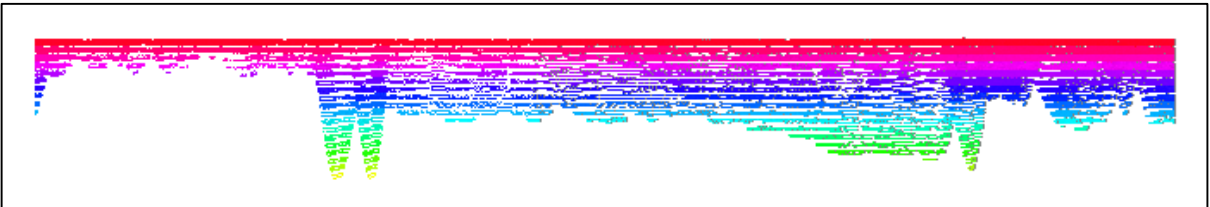
| Element Name | Observation | Location of Distress | Photo No. | Units | Distress Details | | | Area of Repair (Sq.m/ RMT/ m3) |
|---|---|---|---|---|---|---|---|---|
| Wing Wall | Damage | - | 4 | M | 0.41 | 0.70 | | 0.287 |

**4. Wing wall damage observed, measuring 0.41 m in length and 0.70 m in width, covering an area of 0.287 m<sup>2</sup>.**

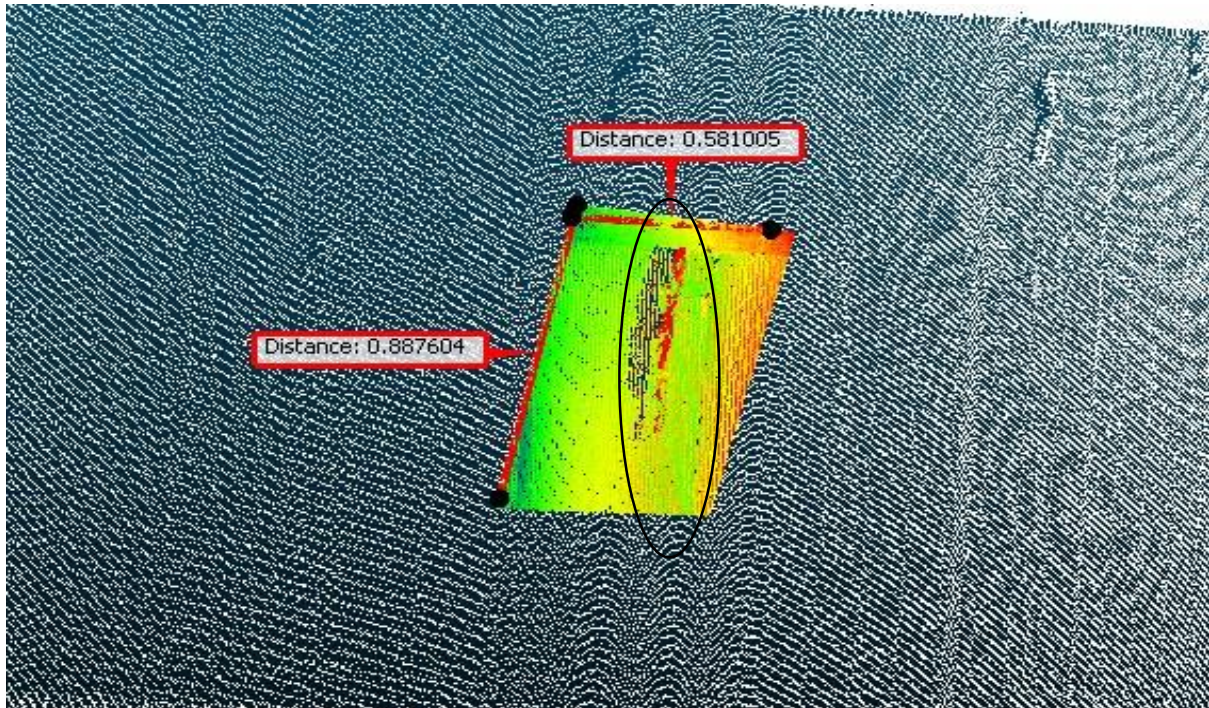
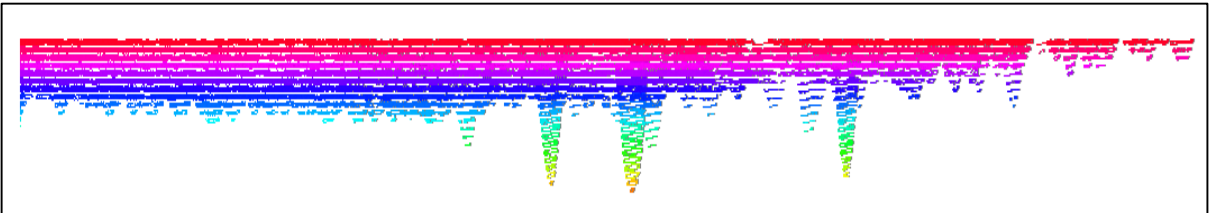
| Element Name | Observation | Location of Distress | Photo No. | Units | Distress Details | | | Area of Repair (Sq.m/ RMT/ m3) |
|---|---|---|---|---|---|---|---|---|
| Abutment Wall | Damage | - | 5 | M | 0.58 | 0.88 | | 0.5104 |

**5. Abutment wall damage observed, measuring 0.58 m in length and 0.88 m in width, covering an area of 0.5104 m<sup>2</sup>.**
