# **LIDAR Inspection Report of MNB ch.929 + 030**

**Bridge No:** MNB - 930/1

**Bridge Chainage:** 929 + 030 (CKRP)

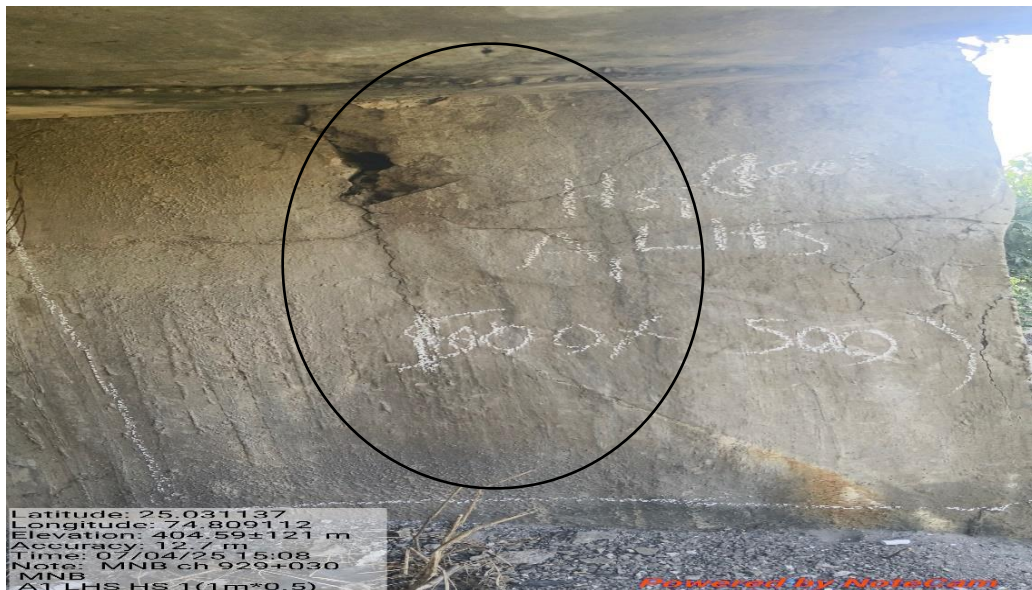
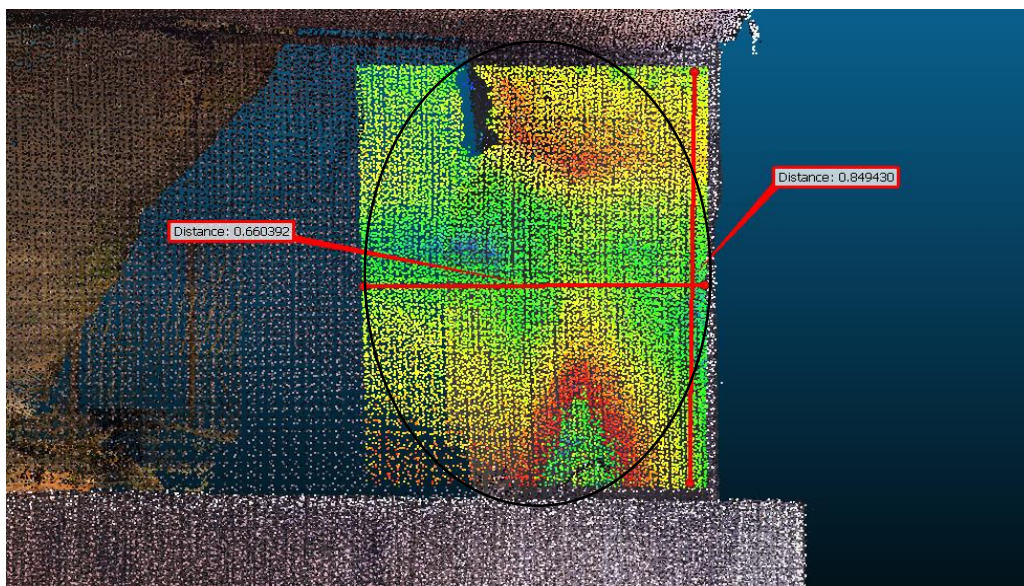
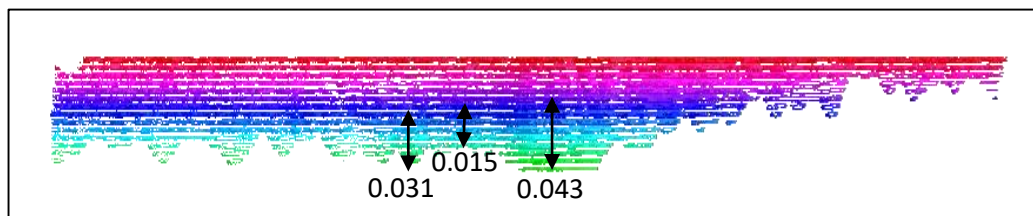
| Element Name | Observation | Location of Distress | Photo No. | Units | Distress Details | | | Area of Repair (Sq./RM T/m3) |
|---|---|---|---|---|---|---|---|---|
| Abutment 1 | Hollow Section | | 1 | | 0.84 | 0.66 | 0.031 | 0.017 |

**1. Hollow Section observed at LHS Abutment , measuring 0.84 m in length and 0.66 m in width, Depth ranges from 0.015 m (min) to 0.043 m (max), with an average depth of 0.031 m. The calculated volume of the distress is 0.017 m<sup>3</sup>.**

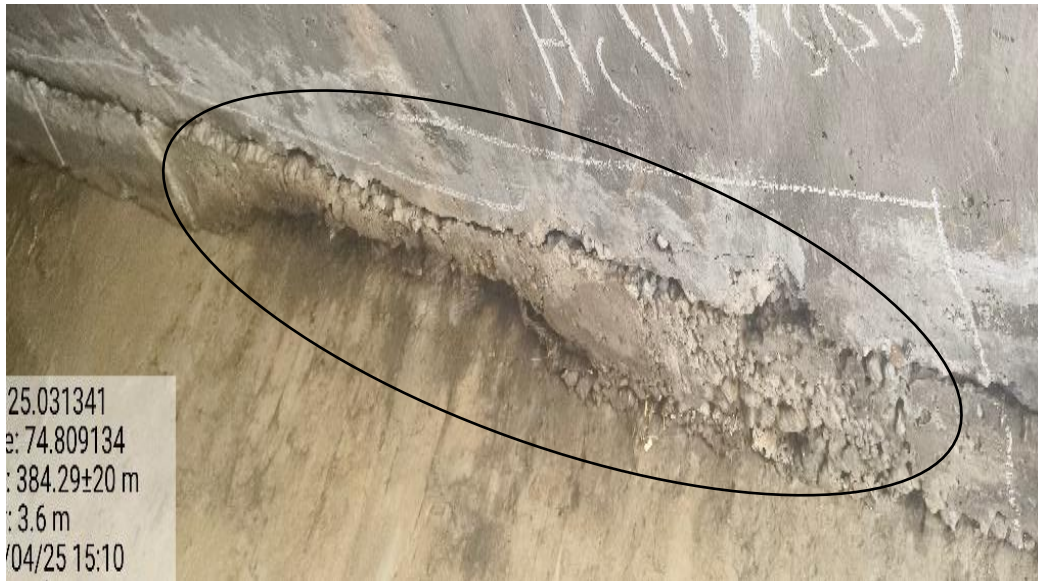
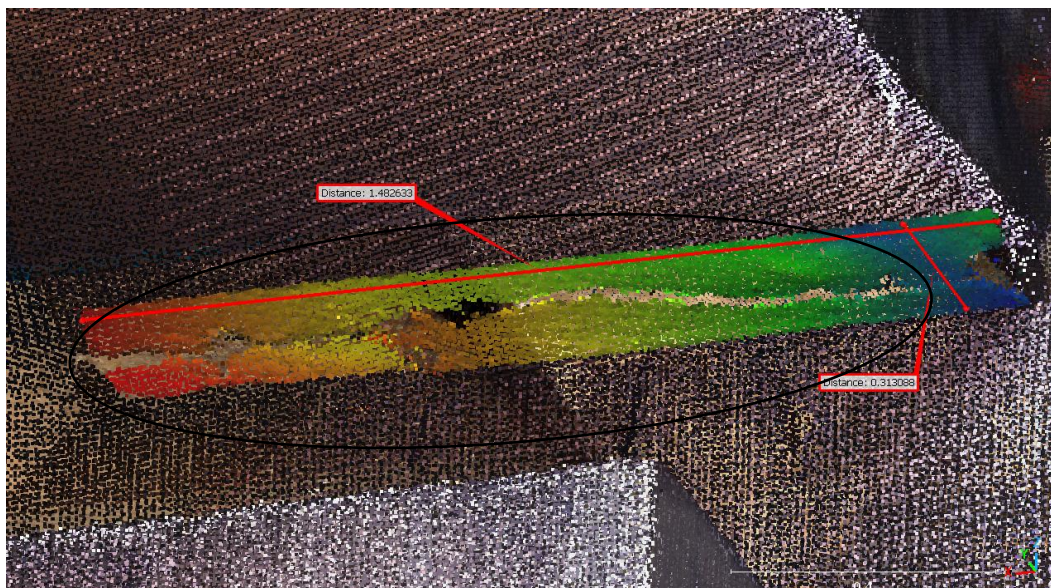
| Element Name | Observation | Location of Distress | Photo No. | Units | Distress Details | | | Area of Repair (Sq./RM T/m3) |
|---|---|---|---|---|---|---|---|---|
| Abutment 1 | Honey Combing | | 2 | | 1.48 | 0.31 | | 0.4588 |

2. **Honey Combing** observed at LHS Abutment 1 HC1, located at the approach slab bottom, measuring 1.48 m in length and 0.31 m in width, covering an area of 0.4588 m<sup>2</sup>.

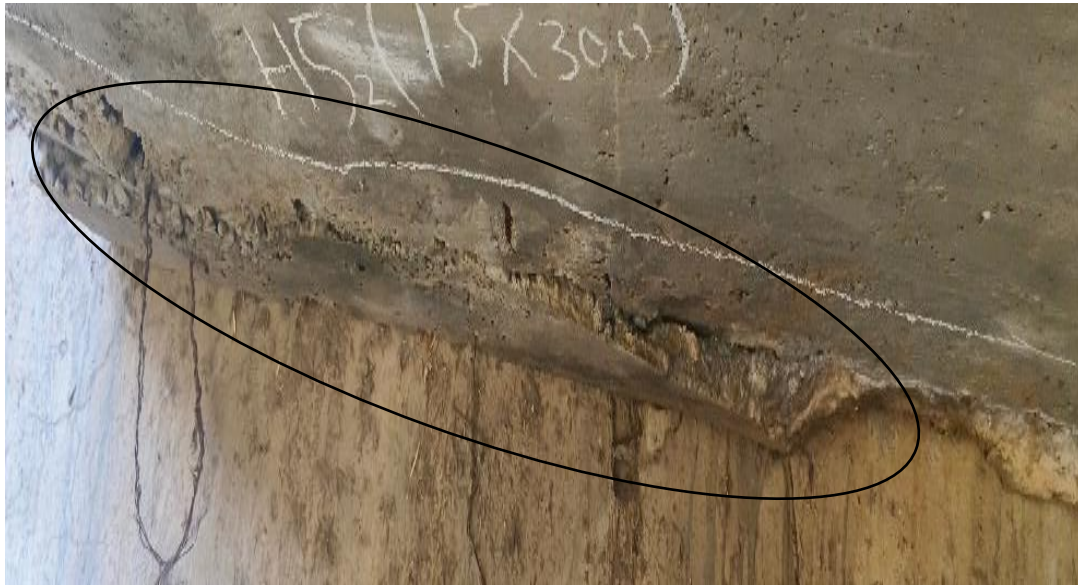
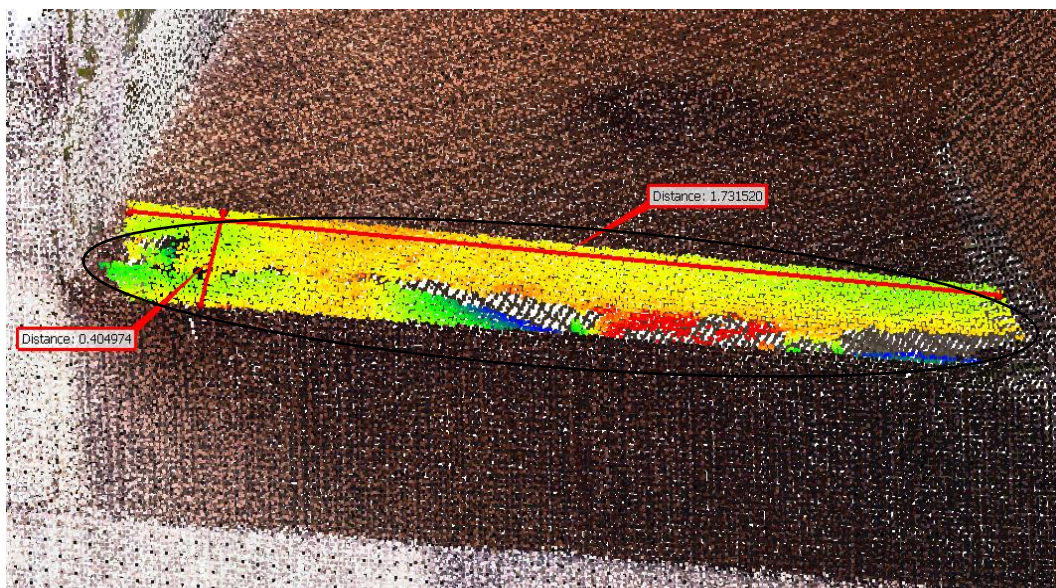
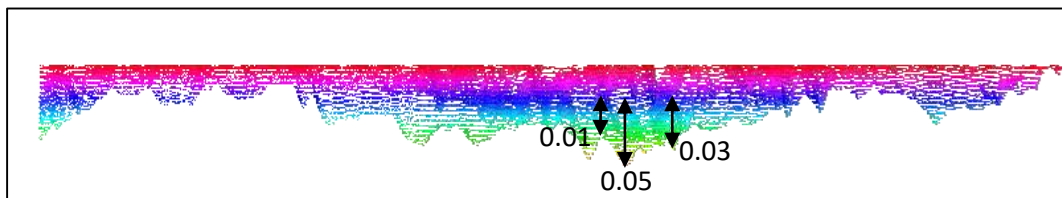
| Element Name | Observation | Location of Distress | Photo No. | Units | Distress Details | | | Area of Repair (Sq./RM T/m3) |
|---|---|---|---|---|---|---|---|---|
| Bearing 1 | Hollow Section | | 3 | | 1.73 | 0.40 | 0.033 | 0.022 |

**3. Hollow Section distress observed at LHS Abutment measuring 1.73 m in length and 0.40 m in width , Depth ranges from 0.017 m (min) to 0.056m (max), with an average depth of 0.033 m. The calculated volume of the distress is 0.022<sup>3</sup>.**

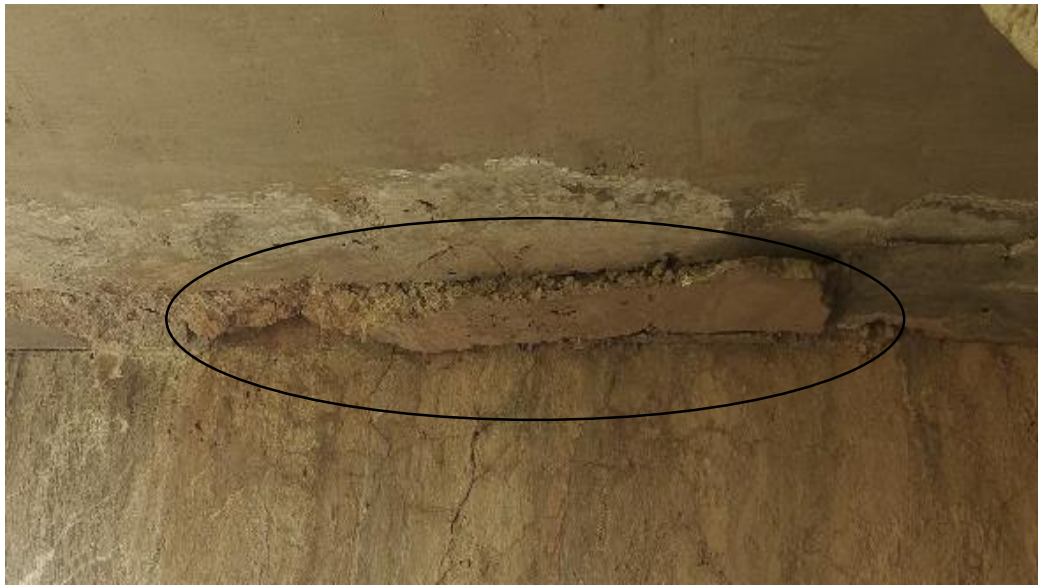
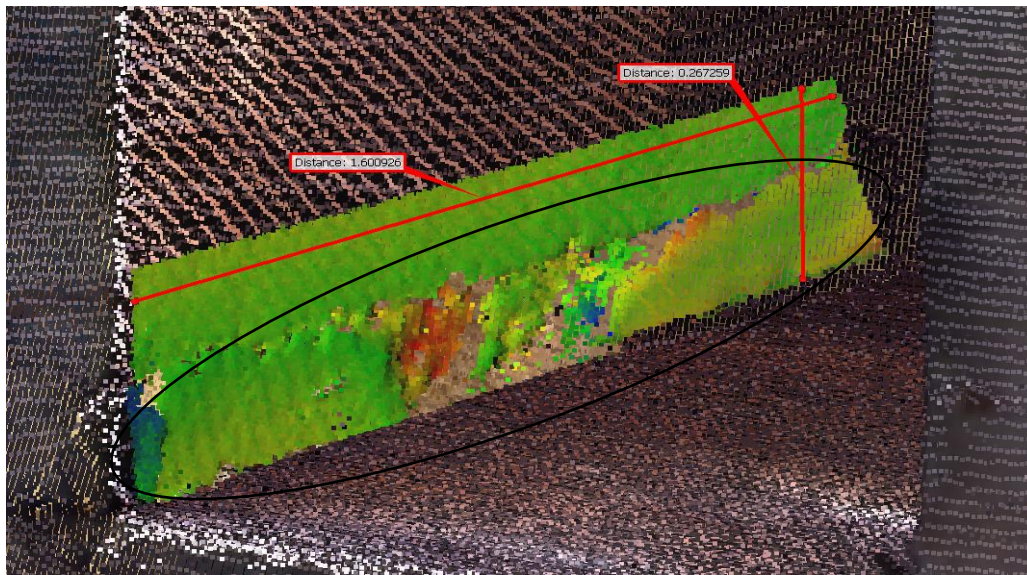
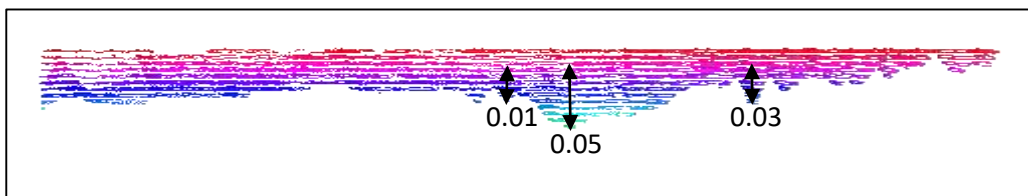
| Element Name | Observation | Location of Distress | Photo No. | Units | Distress Details | | | Area of Repair (Sq./RM T/m3) |
|---|---|---|---|---|---|---|---|---|
| Dirt Wall | Hollow Section | | 4 | | 1.60 | 0.26 | 0.035 | 0.014 |

**4. Hollow section distress observed on dirt wall at LHS Abutment toe end measuring 1.60 m in length and 0.26 m in width, Depth ranges from 0.019m (min) to 0.058m (max), with an average depth of 0.035 m. The calculated volume of the distress is 0.014 m<sup>3</sup>.**

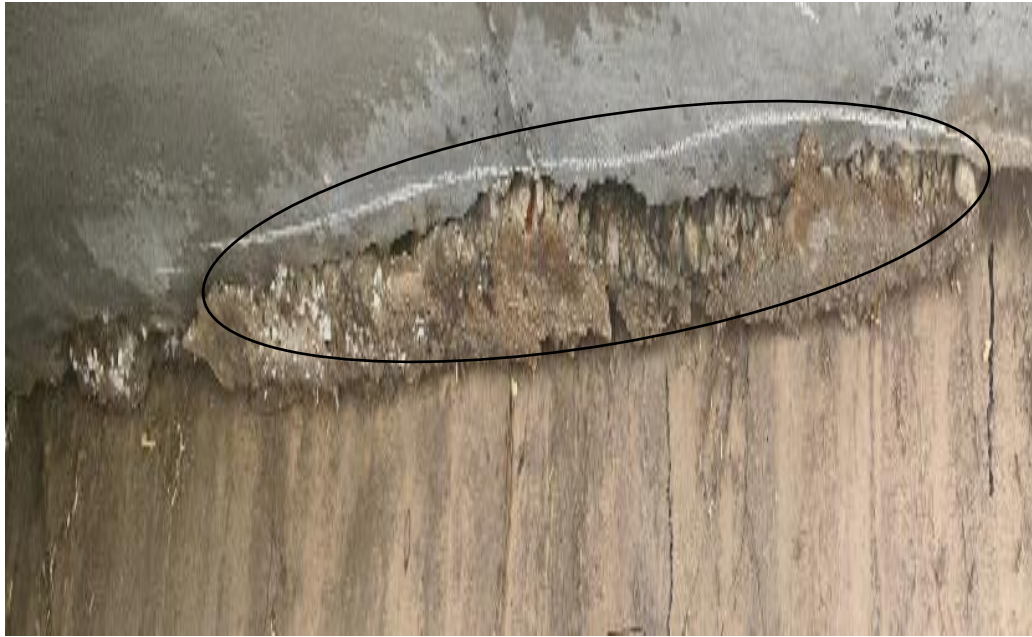
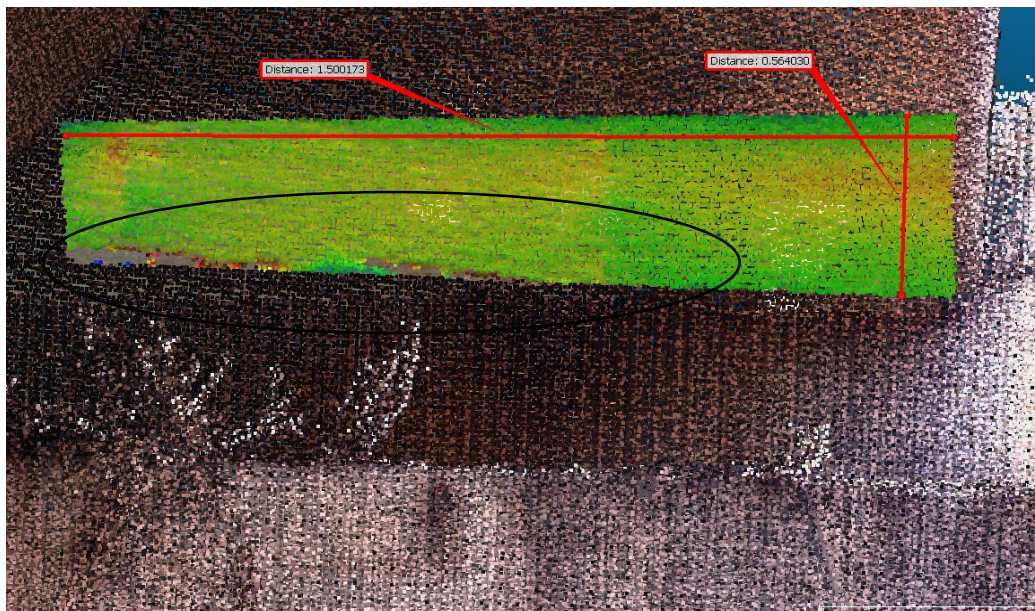
| Element Name | Observation | Location of Distress | Photo No. | Units | Distress Details | | | Area of Repair (Sq./RM T) |
|---|---|---|---|---|---|---|---|---|
| Bearing 1 | Honey Combing | | 5 | | 1.50 | 0.56 | | 0.84 |

**5. Honey Combing observed at RHS Abutment 1 Bearing 1 , measuring 1.50 m in length and 0.56 m in width, covering an area of 0.8400 m<sup>2</sup>.**

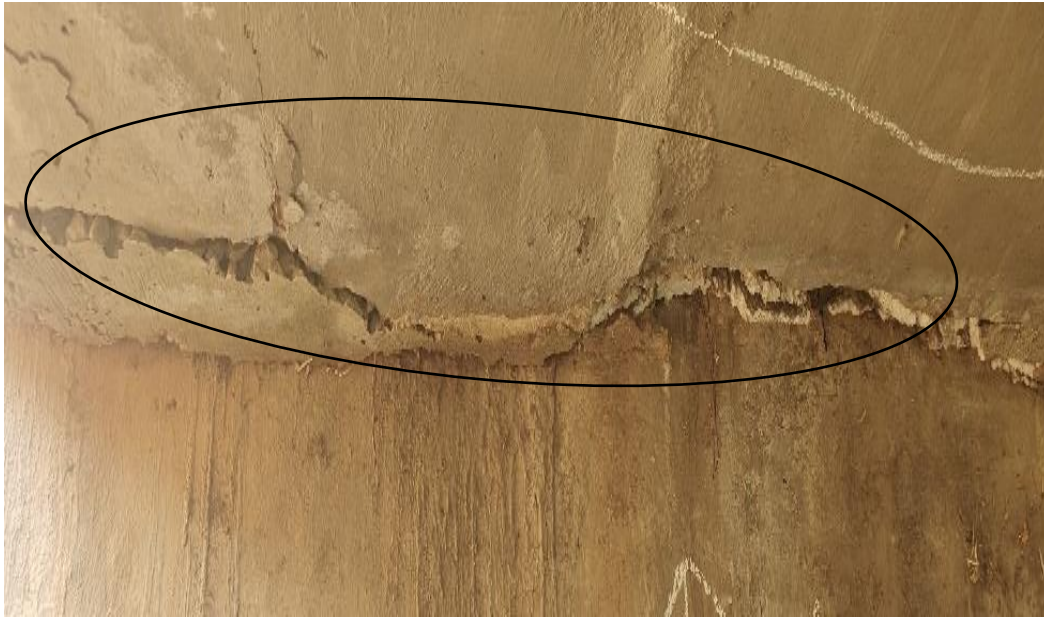
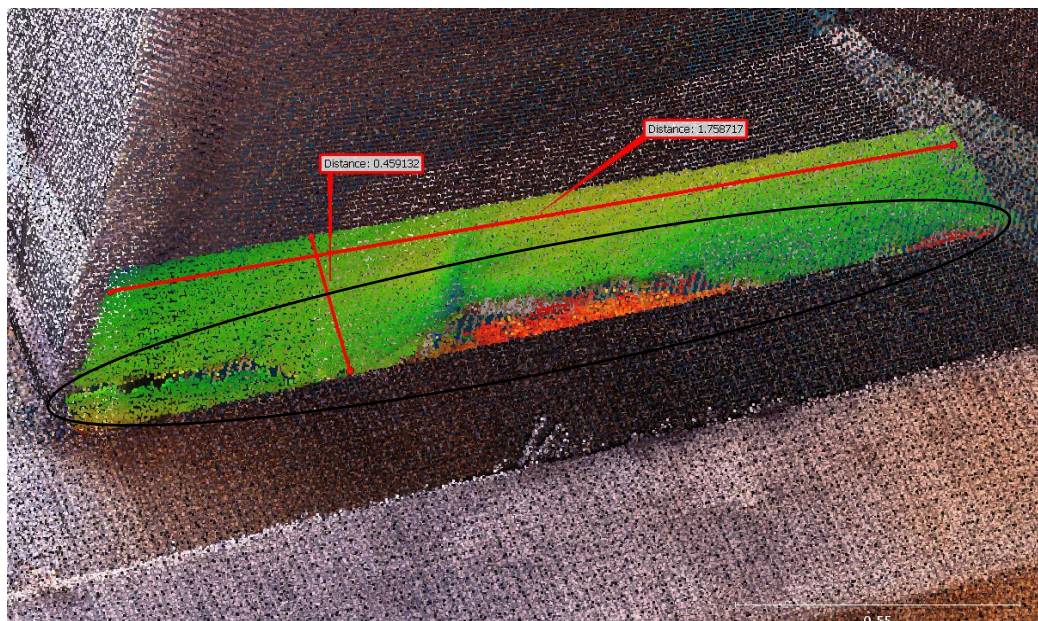
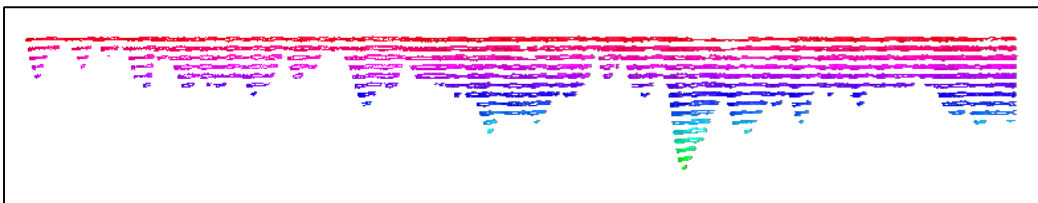
| Element Name | Observation | Location of Distress | Photo No. | Units | Distress Details | | | Area of Repair (Sq./RM T) |
|---|---|---|---|---|---|---|---|---|
| Slab Bottom | Spalling | | 6 | | 1.75 | 0.45 | | 0.7875 |

**6. Spalling observed on RHS Abutment 2 median side (approach slab bottom near dirt wall), measuring 1.75 m in length and 0.45 m in width, covering an area of 0.7875 m<sup>2</sup>.**

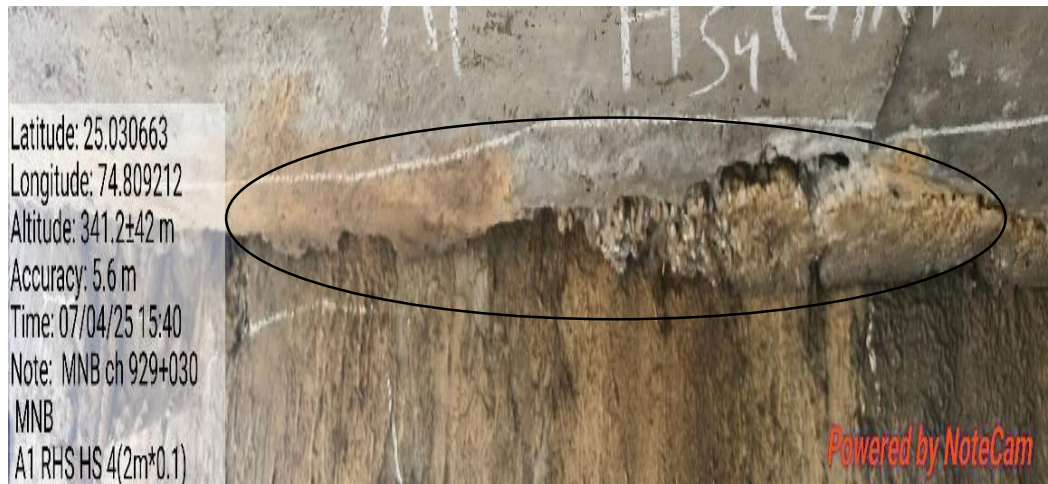
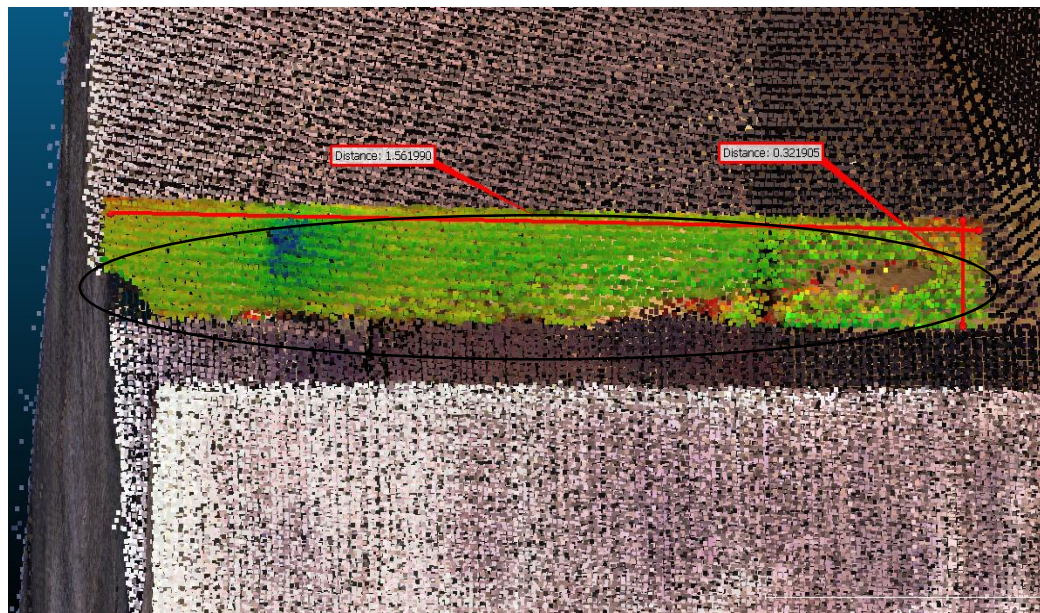
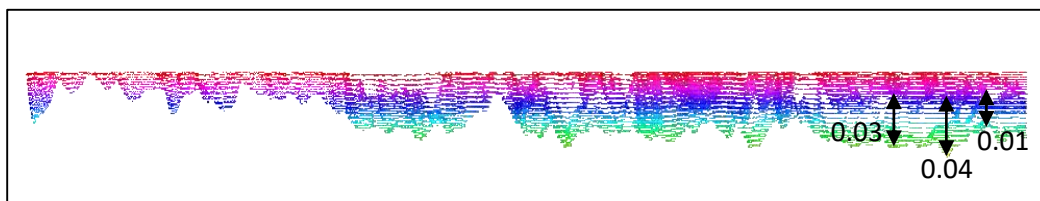
| Element Name | Observation | Location of Distress | Photo No. | Units | Distress Details | | | Area of Repair (Sq./RM T) |
|---|---|---|---|---|---|---|---|---|
| Abutment 1 | Hollow section | | 7 | | 1.56 | 0.32 | 0.032 | 0.013 |

**7. Hollow Section observed at RHS Abutment measuring 1.56 m in length and 0.32 m in width, Depth ranges from 0.013 m (min) to 0.049m (max), with an average depth of 0.032 m. The calculated volume of the distress is 0.015 m<sup>3</sup>.**

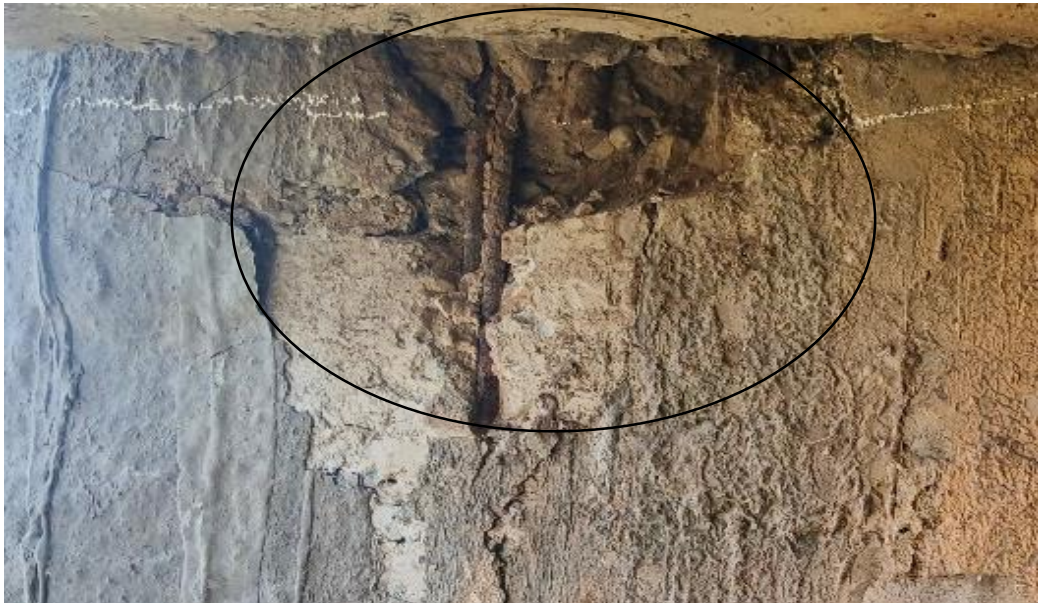
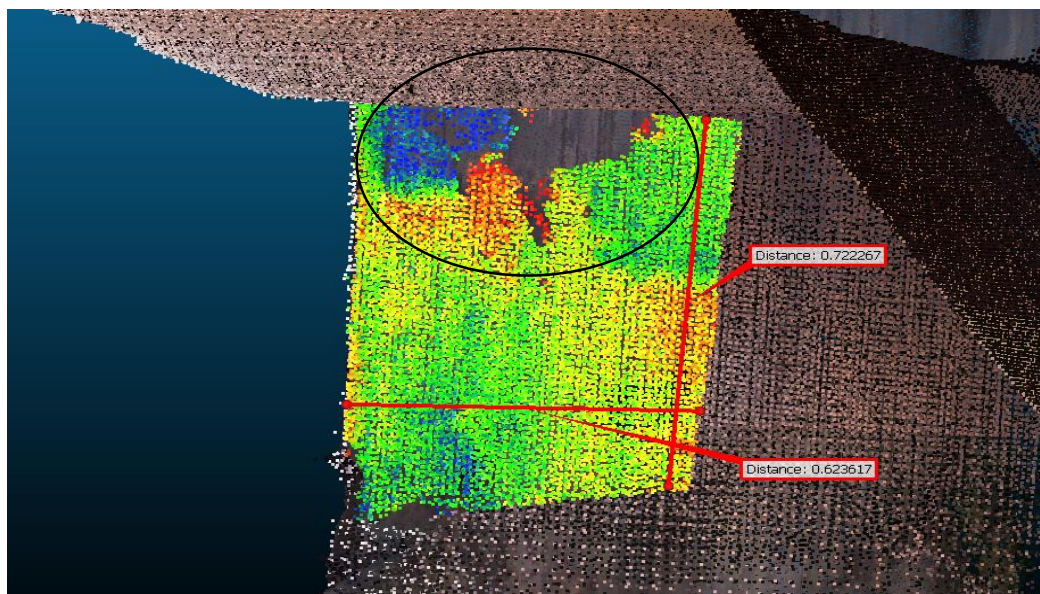
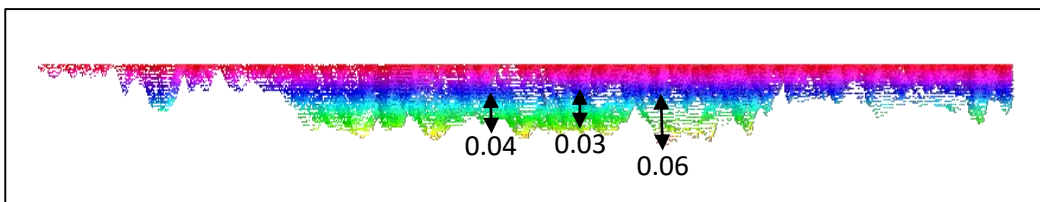
| Element Name | Observation | Location of Distress | Photo No. | Units | Distress Details | | | Area of Repair (Sq./RM T) |
|---|---|---|---|---|---|---|---|---|
| Dirt Wall | Hollow section | | 8 | | 0.72 | 0.62 | 0.06 | 0.017 |

**8. Surface distress observed on dirt wall at RHS Abutment , measuring 0.72 m in length and 0.62 m in width, Depth ranges from 0.03 m (min) to 0.06m (max), with an average depth of 0.04 m. The calculated volume of the distress is 0.017 m<sup>3</sup>.**

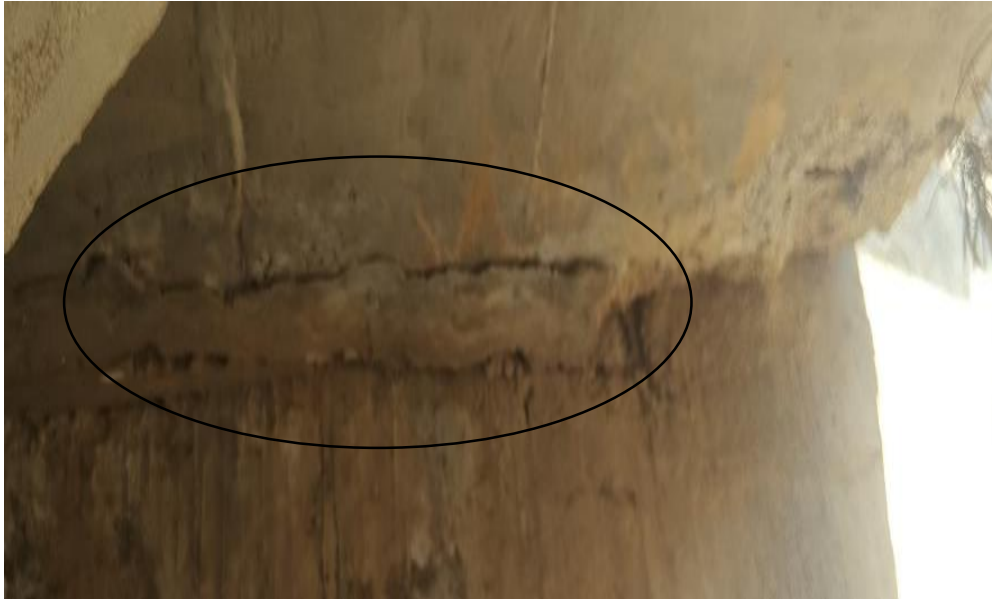
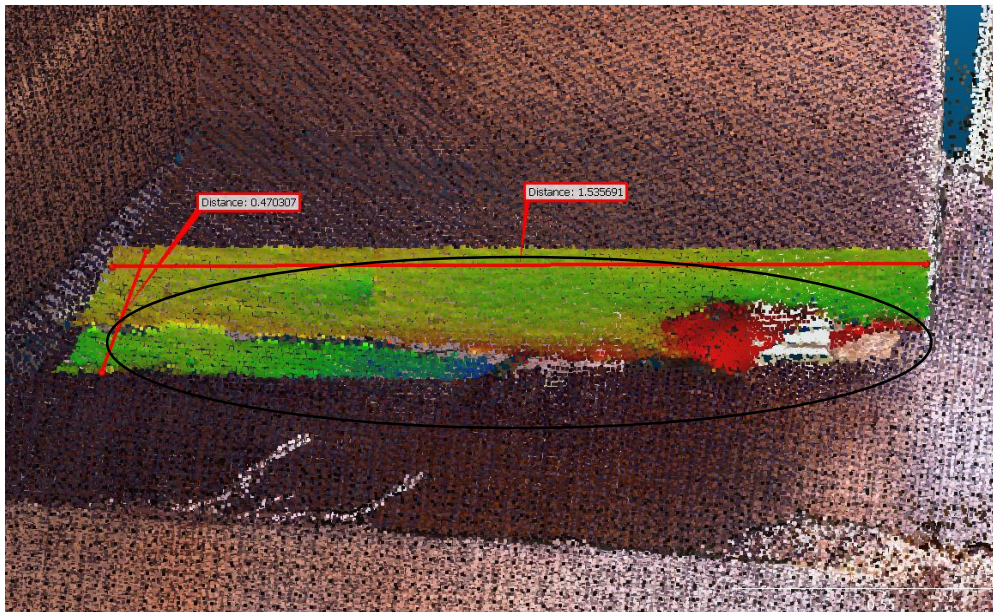
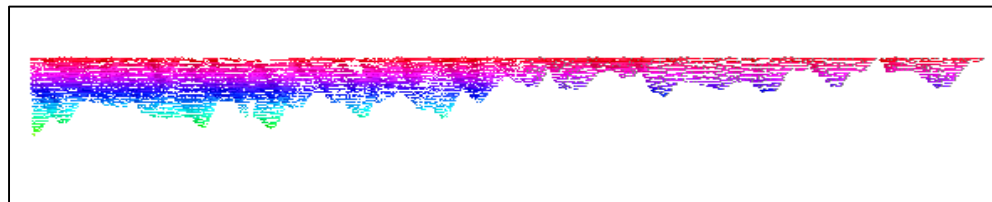
| Element Name | Observation | Location of Distress | Photo No. | Units | Distress Details | | | Area of Repair (Sq./RM T) |
|---|---|---|---|---|---|---|---|---|
| Slab Bottom | Spalling | | 9 | | 1.53 | 0.47 | | 0.7332 |

**9. Spalling observed at LHS Abutment 2 median side (approach slab bottom near dirt wall), measuring 1.53 m in length and 0.47 m in width, covering an area of 0.7332 m<sup>2</sup>.**
