# **LIDAR Inspection Report of PUP ch.929 + 250**

**Bridge Chainage:** 929 + 250 (CKRP)

- **Bridge No:** -
- **Chainage:** 929 +250
- **Structure type:** PUP

- **CKRP:** Chittorgarh to kota
- **State:** Rajasthan NH 27
- **Zone:** RJ-06

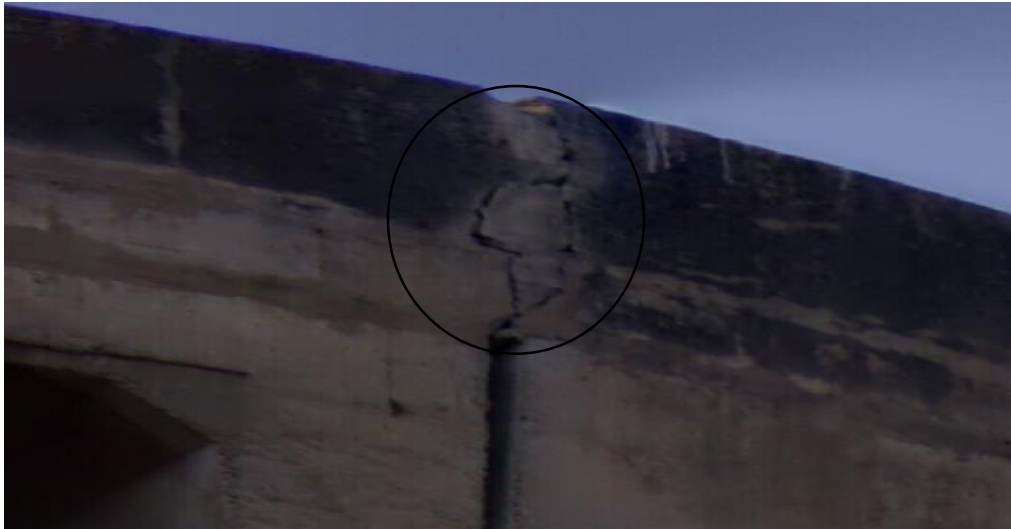
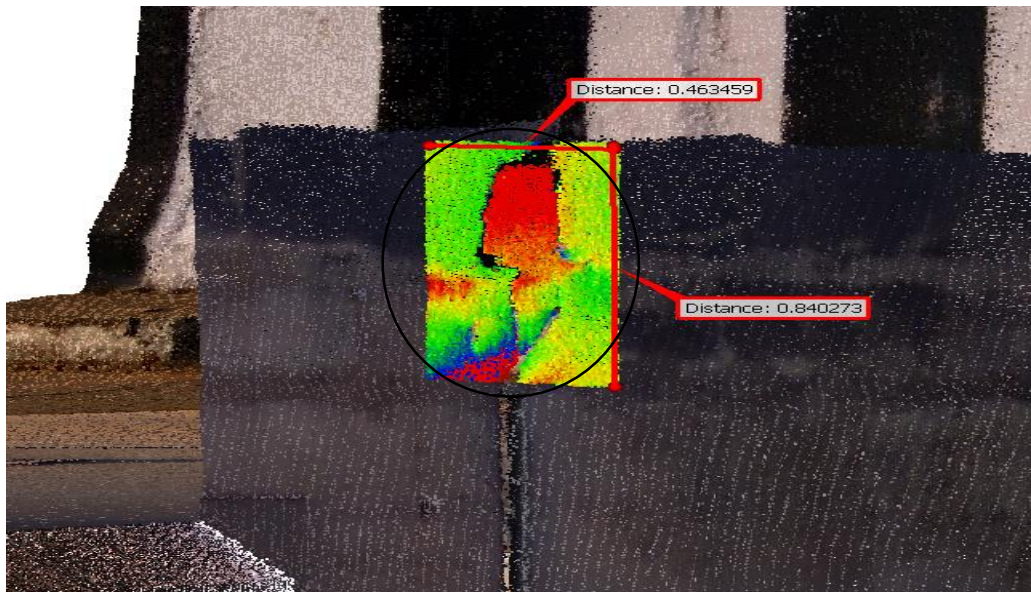
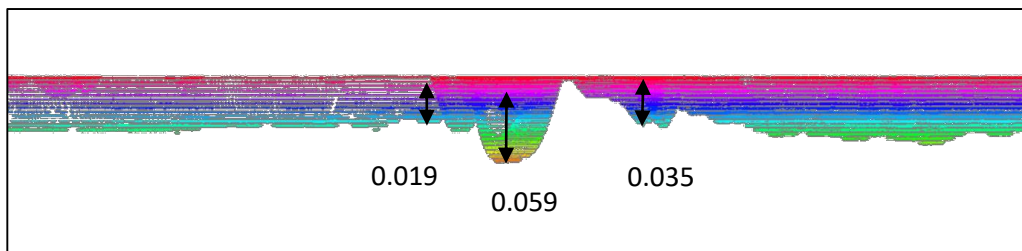
| Element Name | Observation | Location of Distress | Photo No. | Units | Distress Details | | | Area of Repair (Sq.m/ RMT/ m3) |
|---|---|---|---|---|---|---|---|---|
| Wing Wall | Damage | | 1 | M | 0.84 | 0.46 | 0.036 | 0.0060 |

1. Wing wall damage observed on LHS Abutment 1 , measuring 0.84 m in length and 0.46 m in width, Depth ranges from 0.023 m (min) to 0.045 m (max), with an average depth of 0.036 m. The calculated volume of the distress is 0.0035 m<sup>3</sup>.

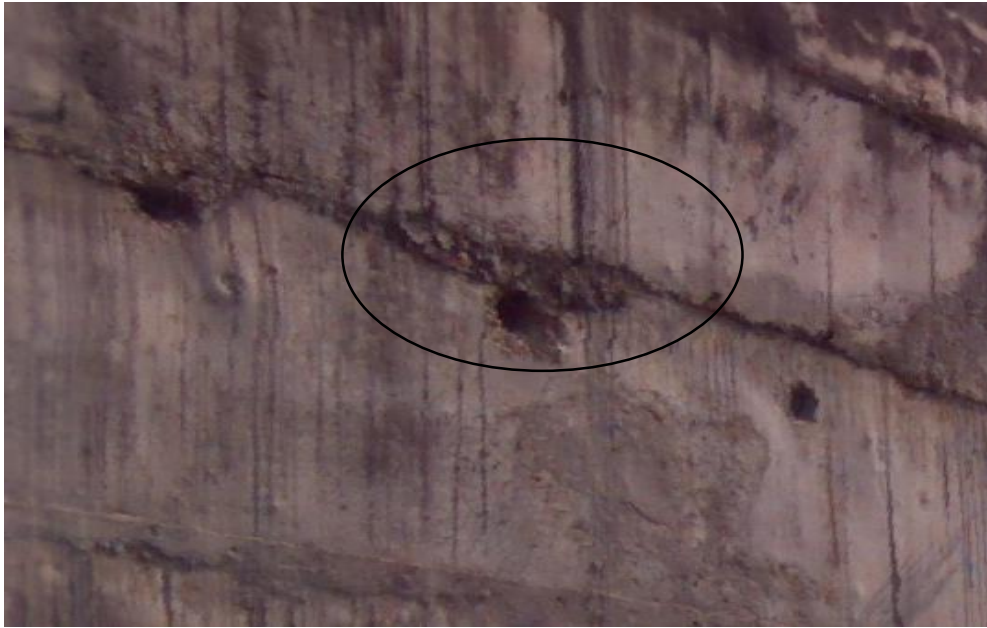
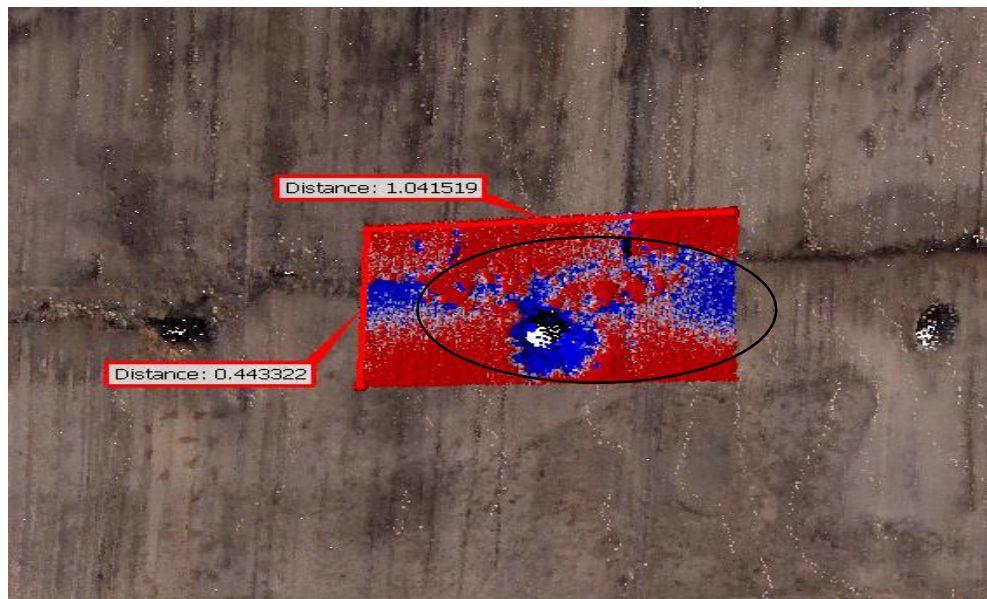
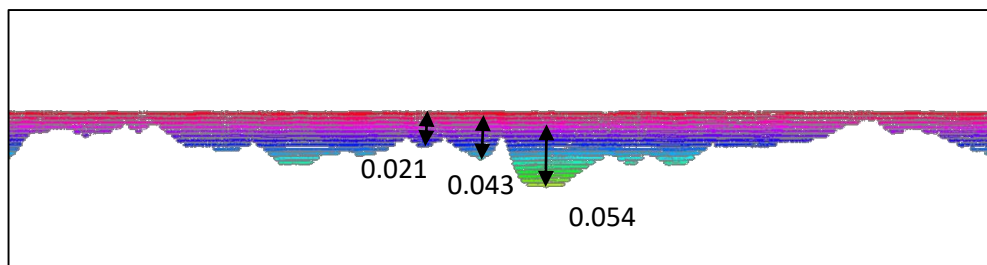
| Element Name | Observation | Location of Distress | Photo No. | Units | Distress Details | | | Area of Repair (Sq.m/ RMT/ m3) |
|---|---|---|---|---|---|---|---|---|
| Wing Wall | Damage | | 2 | M | 1.04 | 0.44 | 0.043 | 0.0191 |

2. Wing wall damage observed on RHS Abutment 2, measuring 1.04 m in length and 0.44 m in width, Depth ranges from 0.021 m (min) to 0.054 m (max), with an average depth of 0.043 m. The calculated volume of the distress is 0.0191 m<sup>3</sup>.

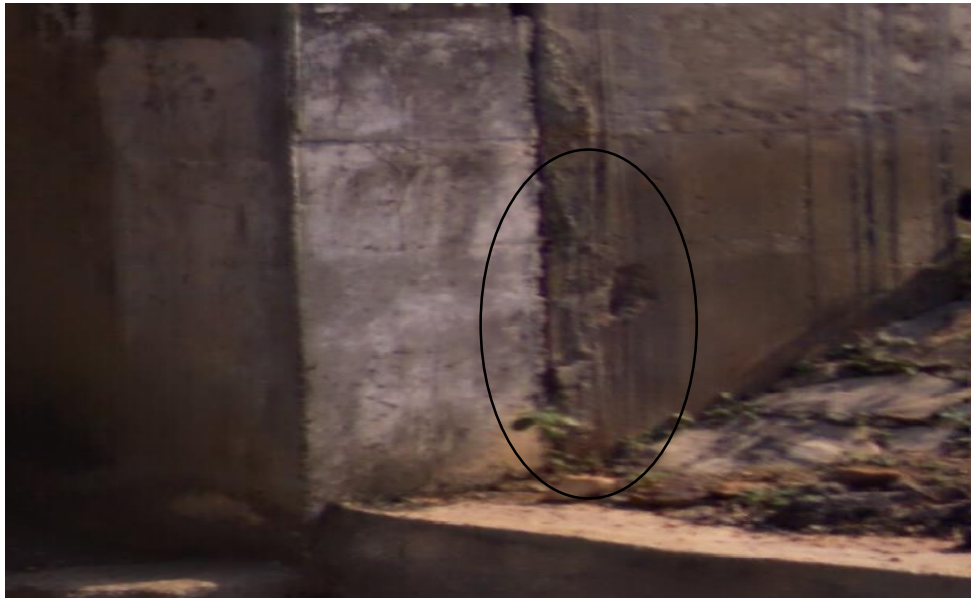
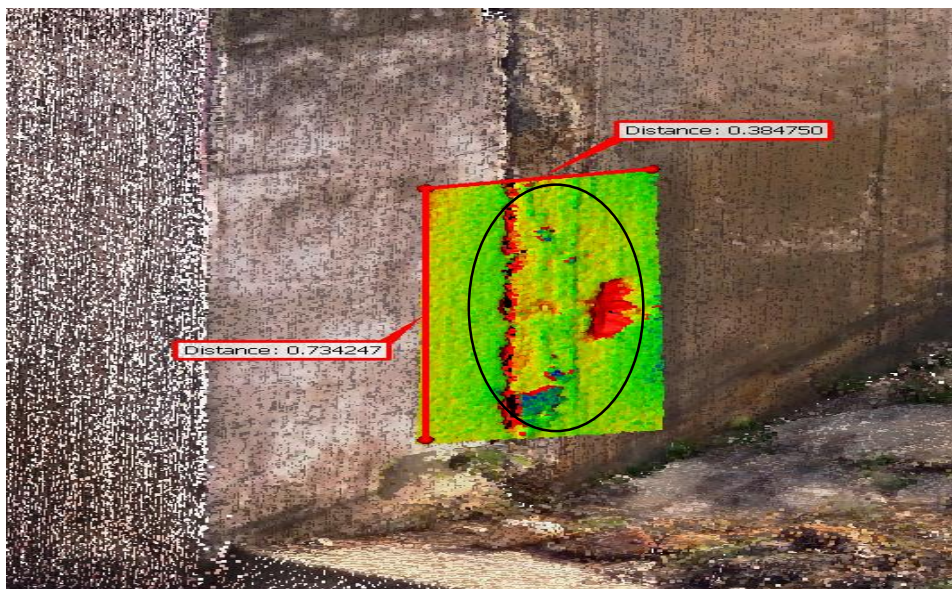
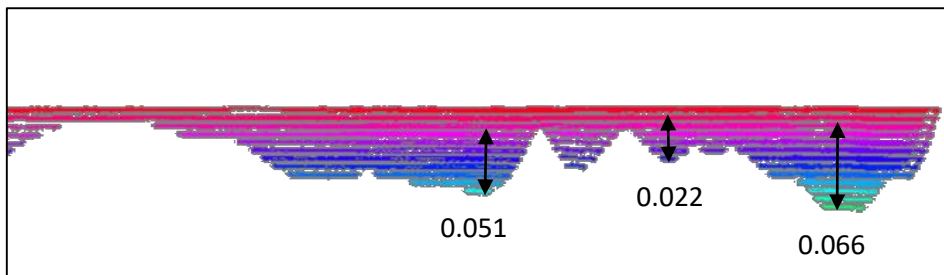
| Element Name | Observation | Location of Distress | Photo No. | Units | Distress Details | | | Area of Repair (Sq.m/ RMT/ m3) |
|---|---|---|---|---|---|---|---|---|
| Wing Wall | Damage | | 3 | M | 0.73 | 0.38 | 0.051 | 0.0141 |

3. Wing wall damage observed on RHS Abutment 2 , measuring 0.73 m in length and 0.38 m in width, Depth ranges from 0.022 m (min) to 0.066 m (max), with an average depth of 0.051 m. The calculated volume of the distress is 0.0141 m<sup>3</sup>.

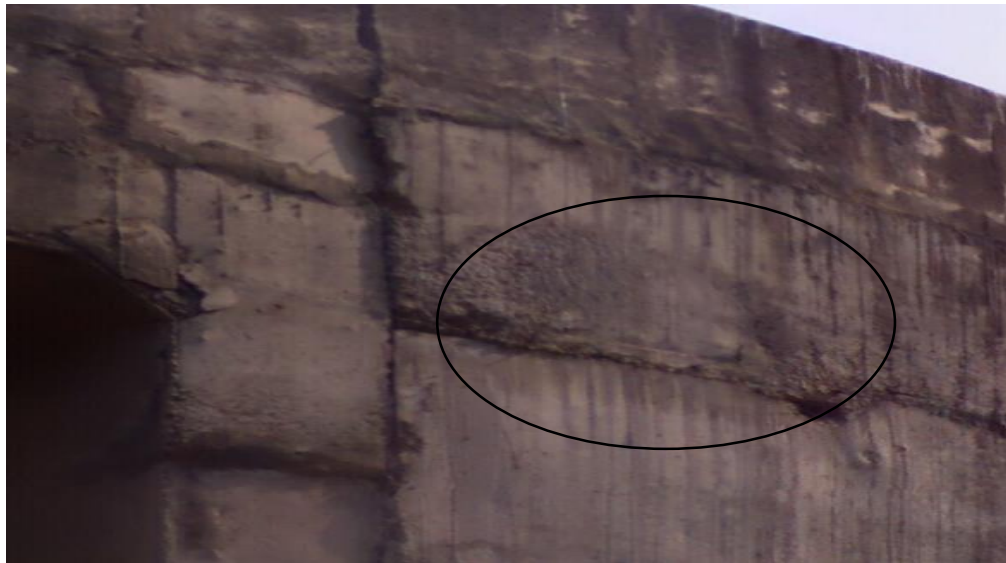
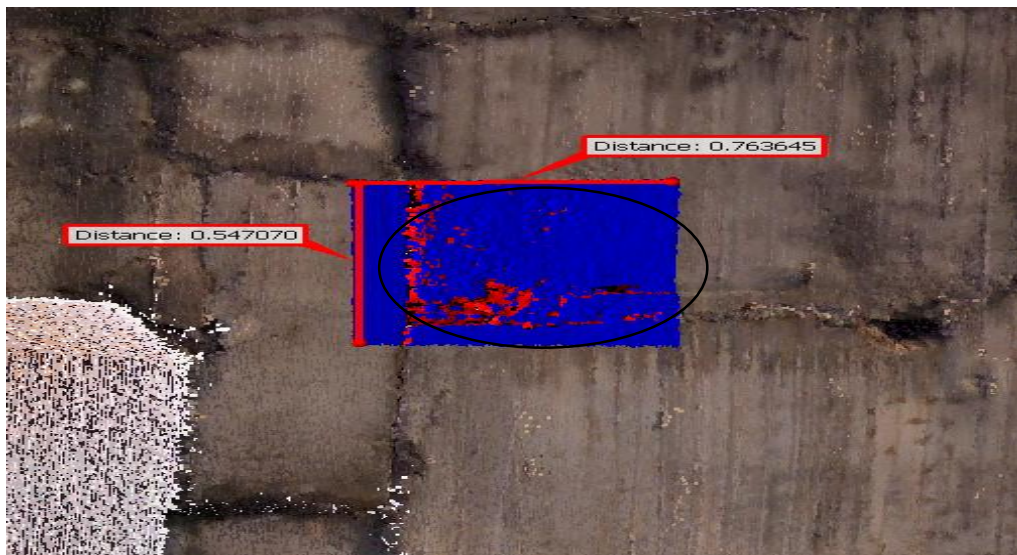
| Element Name | Observation | Location of Distress | Photo No. | Units | Distress Details | | | Area of Repair (Sq.m/ RMT/ m3) |
|---|---|---|---|---|---|---|---|---|
| Wing Wall | Damage | | 4 | M | 0.76 | 0.54 | | 0.4104 |

- 4. Spalling/edge damage observed on RHS Abutment 2 wing wall, measuring 0.76 m in length and 0.54 m in width, covering an area of 0.4104 m<sup>2</sup>.**

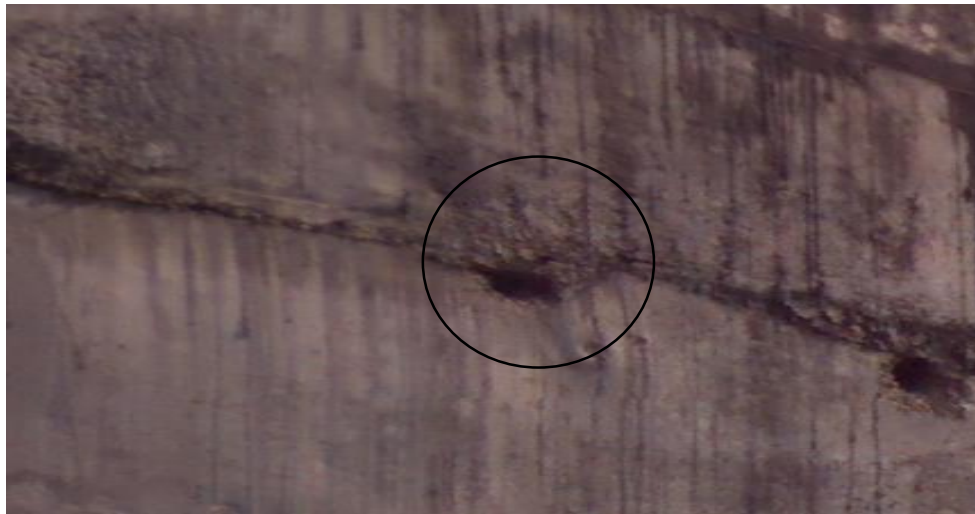
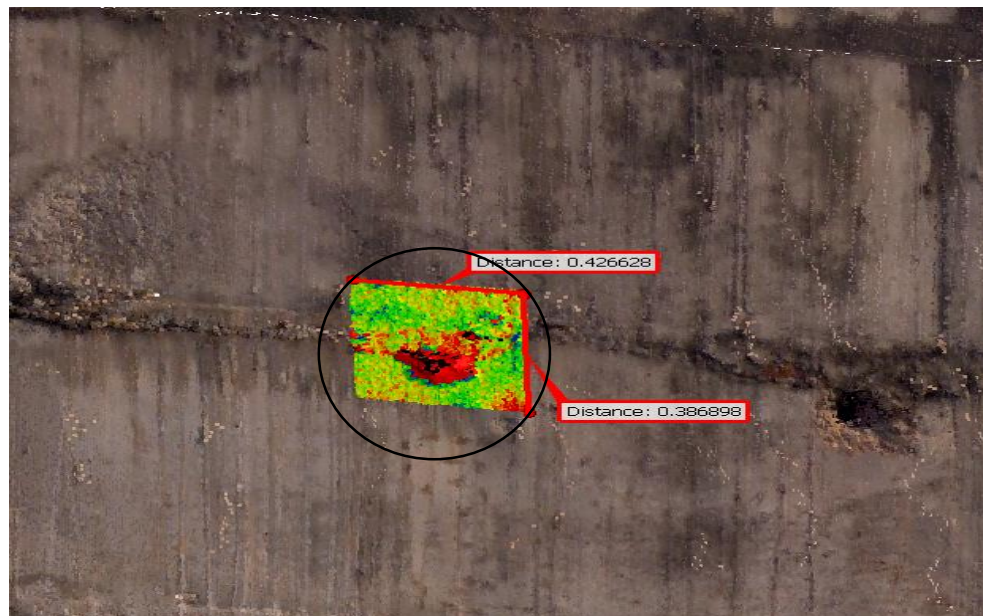
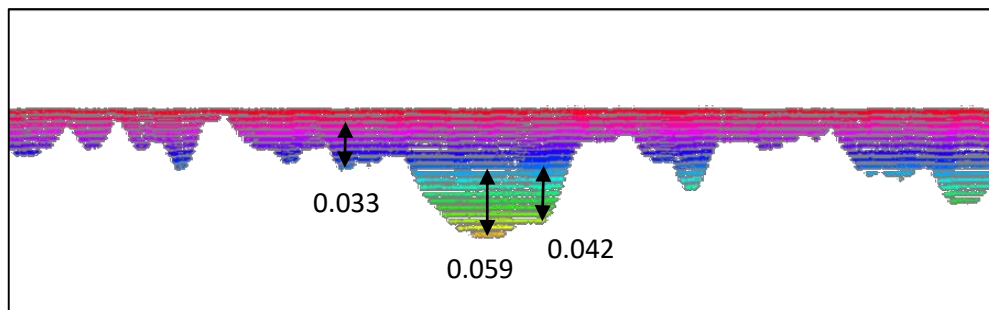
| Element Name | Observation | Location of Distress | Photo No. | Units | Distress Details | | | Area of Repair (Sq.m/ RMT/ m3) |
|---|---|---|---|---|---|---|---|---|
| Wing Wall | Damage | | 5 | M | 0.42 | 0.38 | 0.042 | 0.0067 |

5. Wing wall damage observed on RHS Abutment 2 , measuring 0.42 m in length and 0.38 m in width, Depth ranges from 0.033 m (min) to 0.059 m (max), with an average depth of 0.042 m. The calculated volume of the distress is 0.0067m<sup>3</sup>.
