# LIDAR Inspection Report of **Box Culvert** ch.929+034

**Bridge Chainage:** 929+034 (CKRP)

- **CKRP:** Chittorgarh to kota
- **State:** Rajasthan NH 27
- **Zone:** RJ-06

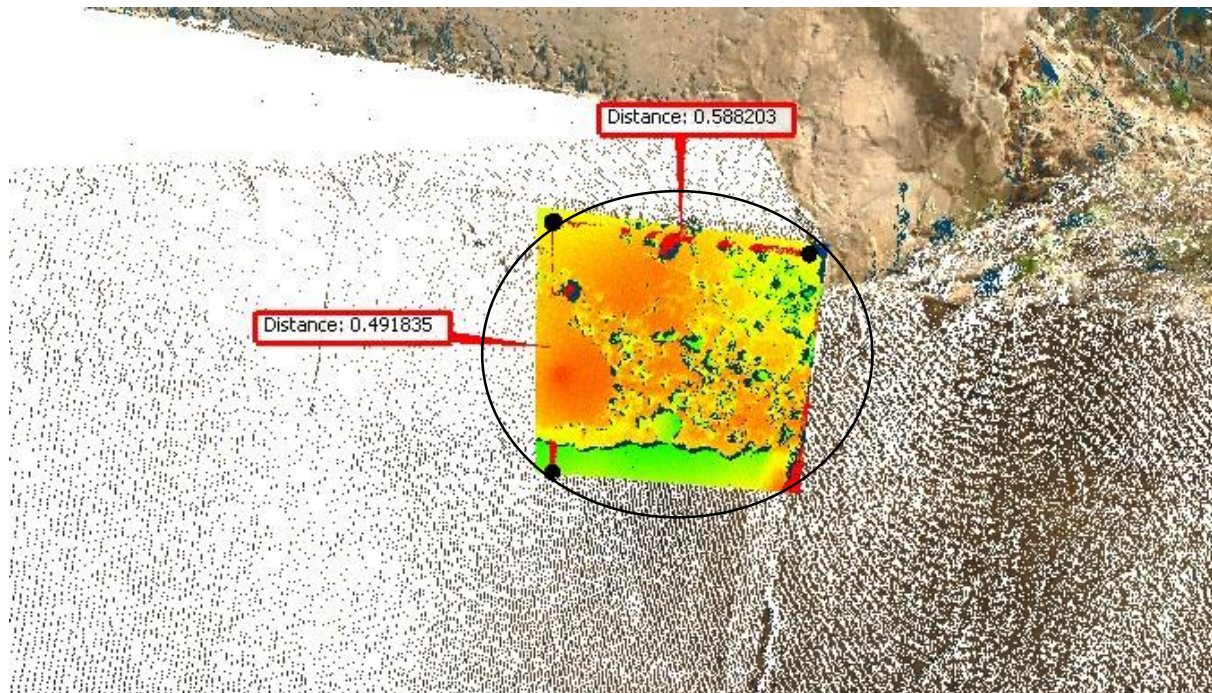
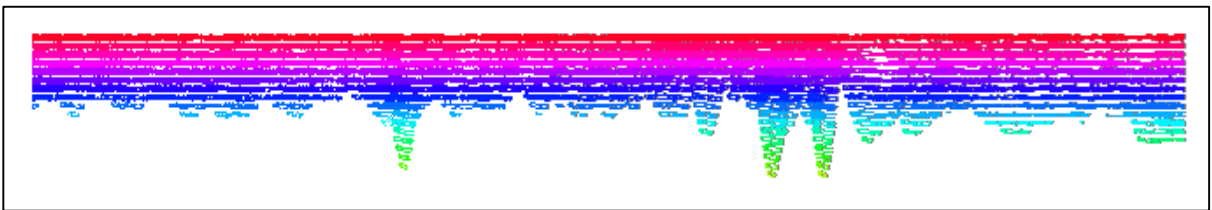
| Element Name | Observation | Location of Distress | Photo No. | Units | Distress Details | | | Area of Repair (Sq.m/ RMT/ m3) |
|---|---|---|---|---|---|---|---|---|
| Abutment Wall | Scaling | - | 1 | M | 0.58 | 0.49 | | 0.2842 |

**1. Abutment wall scaling observed, measuring 0.58 m in length and 0.49 m in width, covering an area of 0.2842 m<sup>2</sup>.**

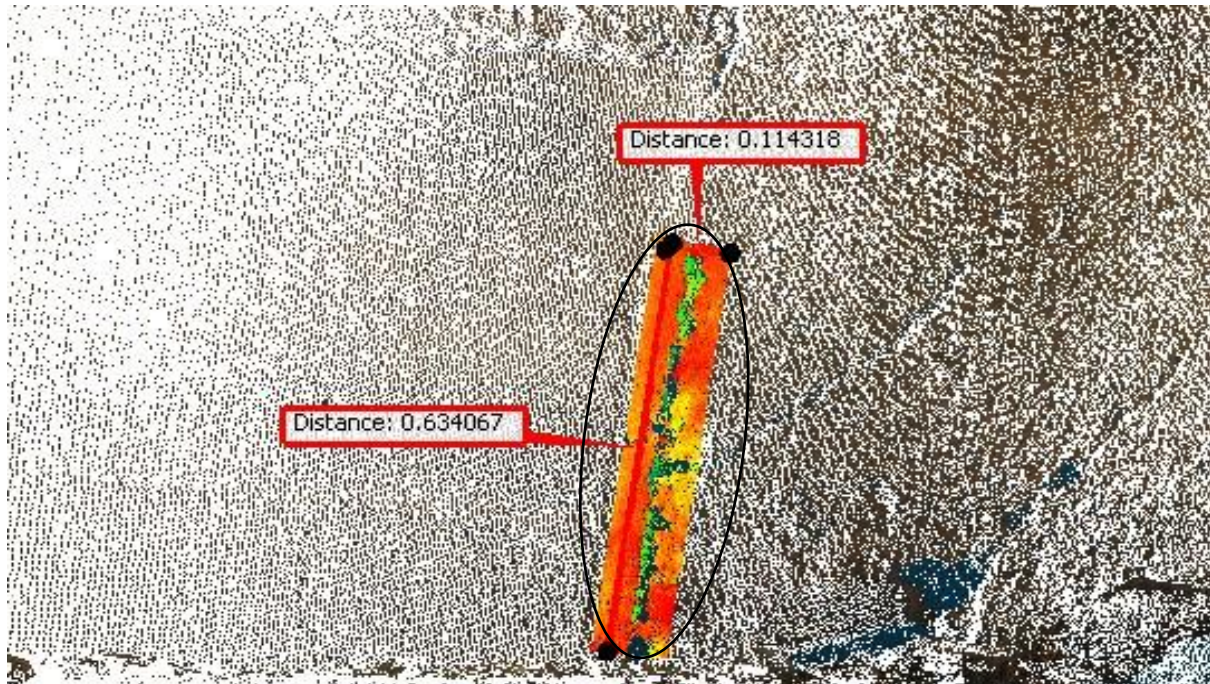
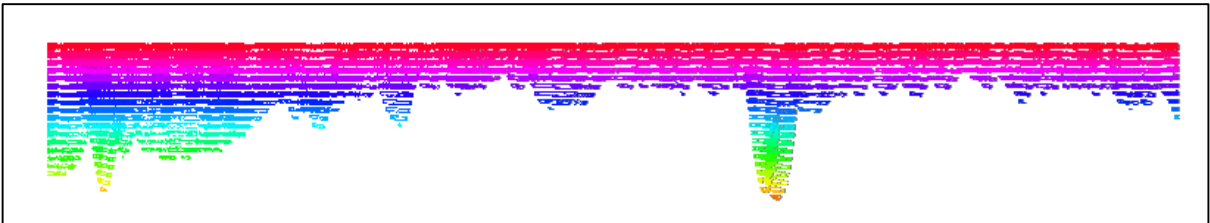
| Element Name | Observation | Location of Distress | Photo No. | Units | Distress Details | | | Area of Repair (Sq.m/ RMT/ m3) |
|---|---|---|---|---|---|---|---|---|
| Wing Wall | Damage | - | 2 | M | 0.11 | 0.63 | | 0.0693 |

**2. Wing wall damage observed, measuring 0.11 m in length and 0.63 m in width, covering an area of 0.0693 m<sup>2</sup>.**

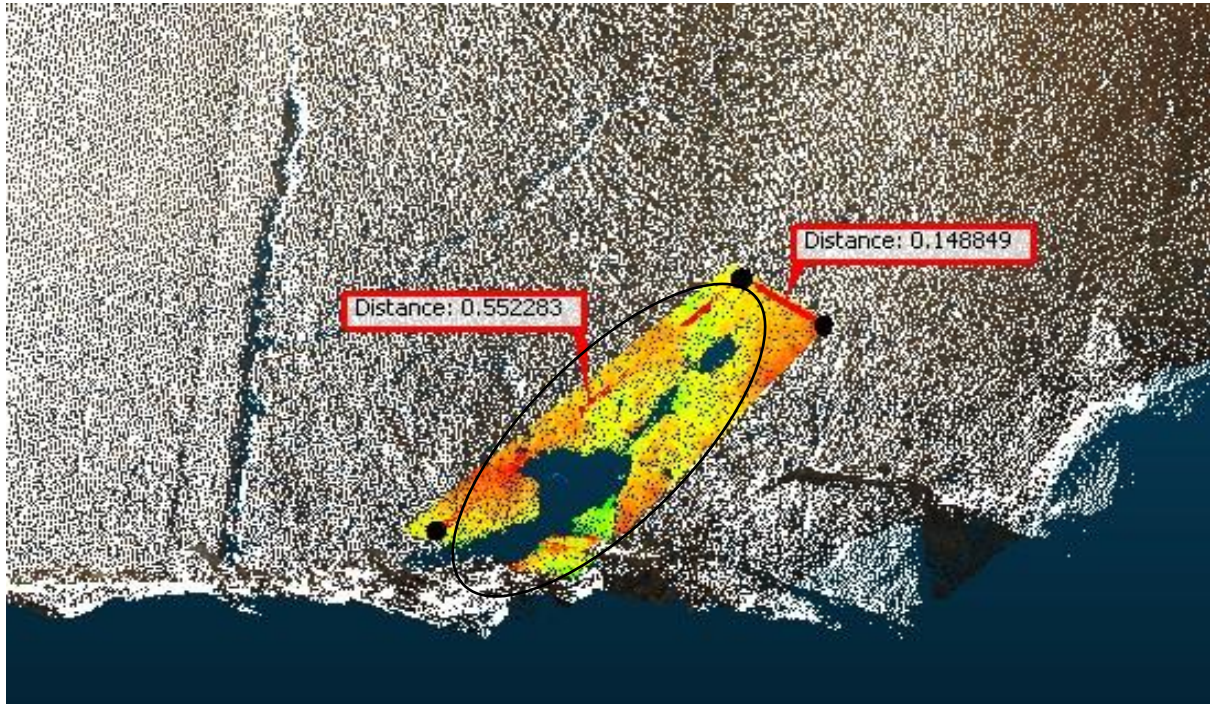
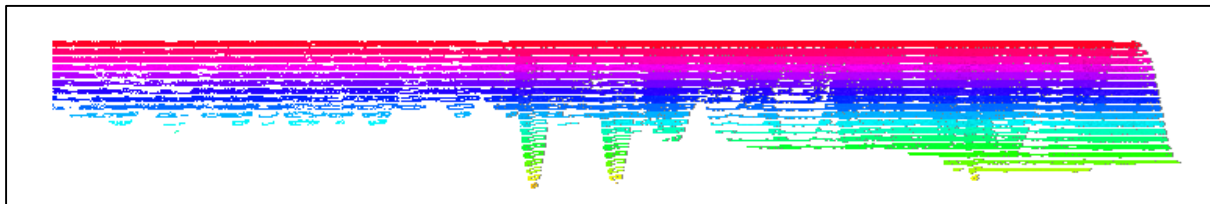
| Element Name | Observation | Location of Distress | Photo No. | Units | Distress Details | | | Area of Repair (Sq.m/ RMT/ m3) |
|---|---|---|---|---|---|---|---|---|
| Wing Wall | Damage | - | 3 | M | 0.14 | 0.55 | | 00.077 |

**3. Wing wall damage observed, measuring 0.14 m in length and 0.55 m in width, covering an area of 0.077 m<sup>2</sup>.**

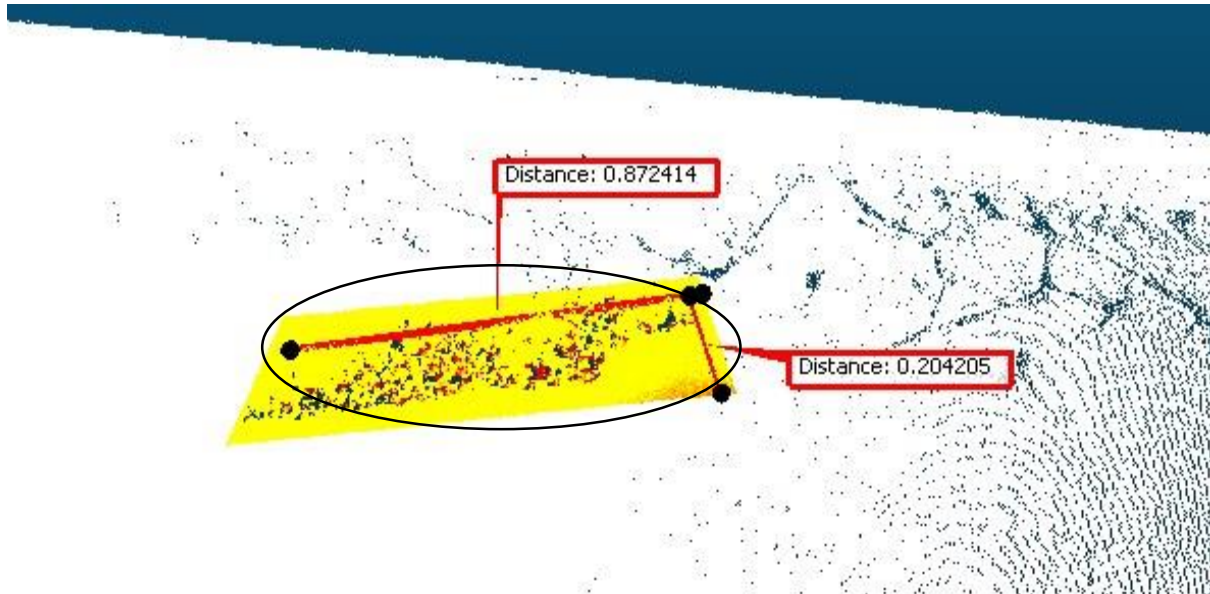
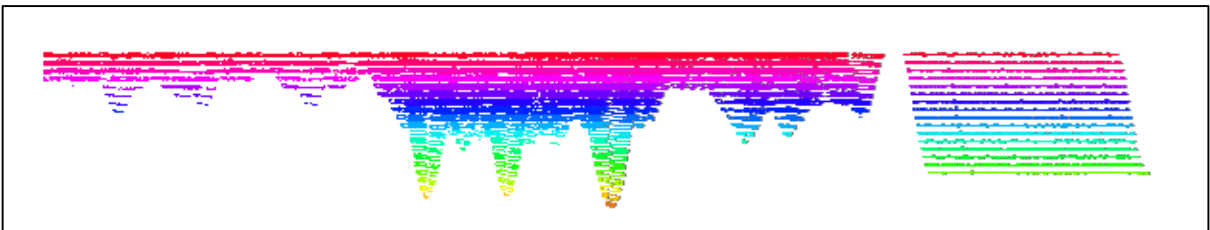
| Element Name | Observation | Location of Distress | Photo No. | Units | Distress Details | | | Area of Repair (Sq.m/ RMT/ m3) |
|---|---|---|---|---|---|---|---|---|
| Abutment Wall | Scaling | - | 4 | M | 0.87 | 0.20 | | 0.174 |

**4. Abutment wall scaling observed, measuring 0.87 m in length and 0.20 m in width, covering an area of 0.174 m<sup>2</sup>.**

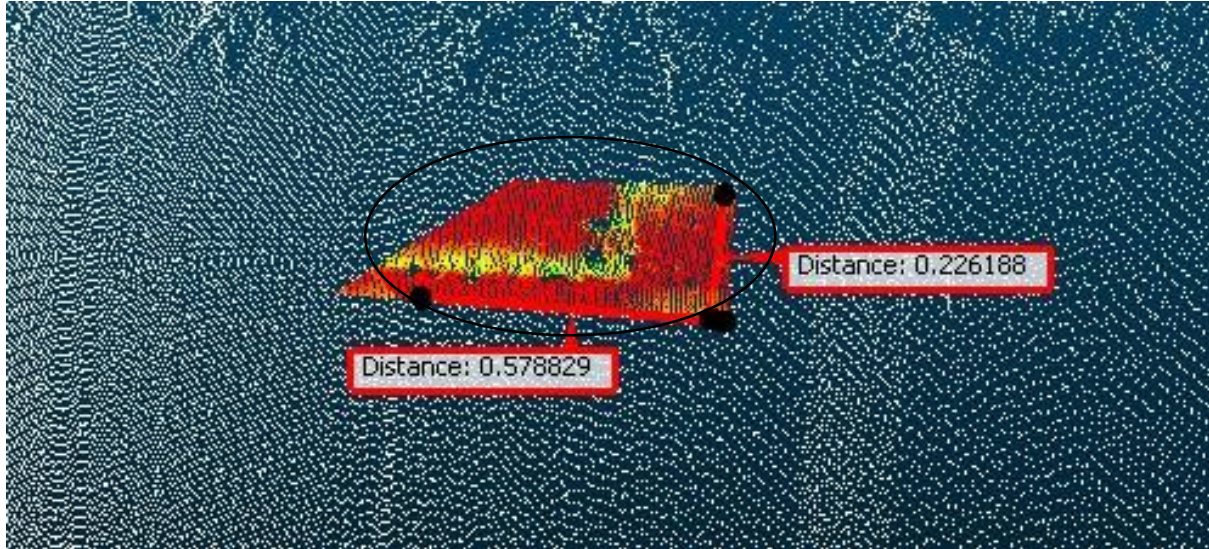
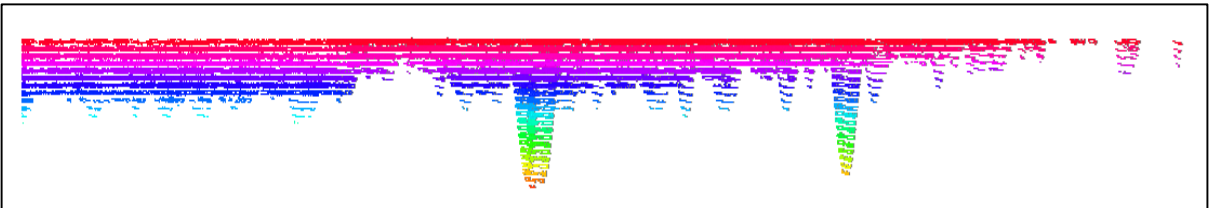
| Element Name | Observation | Location of Distress | Photo No. | Units | Distress Details | | | Area of Repair (Sq.m/ RMT/ m3) |
|---|---|---|---|---|---|---|---|---|
| Abutment Wall | Scaling | - | 5 | M | 0.63 | 0.22 | | 0.1254 |

**5. Abutment wall scaling observed, measuring 0.57 m in length and 0.22 m in width, covering an area of 0.1254 m<sup>2</sup>.**

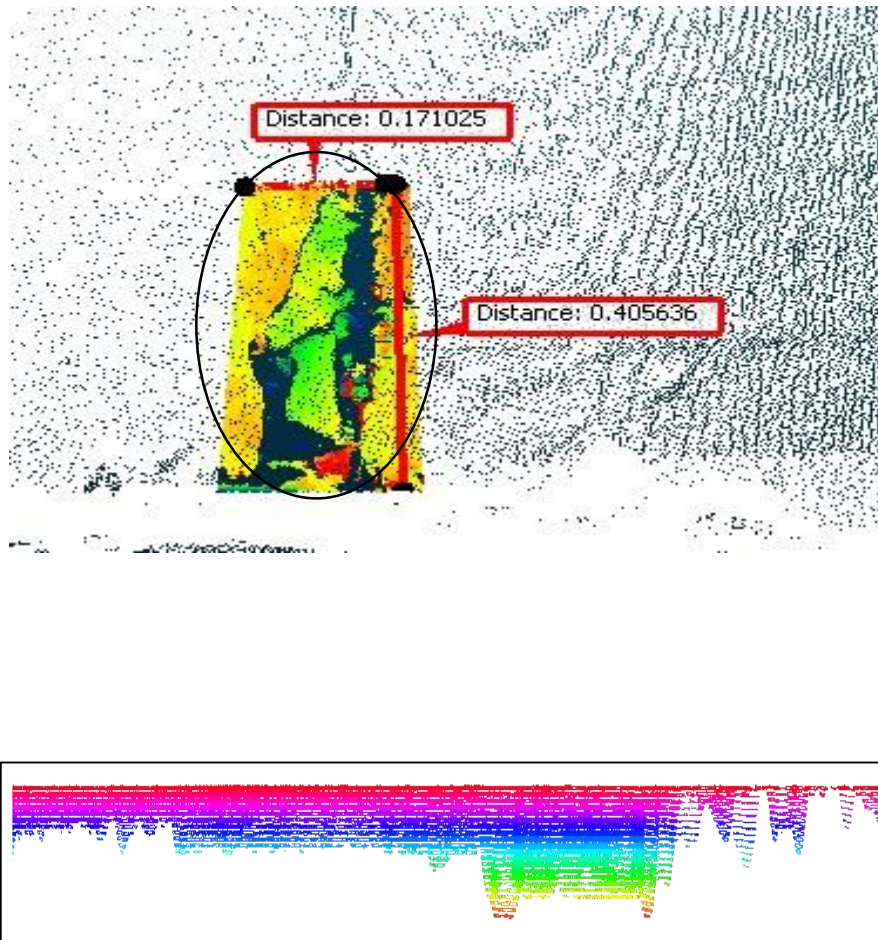
| Element Name | Observation | Location of Distress | Photo No. | Units | Distress Details | | | Area of Repair (Sq.m/ RMT/ m3) |
|---|---|---|---|---|---|---|---|---|
| Wing Wall | Damage | - | 6 | M | 0.17 | 0.40 | | 0.068 |

**6. Wing wall damage observed, measuring 0.17 m in length and 0.40 m in width, covering an area of 0.068 m<sup>2</sup>.**

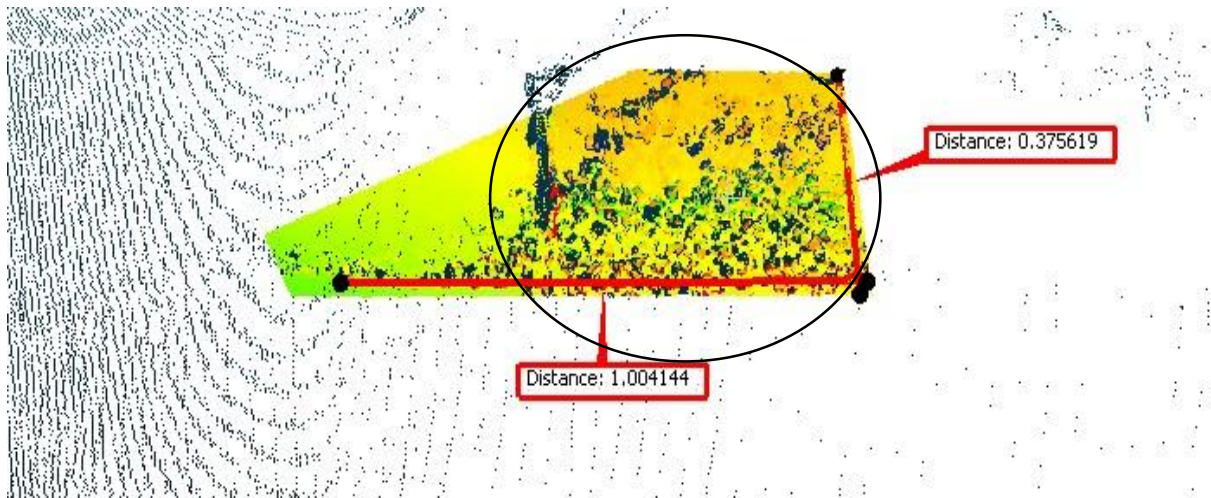
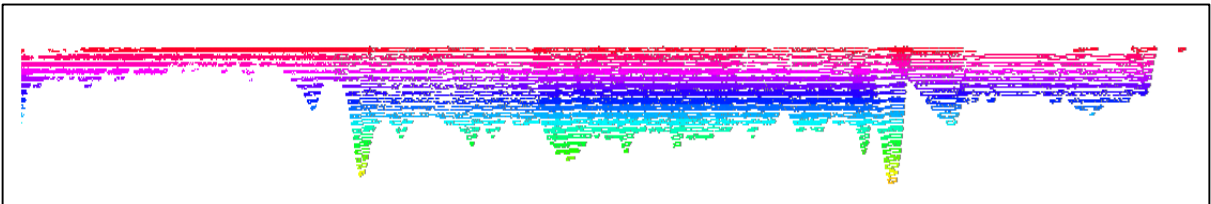
| Element Name | Observation | Location of Distress | Photo No. | Units | Distress Details | | | Area of Repair (Sq.m/ RMT/ m3) |
|---|---|---|---|---|---|---|---|---|
| Abutment Wall | Scaling | - | 7 | M | 1.00 | 0.37 | | 0.37 |

**7. Abutment wall scaling observed, measuring 1.00 m in length and 0.37 m in width, covering an area of 0.37 m<sup>2</sup>.**

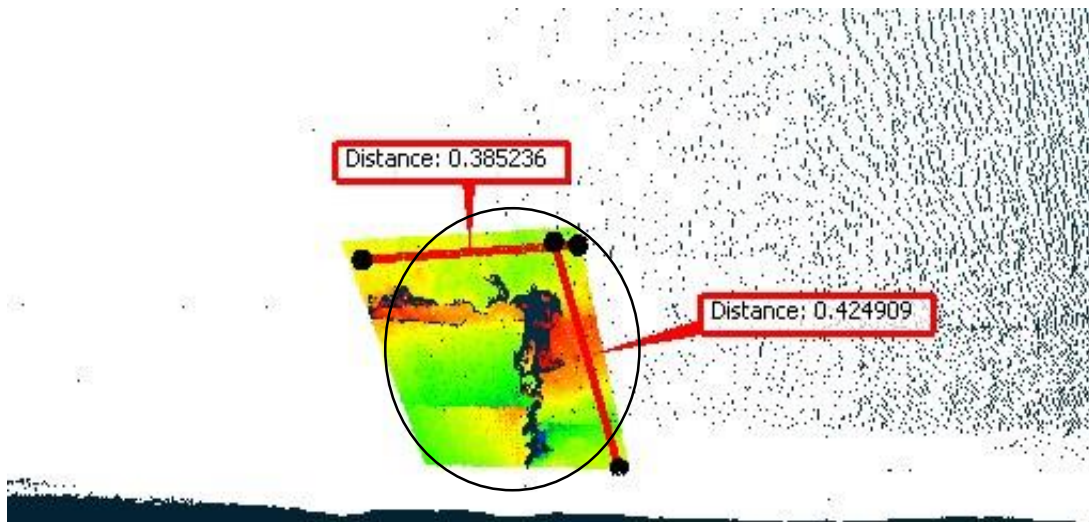
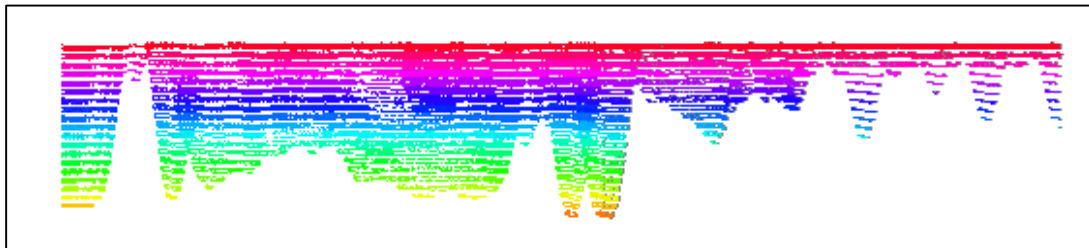
| Element Name | Observation | Location of Distress | Photo No. | Units | Distress Details | | | Area of Repair (Sq.m/ RMT/ m3) |
|---|---|---|---|---|---|---|---|---|
| Abutment Wall | Damage | - | 8 | M | 0.38 | 0.42 | | 0.1596 |

**8. Abutment wall damage observed, measuring 0.38 m in length and 0.42 m in width, covering an area of 0.1596 m<sup>2</sup>.**

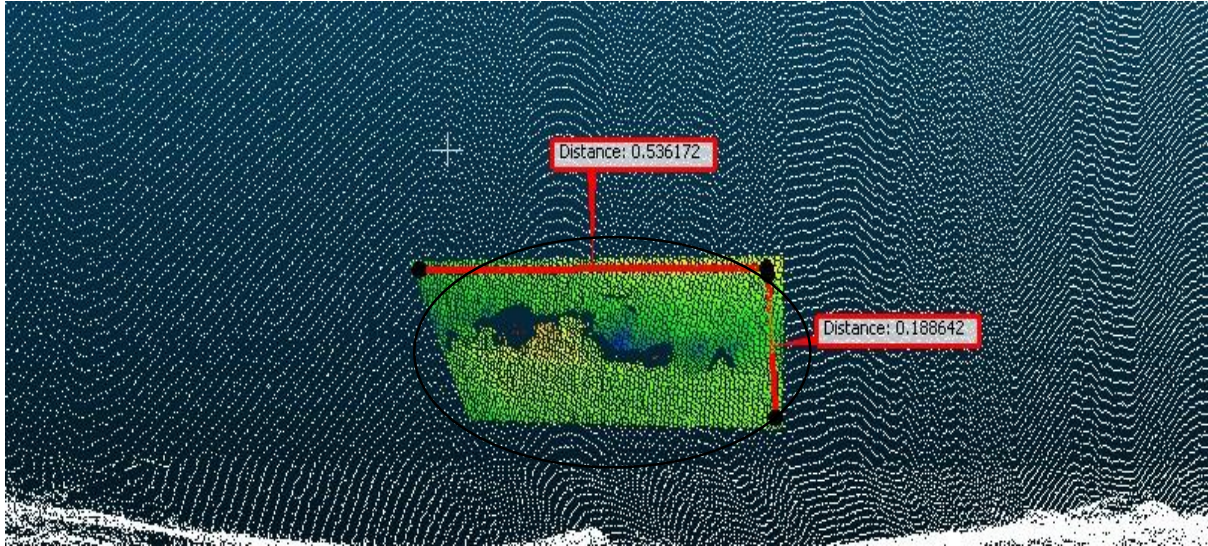
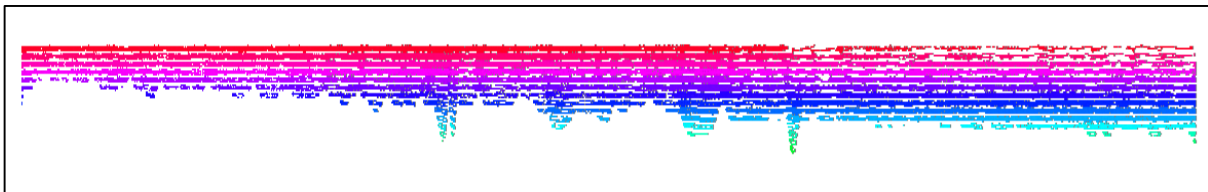
| Element Name | Observation | Location of Distress | Photo No. | Units | Distress Details | | | Area of Repair (Sq.m/ RMT/ m3) |
|---|---|---|---|---|---|---|---|---|
| Abutment Wall | Damage | - | 9 | M | 0.53 | 0.18 | | 0.0954 |

**9. Abutment wall damage observed, measuring 0.53 m in length and 0.18 m in width, covering an area of 0.0954 m<sup>2</sup>.**
