# **LIDAR Inspection Report of Slab Culvert ch.930+820**

**Bridge Chainage:** 930 +820 (CKRP)

- **CKRP:** Chittorgarh to kota
- **State:** Rajasthan NH 27
- **Zone:** RJ-06

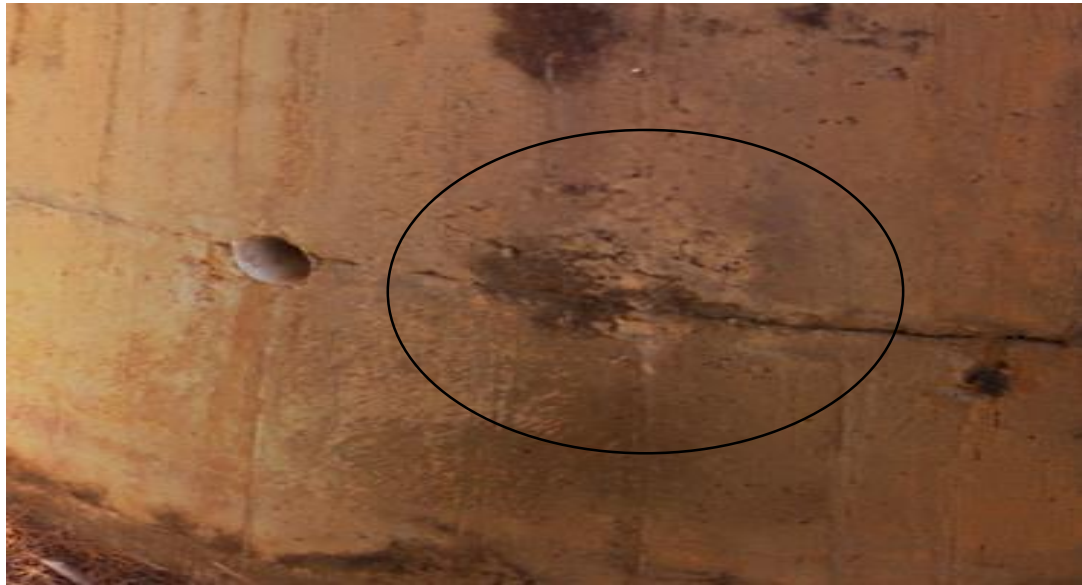
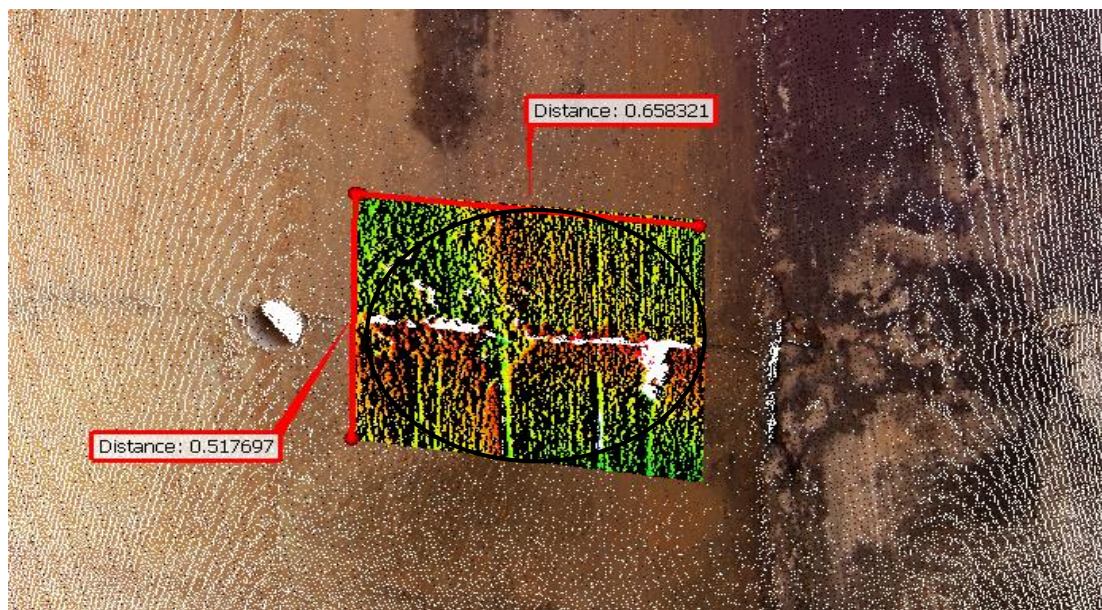
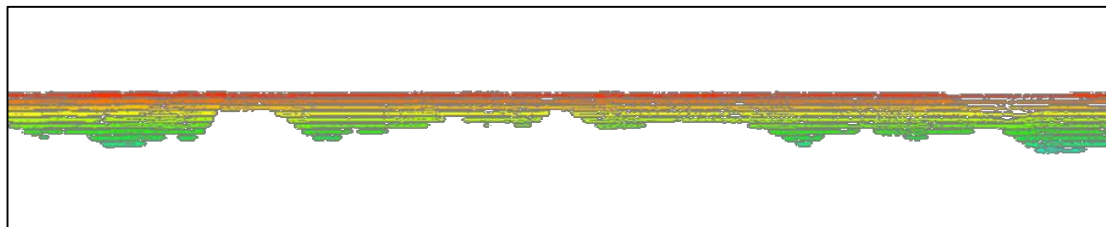
| Element Name | Observation | Location of Distress | Photo No. | Units | Distress Details | | | Area of Repair (Sq.m/R MT/m3) |
|---|---|---|---|---|---|---|---|---|
| Abutment 1 | Scaling | | 1 | M | 0.65 | 0.51 | | 0.3315 |

**1. Scaling observed on Abutment 1 LHS , measuring 0.65 m in length and 0.51 m in width, covering an area of 0.3315 m<sup>2</sup>.**

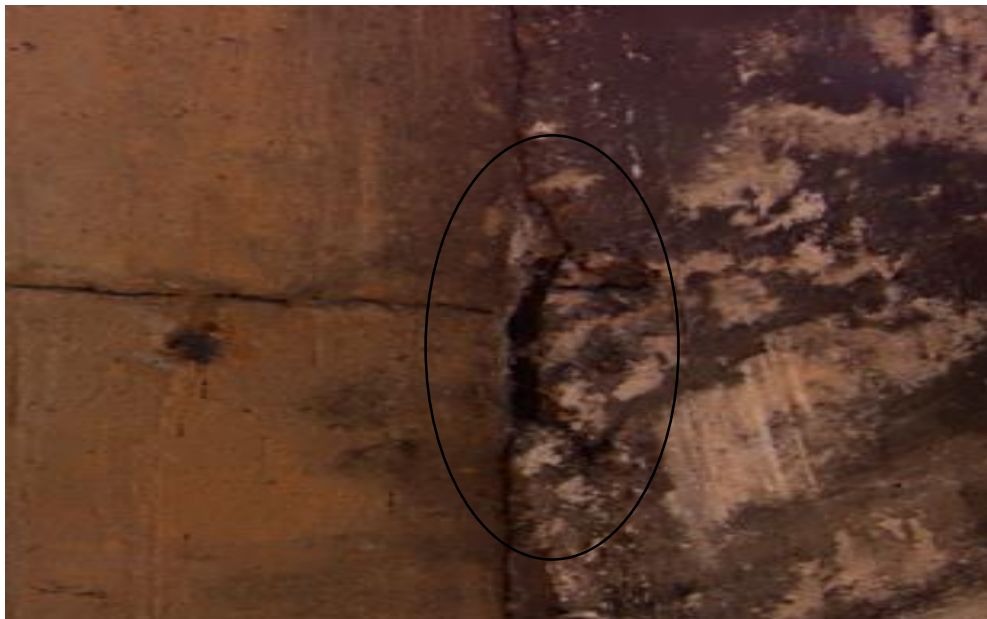
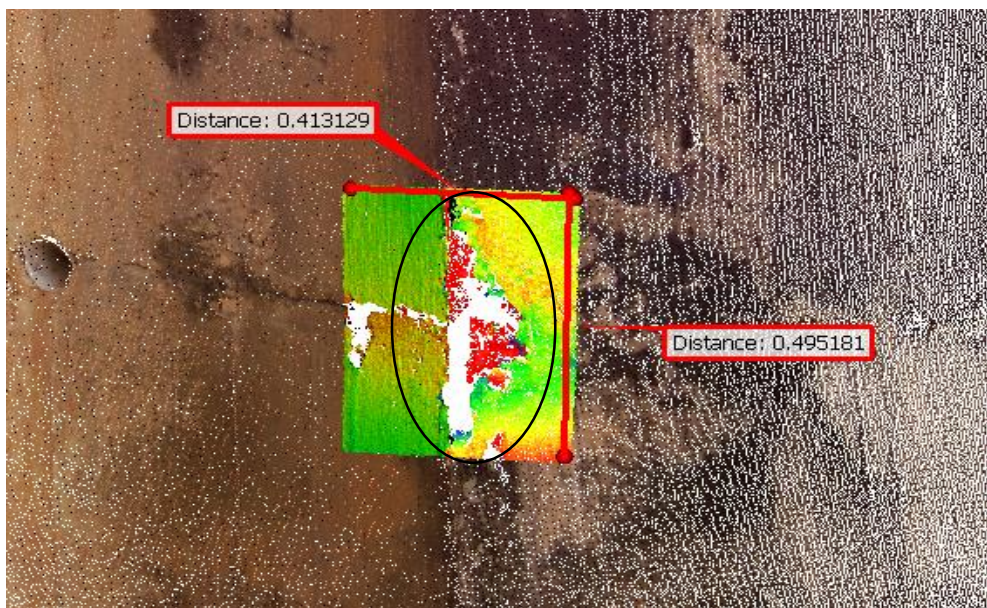
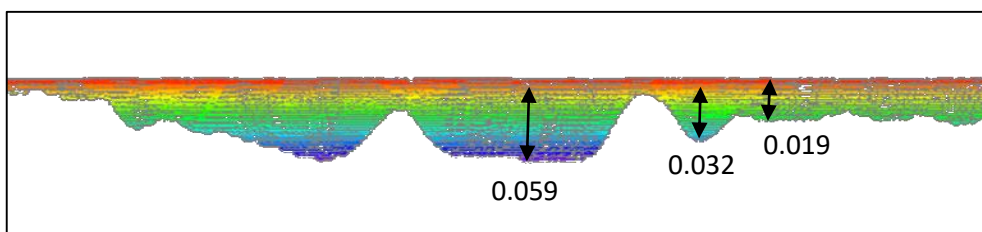
| Element Name | Observation | Location of Distress | Photo No. | Units | Distress Details | | | Area of Repair (Sq.m/R MT/m3) |
|---|---|---|---|---|---|---|---|---|
| Abutment 1 | Hollow Section | | 2 | M | 0.49 | 0.41 | 0.032 | 0.0064 |

**2. Hollow Section observed on Abutment 1 LHS , measuring 0.49 m in length and 0.41 m in width, Depth ranges from 0.019 m (min) to 0.059 m (max), with an average depth of 0.032 m. The calculated volume of the distress is 0.0064 m<sup>3</sup>.**

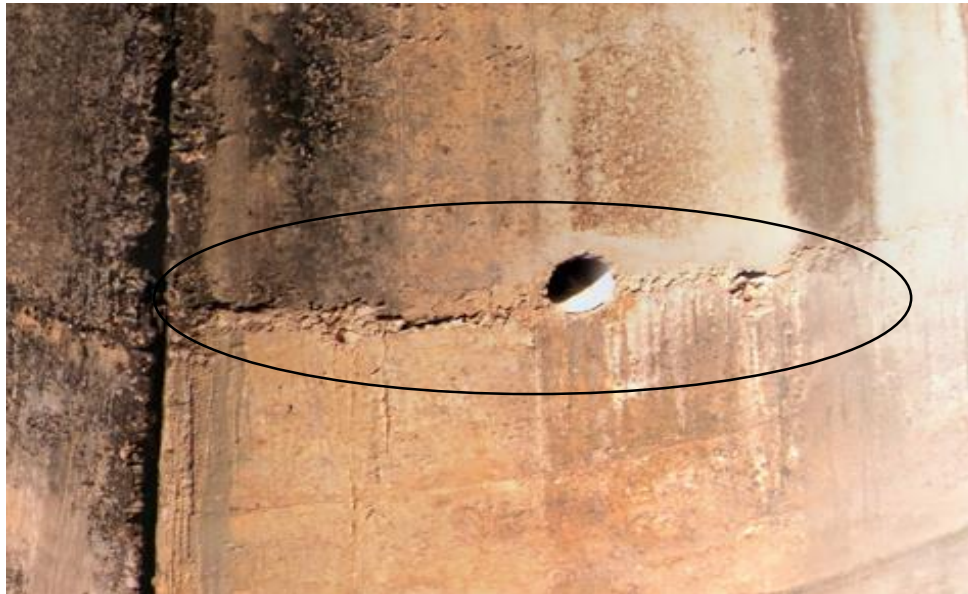
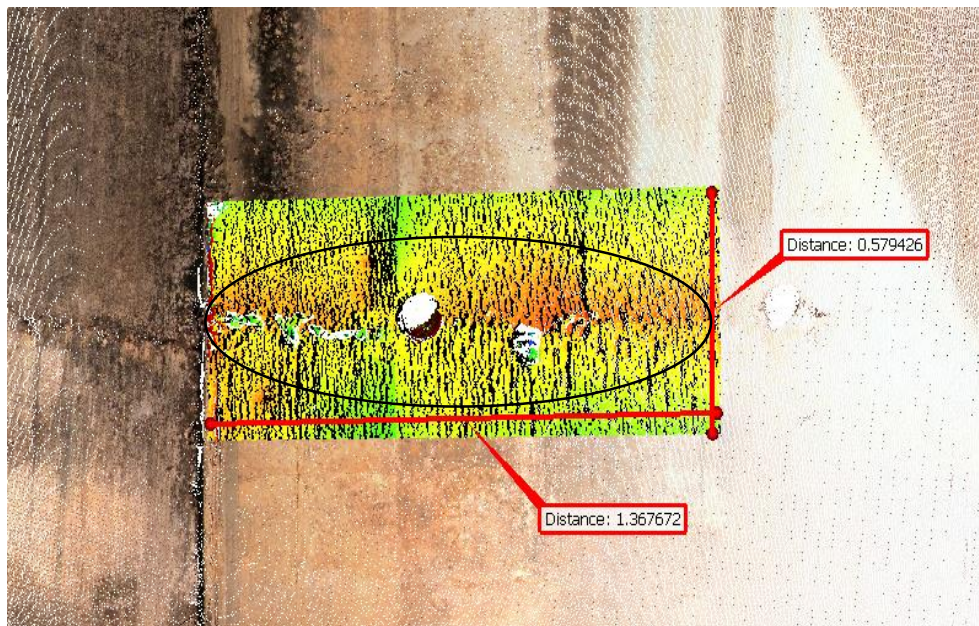
| Element Name | Observation | Location of Distress | Photo No. | Units | Distress Details | | | Area of Repair (Sq.m/R MT/m3) |
|---|---|---|---|---|---|---|---|---|
| Abutment 2 | Scaling | | 3 | M | 1.36 | 0.57 | | 0.7752 |

**3. Scaling observed on Abutment 2 LHS , measuring 1.36 m in length and 0.57 m in width, covering an area of 0.7752 m<sup>2</sup>.**

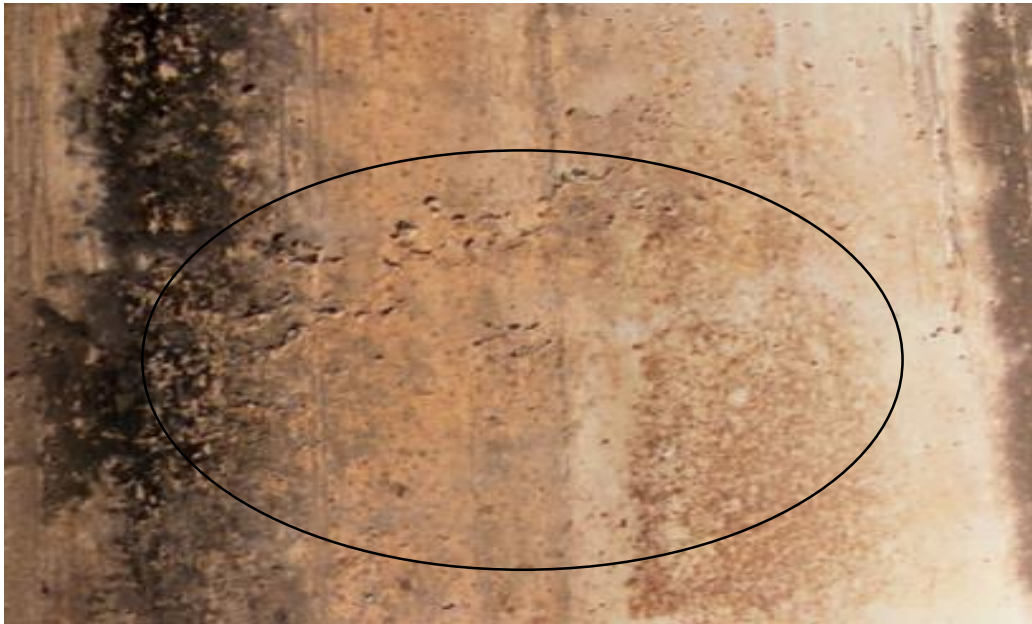
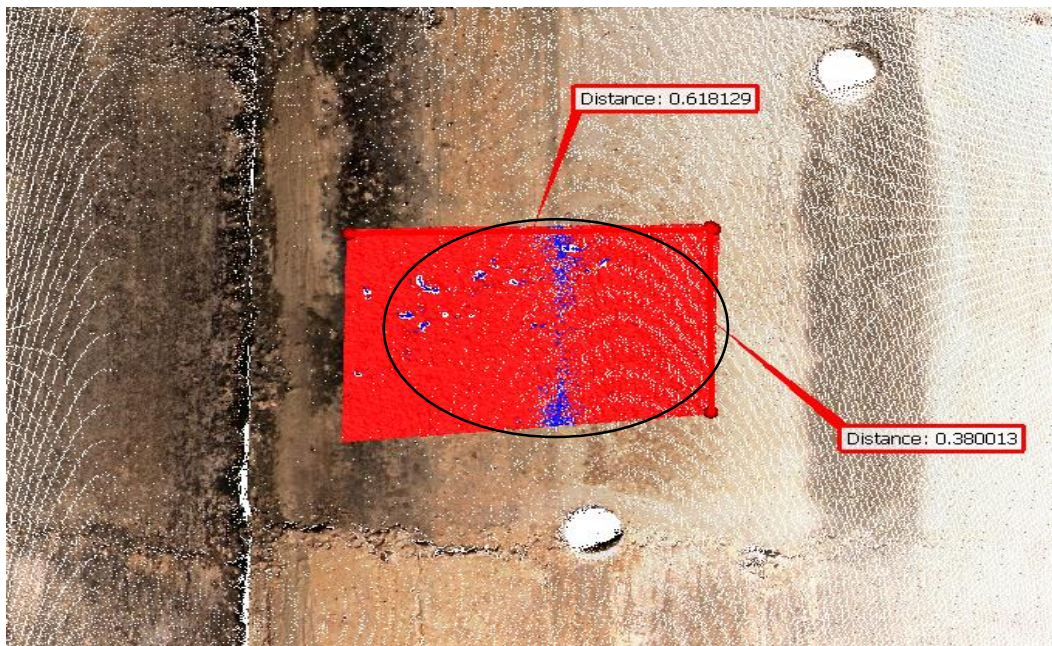
| Element Name | Observation | Location of Distress | Photo No. | Units | Distress Details | | | Area of Repair (Sq.m/R MT/m3) |
|---|---|---|---|---|---|---|---|---|
| Abutment 2 | Honey Combing | | 4 | M | 0.38 | 0.61 | | 0.2511 |

**4. Honeycombing observed on Abutment 2 LHS , measuring 0.38 m in length and 0.61 m in width, covering an area of 0.2511 m<sup>2</sup>.**

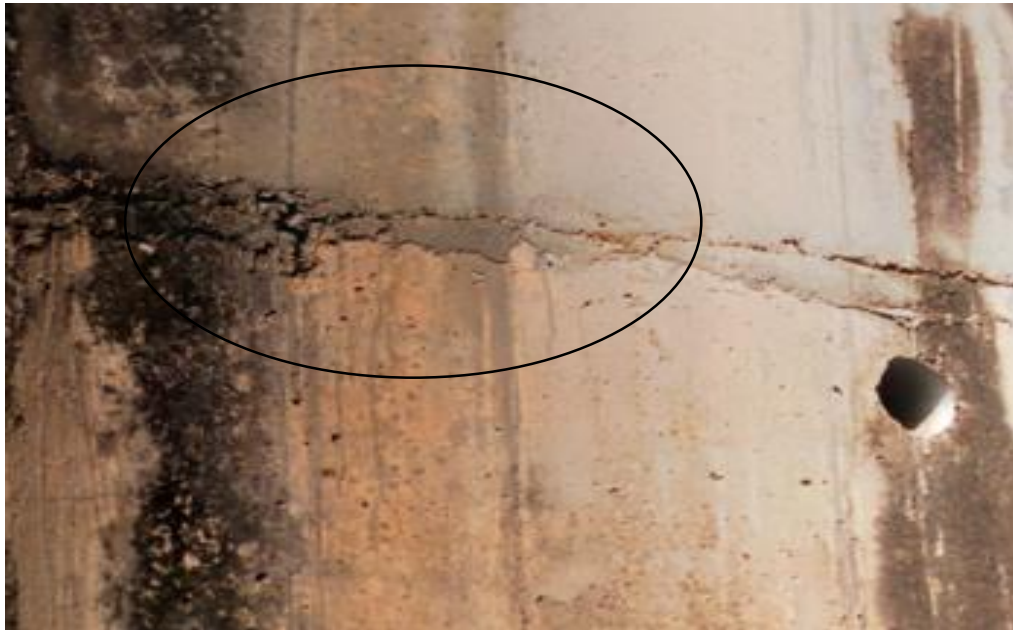
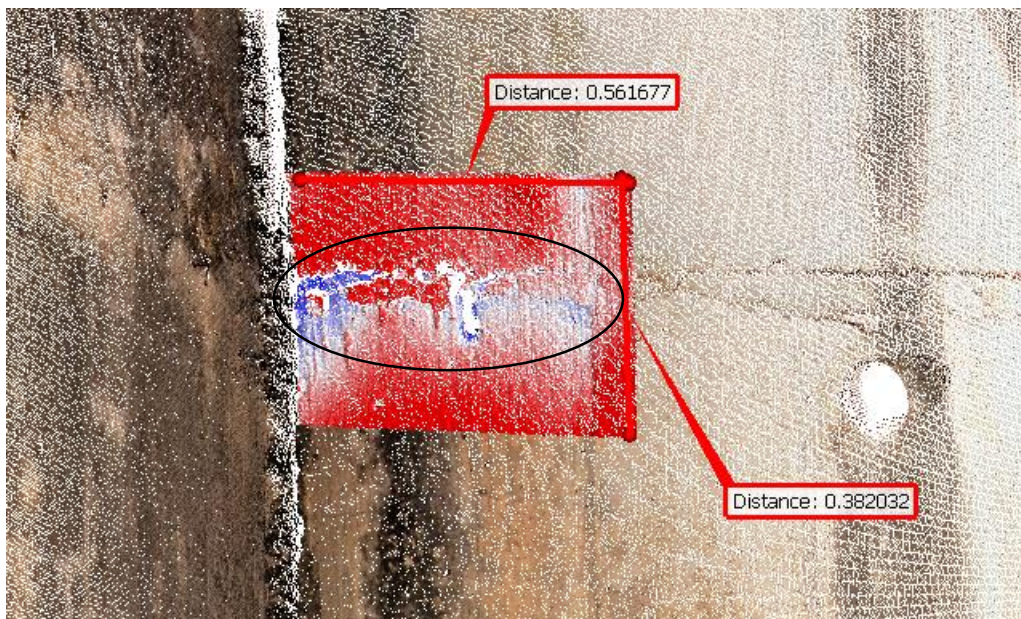
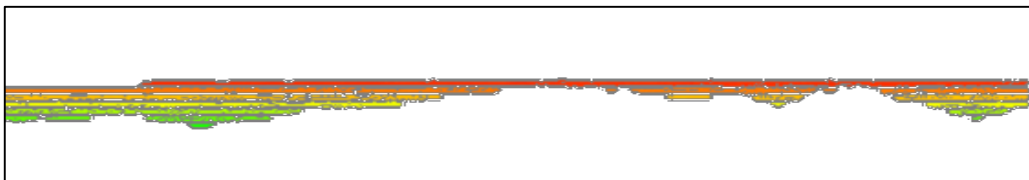
| Element Name | Observation | Location of Distress | Photo No. | Units | Distress Details | | | Area of Repair (Sq.m/R MT/m3) |
|---|---|---|---|---|---|---|---|---|
| Abutment 2 | Scaling | | 5 | M | 0.56 | 0.38 | | 0.2128 |

**5. Scaling observed on Abutment 2 LHS , measuring 0.56 m in length and 0.38 m in width, covering an area of 0.2128 m<sup>2</sup>.**

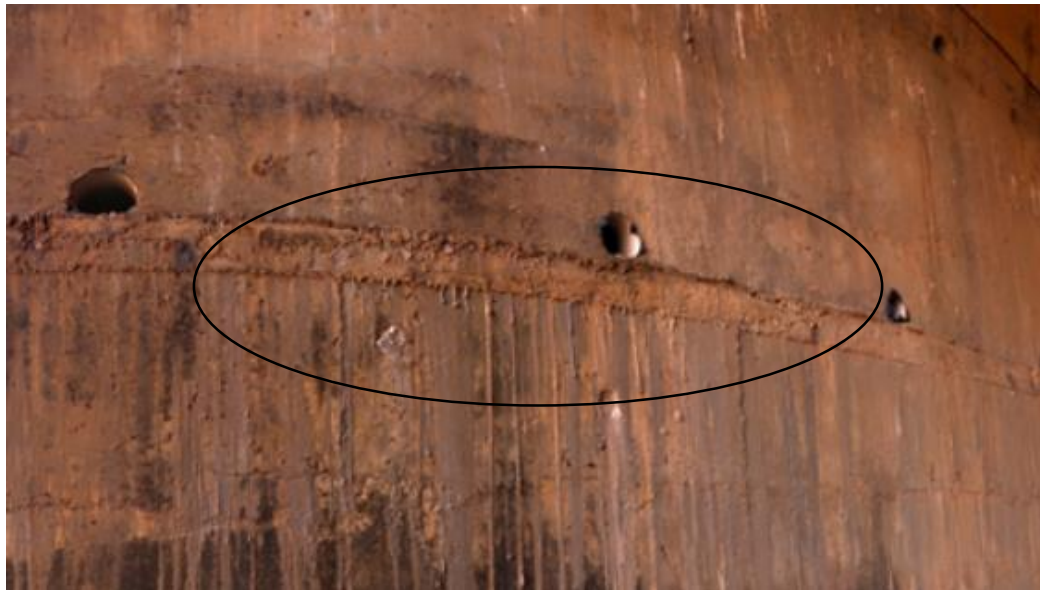
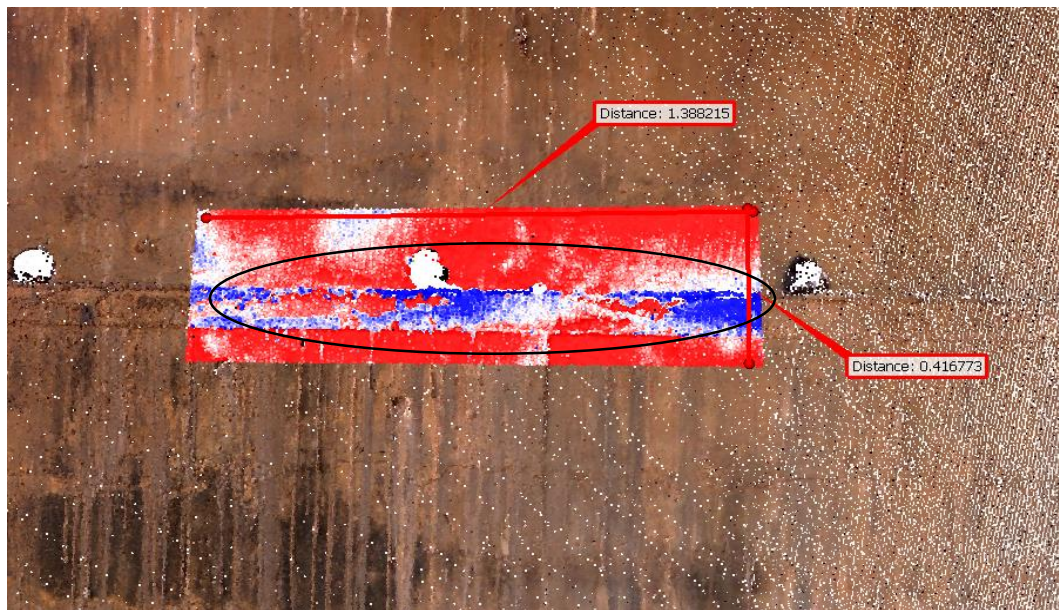
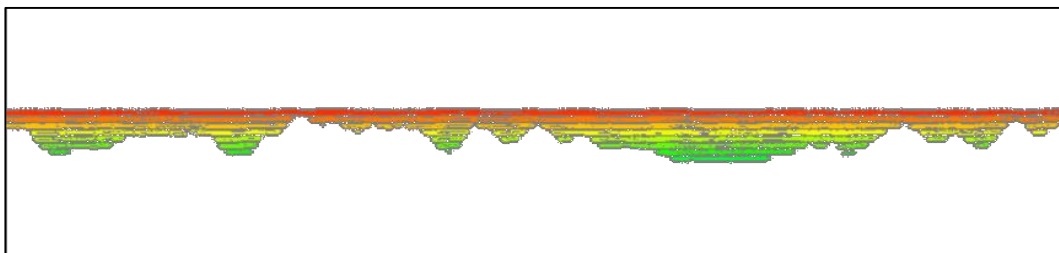
| Element Name | Observation | Location of Distress | Photo No. | Units | Distress Details | | | Area of Repair (Sq.m/R MT/m3) |
|---|---|---|---|---|---|---|---|---|
| Abutment 1 | Scaling | - | 4 | M | 1.38 | 0.41 | | 0.0722 |

**6. Scaling observed on Abutment 1 RHS , measuring 1.38 m in length and 0.41 m in width, covering an area of 0.5658 m<sup>2</sup>.**

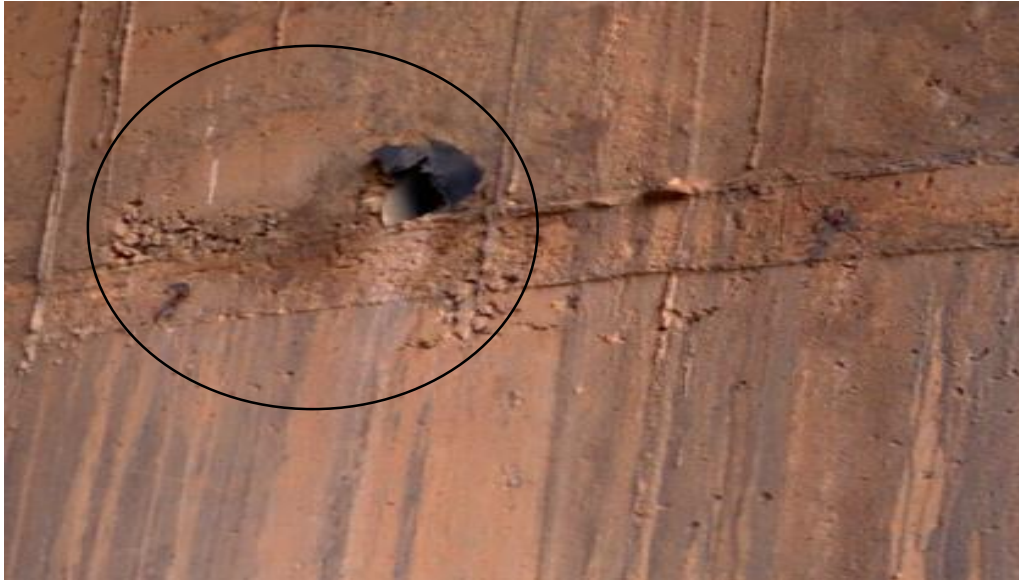
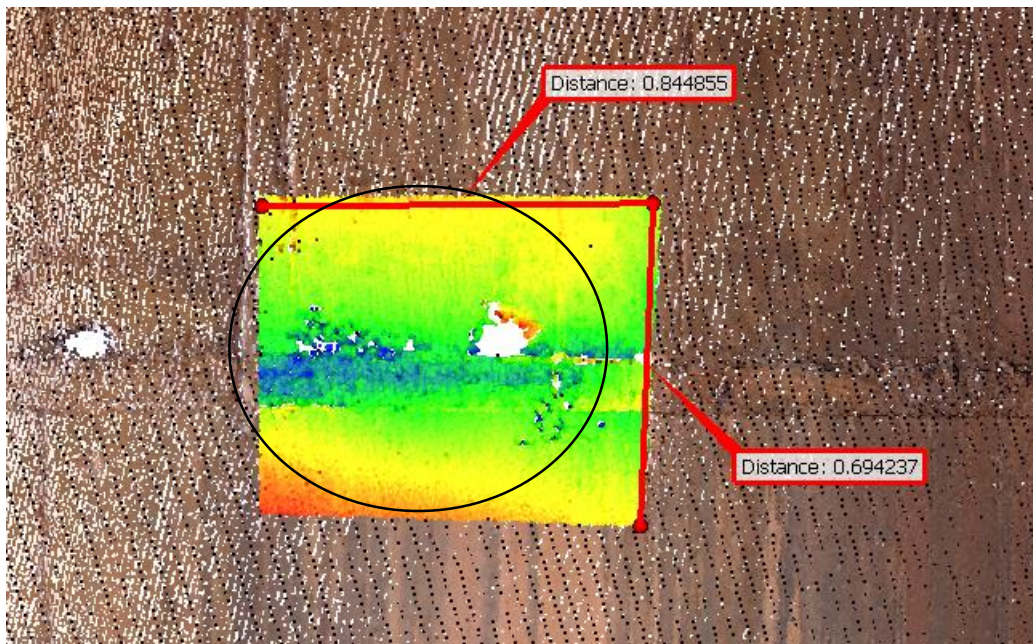
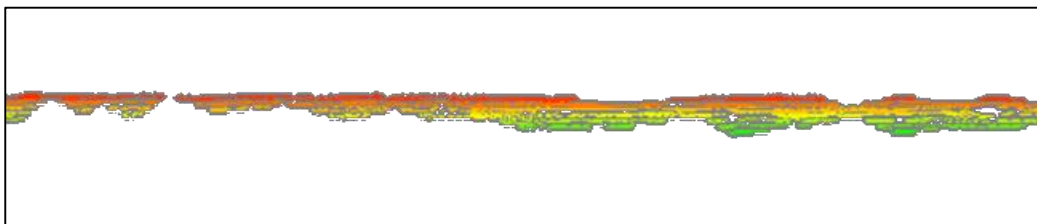
| Element Name | Observation | Location of Distress | Photo No. | Units | Distress Details | | | Area of Repair (Sq.m/R MT/m3) |
|---|---|---|---|---|---|---|---|---|
| Abutment 1 | Honey Combing | | 5 | M | 0.84 | 0.69 | | 0.5796 |

**7. Honeycombing observed on Abutment 1 RHS , measuring 0.84 m in length and 0.69 m in width, covering an area of 0.5796 m<sup>2</sup>.**

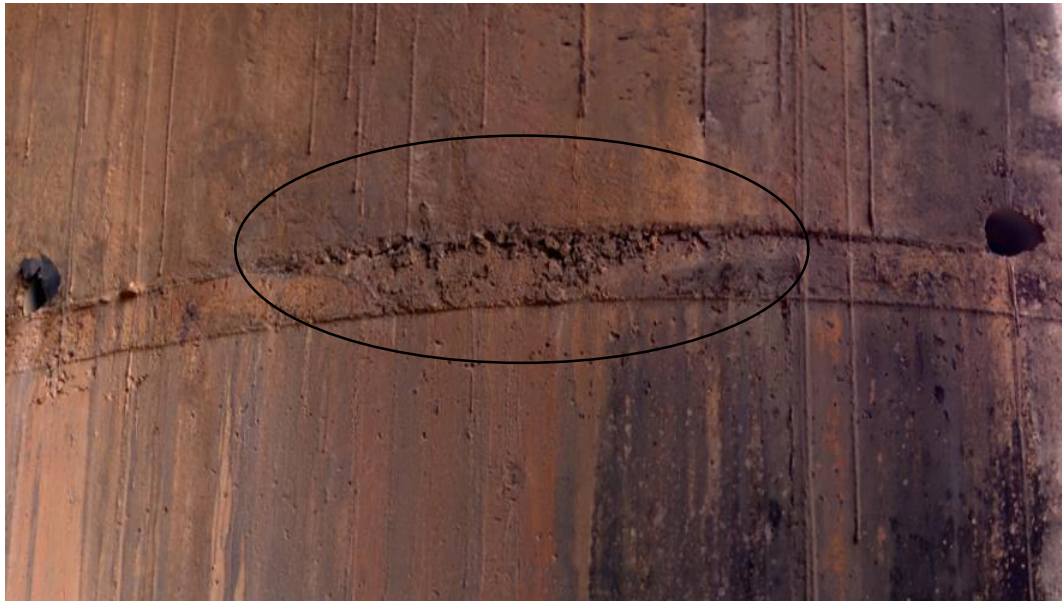
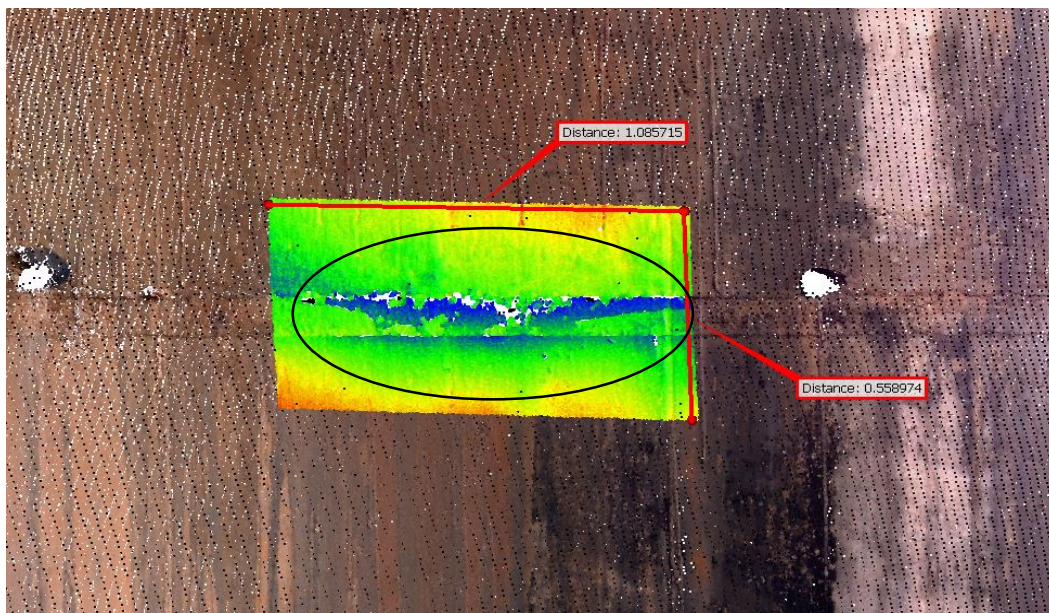
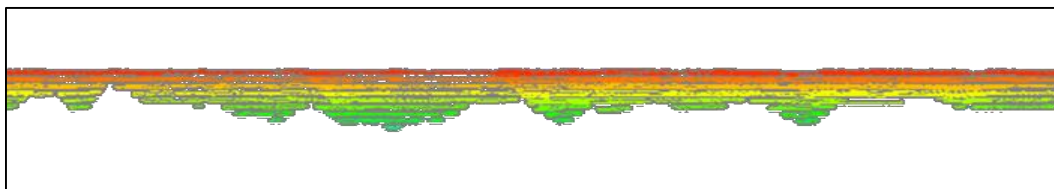
| Element Name | Observation | Location of Distress | Photo No. | Units | Distress Details | | | Area of Repair (Sq.m/R MT/m3) |
|---|---|---|---|---|---|---|---|---|
| Abutment 2 | Scaling | | 6 | M | 1.08 | 0.55 | | 0.594 |

**8. Scaling observed on Abutment 2 RHS , measuring 1.08 m in length and 0.55 m in width, covering an area of 0.5940 m<sup>2</sup>.**
