# **LIDAR Inspection Report of MJB ch.930+450**

**Bridge No:** 931/1

**Bridge Chainage:** 930+450

- **CKRP:** Chittorgarh to kota
- **State:** Rajasthan NH 27
- **Zone:** RJ-20

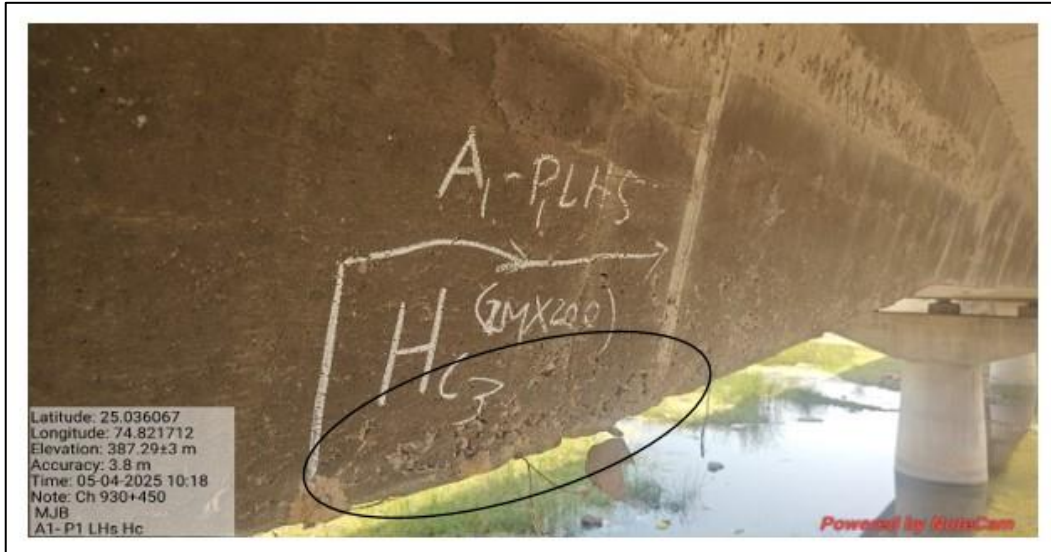
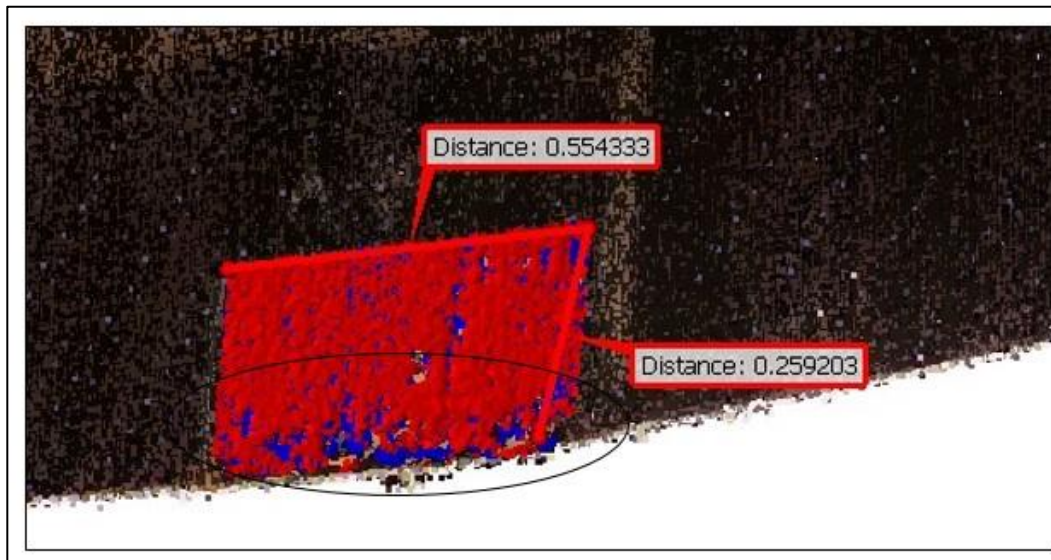
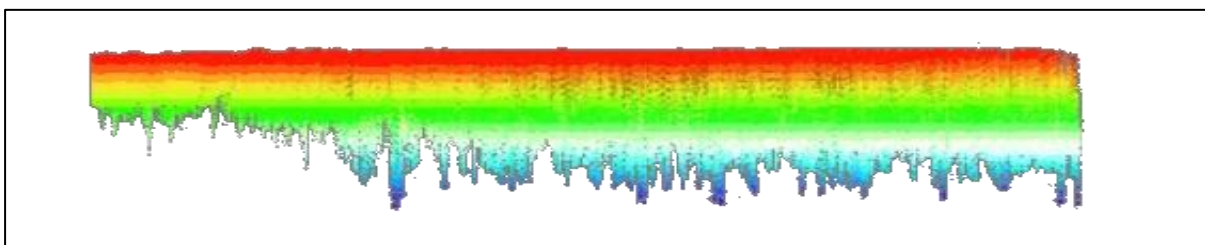
| Element Name | Observation | Location of Distress | Photo No. | Units | Distress Details | | | Area of Repair (Sq./RM T/m3) |
|---|---|---|---|---|---|---|---|---|
| Deck Slab | Honeycombing | - | 1 | Sq m | 0.55 | 0.25 | - | 0.137 |

**1.Honeycombing observed on Deck Slab at Pier 1 to Abutment 1 Span , measuring 0.55 m in length and 0.25 m in width, covering an area of 0.137 m<sup>2</sup>.**

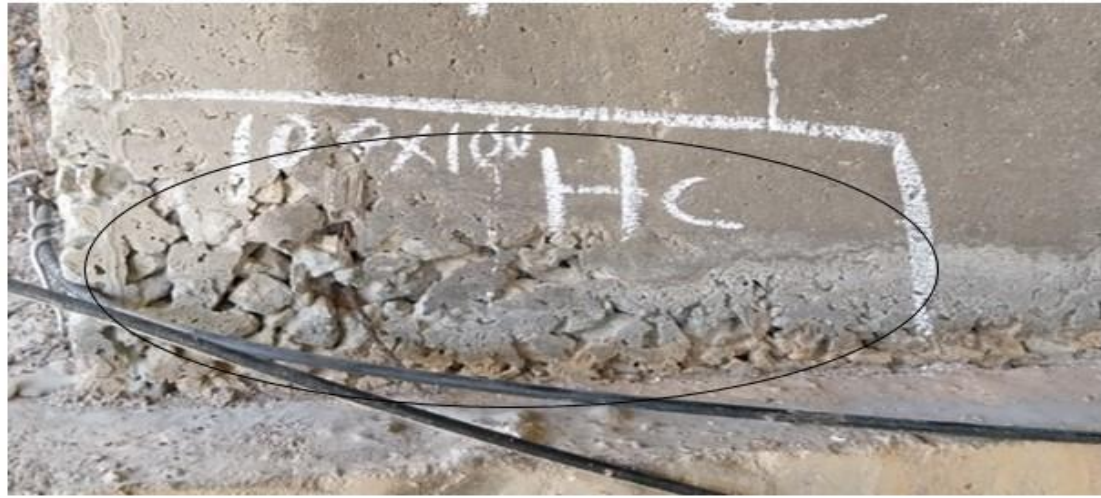
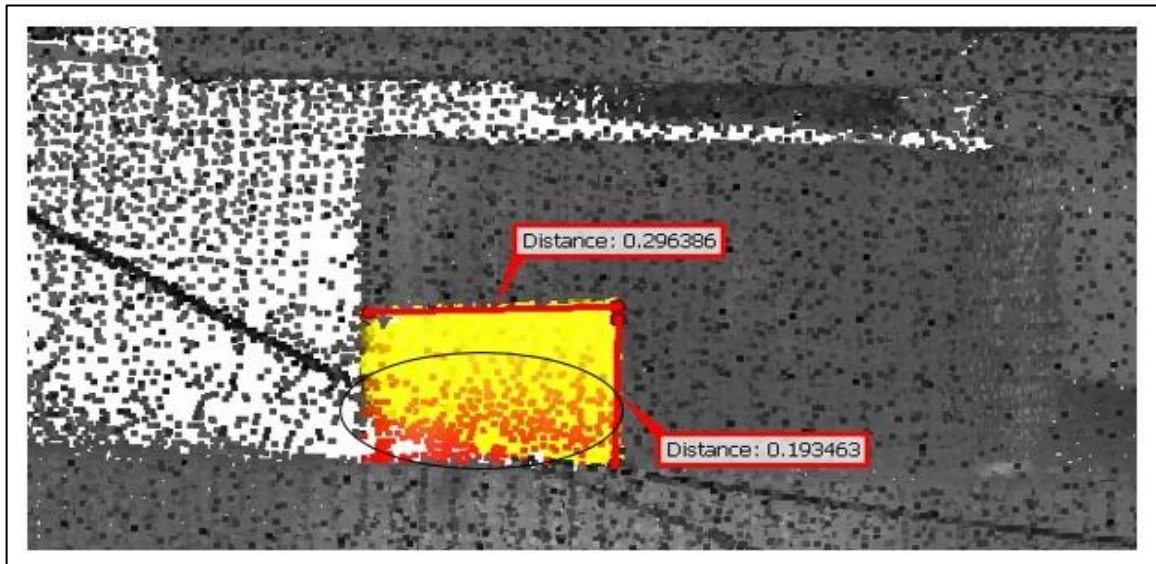
| Element Name | Observation | Location of Distress | Photo No. | Units | Distress Details | | | Area of Repair (Sq./RM T/m3) |
|---|---|---|---|---|---|---|---|---|
| Bearing | Honeycombing | - | 2 | Sq m | 0.29 | 0.19 | - | 0.055 |

**2.Honeycombing observed on Bearing 3 of Abutment Wall, measuring 0.29 m in length and 0.19 m in width, covering an area of 0.055 m<sup>2</sup>.**

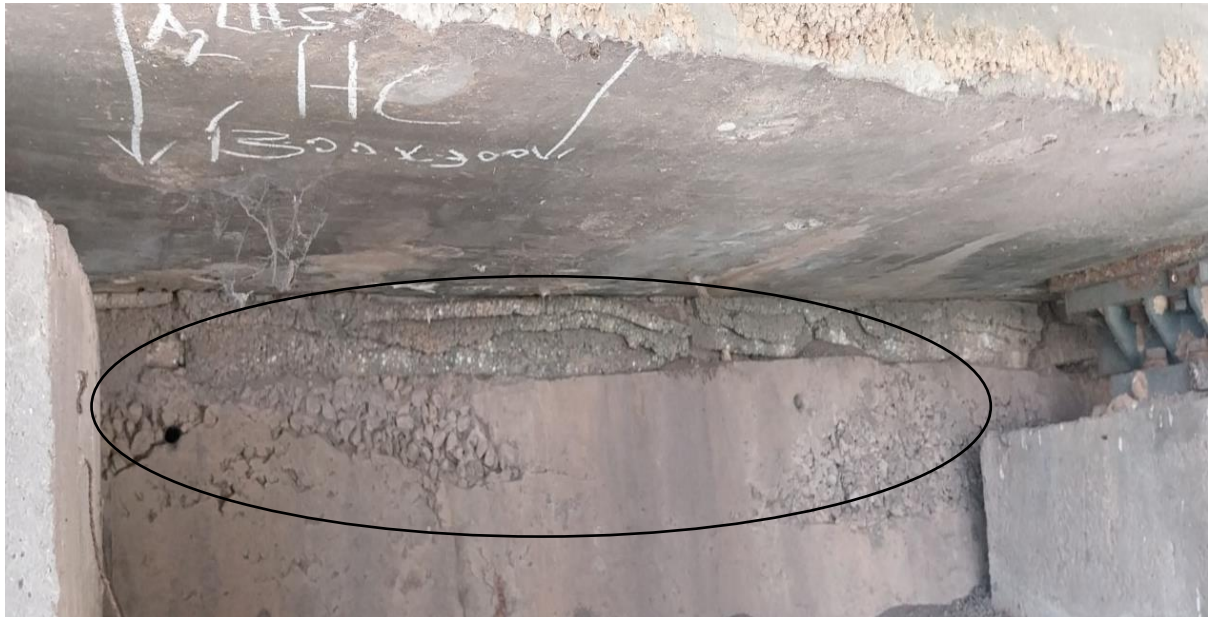
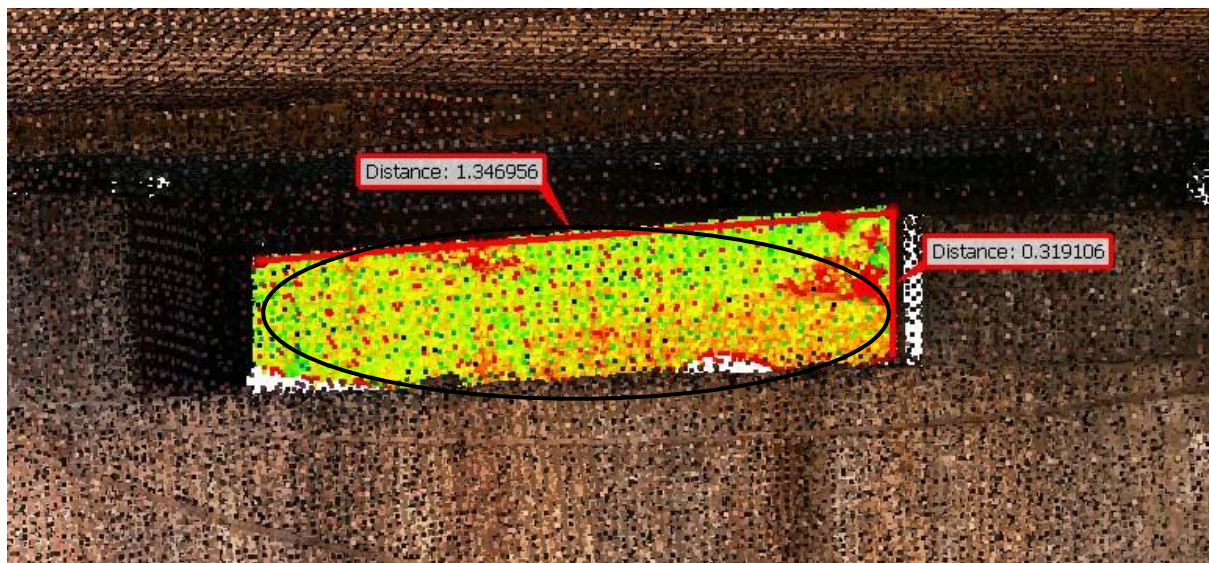
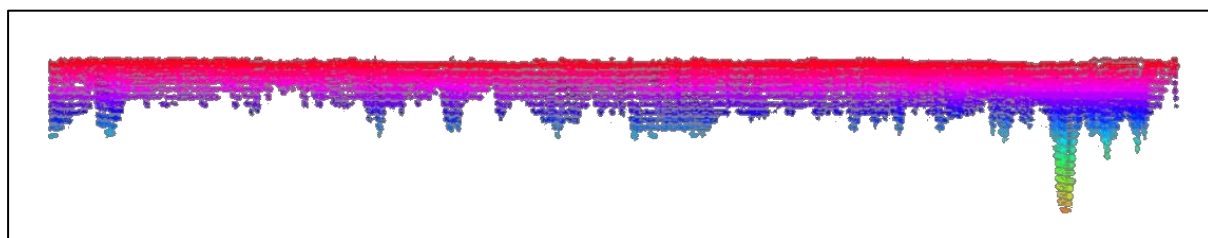
| Element Name | Observation | Location of Distress | Photo No. | Units | Distress Details | | | Area of Repair (Sq./RM T/m3) |
|---|---|---|---|---|---|---|---|---|
| Abutment 2 | Honeycombing | - | 3 | Sq m | 1.3 | 0.31 | - | 0.403 |

**3.Honeycombing observed on Abutment 2, measuring 1.3 m in length and 0.31 m in width, covering an area of 0.403 m<sup>2</sup>.**

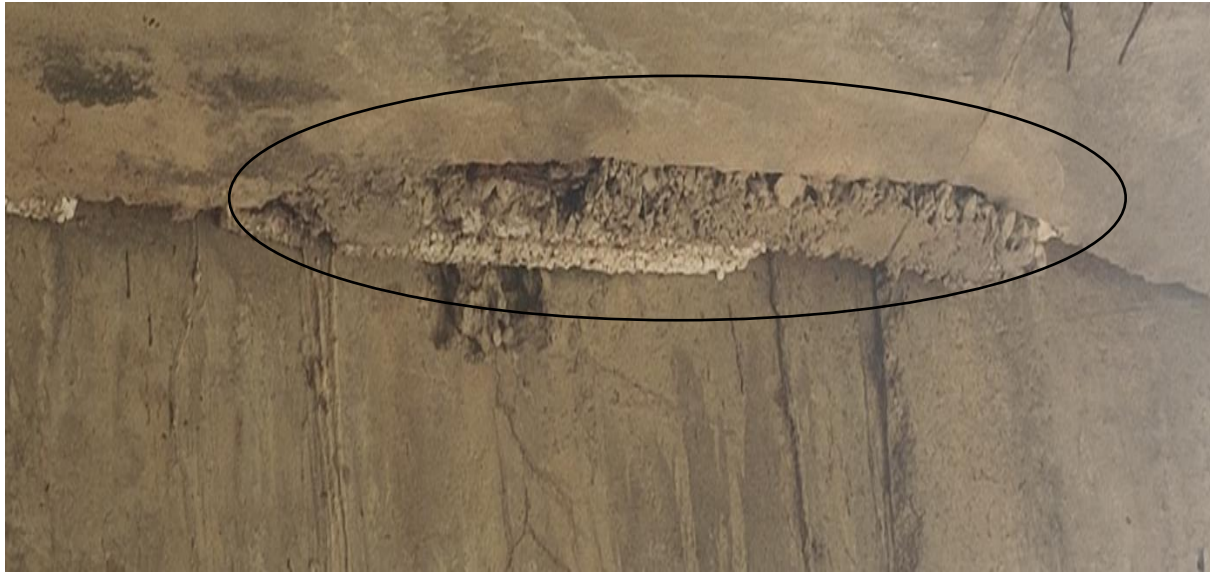
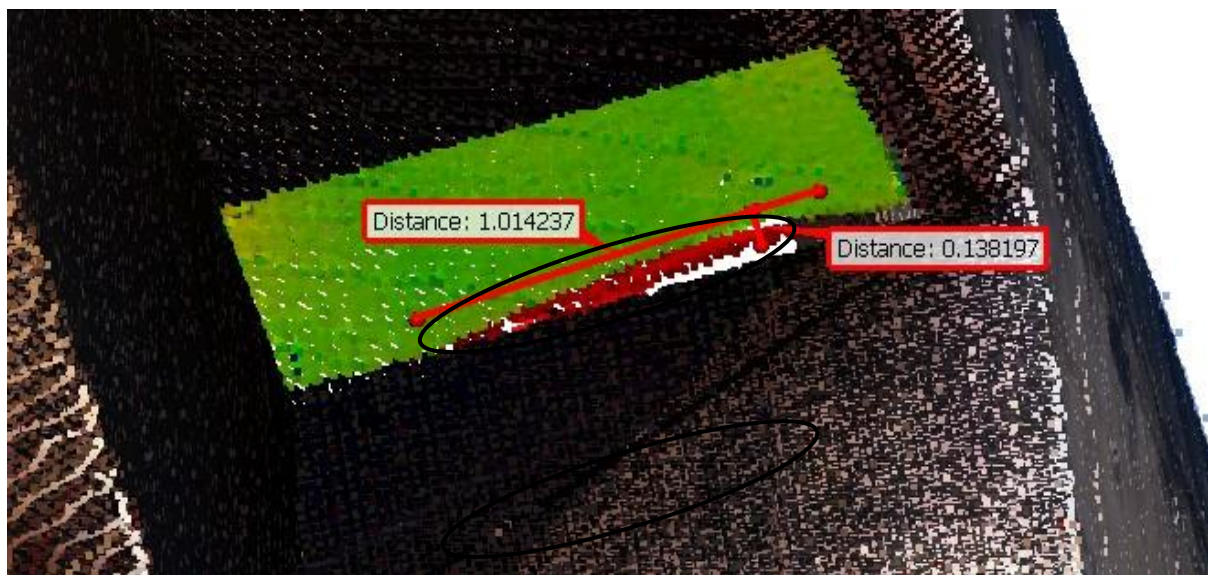
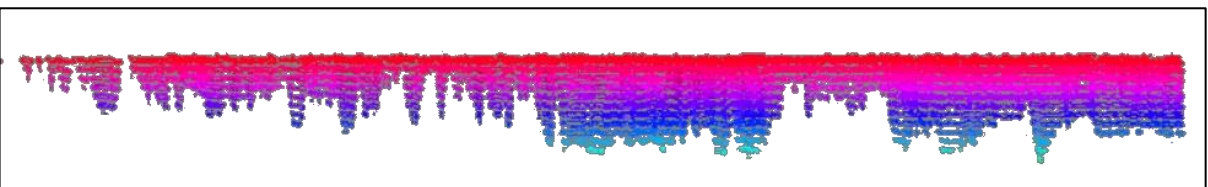
| Element Name | Observation | Location of Distress | Photo No. | Units | Distress Details | | | Area of Repair (Sq./RM T) |
|---|---|---|---|---|---|---|---|---|
| Abutment 2 | Steel Exposed | - | 4 | Cu m | 1.01 | 0.13 | 0.023 | 0.003 |

**4. Steel exposed observed on Abutment 2, measuring 1.01 m in length and 0.13 m in width. Depth ranges from 0.019 m (min) to 0.038 m (max), with an average depth of 0.023 m. The calculated area of the distress is 0.003 m<sup>2</sup>.**

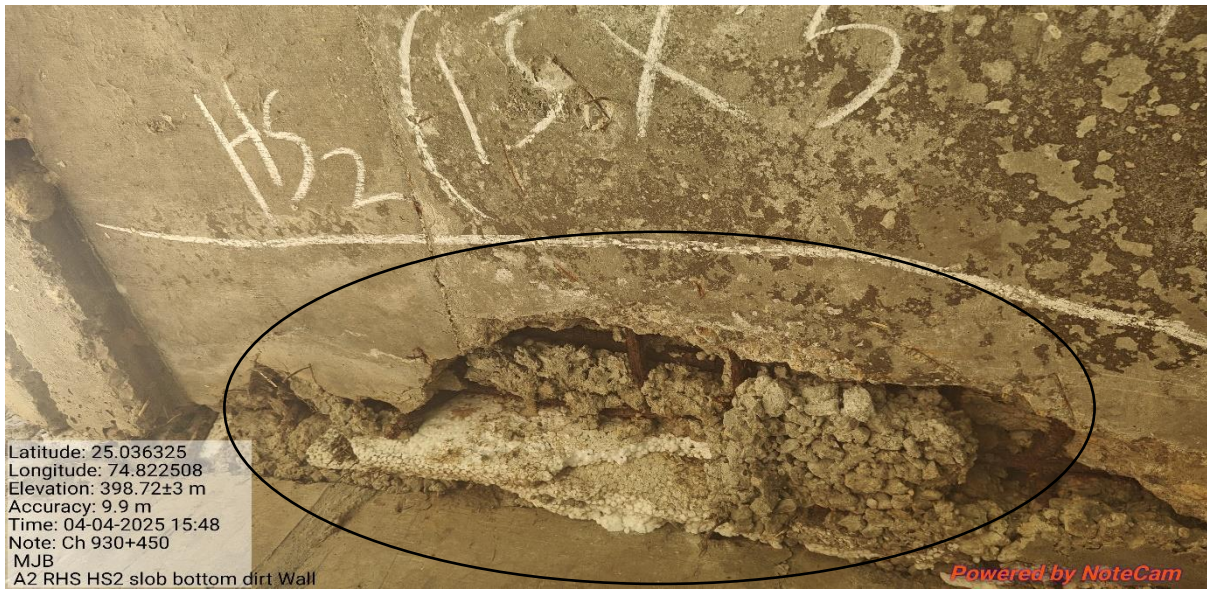
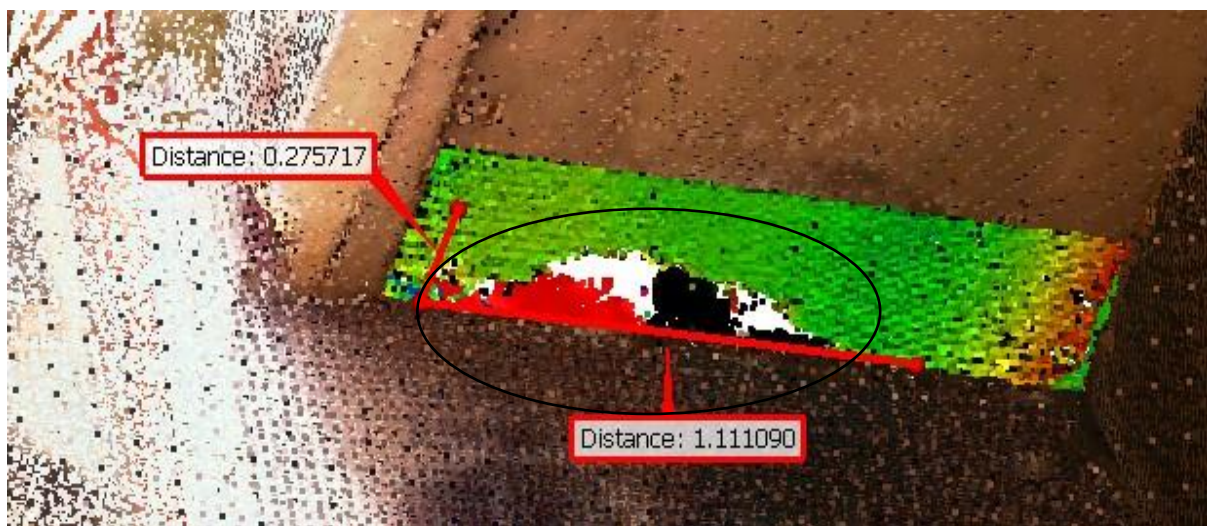
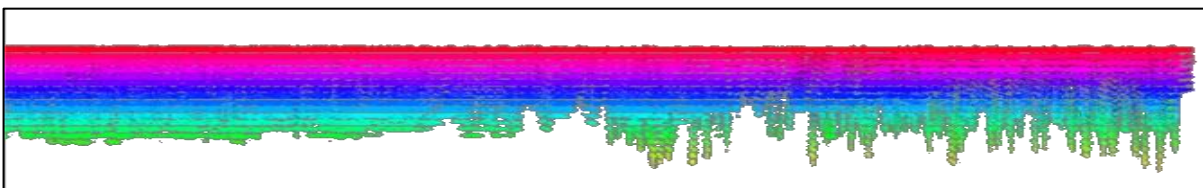
| Element Name | Observation | Location of Distress | Photo No. | Units | Distress Details | | | Area of Repair (Sq./RM T) |
|---|---|---|---|---|---|---|---|---|
| Slab Bottom | Hollow Section | - | 5 | Cu m | 1.11 | 0.27 | 0.003 | 0.0008 |

**5. Hollow section observed on Abutment 2 slab bottom, measuring 1.11 m in length and 0.27 m in width. Depth ranges from 0.002 m (min) to 0.005 m (max), with an average depth of 0.003 m. The calculated area of the distress is 0.0008 m<sup>3</sup>.**

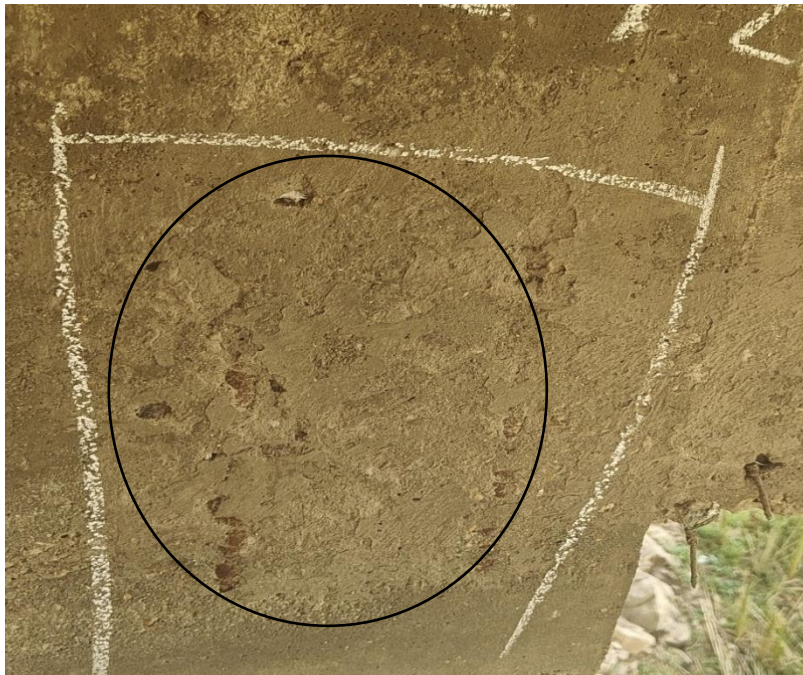
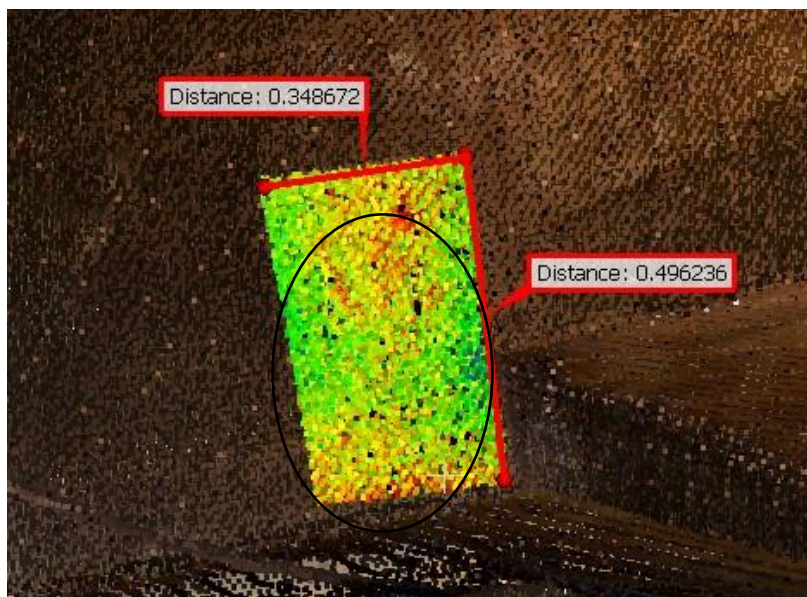
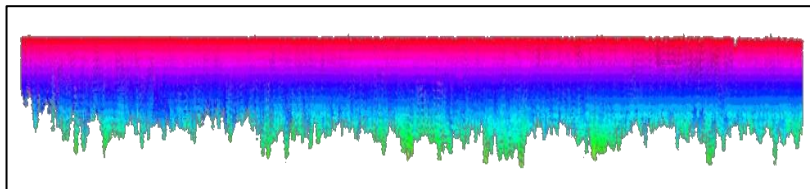
| Element Name | Observation | Location of Distress | Photo No. | Units | Distress Details | | | Area of Repair (Sq./RM T) |
|---|---|---|---|---|---|---|---|---|
| Girder | Steel Exposed | - | 6 | Sq m | 0.49 | 0.34 | - | 0.16 |

**6. Steel exposed observed on Abutment Girder RHS side, measuring 0.49 m in length and 0.34 m in width, covering an area of 0.16 m<sup>2</sup>.**

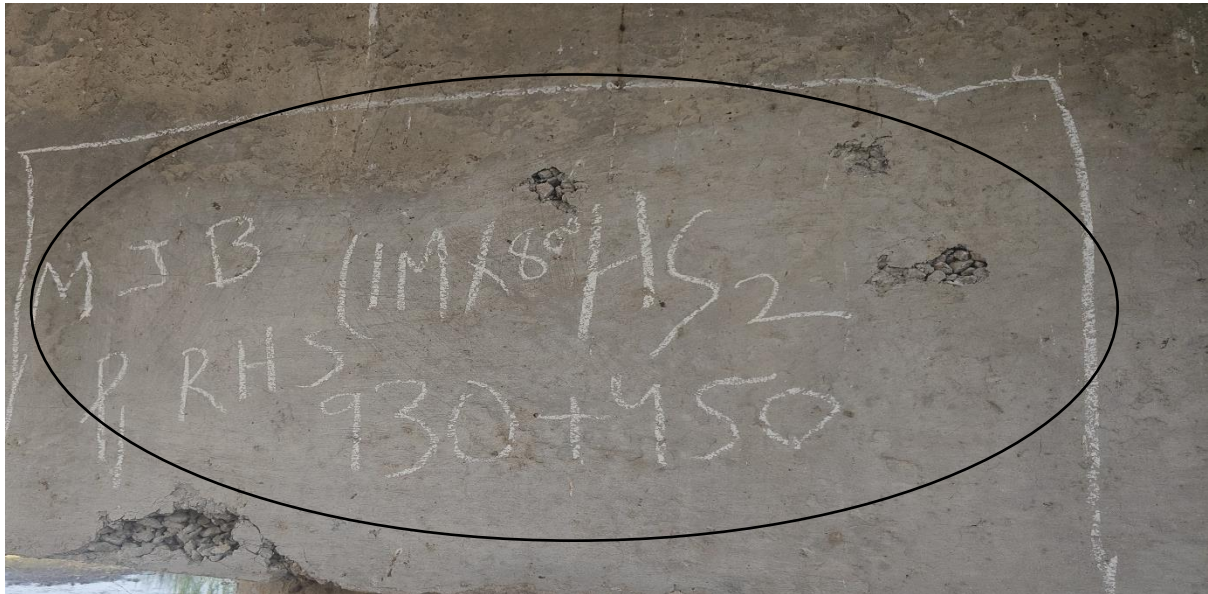
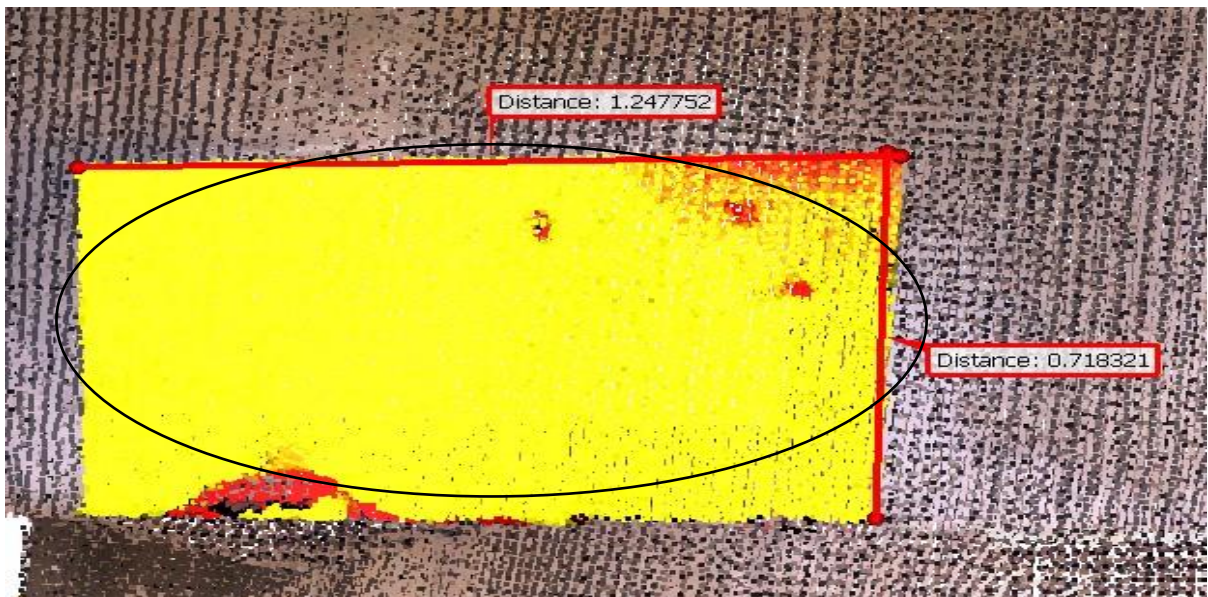
| Element Name | Observation | Location of Distress | Photo No. | Units | Distress Details | | | Area of Repair (Sq./RM T) |
|---|---|---|---|---|---|---|---|---|
| Pier Cap | Hollow Section | - | 7 | Cu m | 1.24 | 0.71 | 0.0532 | 0.04683 |

**7. Hollow section observed on Pier Cap, measuring 1.24 m in length and 0.71 m in width, Depth is 0.0532 m.**
