# LIDAR Inspection Report of **Slab Culvert** ch.931+225

**Bridge Chainage:** 931 +225 (CKRP)

- **CKRP:** Chittorgarh to kota
- **State:** Rajasthan NH 27
- **Zone:** RJ-06

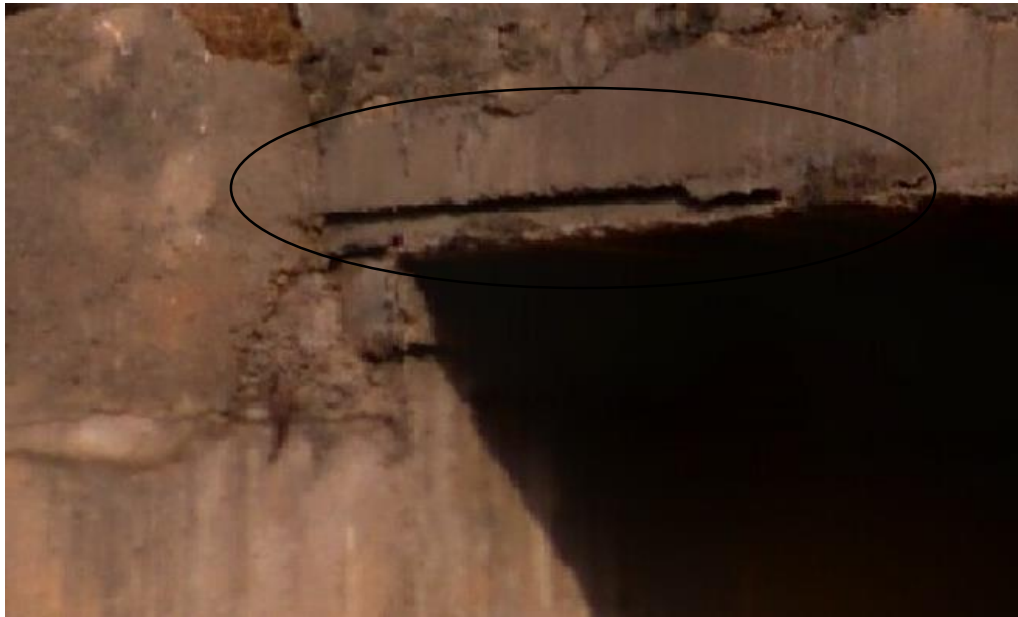
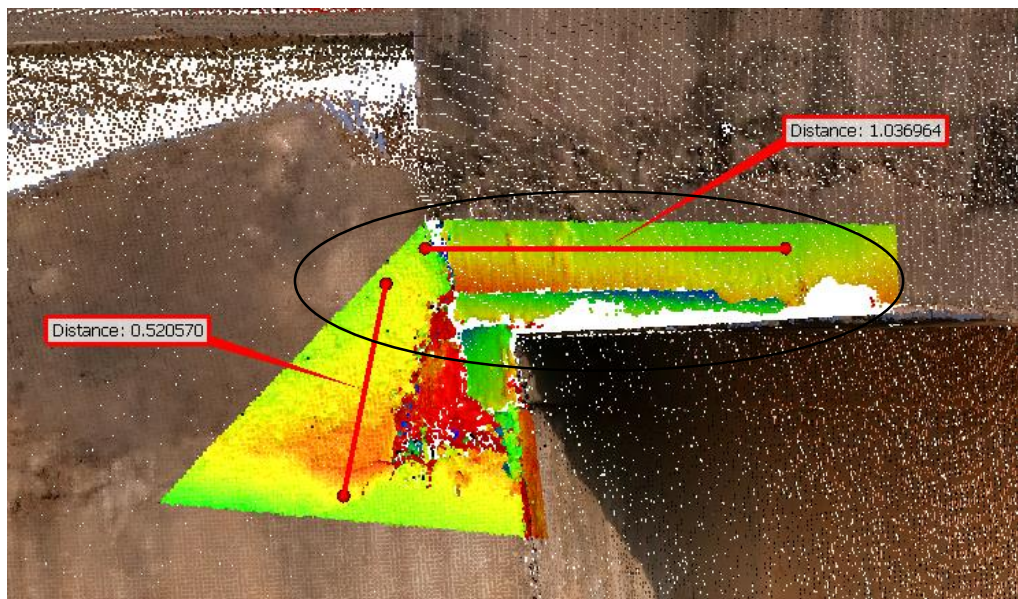
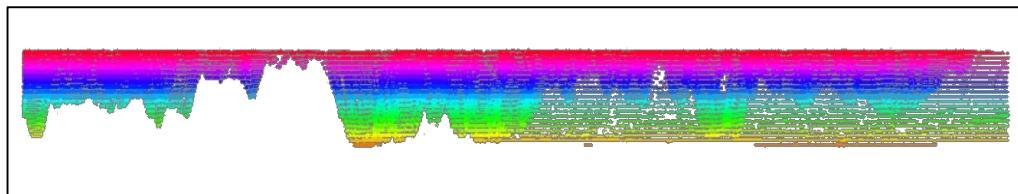
| Element Name | Observation | Location of Distress | Photo No. | Units | Distress Details | | | Area of Repair (Sq.m/R MT/m3) |
|---|---|---|---|---|---|---|---|---|
| Abutment 1 | Scaling | | 1 | M | 1.03 | 0.52 | | 0.5356 |

1. Scaling observed on LHS , measuring 1.03 m in length and 0.52 m in width, covering an area of 0.5356 m<sup>2</sup>

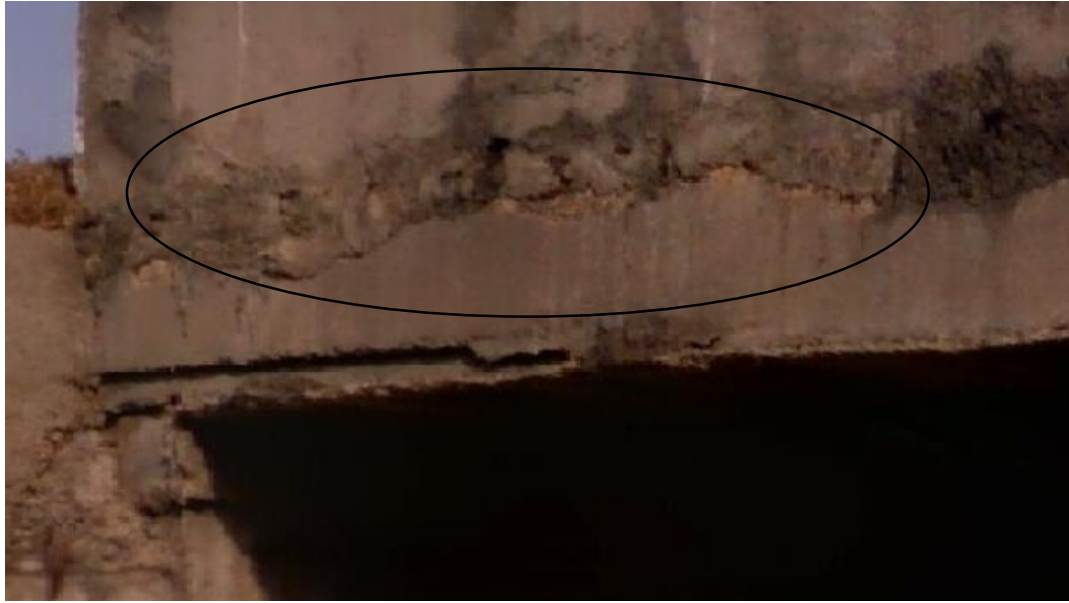
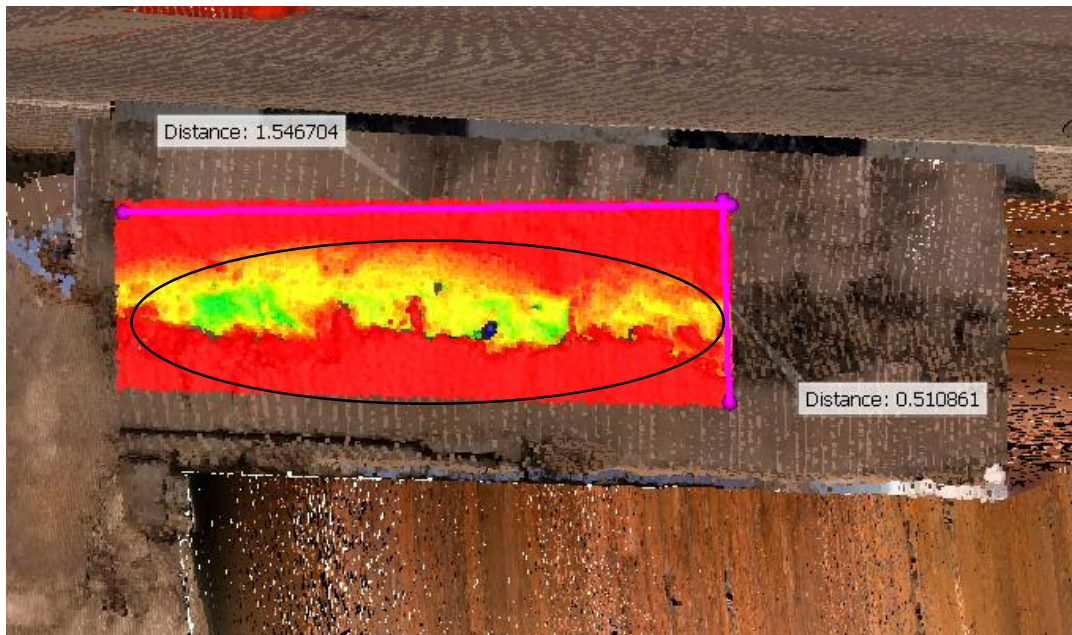
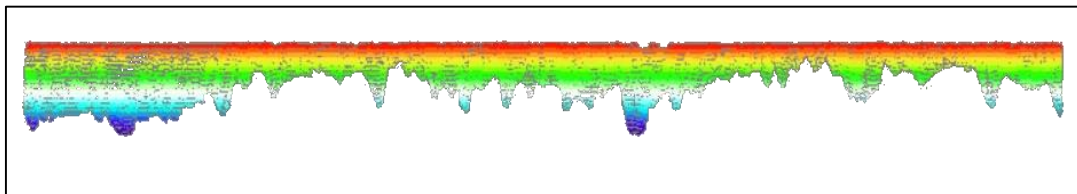
| Element Name | Observation | Location of Distress | Photo No. | Units | Distress Details | | | Area of Repair (Sq.m/R MT/m3) |
|---|---|---|---|---|---|---|---|---|
| Abutment 1 | Scaling | | 2 | M | 1.54 | 0.51 | | 0.7854 |

**2. Scaling observed on LHS , measuring 1.54 m in length and 0.51 m in width, covering an area of 0.7854 m<sup>2</sup>**

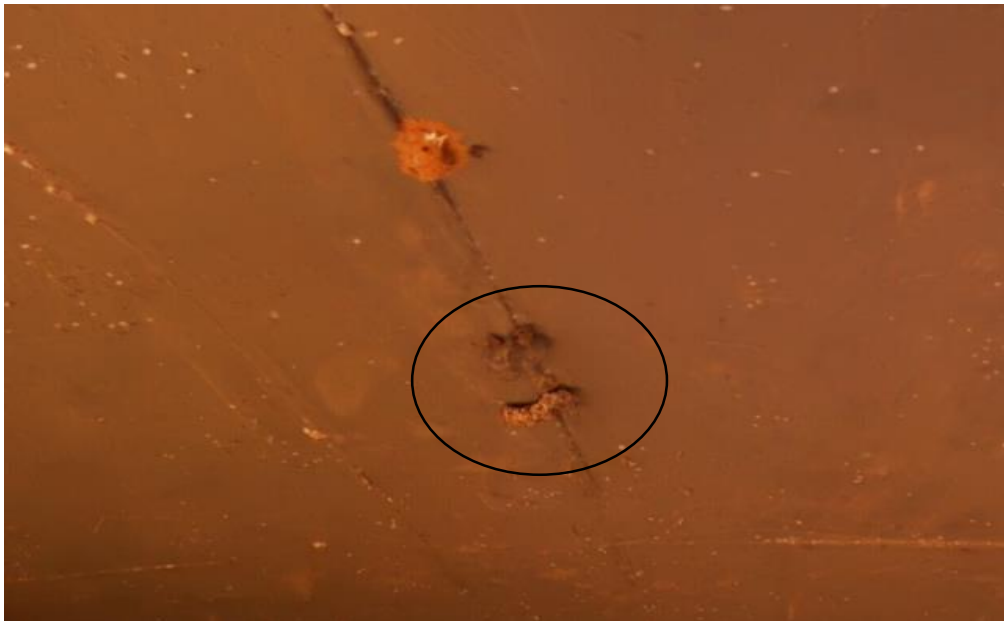
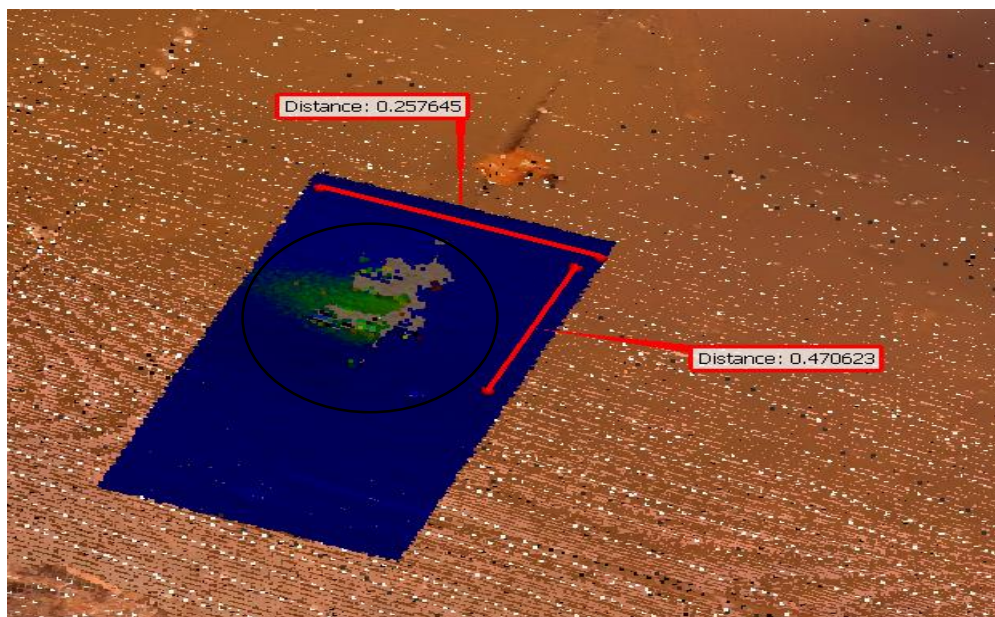
| Element Name | Observation | Location of Distress | Photo No. | Units | Distress Details | | | Area of Repair (Sq.m/R MT/m3) |
|---|---|---|---|---|---|---|---|---|
| Slab Bottom | Scaling | | 3 | M | 0.47 | 0.25 | | 0.1175 |

**3. Scaling observed on LHS Slab Bottom , measuring 0.47 m in length and 0.25 m in width, covering an area of 0.1175 m<sup>2</sup>.**

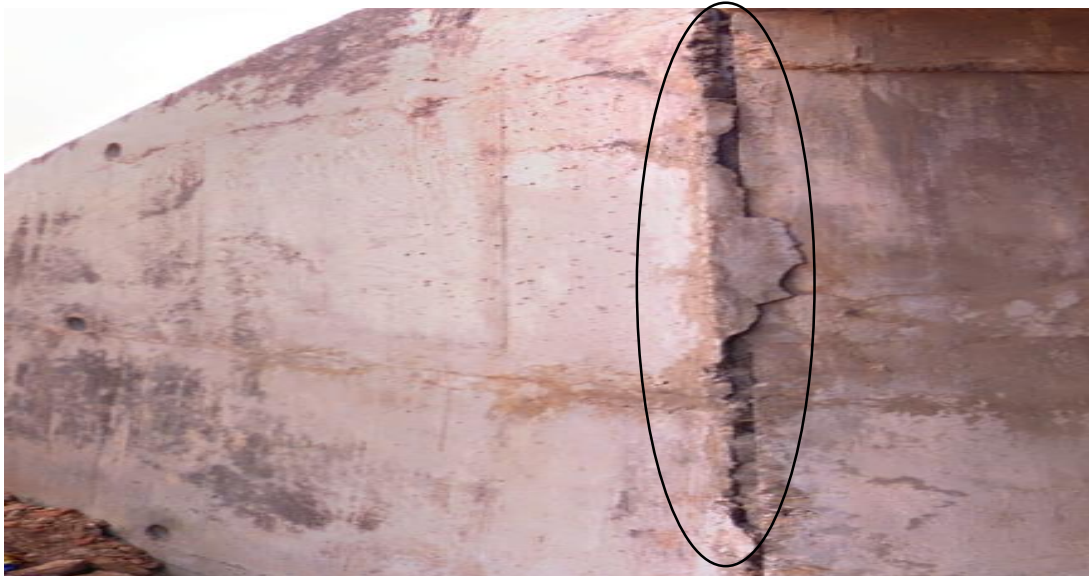
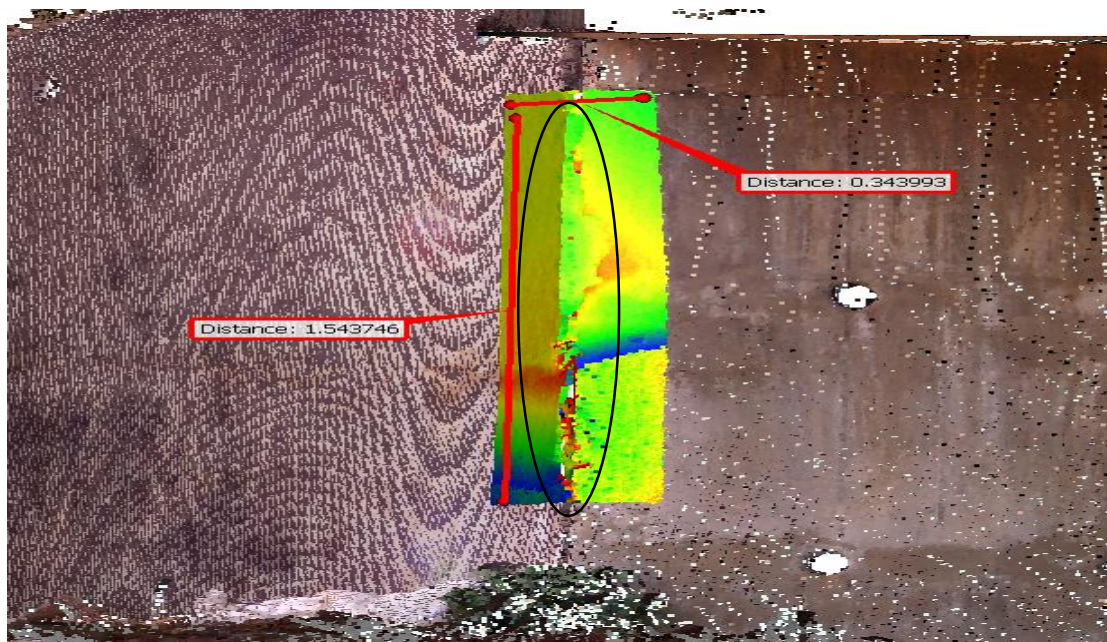
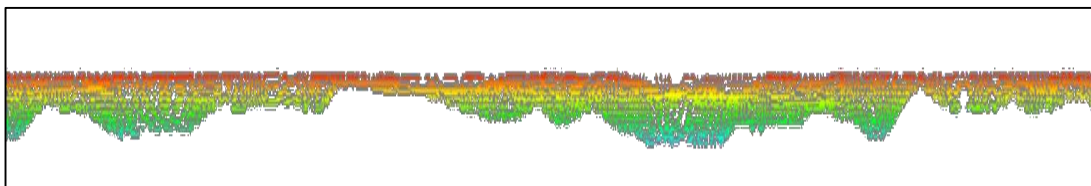
| Element Name | Observation | Location of Distress | Photo No. | Units | Distress Details | | | Area of Repair (Sq.m/R MT/m3) |
|---|---|---|---|---|---|---|---|---|
| Abutment 2 | Scaling | | 5 | M | 1.54 | 0.34 | | 0.5236 |

**5. Scaling observed on RHS , measuring 1.54 m in length and 0.34 m in width, covering an area of 0.5236 m<sup>2</sup>**
