# **LIDAR Inspection Report of VUP ch.932 + 120**

**Bridge Chainage:** 932 +120 (CKRP)

- **Bridge No:** -
- **Chainage:** 932 +120
- **Structure type:** VUP

- **CKRP:** Chittorgarh to kota
- **State:** Rajasthan NH 27
- **Zone:** RJ-06

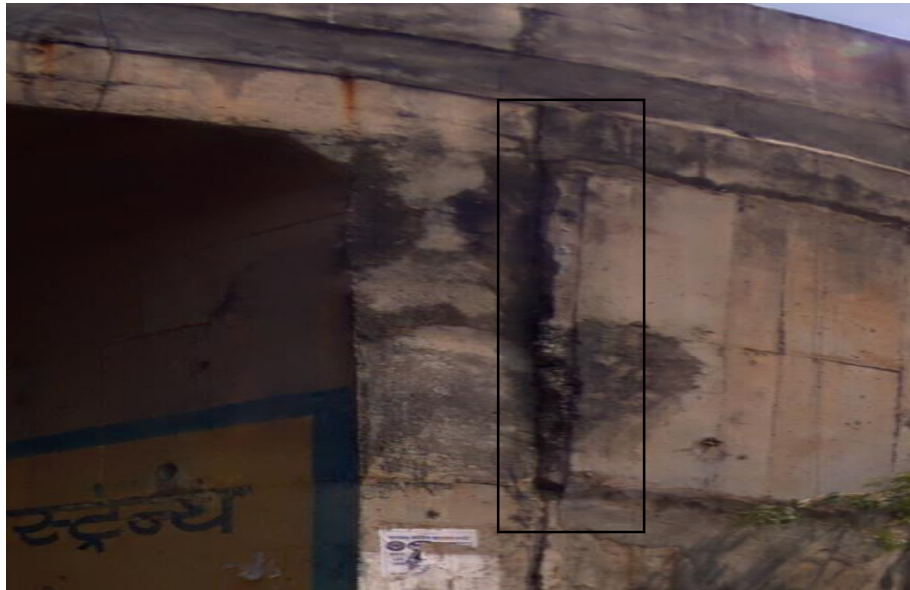
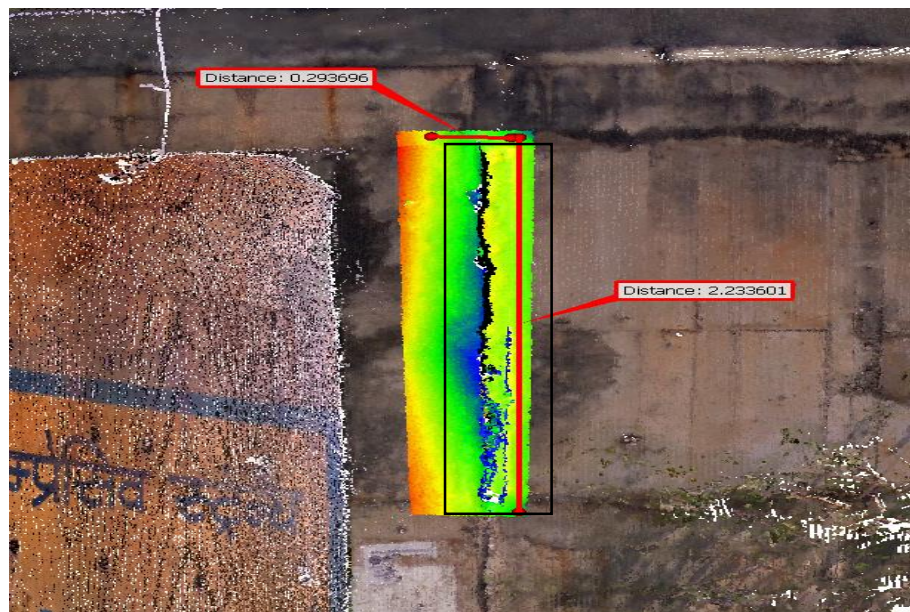
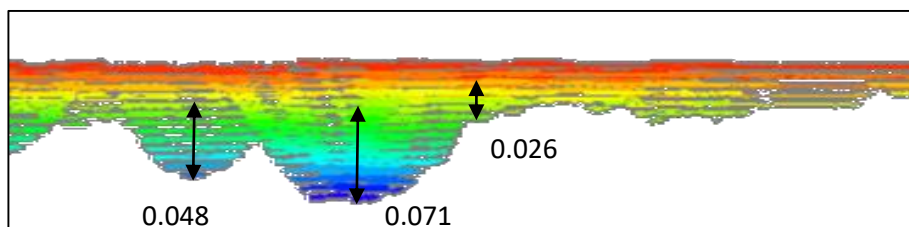
| Element Name | Observation | Location of Distress | Photo No. | Units | Distress Details | | | Area of Repair (Sq.m/ RMT/ m3) |
|---|---|---|---|---|---|---|---|---|
| Wing Wall | Damage | | 1 | M | 2.23 | 0.29 | 0.048 | 0.0310 |

**1. Damage observed on LHS Wing Wall 1, measuring 2.23 m in length and 0.29 m in width, Depth ranges from 0.026 m (min) to 0.071 m (max), with an average depth of 0.048 m. The calculated volume of the distress is 0.0310 m<sup>3</sup>.**

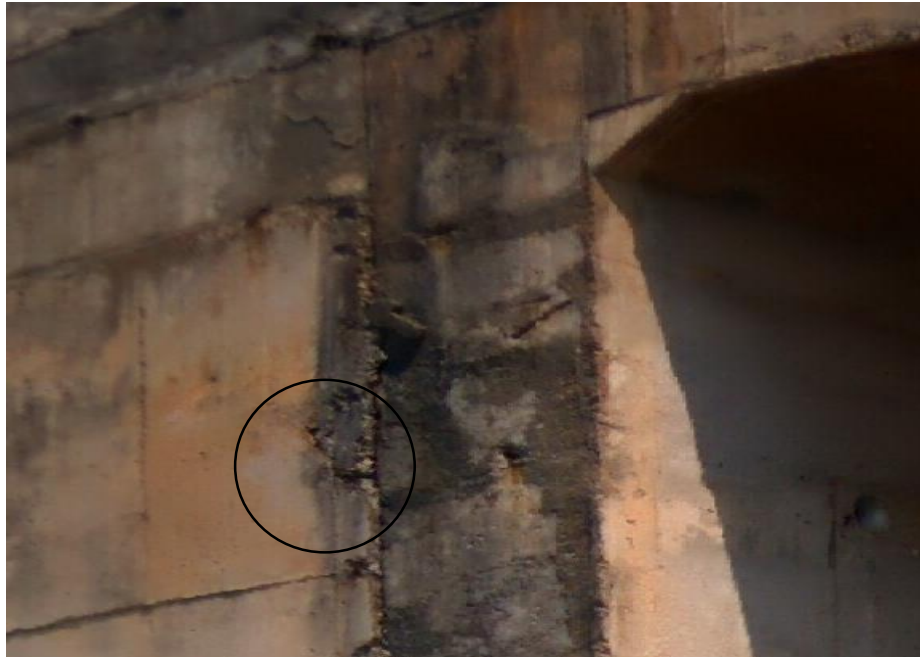
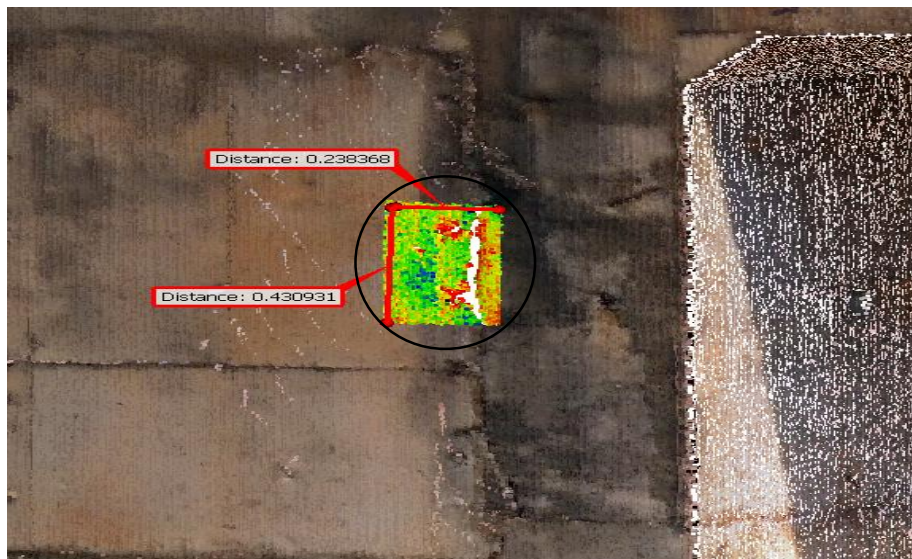
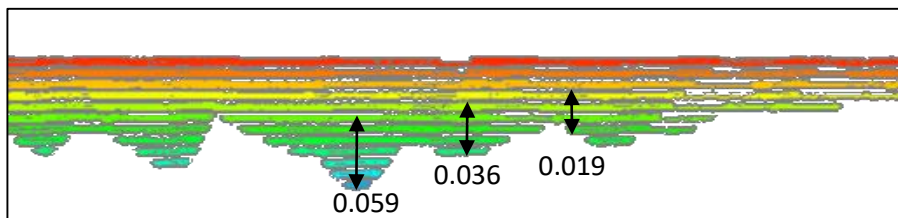
| Element Name | Observation | Location of Distress | Photo No. | Units | Distress Details | | | Area of Repair (Sq.m/ RMT/ m3) |
|---|---|---|---|---|---|---|---|---|
| Wing Wall | Damage | | 2 | M | 0.43 | 0.23 | 0.036 | 0.0989 |

**2. Damage observed on Abutment 2 LHS Wing Wall 1, measuring 0.43 m in length and 0.23 m in width, Depth ranges from 0.019 m (min) to 0.059 m (max), with an average depth of 0.036 m. The calculated volume of the distress is 0.0035 m<sup>3</sup>.**

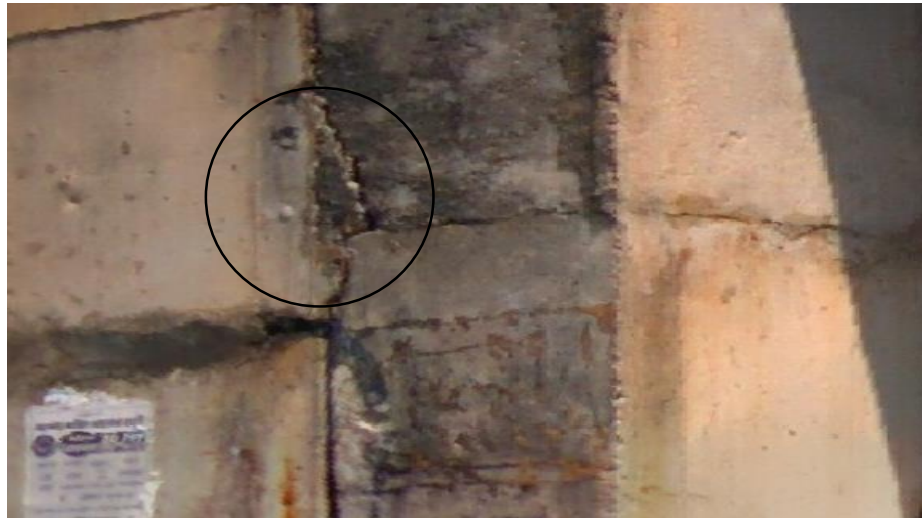
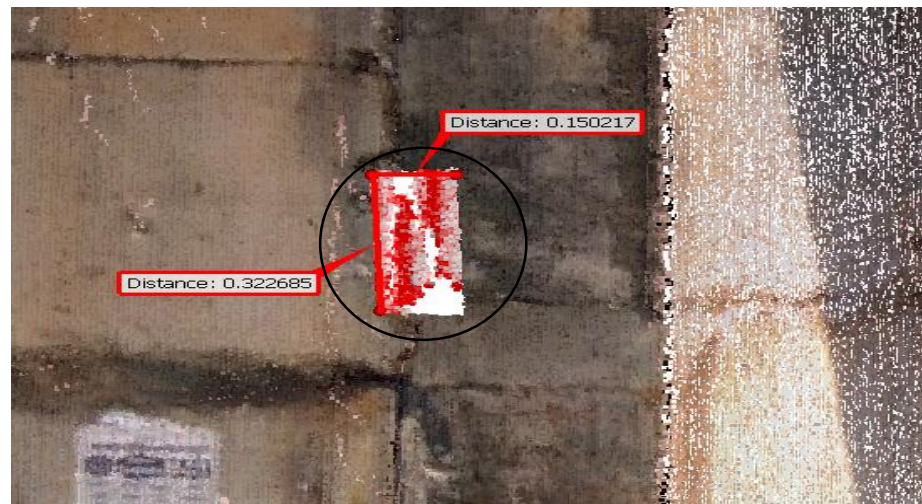
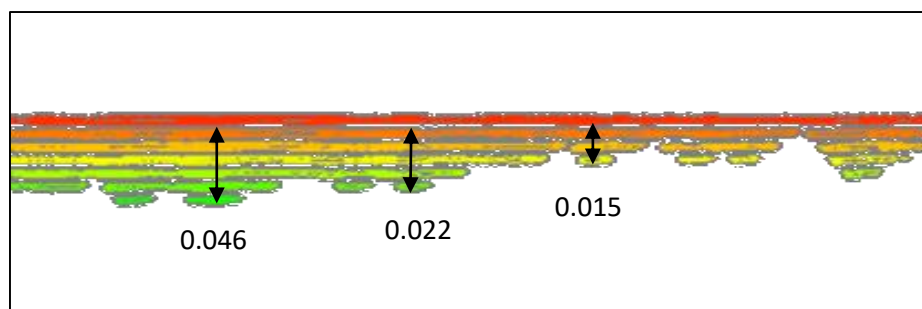
| Element Name | Observation | Location of Distress | Photo No. | Units | Distress Details | | | Area of Repair (Sq.m/ RMT/ m3) |
|---|---|---|---|---|---|---|---|---|
| Wing Wall | Damage | | 3 | M | 0.32 | 0.15 | 0.022 | 0.0010 |

**3. Damage observed on Abutment 2 LHS Wing Wall 2, measuring 0.32 m in length and 0.15 m in width, Depth ranges from 0.015 m (min) to 0.046m (max), with an average depth of 0.022 m. The calculated volume of the distress is 0.0010 m<sup>3</sup>.**

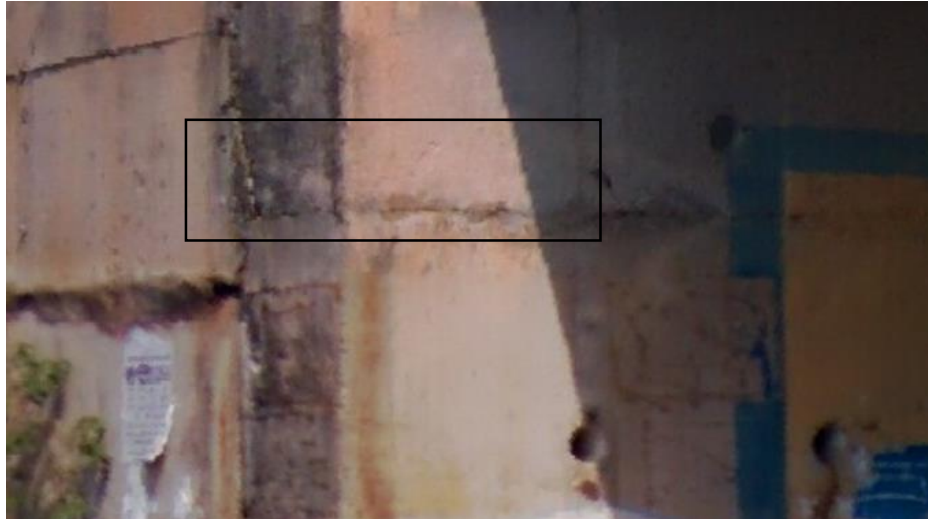
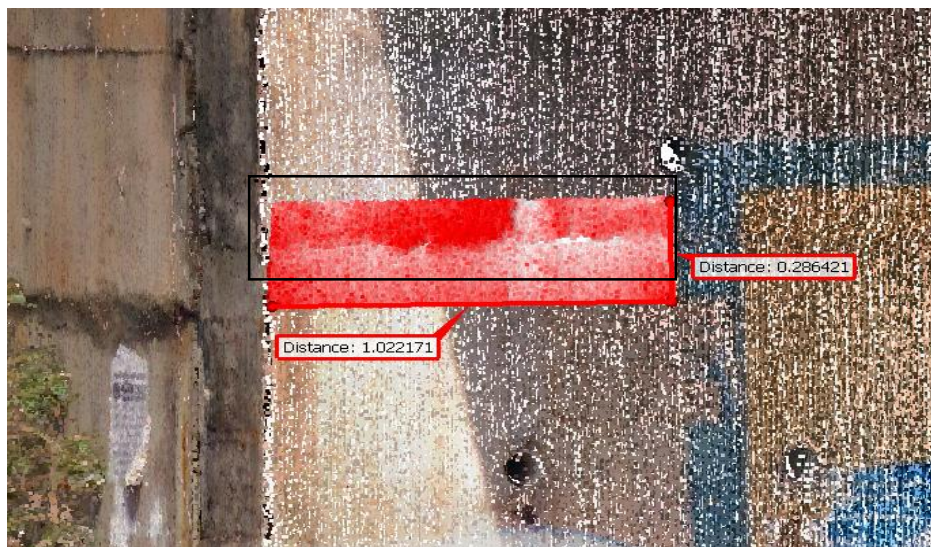
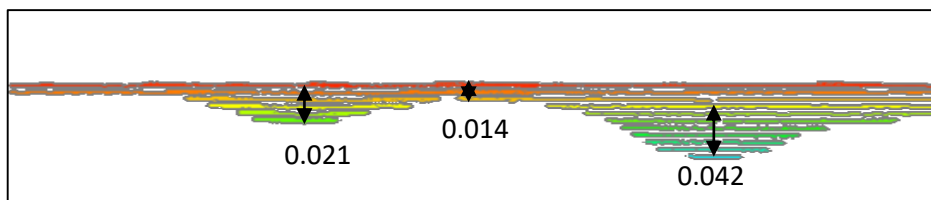
| Element Name | Observation | Location of Distress | Photo No. | Units | Distress Details | | | Area of Repair (Sq.m/ RMT/ m3) |
|---|---|---|---|---|---|---|---|---|
| Abutment 2 | Damage | | 4 | M | 1.02 | 0.28 | 0.021 | 0.0059 |

**4. Damage observed on Abutment 2 LHS Area 3, measuring 1.02 m in length and 0.28 m in width, Depth ranges from 0.014 m (min) to 0.042m (max), with an average depth of 0.021 m. The calculated volume of the distress is 0.0059 m<sup>3</sup>.**

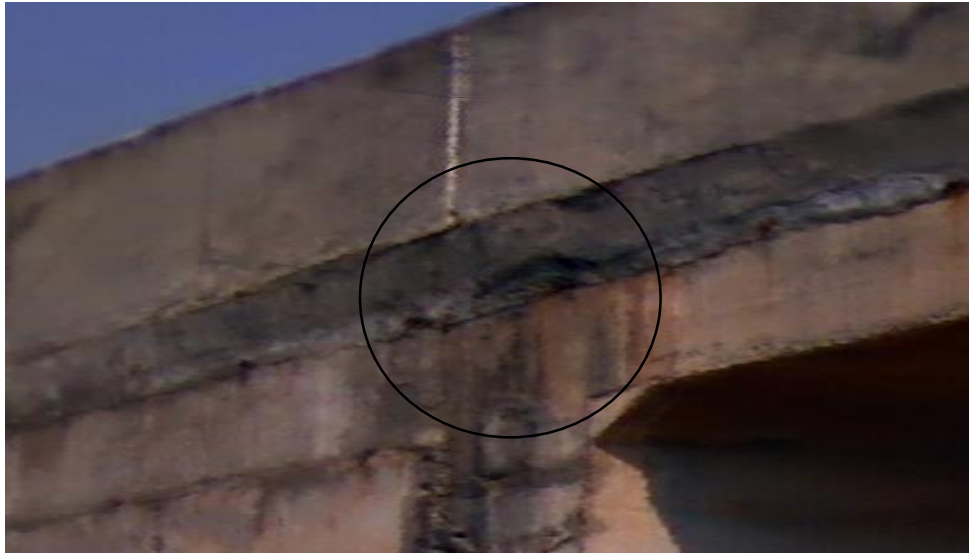
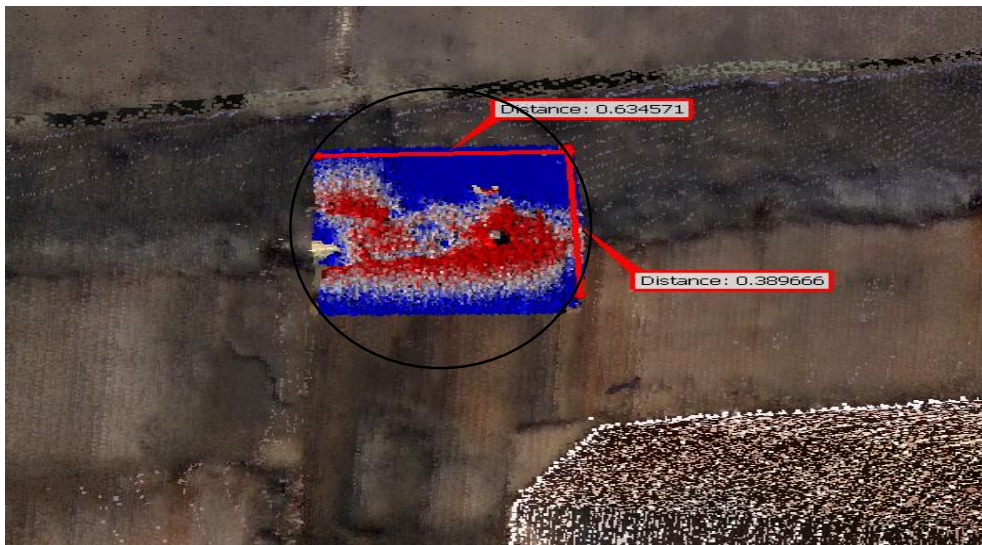
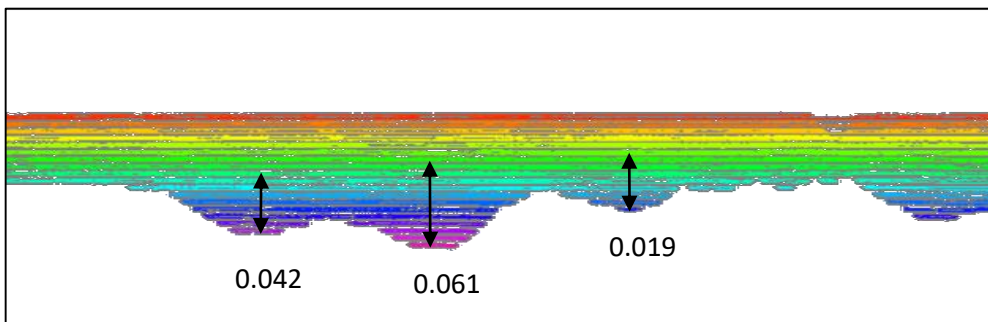
| Element Name | Observation | Location of Distress | Photo No. | Units | Distress Details | | | Area of Repair (Sq.m/ RMT/ m3) |
|---|---|---|---|---|---|---|---|---|
| Parapet Wall | Damage | | 5 | M | 0.63 | 0.38 | 0.042 | 0.0100 |

**5. Damage observed on LHS Parapet Wall 4, measuring 0.63 m in length and 0.38 m in width, Depth ranges from 0.019 m (min) to 0.061m (max), with an average depth of 0.042 m. The calculated volume of the distress is 0.0100 m<sup>3</sup>.**

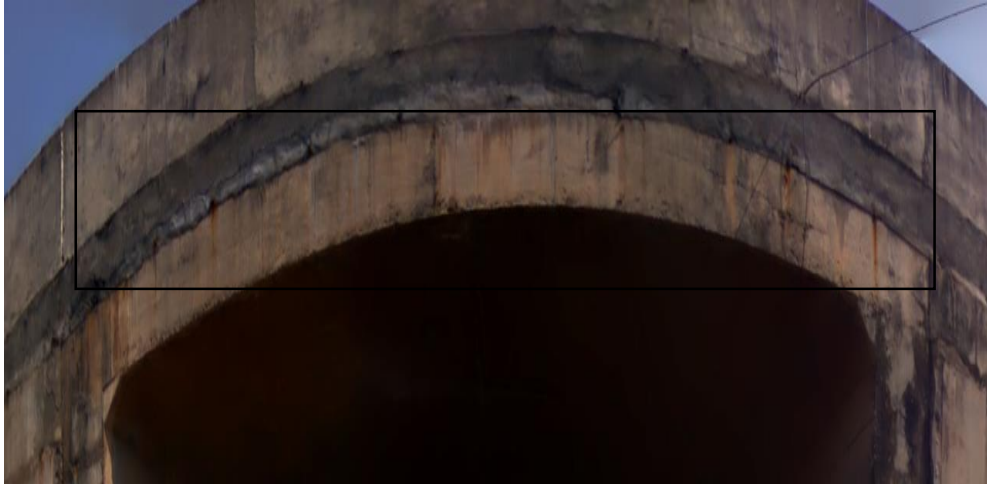
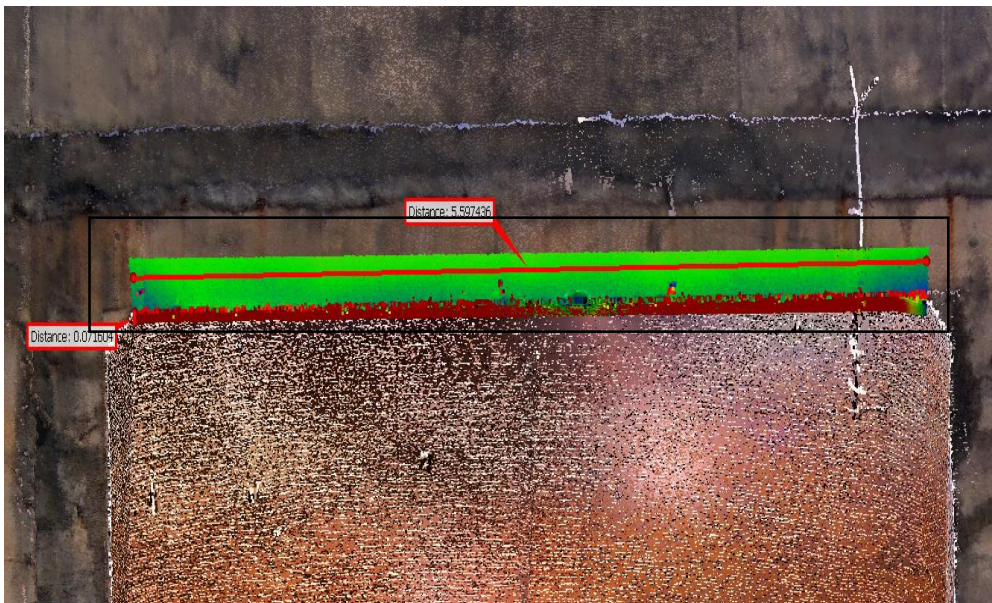
| Element Name | Observation | Location of Distress | Photo No. | Units | Distress Details | | | Area of Repair (Sq.m/ RMT/ m3) |
|---|---|---|---|---|---|---|---|---|
| Parapet Wall | Scaling | | 6 | M | 5.59 | 0.07 | | 0.3913 |

**6. Scaling observed on LHS Parapet Wall, measuring 5.59 m in length and 0.07 m in width, covering an area of 0.3913 m<sup>2</sup>.**
