# **LIDAR Inspection Report of Box Culvert ch.932+464**

**Bridge Chainage:** 932+464

# **CH: 932+464 BOX CULVERT**

**DISTRESS PHOTOS**

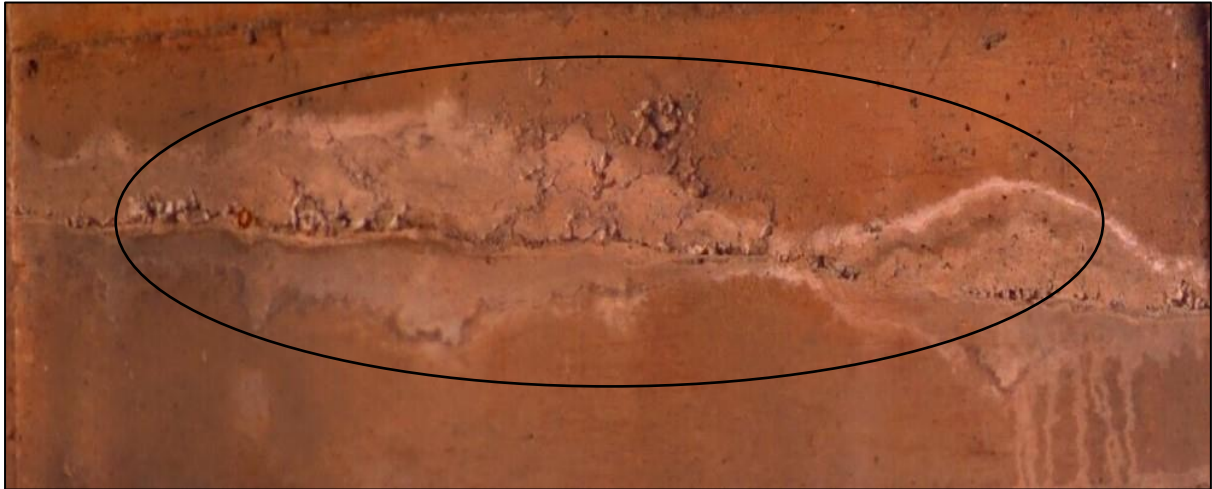
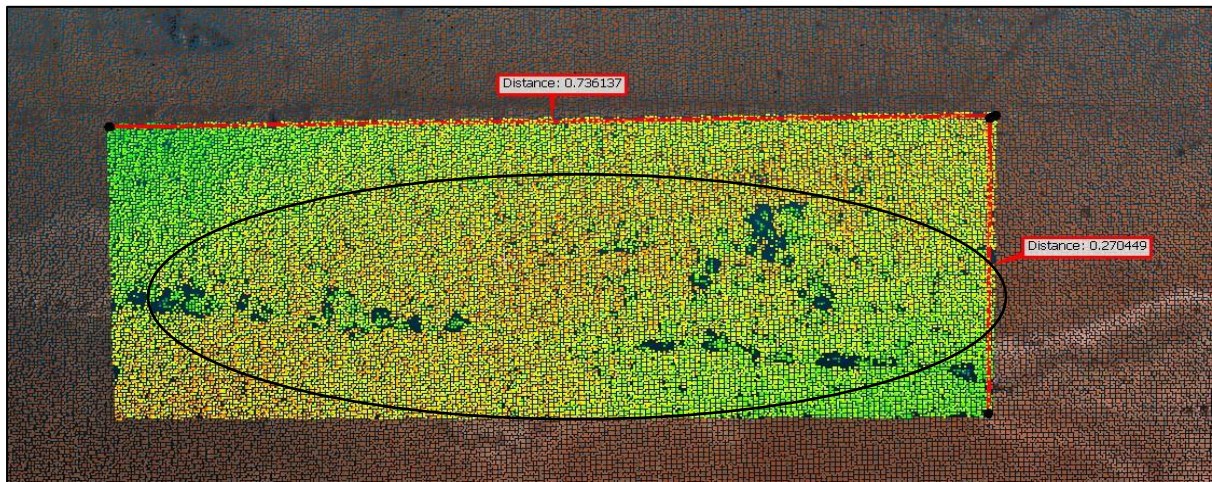
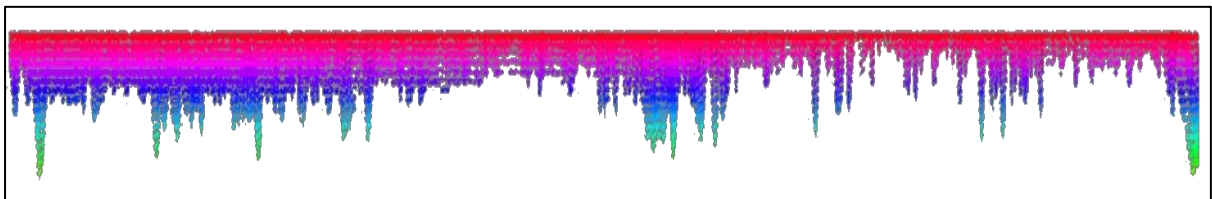
| Element Name | Observation | Location of Distress | Photo No. | Units | Distress Details | | | Area of Repair (Sq.m/R MT/m3) |
|---|---|---|---|---|---|---|---|---|
| Abutment 1 | Scalling | - | 1 | Sq m | 0.73 | 0.27 | - | 0.19 |

**1. Scaling observed on Abutment 1 LHS side, measuring 0.73 m in length and 0.27 m in width, covering an area of 0.19 m<sup>2</sup>.**

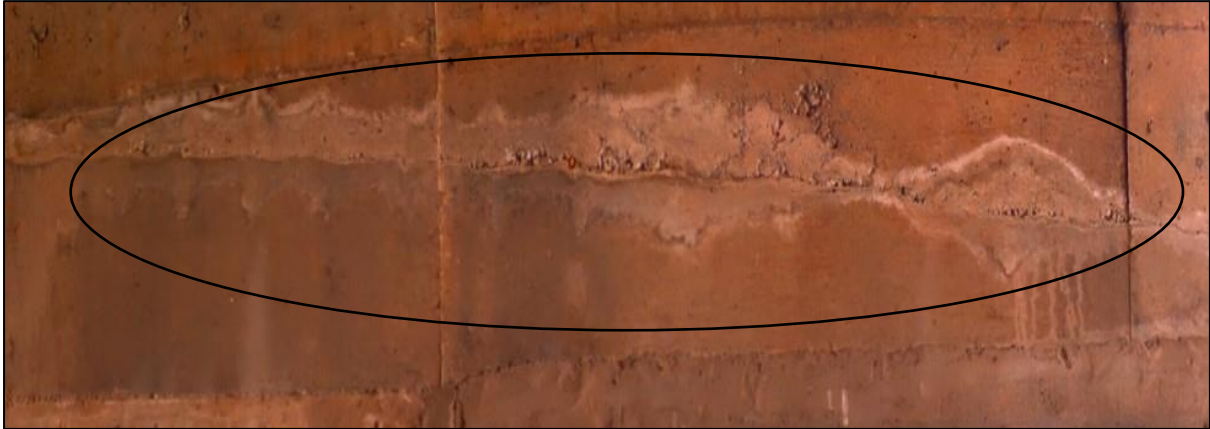
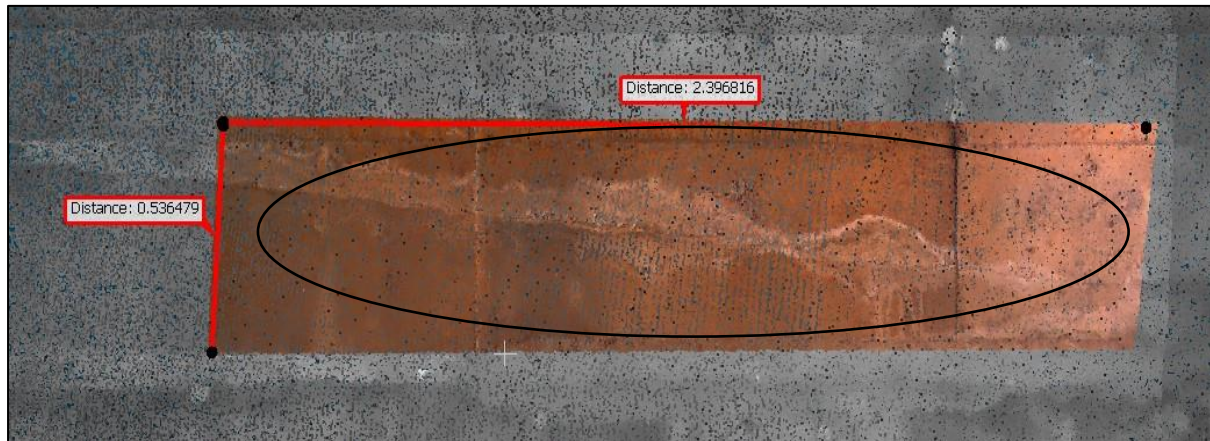
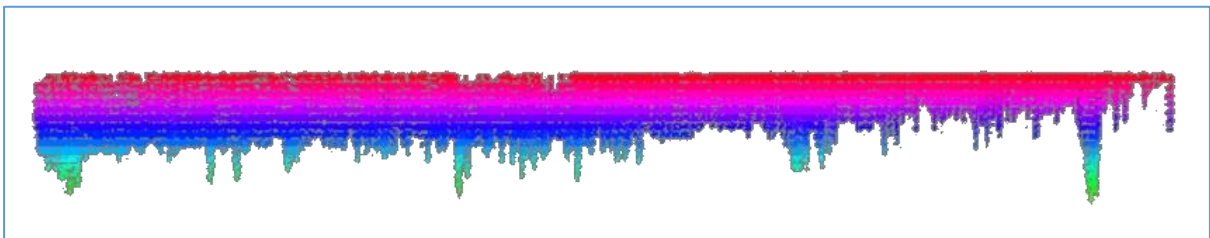
| Element Name | Observation | Location of Distress | Photo No. | Units | Distress Details | | | Area of Repair (Sq.m/R MT/m3) |
|---|---|---|---|---|---|---|---|---|
| Abutment 1 | Efflorescence | - | 2 | Sq m | 2.3 | 0.53 | - | 1.21 |

**2.Efflorescence observed on Abutment 1 LHS side, measuring 2.3 m in length and 0.53 m in width, covering an area of 1.21 m<sup>2</sup>.**
