# **LIDAR Inspection Report of Box Culvert ch.933+374**

**Bridge Chainage:** 933+374

- **Bridge No:** -
- **Chainage:** 933+374
- **Structure type:** Box Culvert

- **CKRP:** Chittorgarh to kota
- **State:** Rajasthan NH 27
- **Zone:** RJ-20

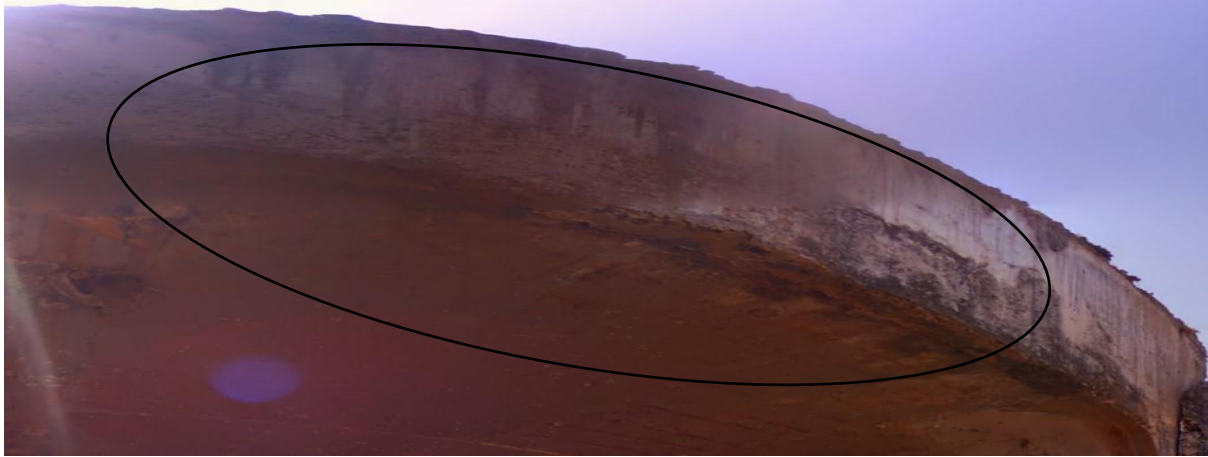
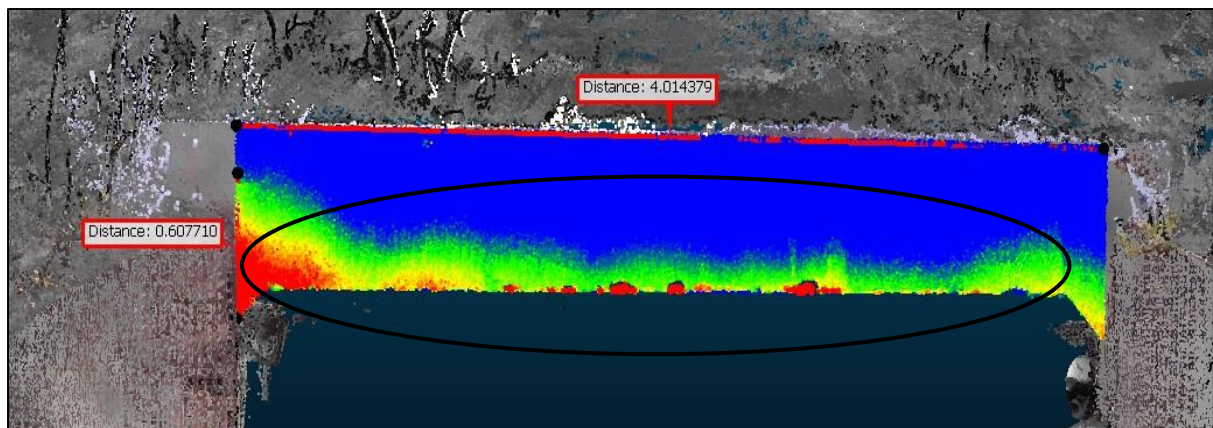
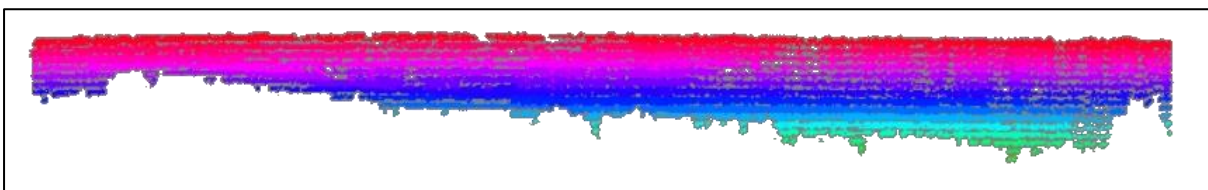
| Element Name | Observation | Location of Distress | Photo No. | Units | Distress Details | | | Area of Repair (Sq.m/R MT/m3) |
|---|---|---|---|---|---|---|---|---|
| Parapet Wall | Scalling | - | 1 | Sq m | 4.01 | 0.60 | - | 2.40 |

**1. Scaling observed on parapet wall RHS side, measuring 4.01 m in length and 0.60 m in width, covering an area of 2.40 m<sup>2</sup>.**

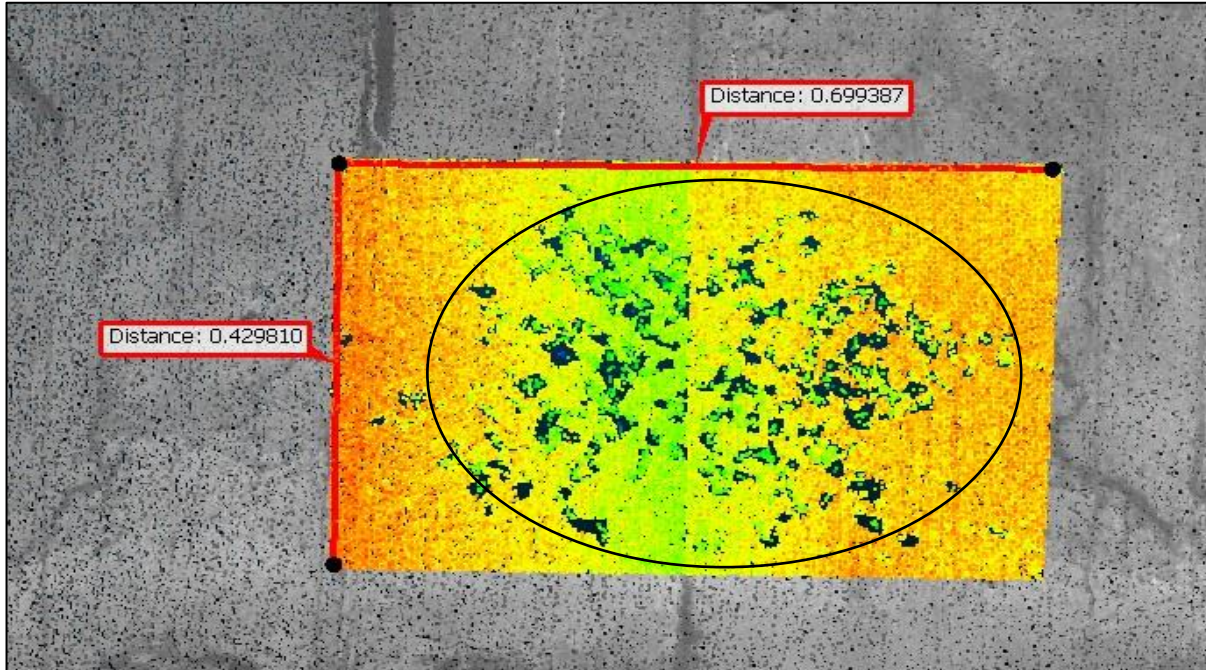
| Element Name | Observation | Location of Distress | Photo No. | Units | Distress Details | | | Area of Repair (Sq.m/R MT/m3) |
|---|---|---|---|---|---|---|---|---|
| Abutment 2 | HoneyCombing | - | 2 | Sq m | 0.60 | 0.42 | - | 0.25 |

**2.Honeycombing observed on Abutment 2 RHS side, measuring 0.60 m in length and 0.42 m in width, covering an area of 0.25 m<sup>2</sup>.**
