# **LIDAR Inspection Report of Slab Culvert ch.933+865**

**Bridge Chainage:** 933 + 865 (CKRP)

- **Bridge No:** -
- **Chainage:** 933 + 865
- **Structure type:** Slab Culvert

## **CH: 933+865-Slab culvert**

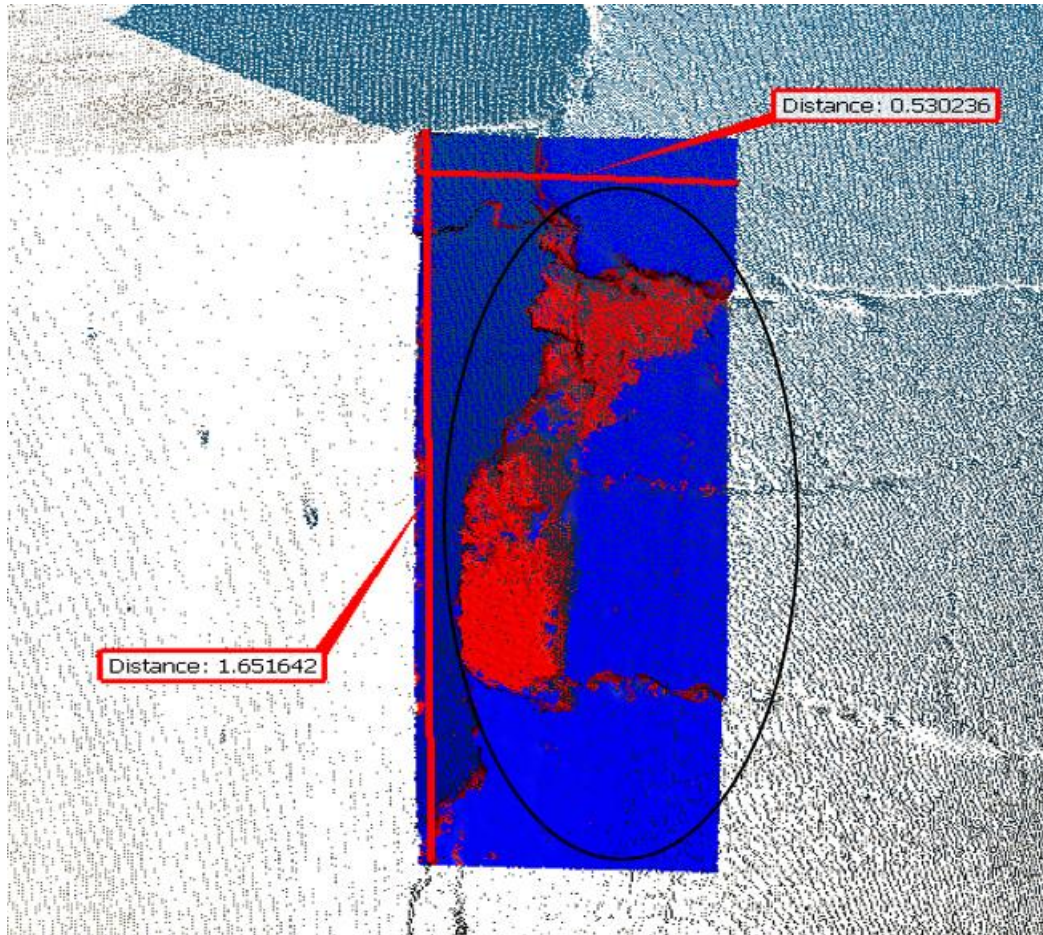
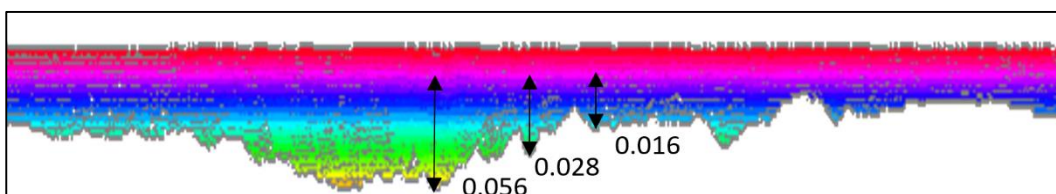
1. Return wall damage observed on LHS, measuring 1.6516 m in length and 0.5302 m in width, Depth ranges from 0.016 m (min) to 0.056 m (max), with an average depth of 0.028 m. The calculated volume of the distress is 0.0245 m<sup>3</sup>.

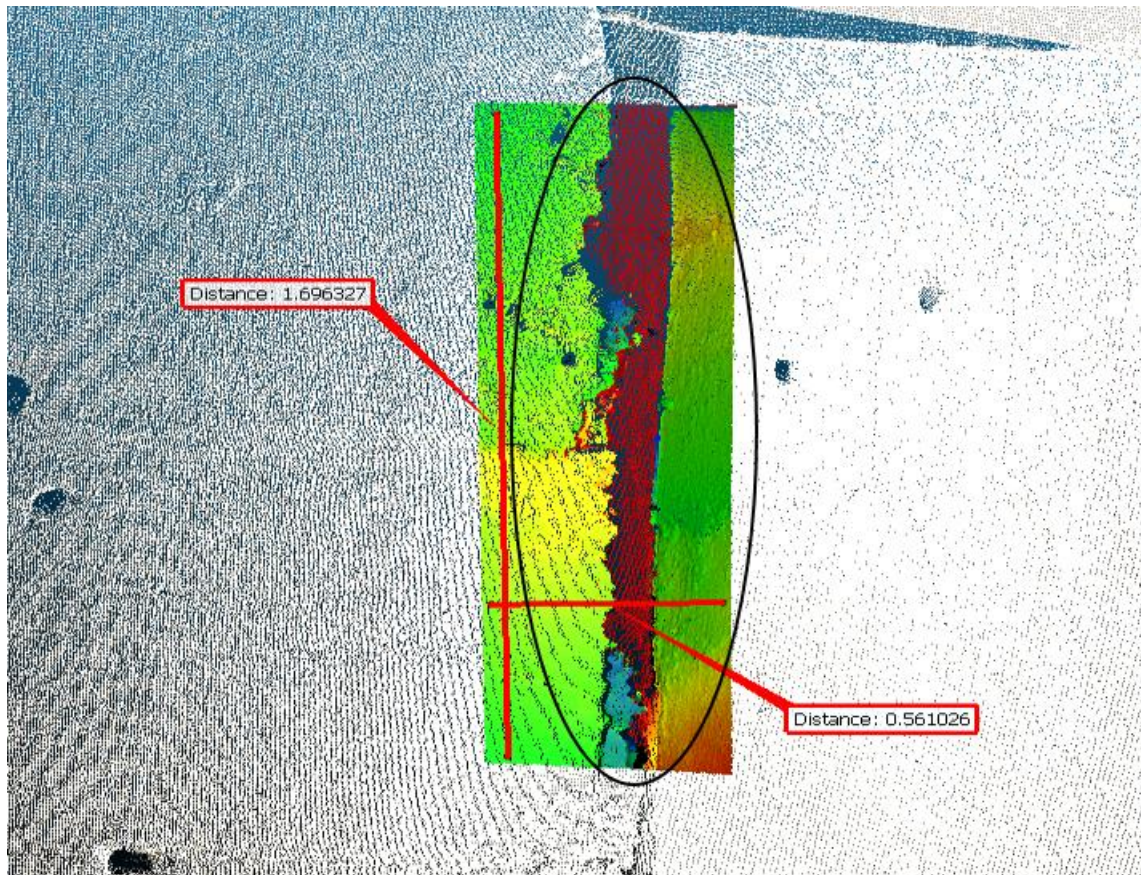
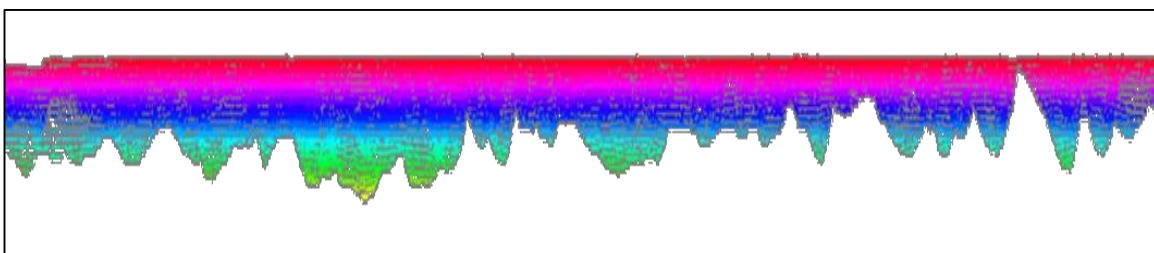
2. Return wall damage observed on LHS, measuring 1.6963 m in length and 0.5610 m in width, covering an area of 0.95 m<sup>2</sup>.

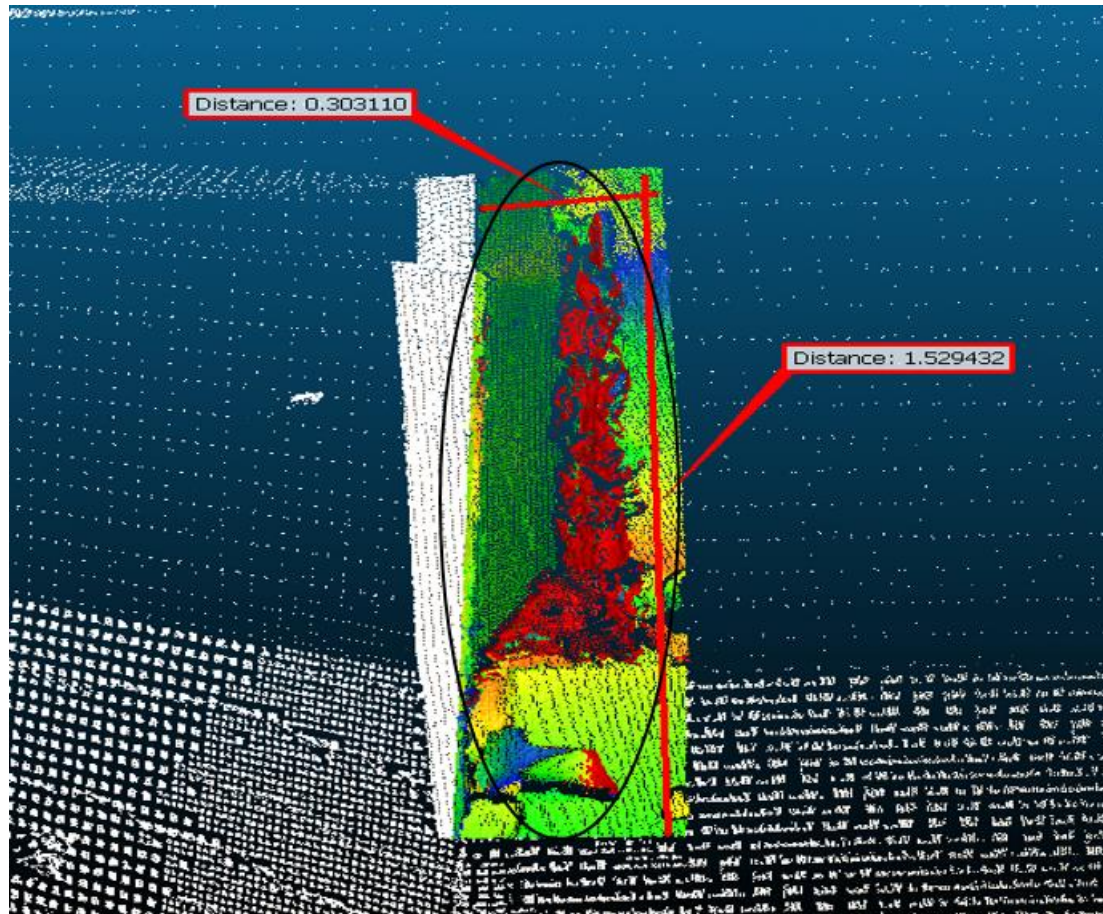
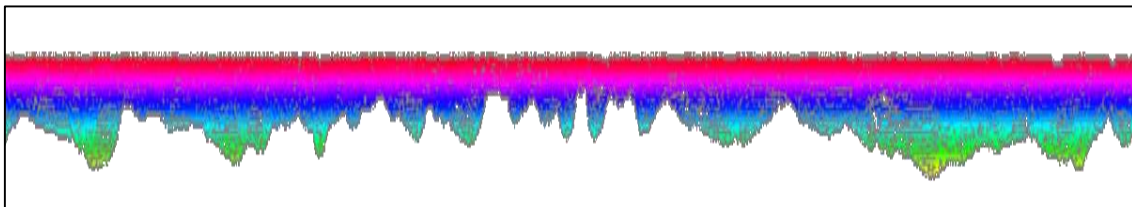
**3. Return wall damage observed on RHS, measuring 1.5294 m in length and 0.3031 m in width, covering an area of 0.46 m<sup>2</sup>.**
