# LIDAR Inspection Report of **Box Culvert** ch.933+974

**Bridge Chainage:** 933+974(CKRP)

- **CKRP:** Chittorgarh to kota
- **State:** Rajasthan NH 27
- **Zone:** RJ-06

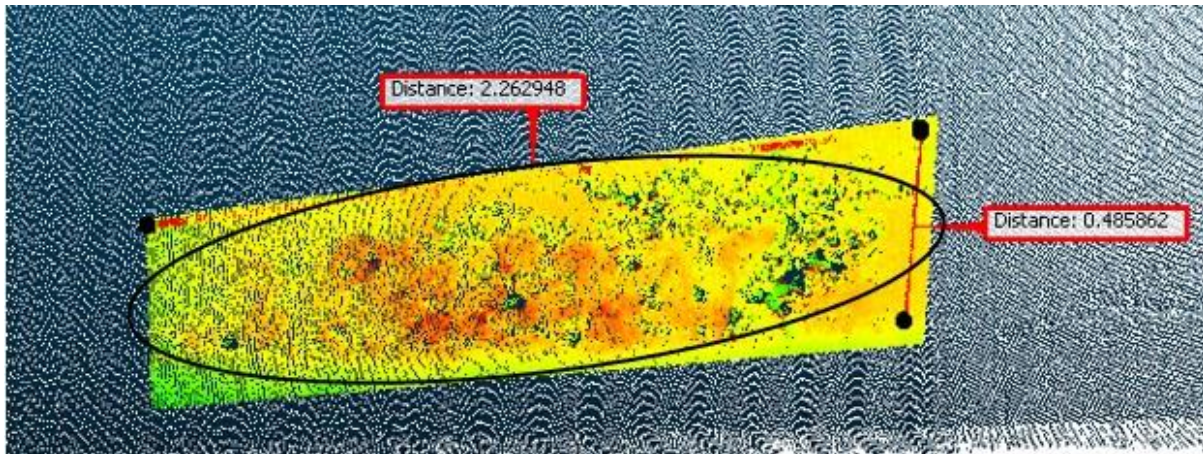
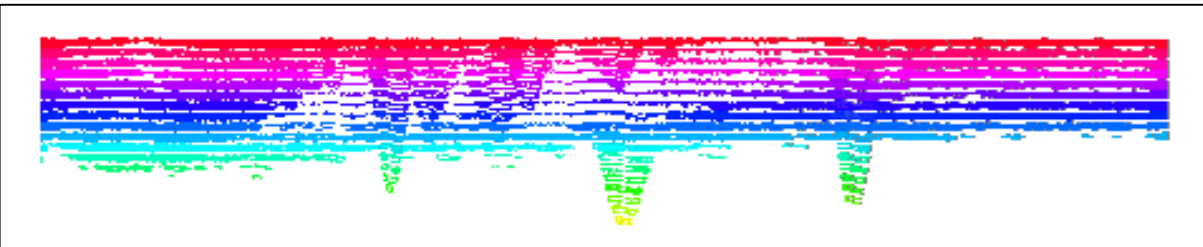
- 1. Abutment wall scaling observed, measuring 2.26 m in length and 0.48 m in width, covering an area of 1.19 m<sup>2</sup>.**

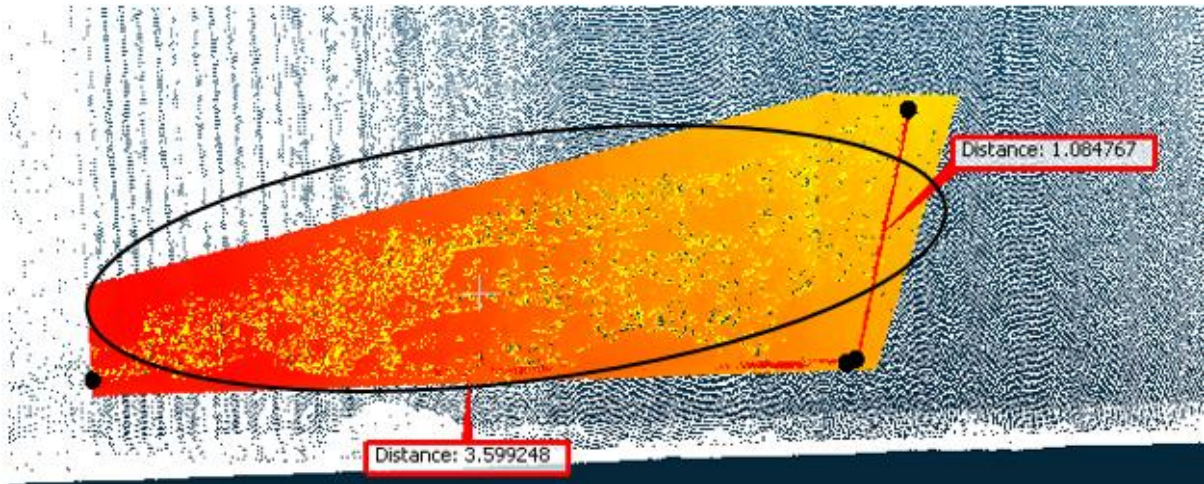
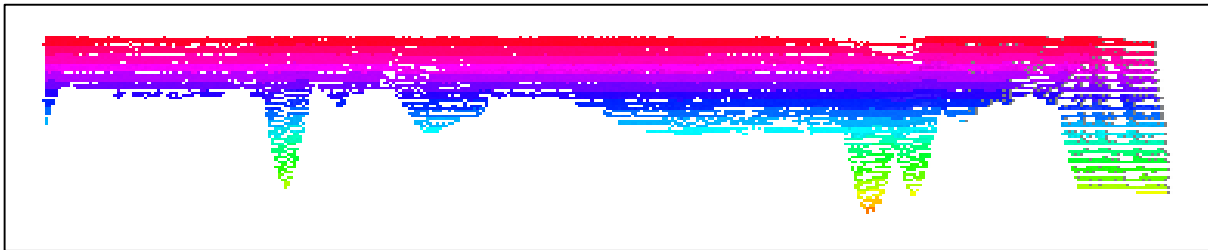
**2. Scaling observed on Abutment Wall, measuring 3.59 m in length and 1.08 m in width, covering an area of 3.87 m<sup>2</sup>.**

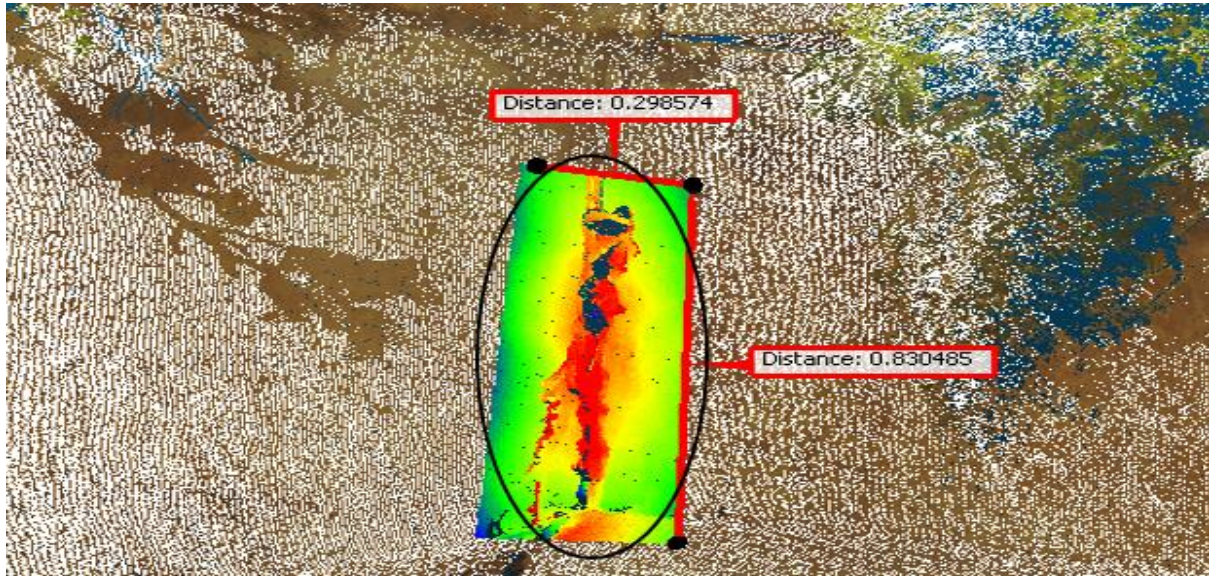
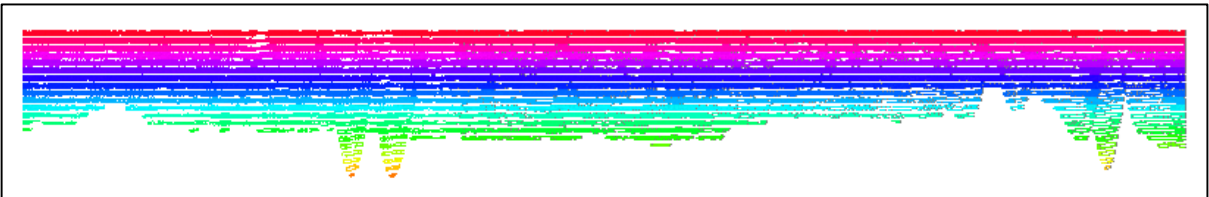
| Sl. No. | Description | Distress Notation | Observation | Location | | Distress Details | | | Area of Repair |
|---|---|---|---|---|---|---|---|---|---|
| 3 | Wing wall | | Damage | | | | | | |

**3. Damage observed on Wing Wall, measuring 0.29 m in length and 0.83 m in width, covering an area of 0.24 m<sup>2</sup>.**

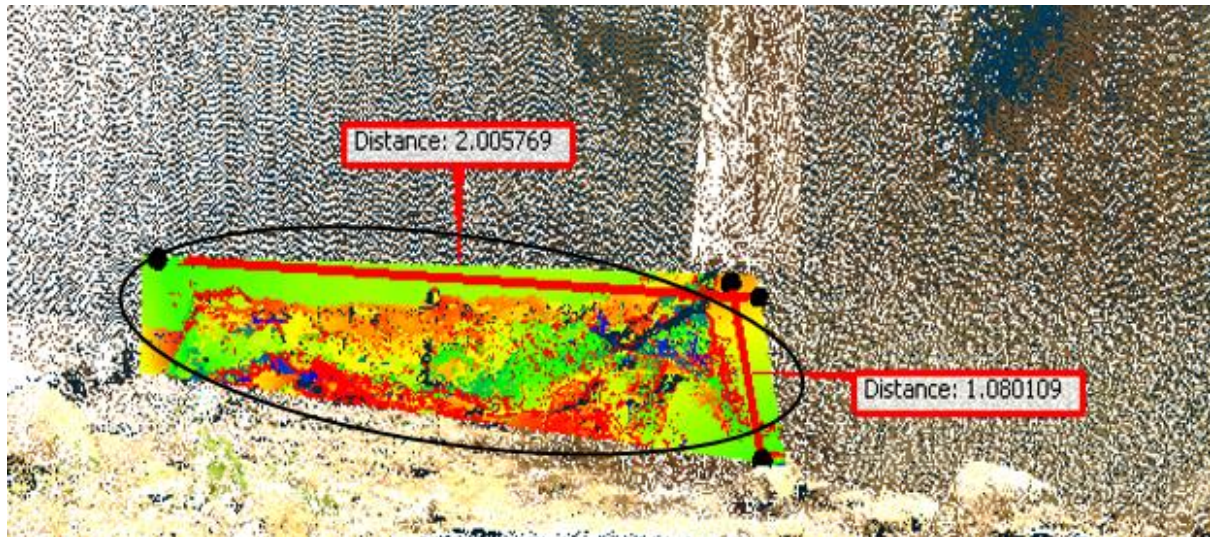
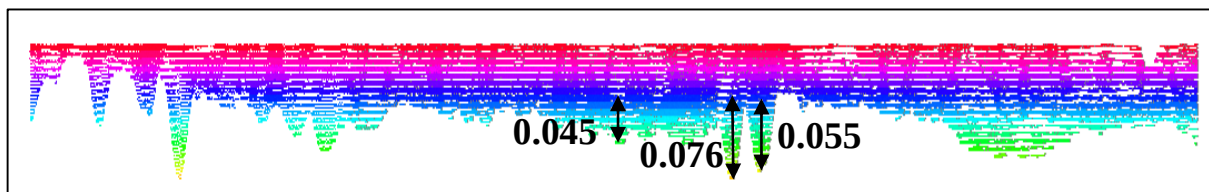
**4. Damage observed on Wing Wall, measuring 2.00 m in length and 1.08 m in width, Depth ranges from 0.045m (min) to 0.076m (max), with an average depth of 0.055m. The calculated volume of the distress is 0.1188 m<sup>3</sup>.**

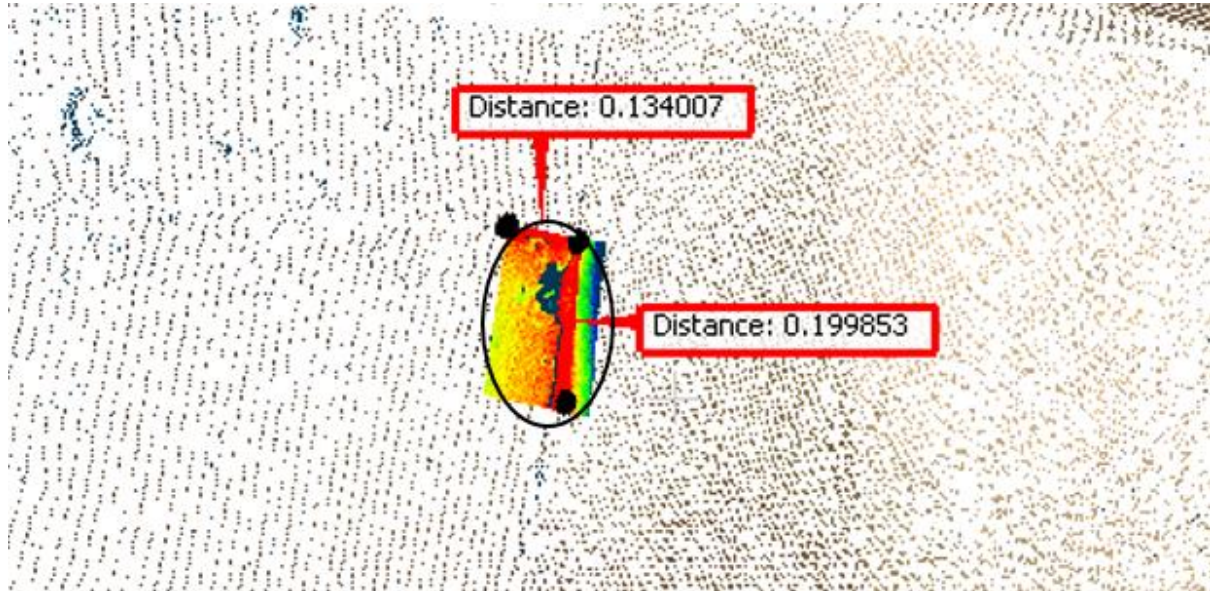
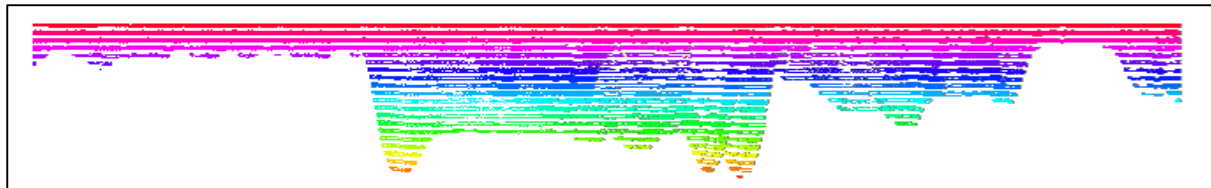
**5. Damage observed on Wing Wall, measuring 0.13 m in length and 0.19 m in width, covering an area of 0.02 m<sup>2</sup>.**
