# **LIDAR Inspection Report of Slab Culvert ch.934+040**

**Bridge Chainage:** 934 +040 (CKRP)

- **Bridge No:** -
- **Chainage:** 934 + 040
- **Structure type:** Slab Culvert

- **CKRP:** Chittorgarh to kota
- **State:** Rajasthan NH 27
- **Zone:** RJ-06

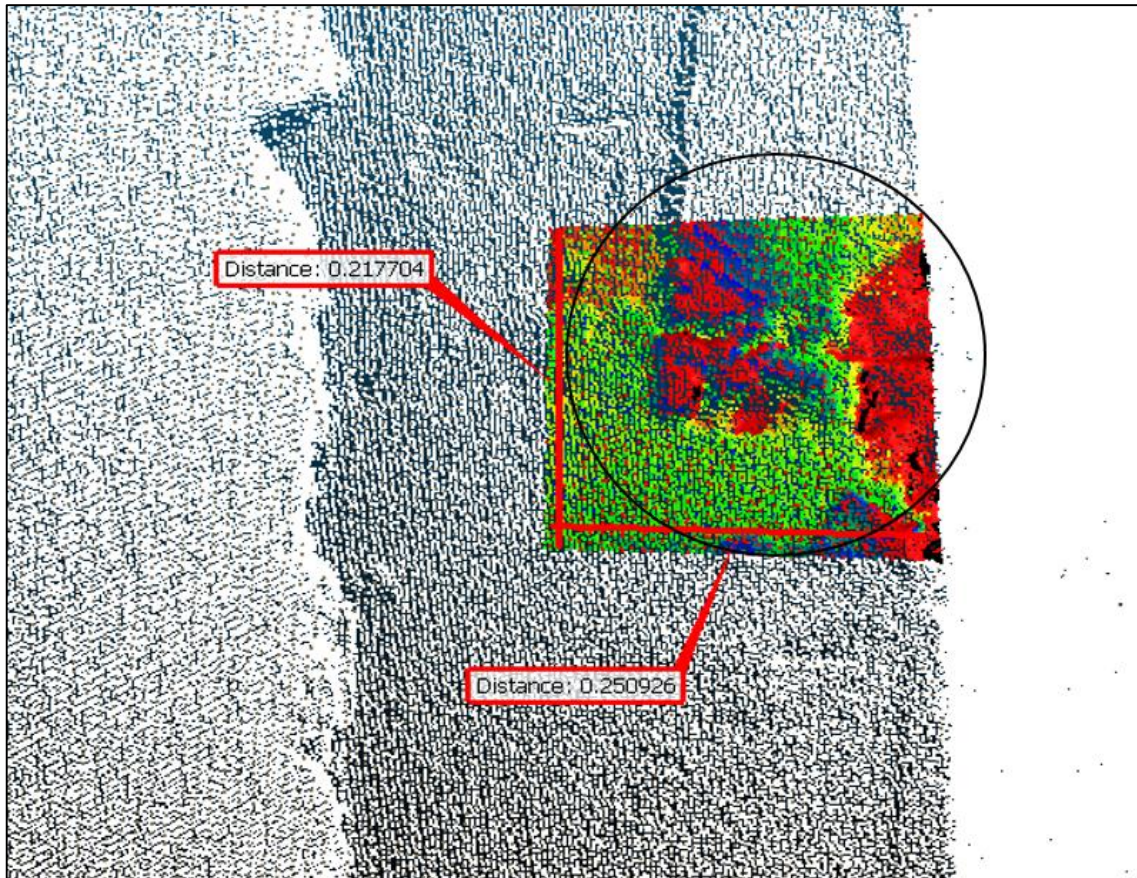
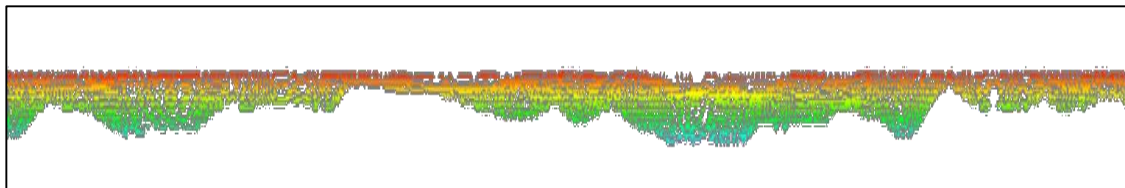
1. Return wall spalling observed on LHS, measuring 0.2509 m in length and 0.2177 m in width, covering an area of 0.05 m<sup>2</sup>.

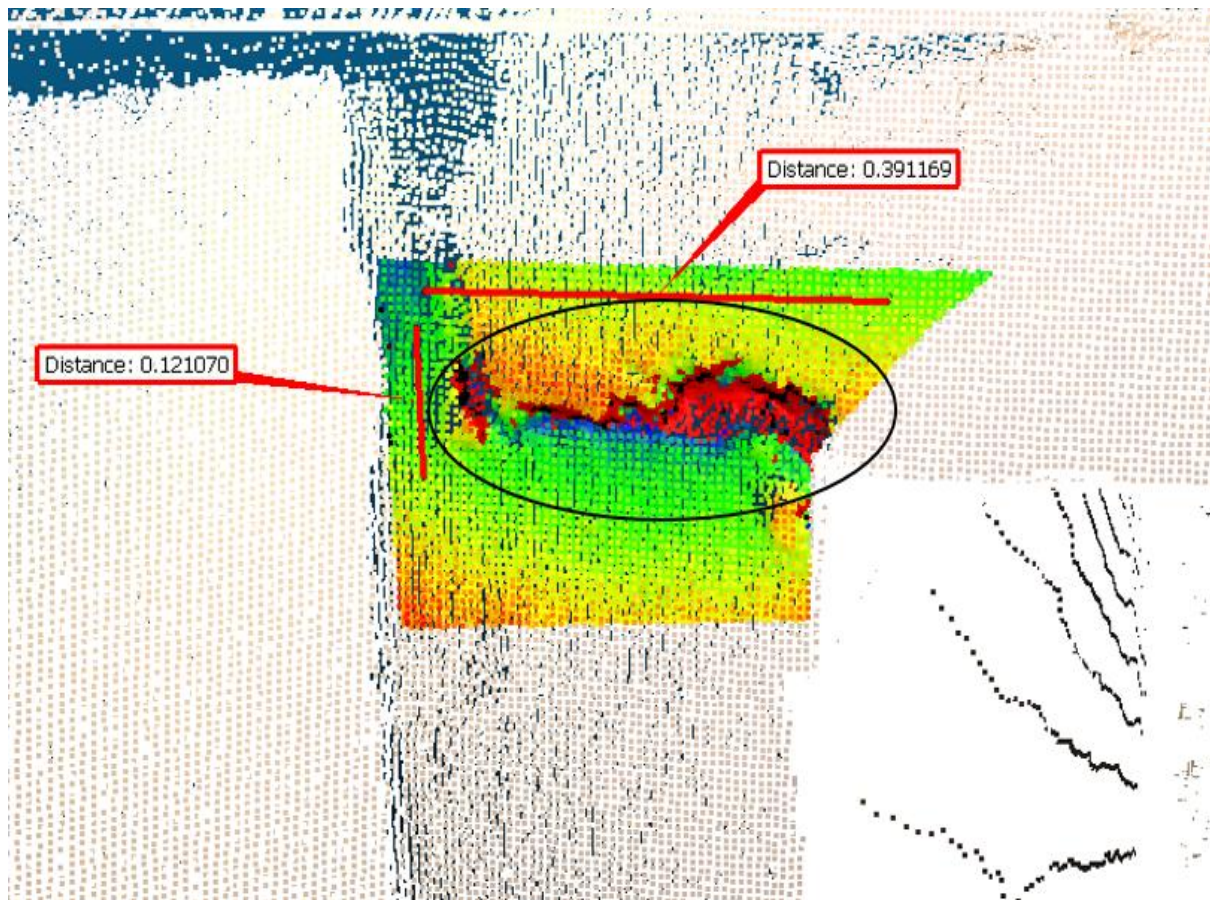
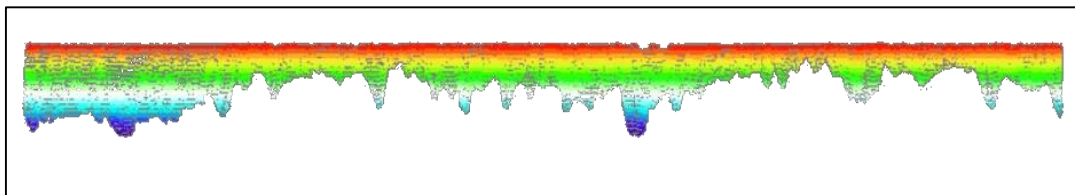
2. Parapet wall damage observed on LHS, measuring 0.3911 m in length and 0.1210 m in width, covering an area of 0.05 m<sup>2</sup>.

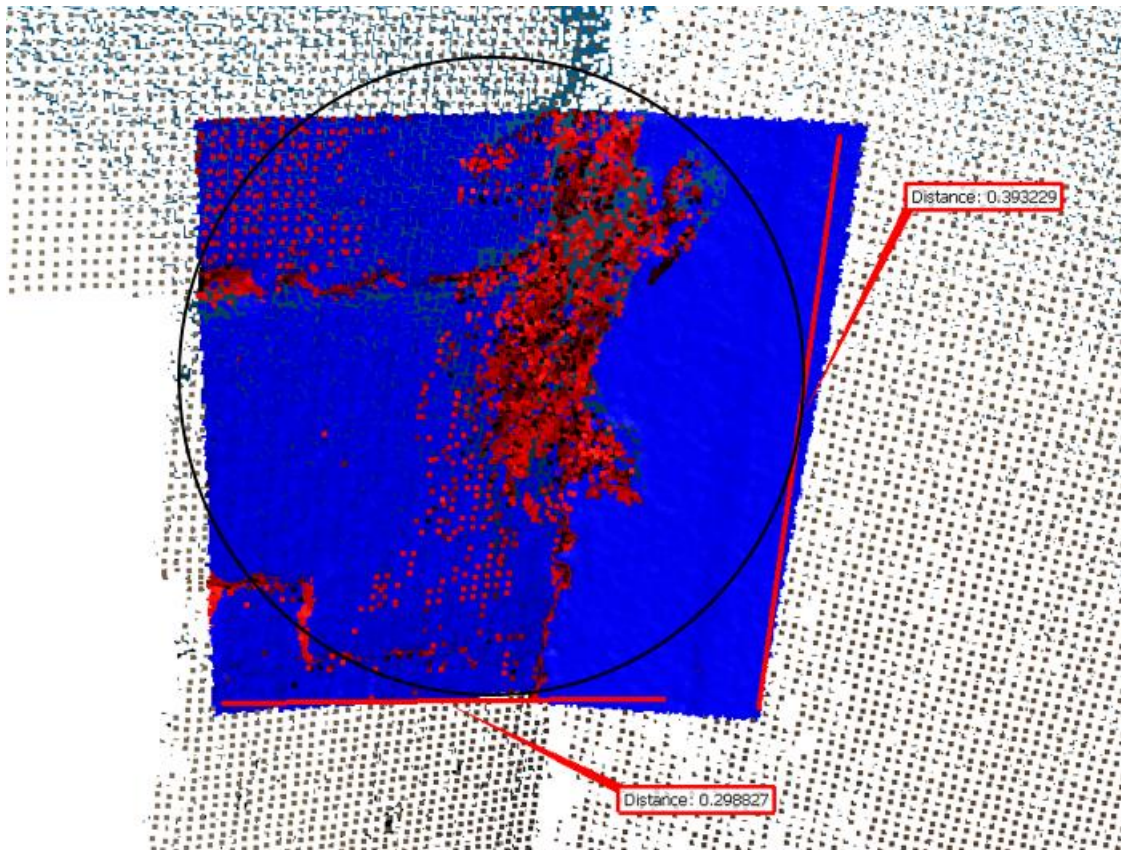
- 3. Return wall damage observed on LHS, measuring 0.3932 m in length and 0.2988 m in width, covering an area of 0.12 m<sup>2</sup>.**
