# **LIDAR Inspection Report of PUP ch.936 + 530**

**Bridge Chainage:** 936 + 530 (CKRP)

- **CKRP:** Chittorgarh to kota
- **State:** Rajasthan NH 27
- **Zone:** RJ-06

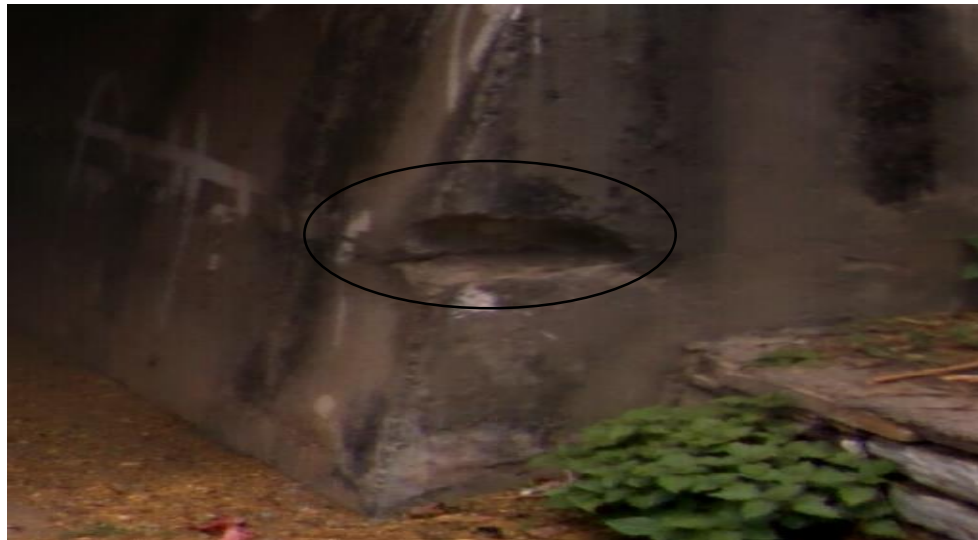
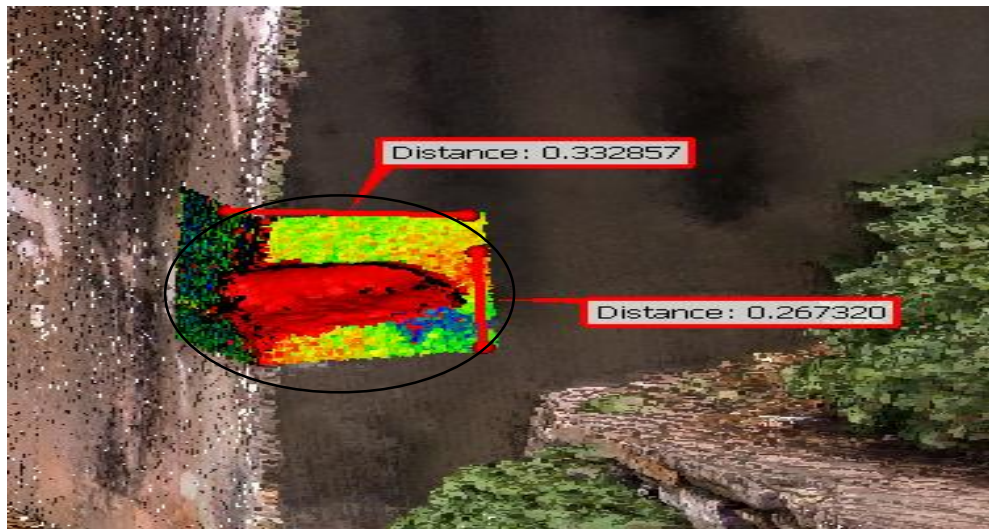
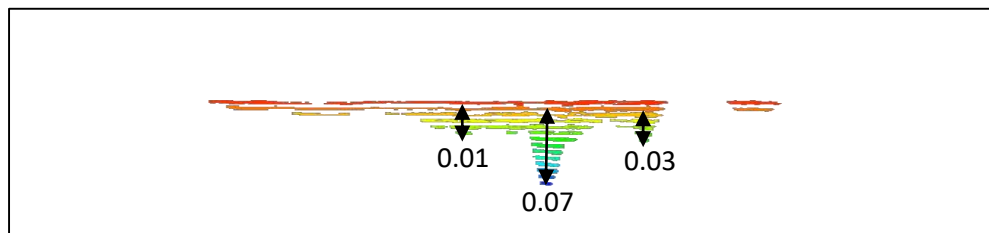
| Element Name | Observation | Location of Distress | Photo No. | Units | Distress Details | | | Area of Repair (Sq.m/R MT/m3) |
|---|---|---|---|---|---|---|---|---|
| Wing Wall | Damage | | 1 | M | 0.33 | 0.26 | 0.33 | 0.0028 |

**1. Wing wall damage observed on RHS Abutment 1, measuring 0.33 m in length and 0.26 m in width, Depth ranges from 0.018 m (min) to 0.075 m (max), with an average depth of 0.033 m. The calculated volume of the distress is 0.0028 m<sup>3</sup>.**

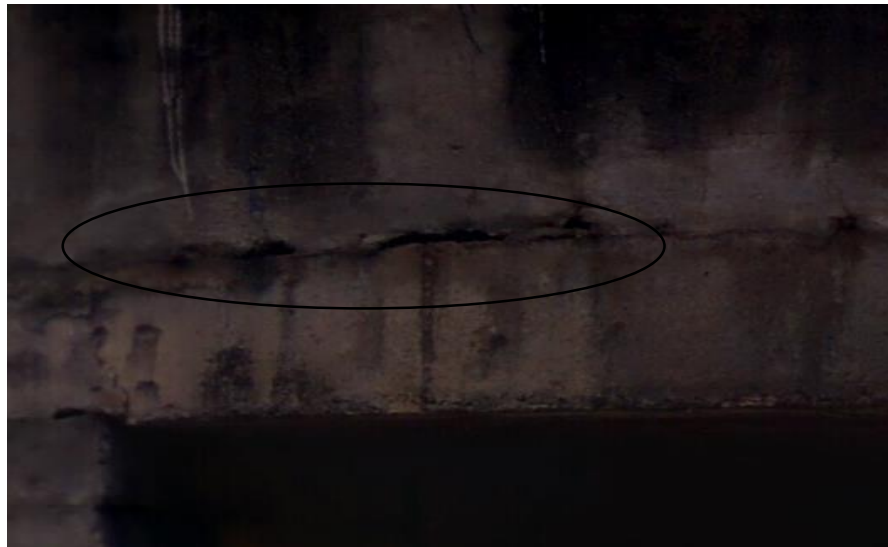
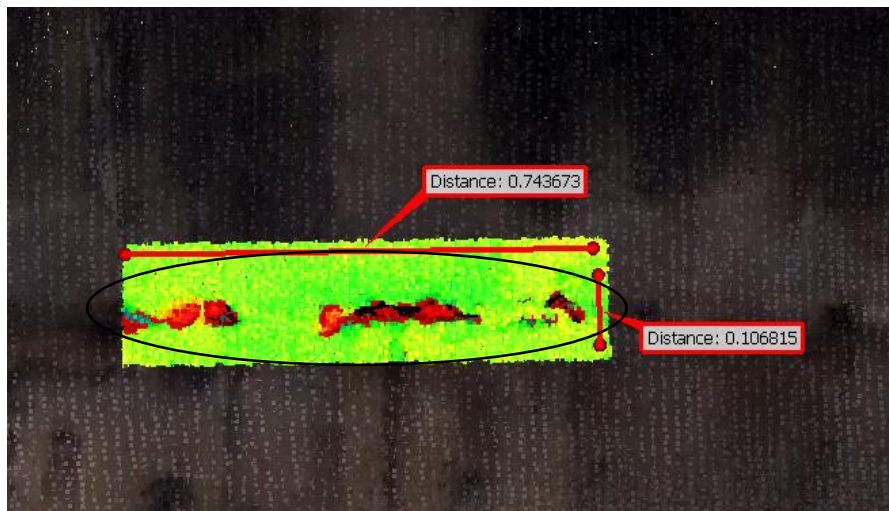
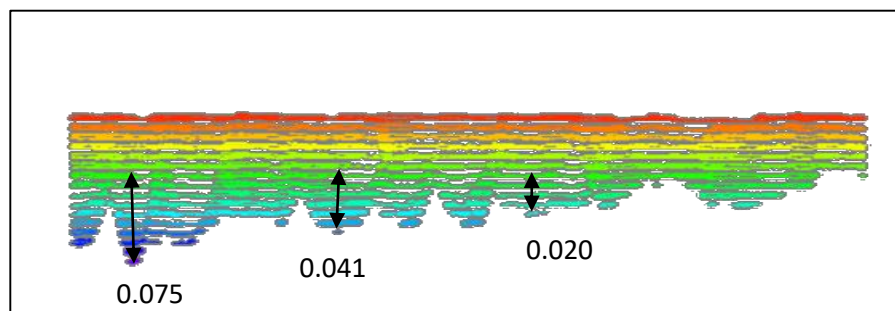
| Element Name | Observation | Location of Distress | Photo No. | Units | Distress Details | | | Area of Repair (Sq.m/R MT/m3) |
|---|---|---|---|---|---|---|---|---|
| Parapet Wall | Damage | | 2 | M | 0.74 | 0.10 | 0.41 | 0.0033 |

**2. Parapet wall damage observed on RHS , measuring 0.74 m in length and 0.10 m in width, Depth ranges from 0.020 m (min) to 0.075 m (max), with an average depth of 0.041 m. The calculated volume of the distress is 0.0030 m<sup>3</sup>.**

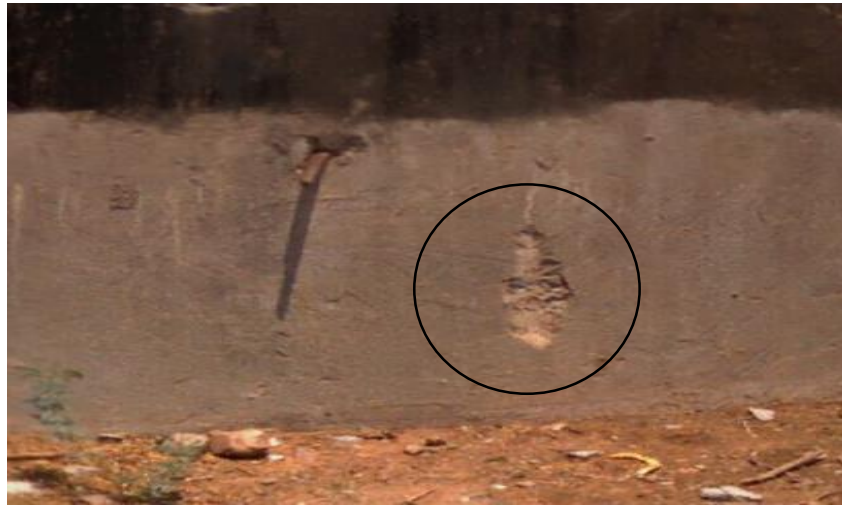
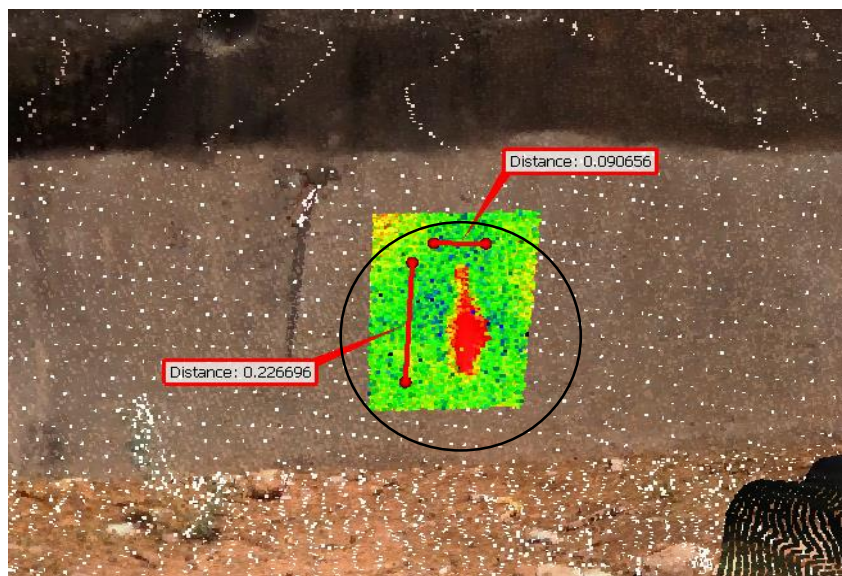
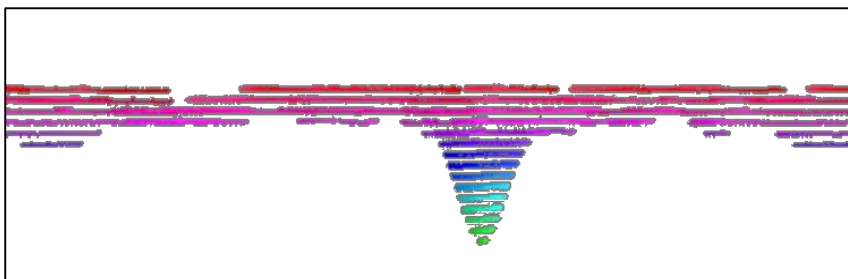
| Element Name | Observation | Location of Distress | Photo No. | Units | Distress Details | | | Area of Repair (Sq.m/R MT/m3) |
|---|---|---|---|---|---|---|---|---|
| Wing Wall | Damage | | 3 | M | 0.22 | 0.09 | | 0.0198 |

**3. Wing wall damage observed on LHS Abutment 2 , measuring 0.22 m in length and 0.09 m in width, covering an area of 0.0198 m<sup>2</sup>.**
