# **LIDAR Inspection Report of PUP ch.937 + 500**

**Bridge Chainage:** 937 + 500 (CKRP)

- **Bridge No:** -
- **Chainage:** 937 +500
- **Structure type:** PUP

- **CKRP:** Chittorgarh to kota
- **State:** Rajasthan NH 27
- **Zone:** RJ-06

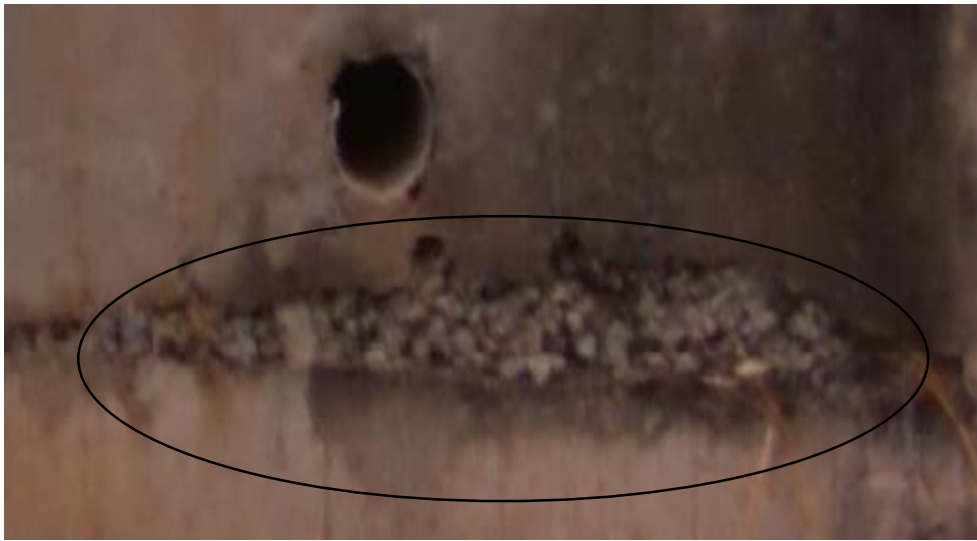
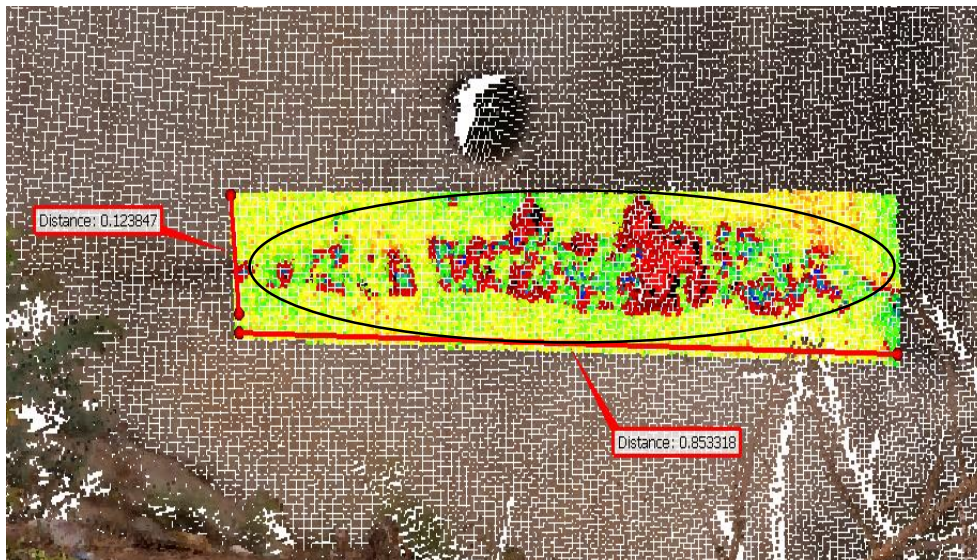
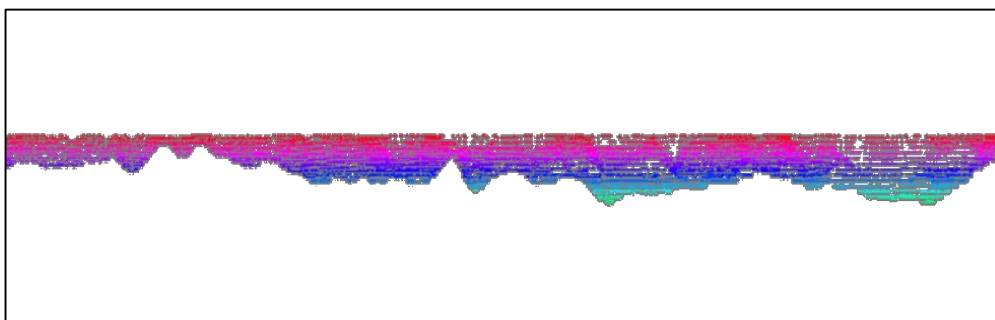
| Element Name | Observation | Location of Distress | Photo No. | Units | Distress Details | | | Area of Repair (Sq.m/ RMT/ m3) |
|---|---|---|---|---|---|---|---|---|
| Wing Wall | Honey Combing | | 1 | M | 0.85 | 0.12 | | 0.1020 |

1. Wing wall Honey Combing observed on RHS Abutment A1, measuring 0.85 m in length and 0.12 m in width, covering an area of 0.1020 m<sup>2</sup>.

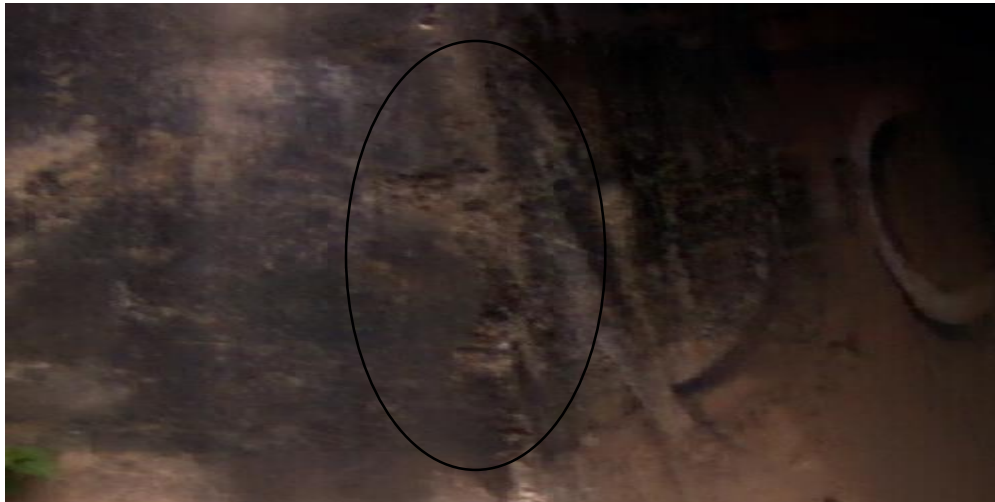
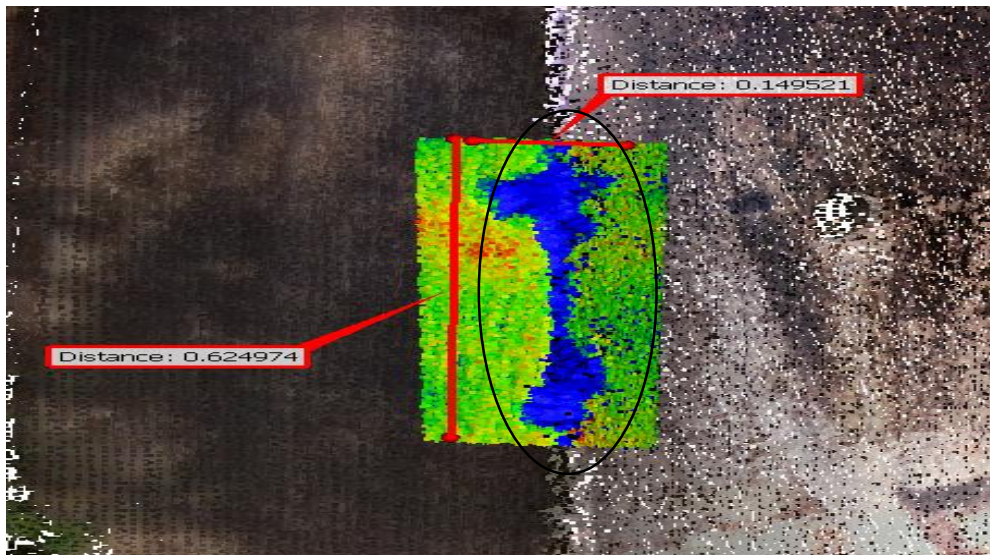
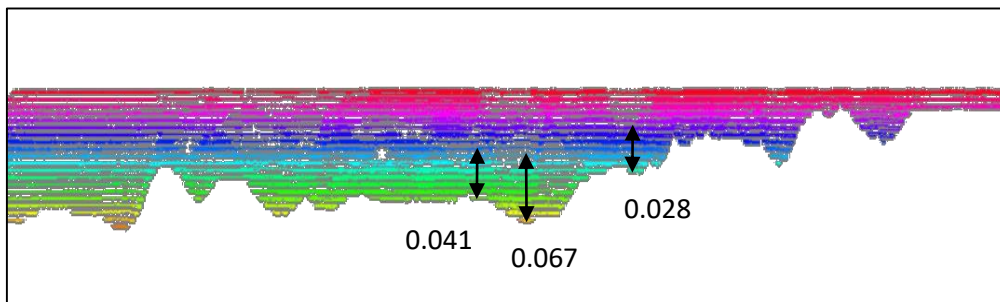
| Element Name | Observation | Location of Distress | Photo No. | Units | Distress Details | | | Area of Repair (Sq.m/ RMT/ m3) |
|---|---|---|---|---|---|---|---|---|
| Wing Wall | Damage | | 2 | M | 0.62 | 0.14 | 0.041 | 0.0035 |

2. Wing wall damage observed on RHS Abutment 1 , measuring 0.62 m in length and 0.14 m in width, Depth ranges from 0.028 m (min) to 0.067 m (max), with an average depth of 0.041 m. The calculated volume of the distress is 0.0035 m<sup>3</sup>.

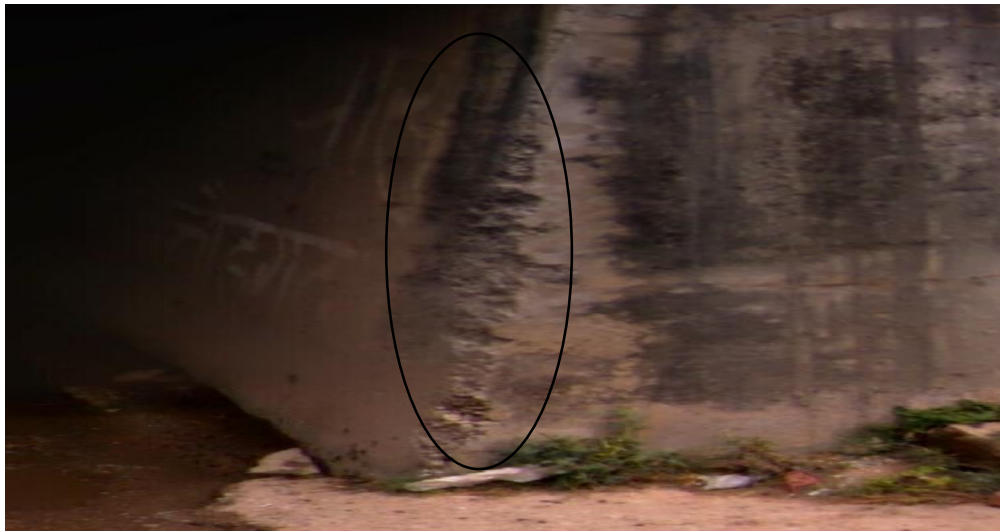
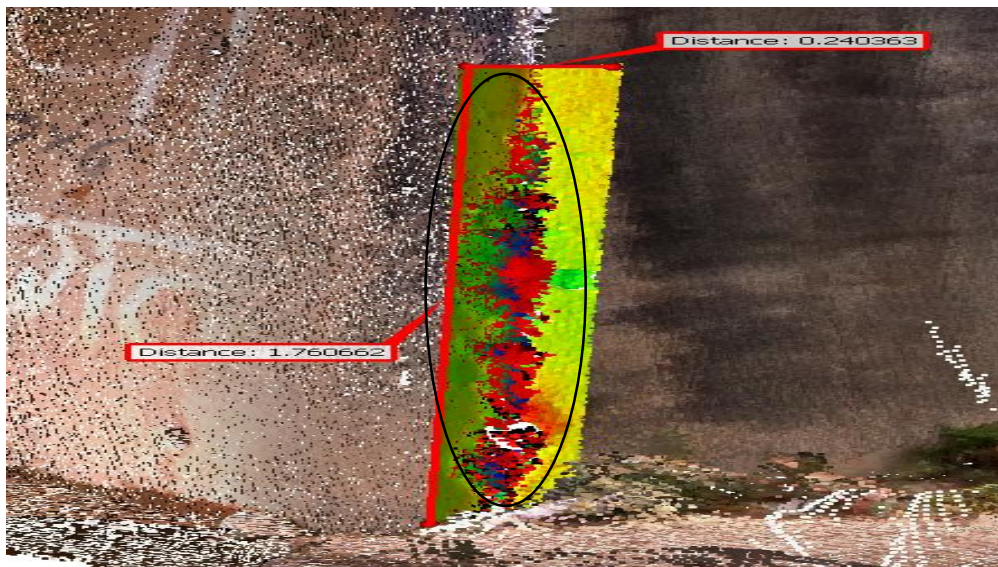
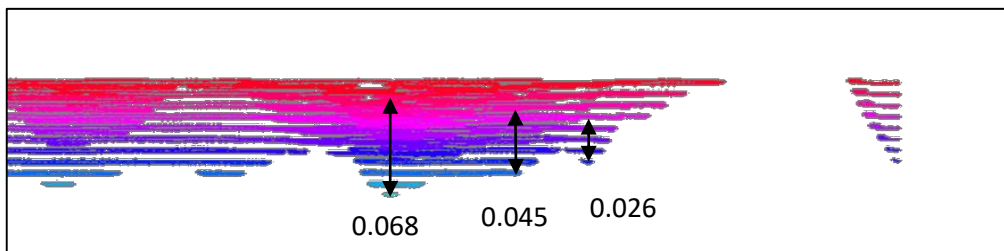
| Element Name | Observation | Location of Distress | Photo No. | Units | Distress Details | | | Area of Repair (Sq.m/ RMT/ m3) |
|---|---|---|---|---|---|---|---|---|
| Wing Wall | Damage | | 3 | M | 1.76 | 0.24 | 0.045 | 0.0190 |

3. Wing wall damage observed on RHS Abutment 2, measuring 1.76 m in length and 0.24 m in width, Depth ranges from 0.026 m (min) to 0.068m (max), with an average depth of 0.045 m. The calculated volume of the distress is 0.0190 m<sup>3</sup>.

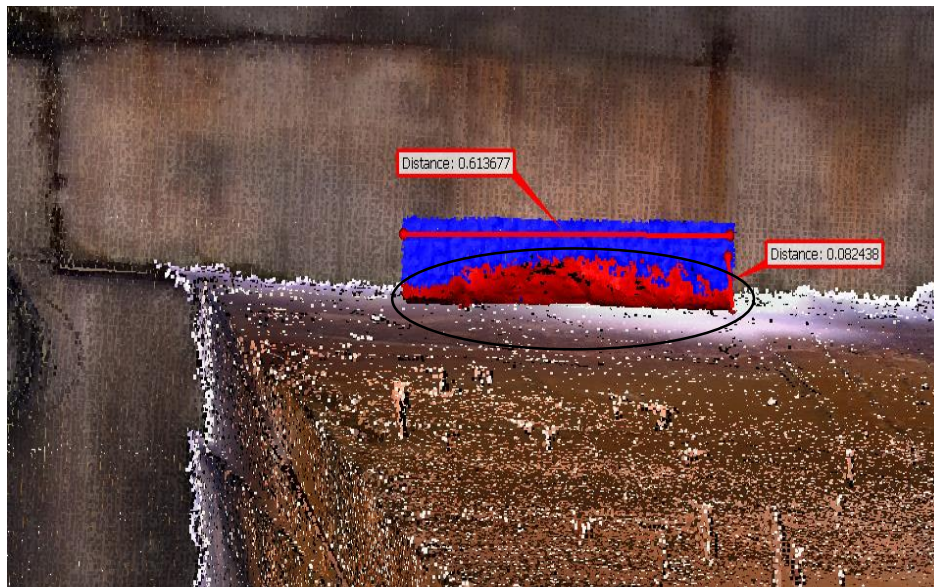
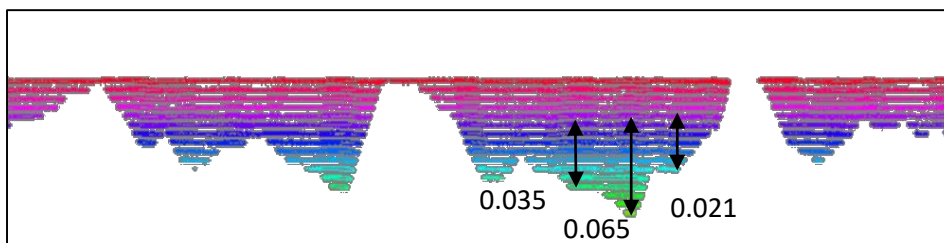
| Element Name | Observation | Location of Distress | Photo No. | Units | Distress Details | | | Area of Repair (Sq.m/ RMT/ m3) |
|---|---|---|---|---|---|---|---|---|
| Slab Bottom | Damage | | 4 | M | 0.61 | 0.08 | 0.035 | 0.0017 |

- 4. Damage observed on bottom of RHS slab, measuring 0.61 m in length and 0.08 m in width, Depth ranges from 0.021 m (min) to 0.065m (max), with an average depth of 0.035 m. The calculated volume of the distress is 0.0017 m<sup>3</sup>.**

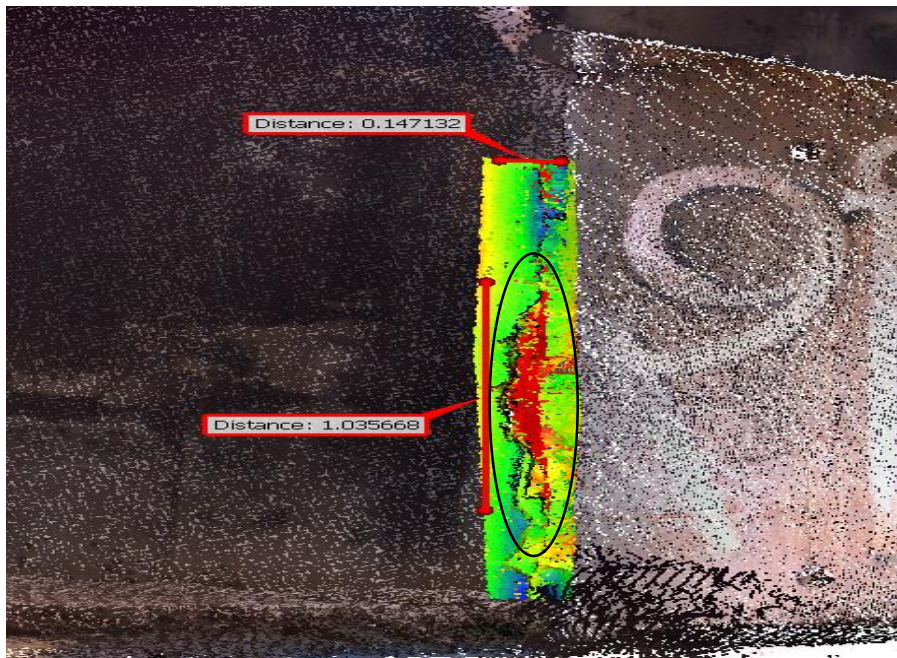
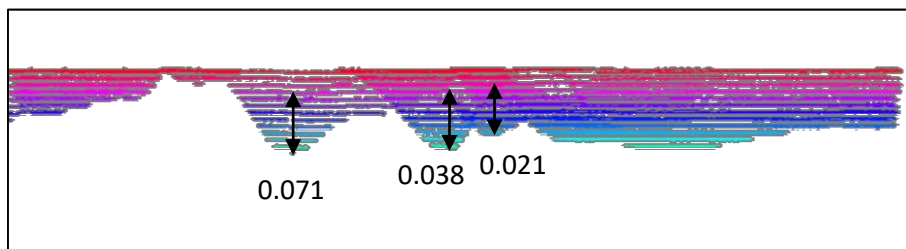
| Element Name | Observation | Location of Distress | Photo No. | Units | Distress Details | | | Area of Repair (Sq.m/ RMT/ m3) |
|---|---|---|---|---|---|---|---|---|
| Wing Wall | Damage | | 5 | M | 1.03 | 0.14 | 0.038 | 0.0054 |

5. Wing wall damage observed on LHS Abutment 2, measuring 1.03 m in length and 0.14 m in width, Depth ranges from 0.021 m (min) to 0.071m (max), with an average depth of 0.038 m. The calculated volume of the distress is 0.0054 m<sup>3</sup>.
