# LIDAR Inspection Report of **Slab Culvert** ch.938+834

**Bridge Chainage:** 938 + 834 (CKRP)

- **CKRP:** Chittorgarh to kota
- **State:** Rajasthan NH 27
- **Zone:** RJ-06

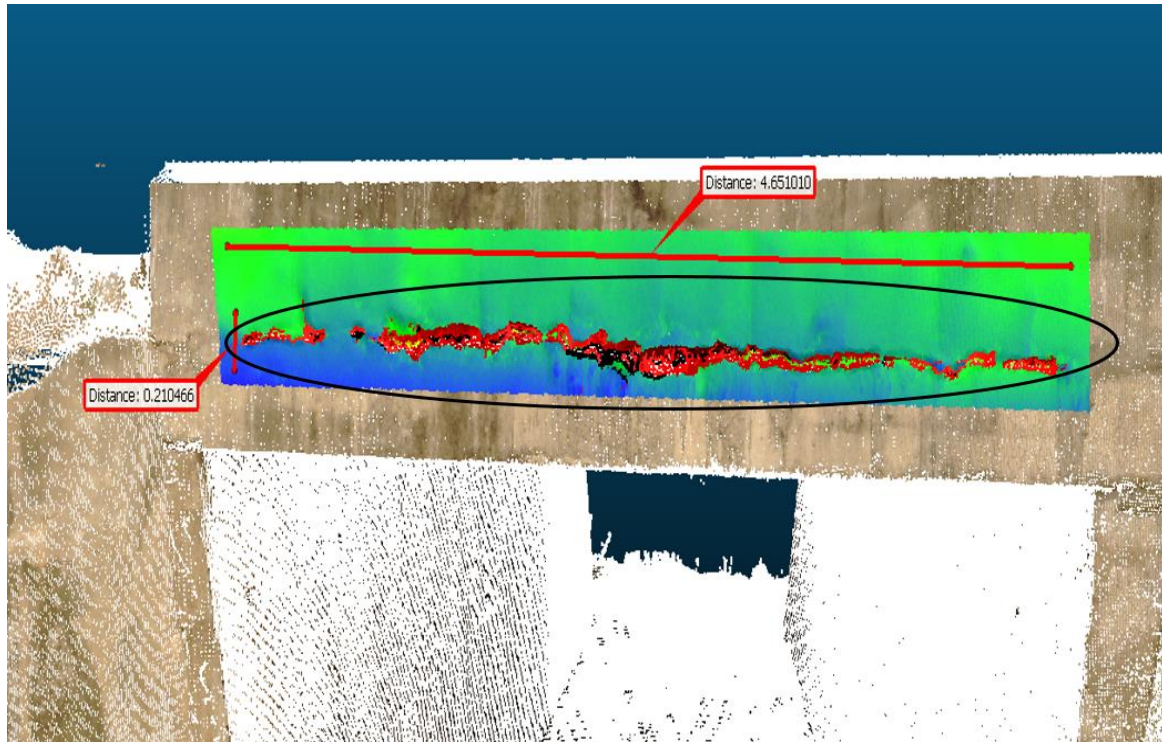
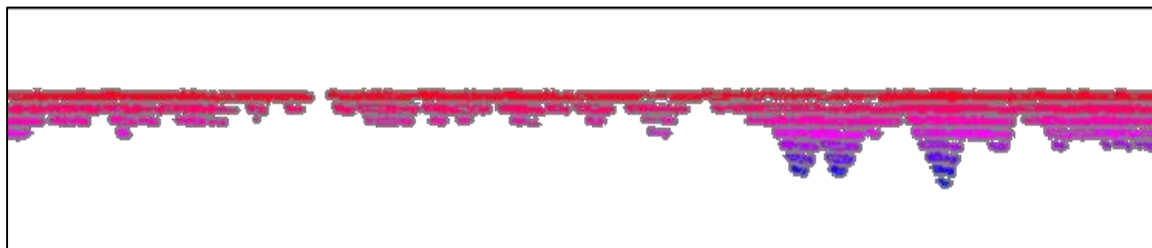
- 1. Parapet wall scaling observed on LHS, measuring 4.6510 m in length and 0.2104 m in width, covering an area of 0.98 m<sup>2</sup>.**
