# **LIDAR Inspection Report of VUP ch.938+100**

**Bridge Chainage:** 938+100 (CKRP)

- **Bridge No:** -
- **Chainage:** 938+100
- **Structure type:** VUP

- **CKRP:** Chittorgarh to kota
- **State:** Rajasthan NH 27
- **Zone:** RJ-06

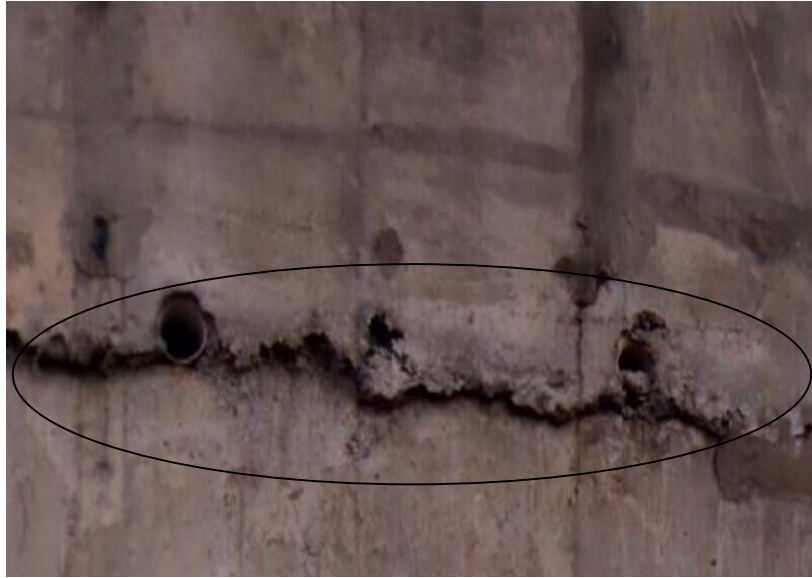
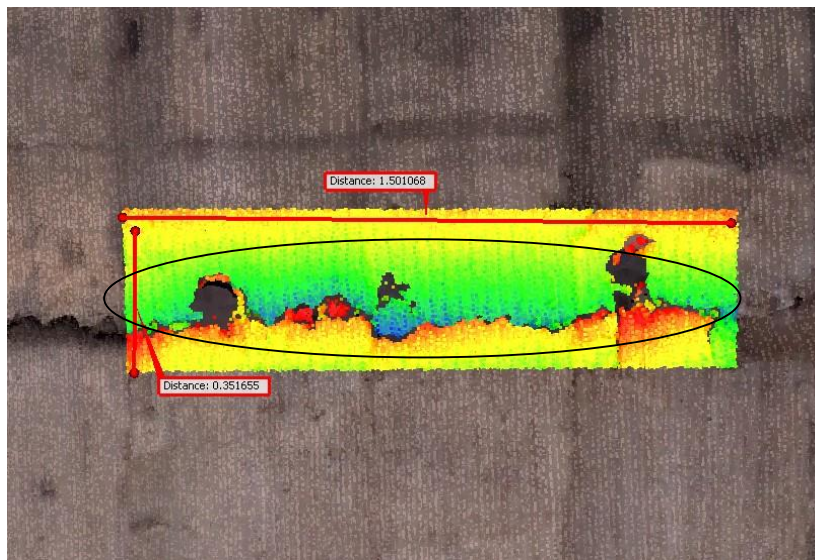
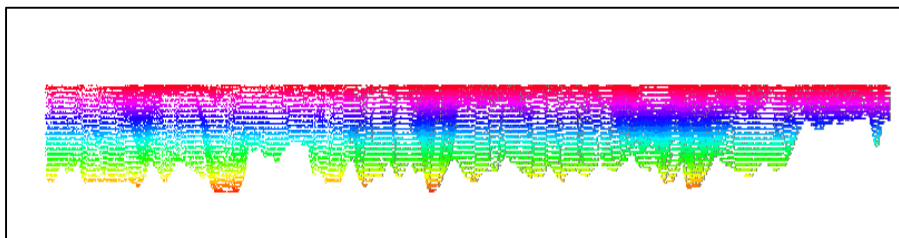
| Element Name | Observation | Location of Distress | Photo No. | Units | Distress Details | | | Area of Repair (Sq.m/RM T/m3) |
|---|---|---|---|---|---|---|---|---|
| Abutment 1 | Damage | - | 1 | M | 1.50 | 0.35 | - | 0.525 |

**1. Wing wall damage observed on LHS A1, measuring 1.50 m in length and 0.35 m in width, covering an area of 0.525 m<sup>2</sup>.**

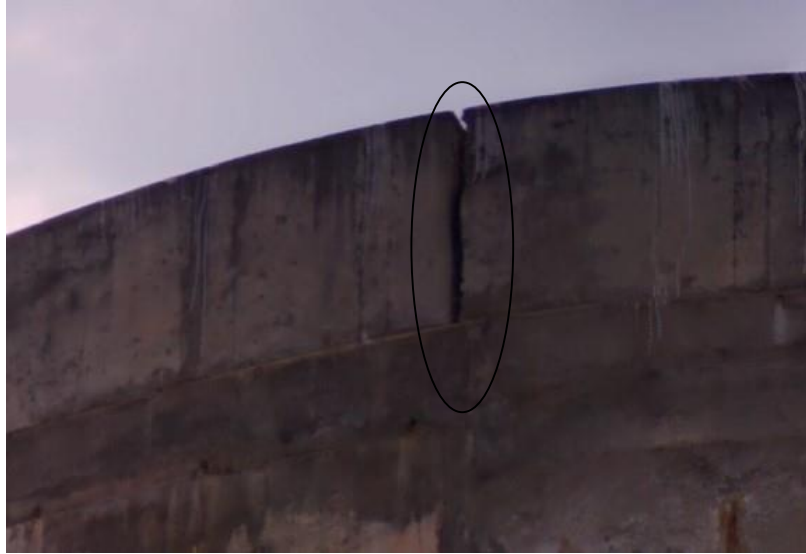
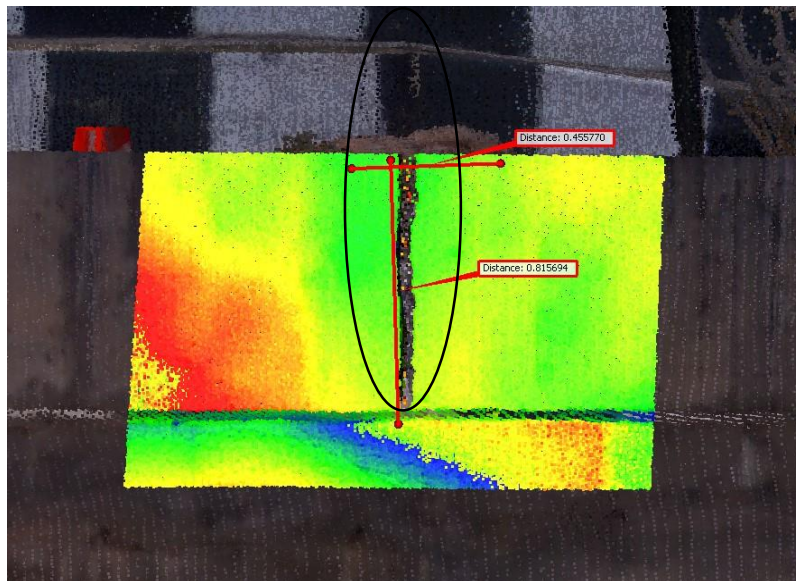
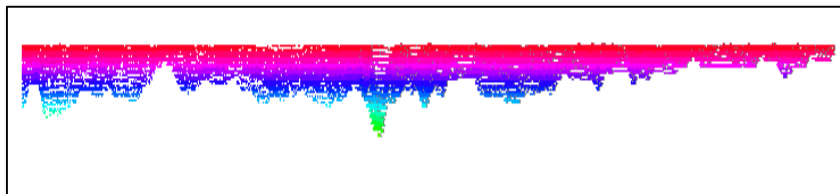
| Element Name | Observation | Location of Distress | Photo No. | Units | Distress Details | | | Area of Repair (Sq.m/RM T/m3) |
|---|---|---|---|---|---|---|---|---|
| Abutment 2 | Damage | - | 1 | M | 0.81 | 0.45 | - | 0.364 |

**2. Parapet wall damage observed on RHS A2, measuring 0.81 m in length and 0.45 m in width, covering an area of 0.364 m<sup>2</sup>.**
