# **Satellite Structural Inspection Interferometric Synthetic Aperture Radar (InSAR) Based**

Bridge No. – 903/2

Bridge Chainage – 938+250

Project - Chittorgarh to Kota

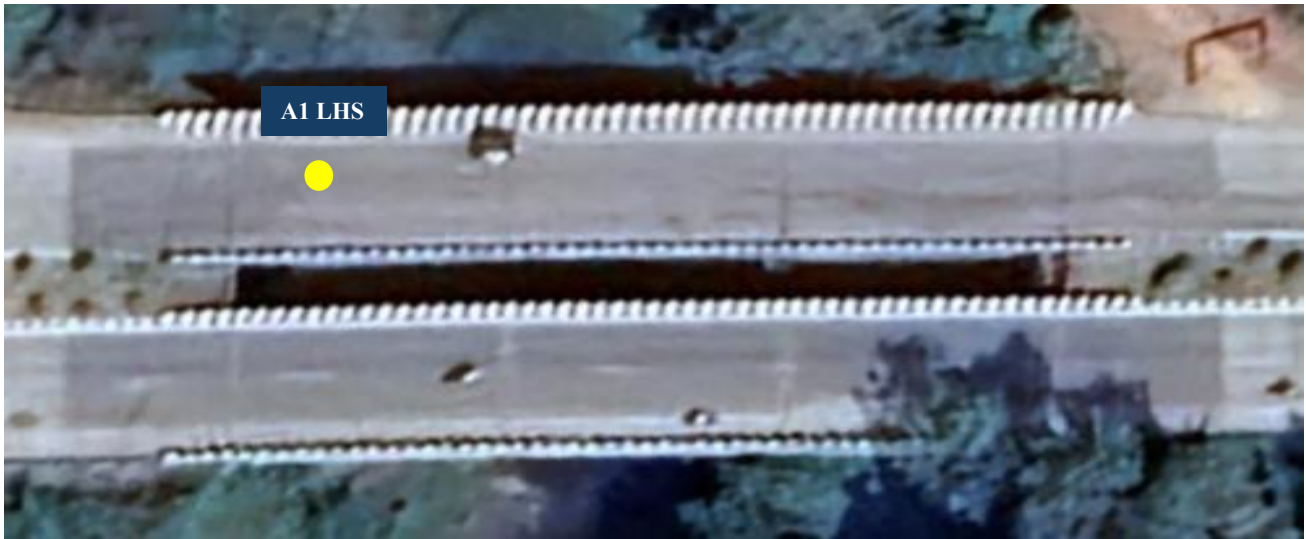
A1 LHS (25.090393973306902, 74.8530886724658)

- **Vertical Displacement (VV)** shows progressively increasing negative values through the monitoring period.
- **Horizontal displacement (VH)** displays moderate variability, ranging from +5 mm to -18 mm.

- **March 2025:** Both VH and VV show a sharp drop (around -10 mm to -15 mm), marking a distinct downward event affecting both vertical and horizontal displacement.
- **April–May 2025:** VV remains consistently negative (between -10 mm to -18 mm), indicating sustained downward settlement.
- **June 2025:** Both VH and VV record some of the most negative values of the entire period (approaching -20 mm), indicating the continuation of structural movement and potential instability at this abutment location.

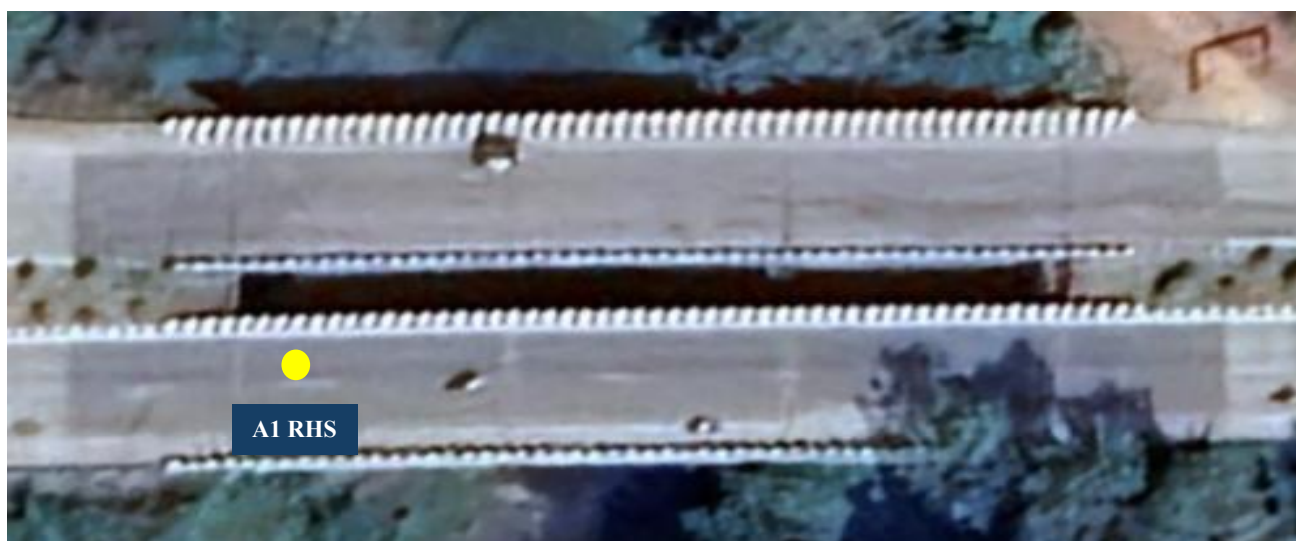
A1 RHS (25.090315317277188, 74.85312875768254)

- **Horizontal displacement (VH)** VH shows alternating upward and downward movement in February–April 2025, followed by a consistent upward trend after May 2025.
- **Vertical displacement (VV)** shows moderate variation throughout the monitoring period, mostly ranging between 0 mm and –15 mm.

- **March 2025:** VV records a sharp drop to around –12 mm, indicating a short-duration settlement event. VH also shows a corresponding dip, reflecting simultaneous vertical and lateral movement.
- **April–May 2025:** VV remains consistently negative (between –10 mm to –15 mm), indicating sustained downward displacement, while VH begins transitioning upward, showing divergence between vertical and horizontal movement.
- **June 2025:** VH increases sharply toward +15 to +18 mm, marking a significant lateral shift.

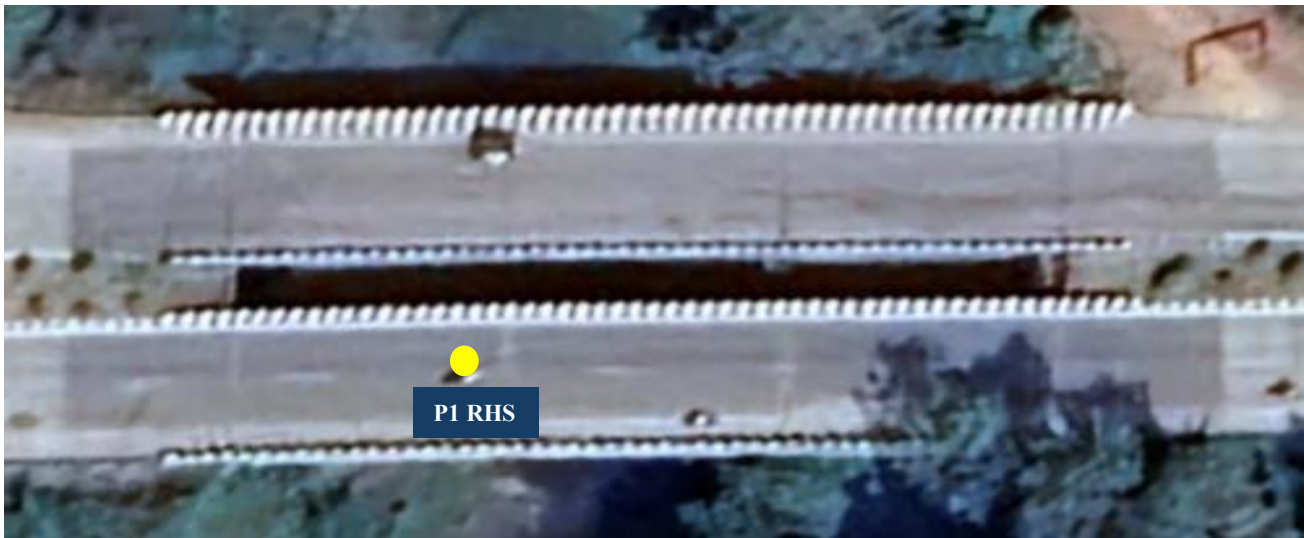
P1 RHS (25.09034643395433, 74.85324996774266)

- **Vertical Displacement (VV)** remains relatively stable with values mostly between **-8 mm and +5 mm**.
- **Horizontal Displacement (VH)** shows a clearer upward trend over time, starting near **0 to +5 mm** in January and gradually rising to **+15–20 mm** by late May and June.

- **March–April 2025:** VH begins a noticeable upward progression, crossing **+10 mm**, while VV remains stable showing separation between vertical and horizontal behaviours.
- **May 2025:** VH reaches its highest levels (**+20 mm**), indicating peak lateral movement. Meanwhile, VV stays within its typical moderate range (**-2 to +2 mm**), showing no corresponding vertical deformation.
- Overall, VH demonstrates **consistent lateral drift**, while VV displays **mild but stable variability**, suggesting lateral deformation at P1 RHS without significant vertical instability.

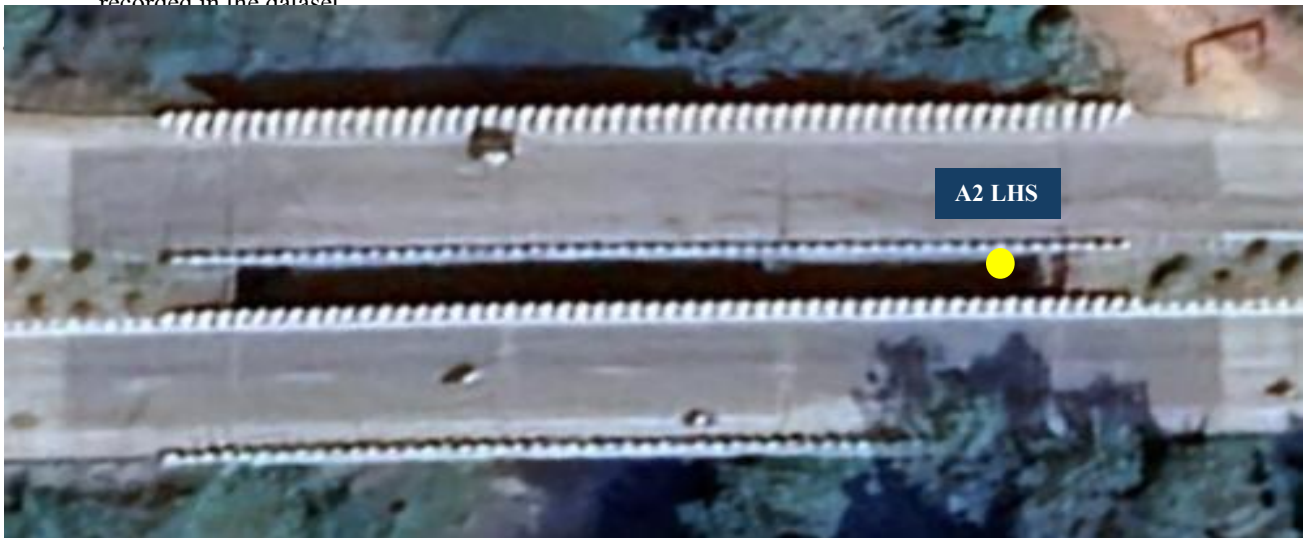
- **Vertical Displacement (VV)** shows higher variability with multiple downward movements, ranging roughly from +5 mm to –20 mm.
- **Horizontal Displacement (VH)** remains mostly positive and stable, generally between 0 mm and +10 mm, except for a few small negative fluctuations. VH shows an upward shift during mid-May and early June before stabilizing again.

- **Feb 2025:** VV experiences an early significant negative drop (approx. –10 mm).
- **March 2025:** Another sharp VV decline occurs, reaching roughly 12 mm, followed by a slow recovery trend.
- **June 2025:** VV remains negative (around –15 mm) while VH returns to moderate positive values (around +4 mm).

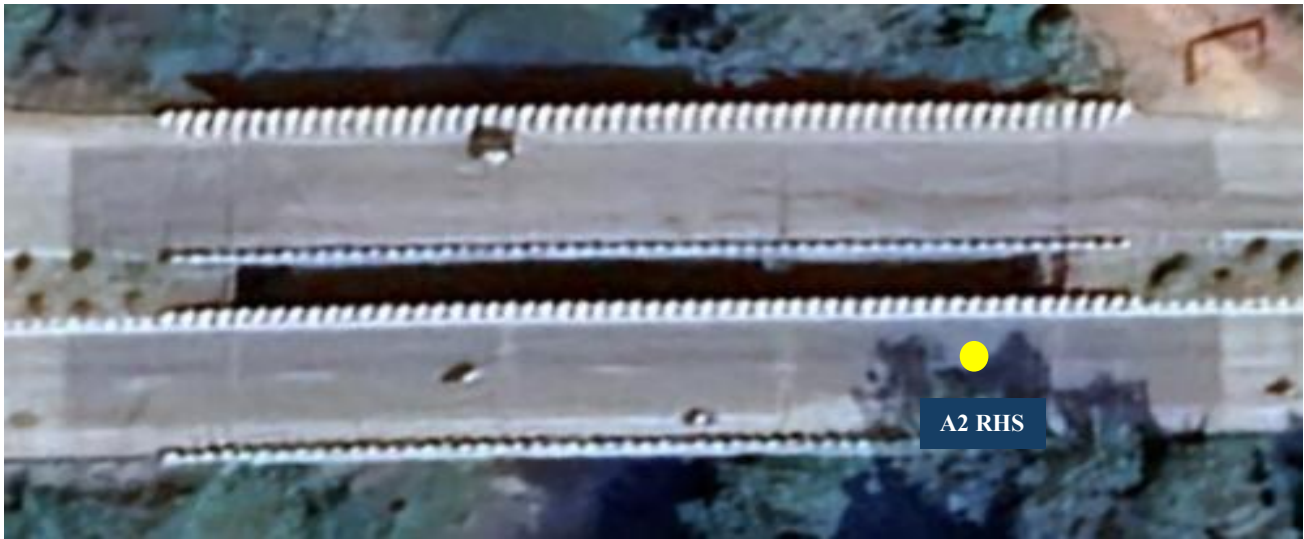
A2 RHS (25.090451187350848, 74.8536001517465)

- **Vertical Displacement (VV)** shows moderate-to-high variability, generally ranging from 0 mm up to 20 mm, with several prominent upward peaks (notably in early April and early June). The VV values exhibit a rising trend in the later months.
- **Horizontal Displacement (VH)** remains mostly positive and stable, with readings between 0 mm and +10 mm. VH shows a mild increasing trend through April–June, indicating consistent lateral movement but without instability. Component.

- **Feb 2025:** A mild early dip in both VV and VH occurs (VV near –2 mm, VH around –3 mm).
- **May 2025:** VH reaches one of its higher values (around +10 mm), corresponding with a moderate VV rise.
- **June 2025:** VV peaks again (+20 mm), followed by a minor drop but remains elevated overall.
