# LIDAR Inspection Report of **Box Culvert** ch.938+424

**Bridge Chainage:** 938+424(CKRP)

# **CH: 938+424 – Box CULVERT**

**DISTRESS PHOTOS**

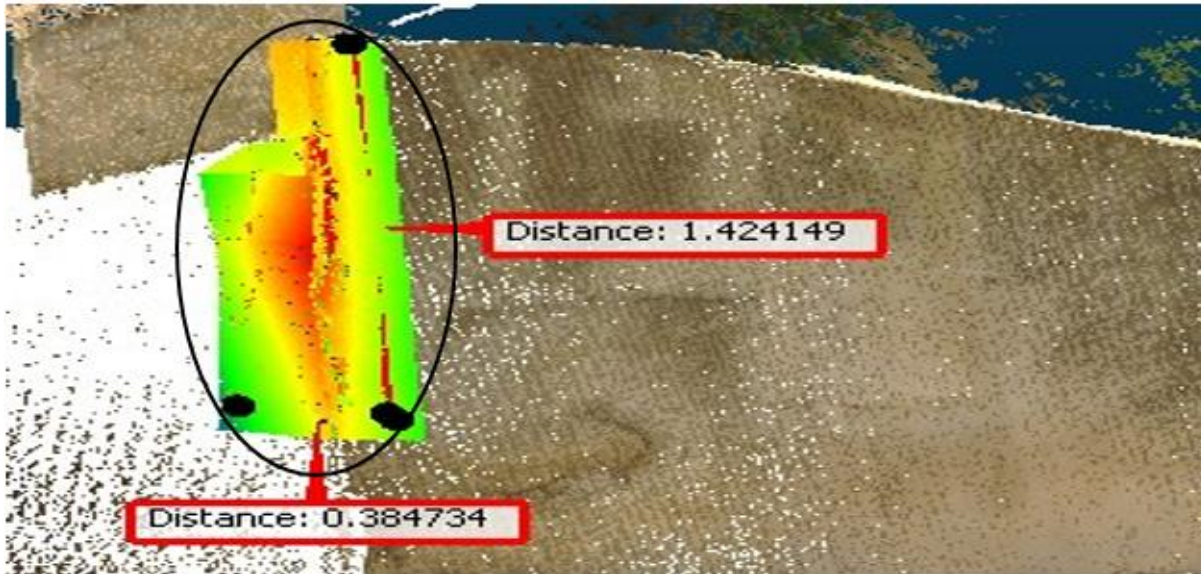
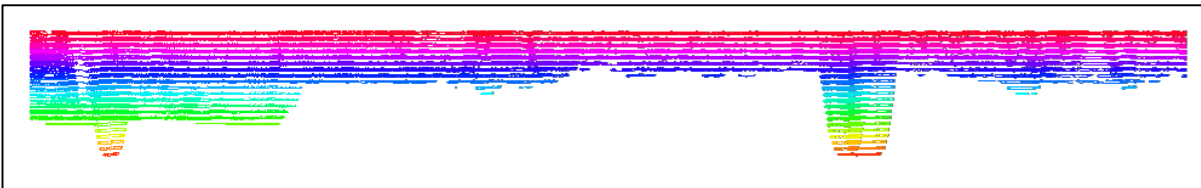
**1. "Wing wall damage observed, measuring 0.38 m in length and 1.42 m in width, covering an area of 0.54 m<sup>2</sup>."**

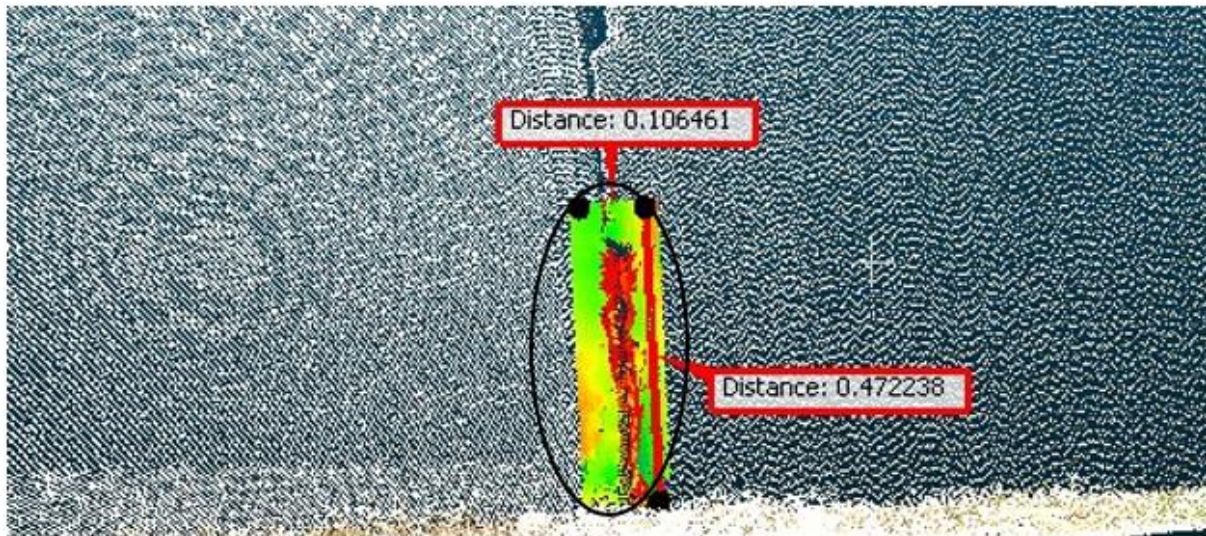
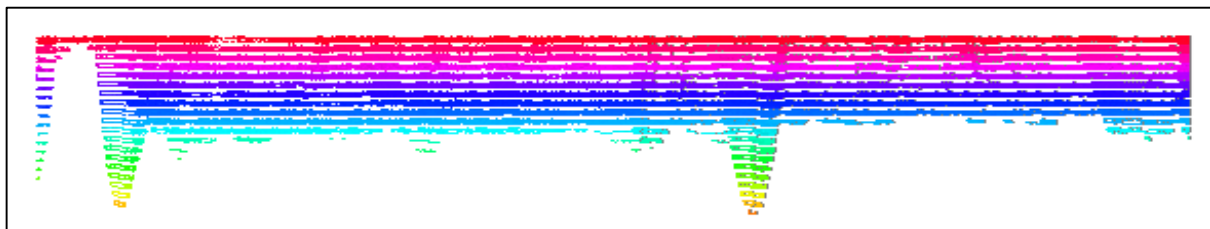
**2. "Wing wall damage observed, measuring 0.10 m in length and 0.47 m in width, covering an area of 0.047 m<sup>2</sup>."**

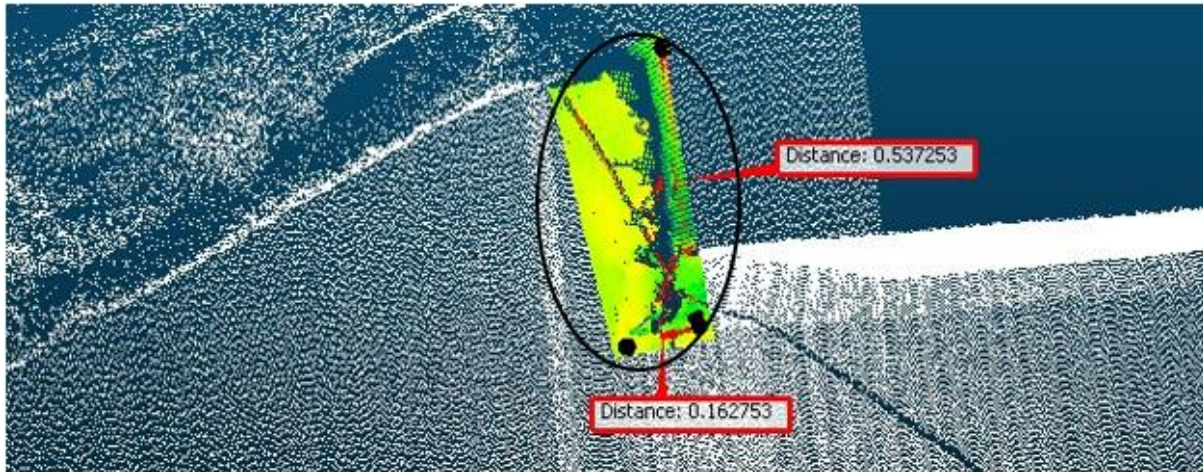
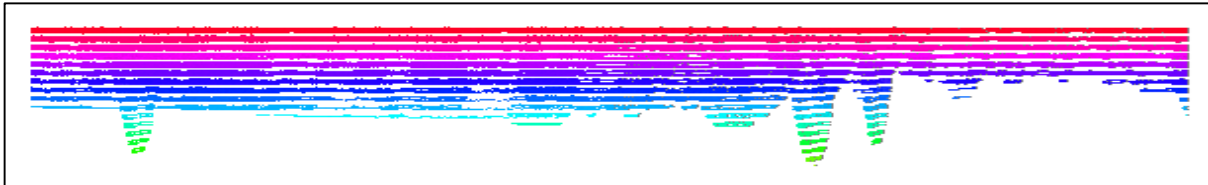
**3. "Wing wall damage observed on LHS A1, measuring 0.16 m in length and 0.53 m in width, covering an area of 0.0848 m<sup>2</sup>."**

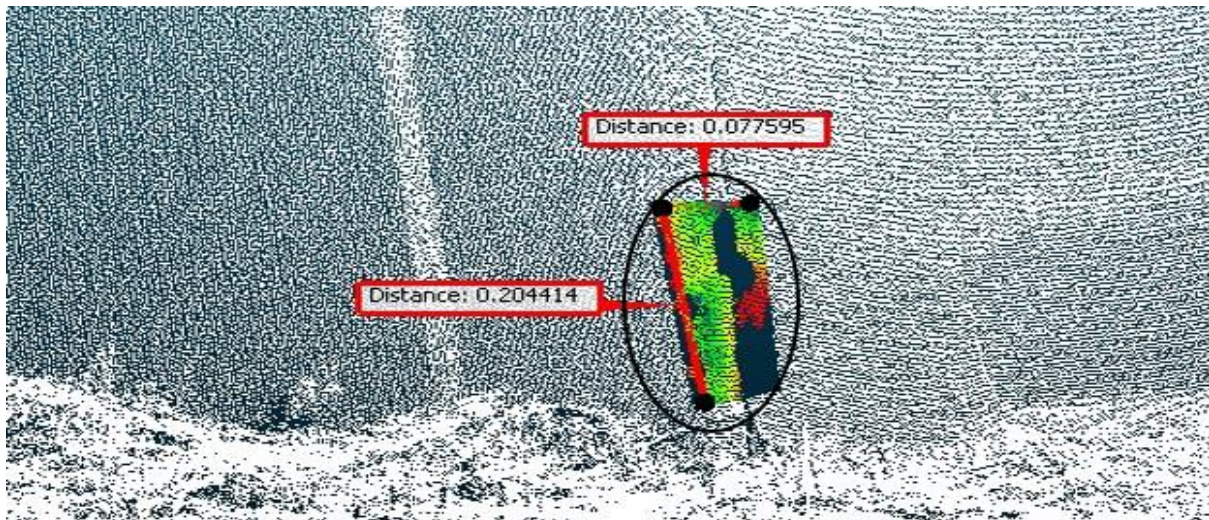
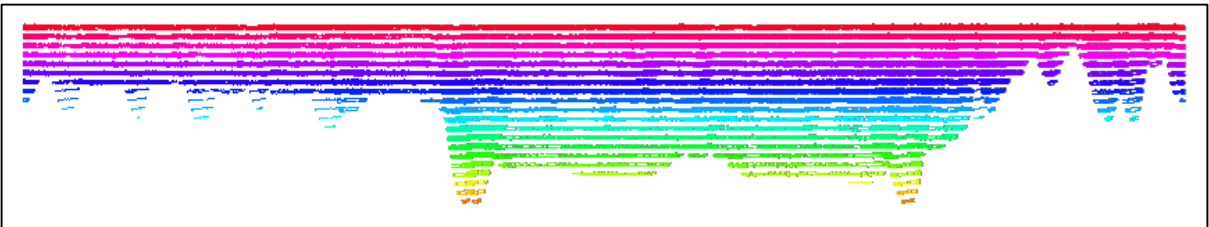
**4. "Wing wall damage observed on LHS A1, measuring 0.07 m in length and 0.20 m in width, covering an area of 0.014 m<sup>2</sup>."**

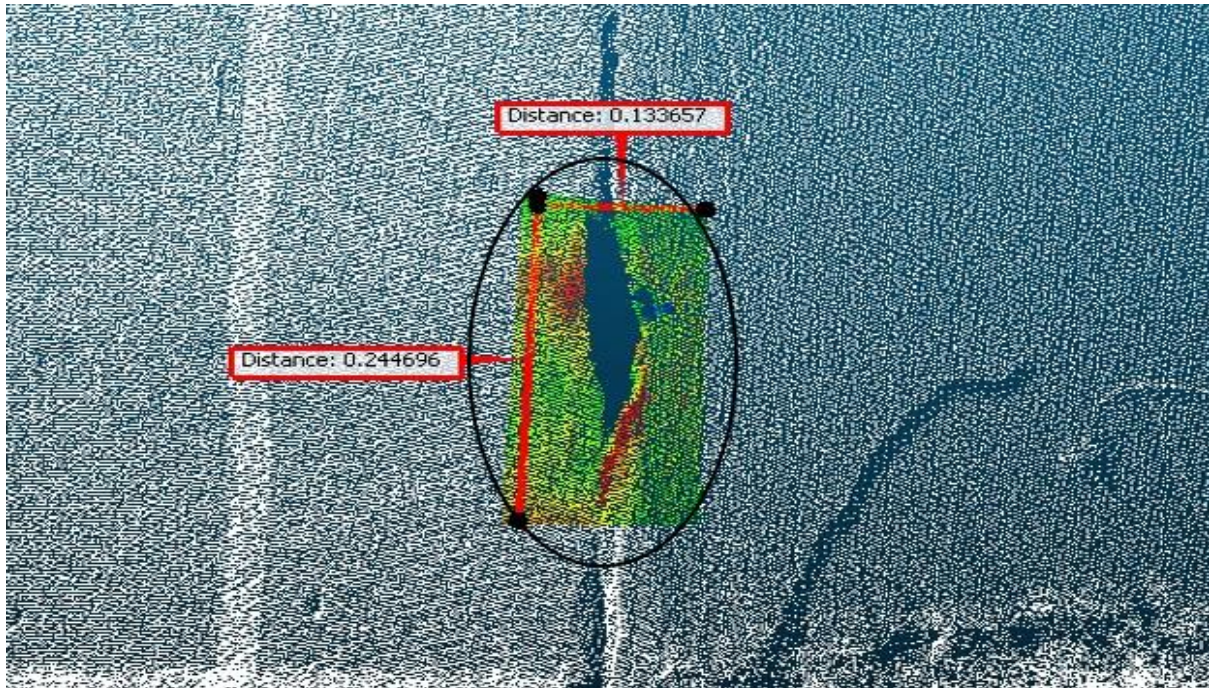
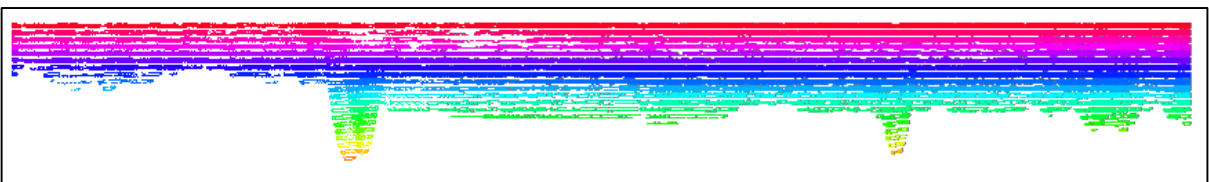
5. "Wing wall damage observed on LHS A1, measuring 0.13 m in length and 0.24 m in width, covering an area of 0.0312 m<sup>2</sup>."
