# LIDAR Inspection Report of **Box Culvert** ch.938+484

**Bridge Chainage:** 938+484(CKRP)

- **CKRP:** Chittorgarh to kota
- **State:** Rajasthan NH 27
- **Zone:** RJ-06

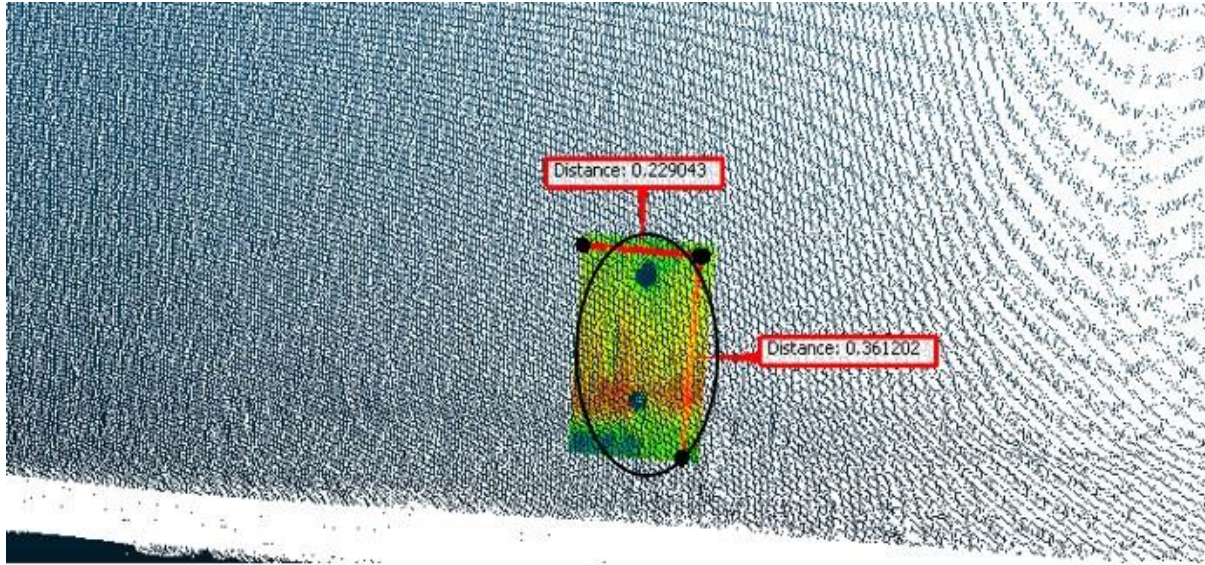
**1. "Damage observed on Abutment Wall, measuring 0.22 m in length and 0.36 m in width, covering an area of 0.0792 m<sup>2</sup>."**

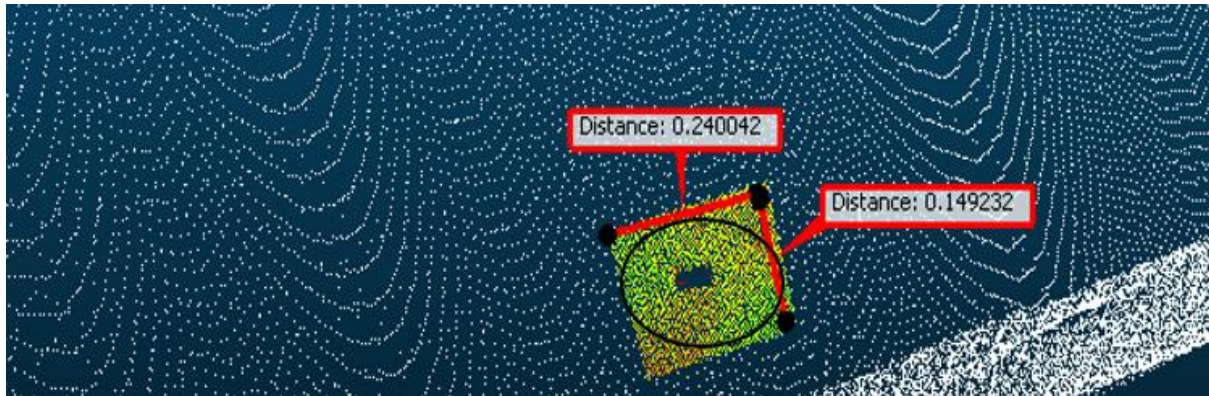
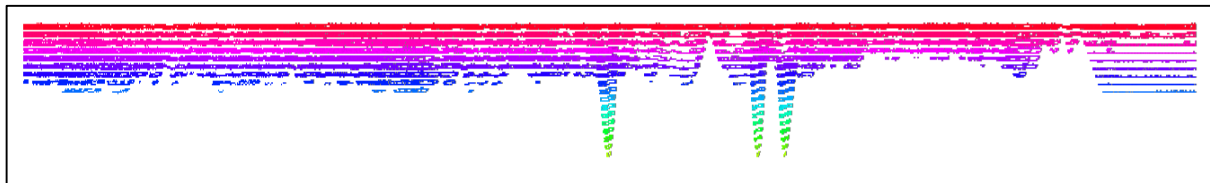
**2. "Damage observed on Abutment Wall, measuring 0.24 m in length and 0.14 m in width, covering an area of 0.0336 m<sup>2</sup>."**

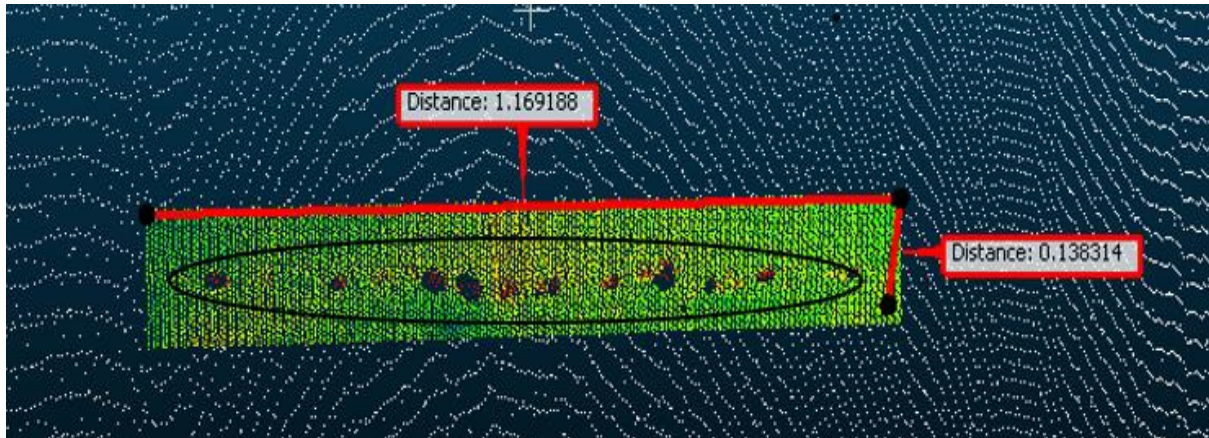
**3. "Scaling observed on Abutment Wall, measuring 1.16 m in length and 0.13 m in width, covering an area of 0.1508 m<sup>2</sup>."**

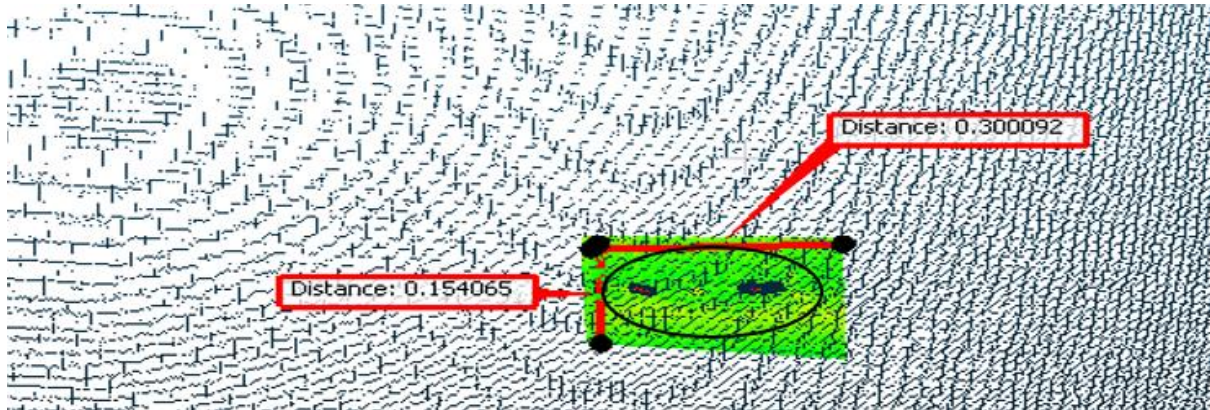
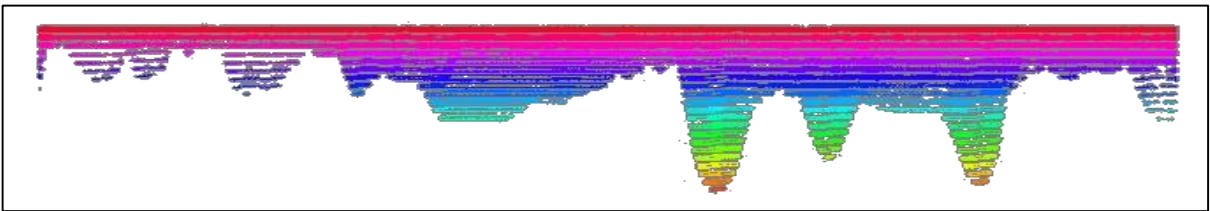
**4. "Damage observed on Abutment Wall, measuring 0.30 m in length and 0.15 m in width, covering an area of 0.045 m<sup>2</sup>."**

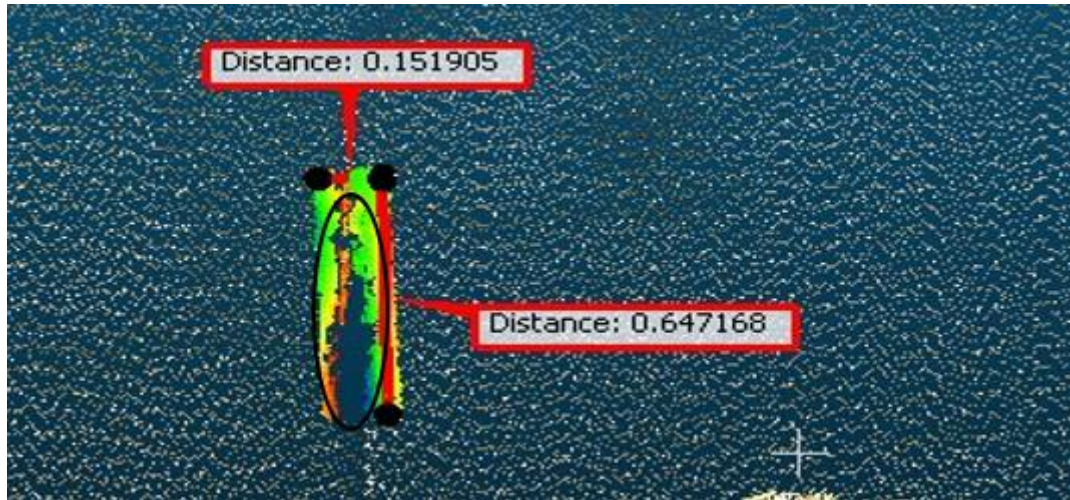
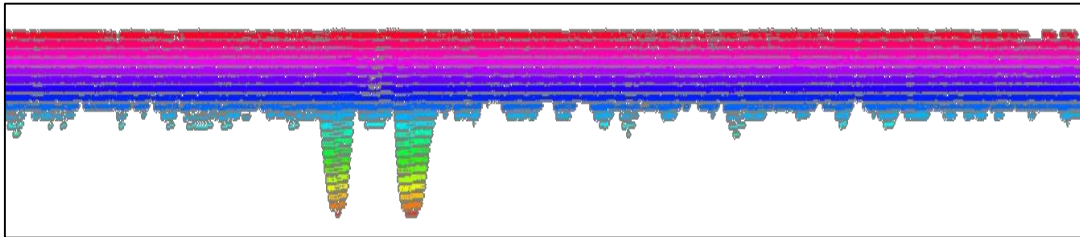
**5. "Damage observed on Wing Wall, measuring 0.15 m in length and 0.64 m in width, covering an area of 0.096 m<sup>2</sup>."**
