# **LIDAR Inspection Report of Box Culvert ch.938+670**

**Bridge Chainage:** 938+670

- **Bridge No:** -
- **Chainage:** 938+670
- **Structure type:** Box Culvert

- **CKRP:** Chittorgarh to kota
- **State:** Rajasthan NH 27
- **Zone:** RJ-20

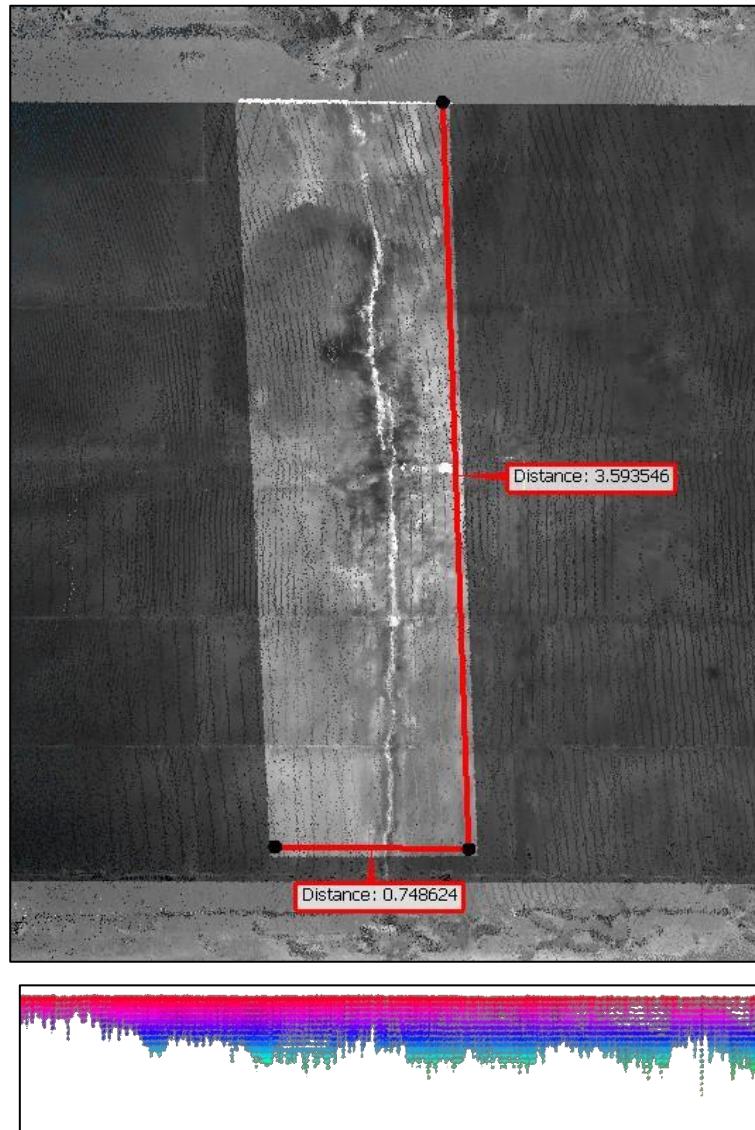
| Element Name | Observation | Location of Distress | Photo No. | Units | Distress Details | | | Area of Repair (Sq.m/R MT/m3) |
|---|---|---|---|---|---|---|---|---|
| Deck Slab | Efflorescence | - | 1 | Sq m | 3.5 | 0.74 | - | 2.59 |

**1.Efflorescence observed on deck slab at LHS A1 HP 8, measuring 3.5 m in length and 0.74 m in width, covering an area of 2.59 m<sup>2</sup>.**
